10 MOOR LANE, BUNNY -
PROTECTED SPECIES APPRAISAL

OCTOBER 2023

CHRIS RICHARDS
BSc (HONS), PGCERT.
PRINCIPAL ECOLOGIST

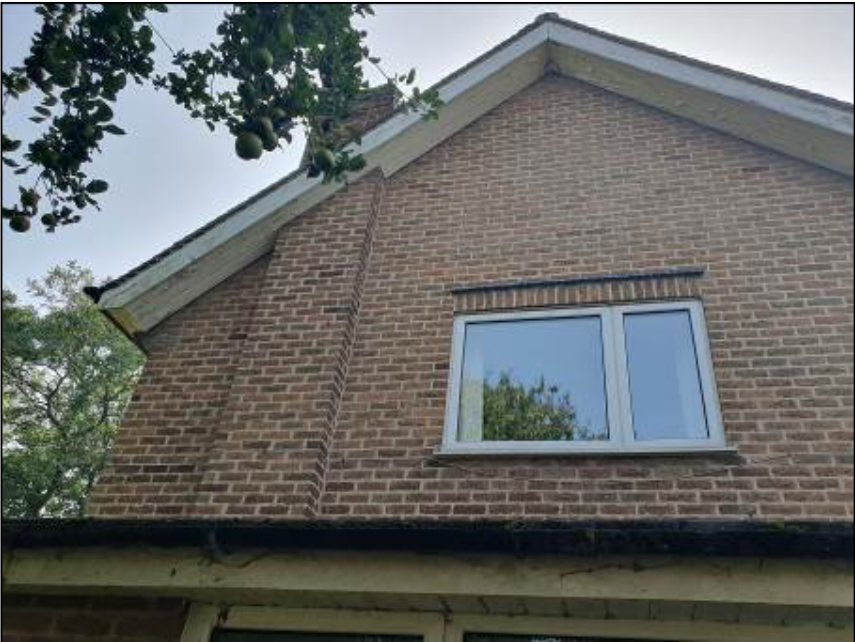
Photograph 1 - North-eastern aspect of building

The building is in a very good state of repair, with no gaps, cracks or crevices in the brickwork and mortar and no raised, missing or slipped tiles on the roof. The only exception to this is a small area of missing mortar at the apex of the northern gable end, but this was assessed to be surface shelling only and would not allow access to the fabric of the building.
