TREE REPORT

7A Smitham Bottom Lane

SBL5/2024/01/JRH

24/02/2024

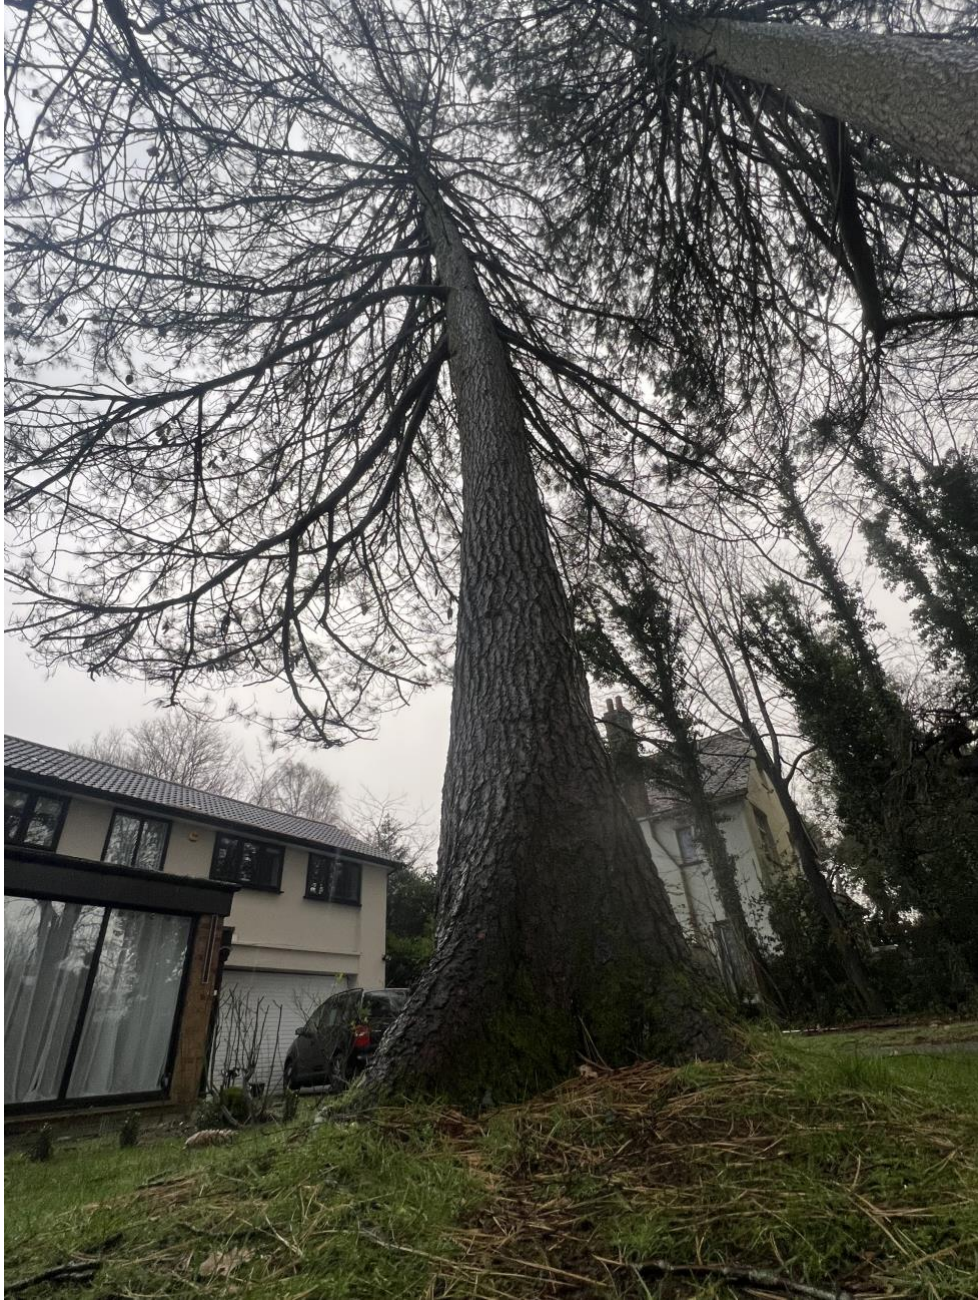
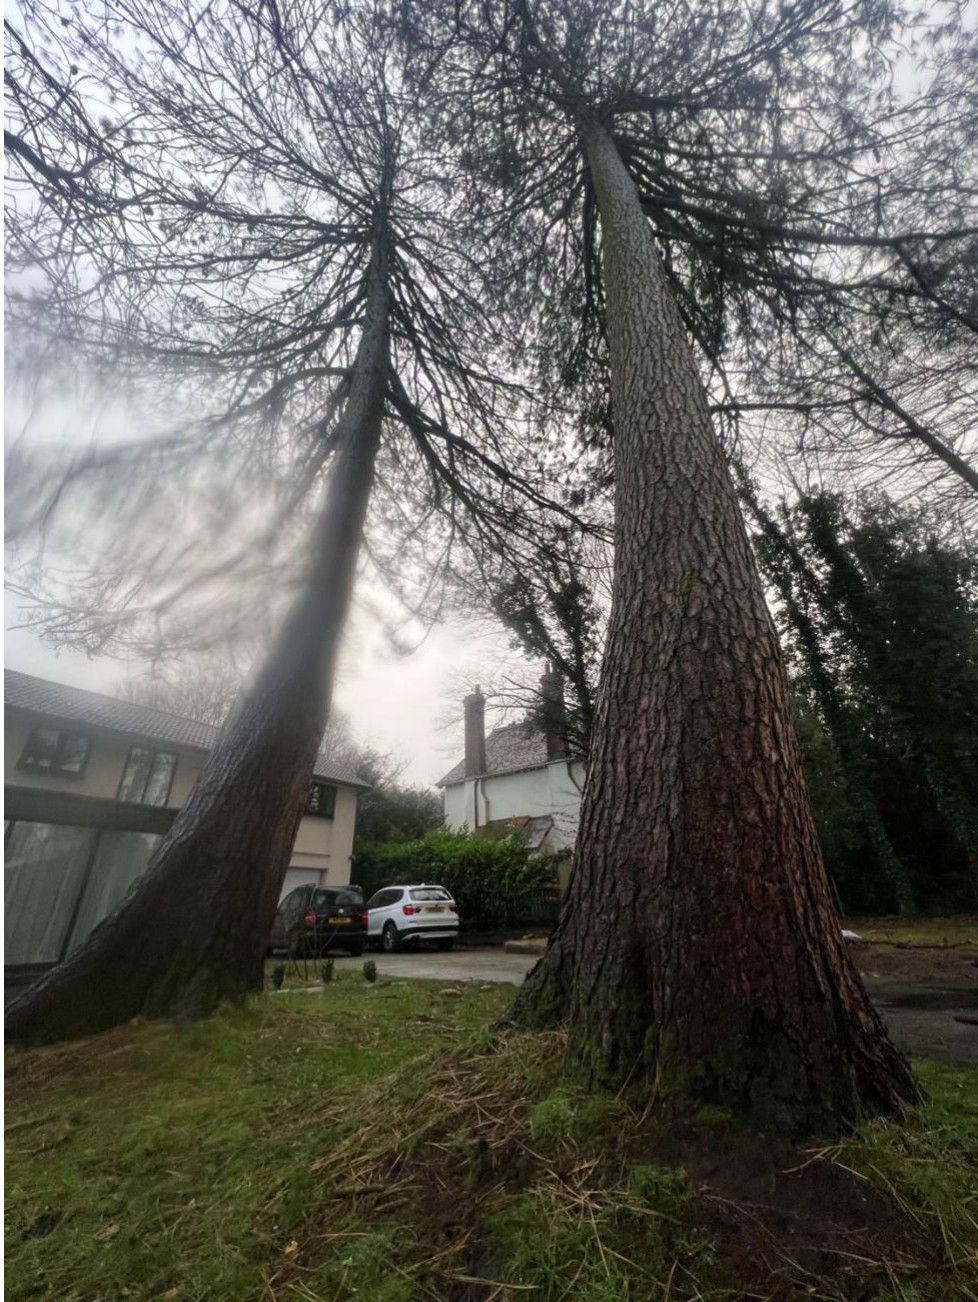
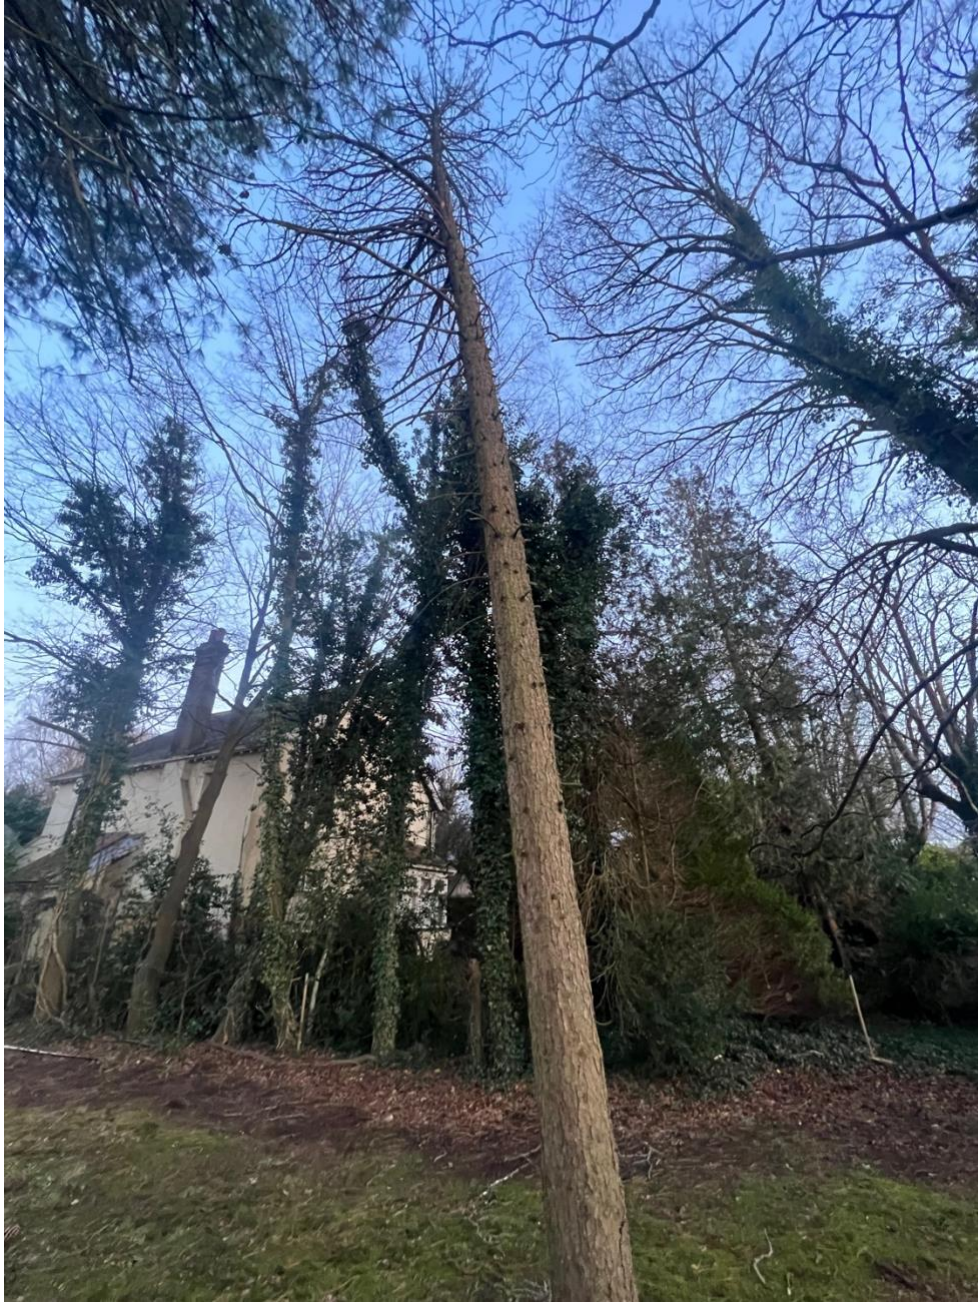
T11 and T12 Austrian Pines exhibit major deadwood, spread around the crown and leans precariously towards property and is slightly uprooted as shown in photographs. T9 The Scot's Pine has died presumably due to lack of sunlight as is completely overshadowed by other larger specimens surrounding it.

Owing to the presence of these findings and close proximity to building recommend complete removal of all three specimens.
