Mayerling, Liss, GU33 7EU

Arboricultural Method Statement & TCP

Ben Clutterbuck *HND Arb, M Arbor A*

Date: 01/03/2024

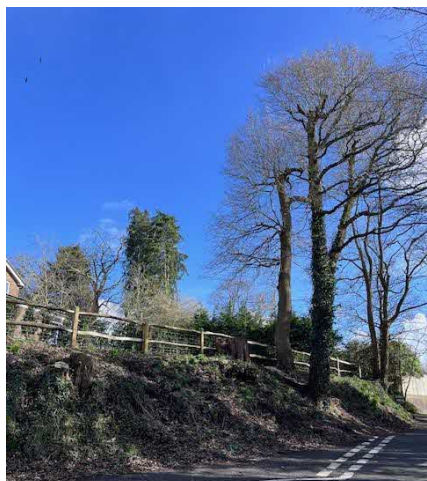
The trees in question are in the bank down to the road, as can be seen in images.

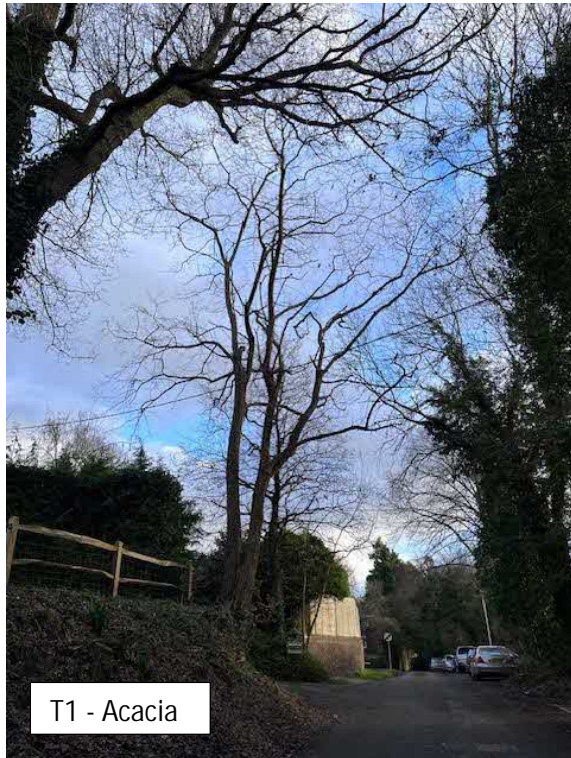
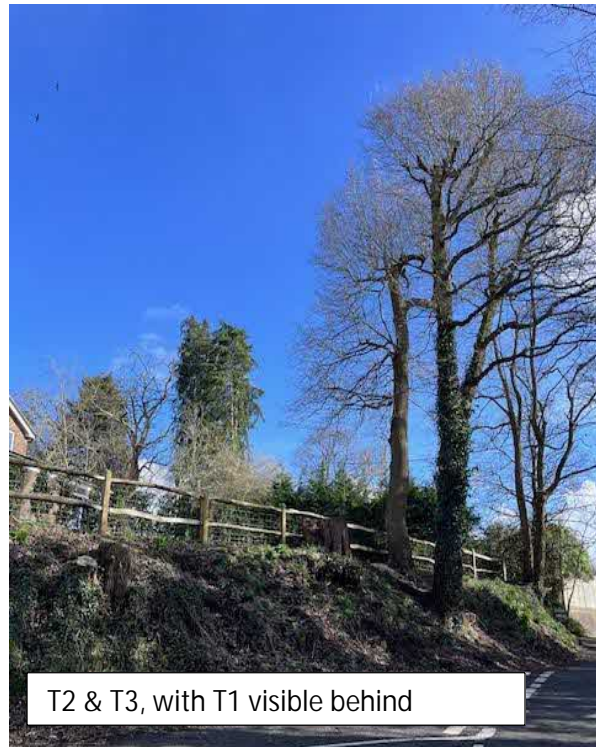
I have graded the trees as 'B' – they are all significant trees despite having signs of significant previous management/pruning which has affected their canopy development. Only the Acacia over the entrance holds a lot of dead wood so has been downgraded to a 'C'.

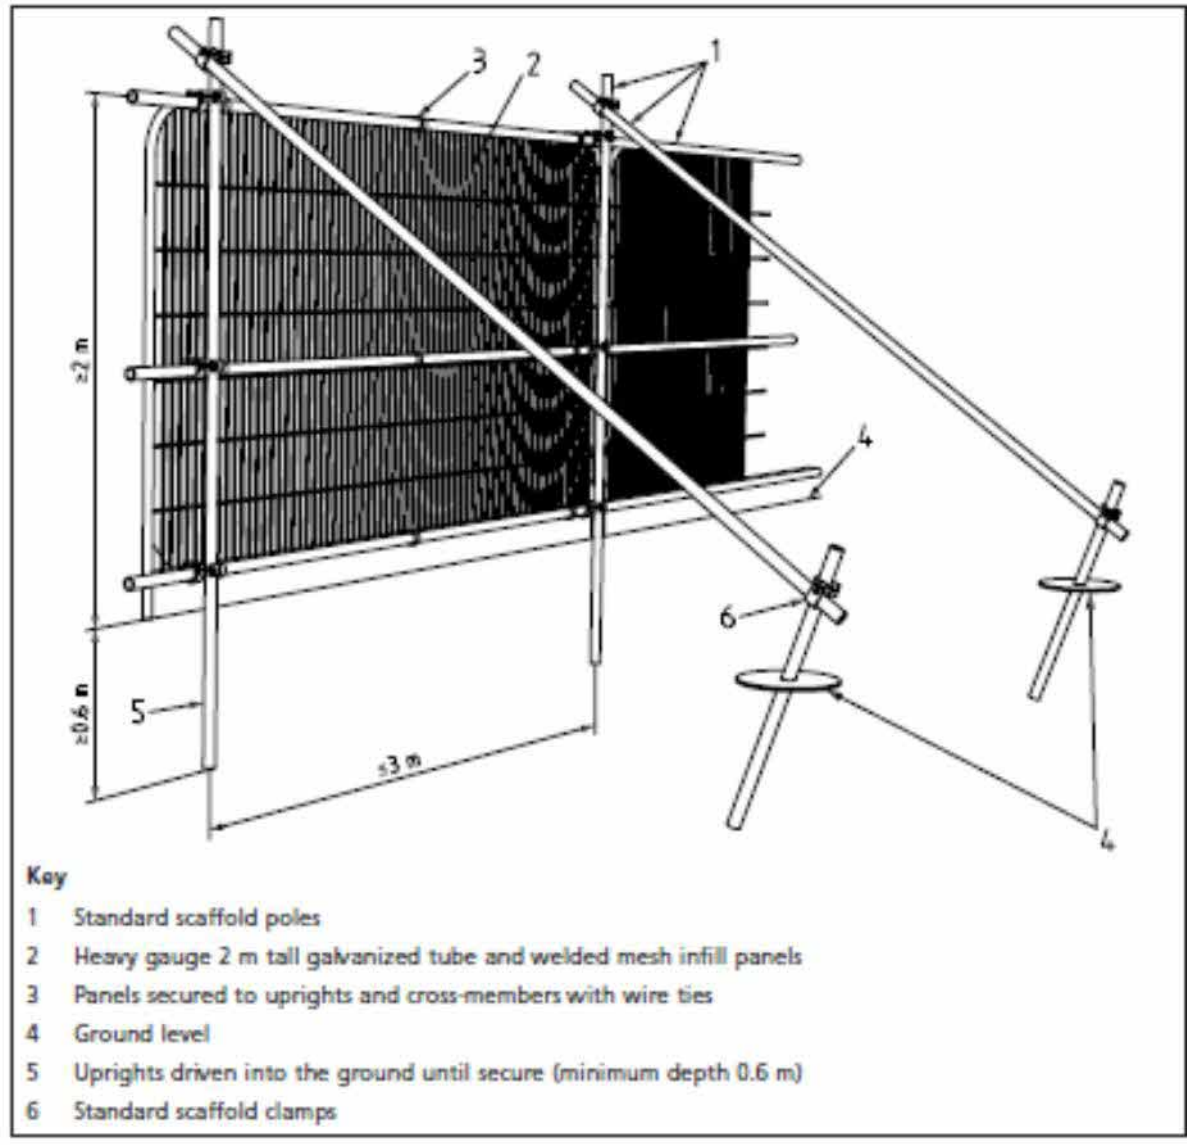
Figure 2 Default specification for protective barrier

This fencing construction can be used where scaffold poles can be knocked into the ground without damage to the rooting system.

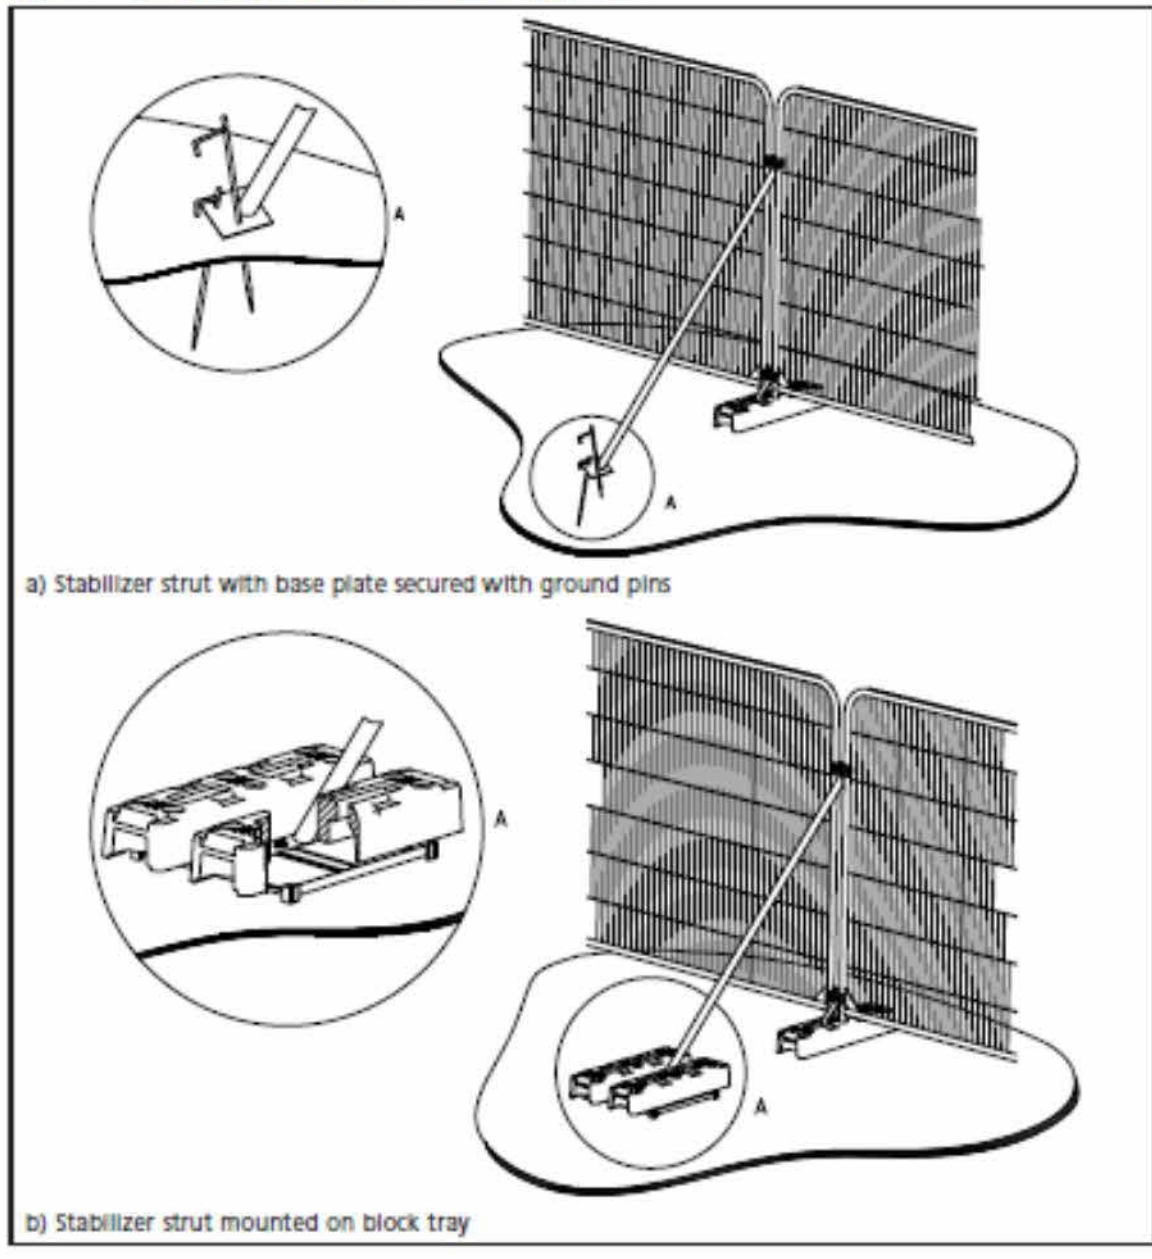
Figure 3 Examples of above-ground stabilizing systems

This type of fencing is to be used in situations where the installation of scaffold poles is likely to cause damage to the rooting system.
