Bat Survey Report

Bec House Outbuildings, Monxton, Andover, SP11 8AH

Project Name: Bec House Outbuildings, Monxton

Report Title: Bat Survey Report

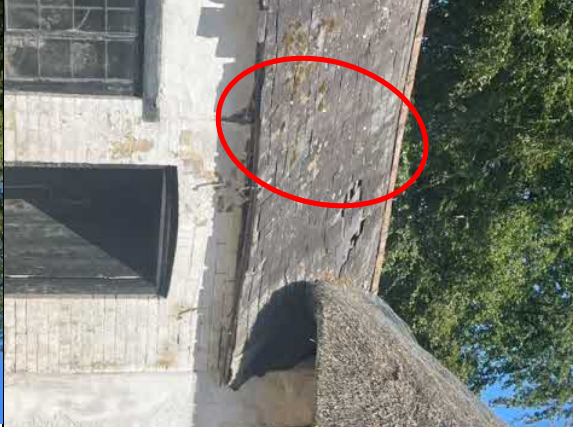
Structure A was found to have bat roosting potential in the form of the gaps under the ridge tiles and broken roof tiles. The potential was assessed according to the scale negligible, low, moderate, or high and the structure was deemed to have moderate bat roosting potential. The loft space was not fully accessible so the area could not entirely be surveyed for evidence of bats.

<p>Photograph 1: Structure A.</p>	<p>Photograph 2: Structure A with gaps in slate roof tiles</p>

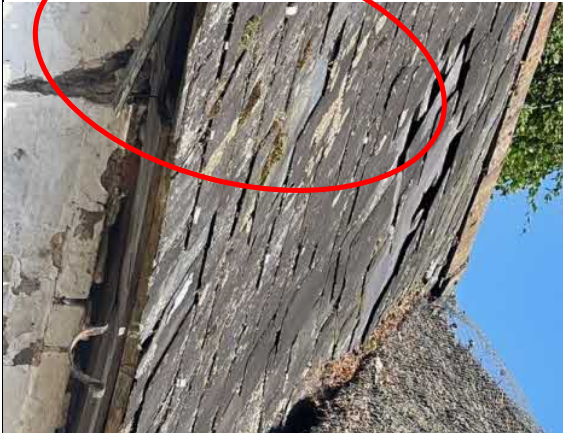
<p>Photograph 3: Building A- Gaps under roof tiles.</p>	<p>Photograph 4: Building A- Gaps under ridge tiles.</p>

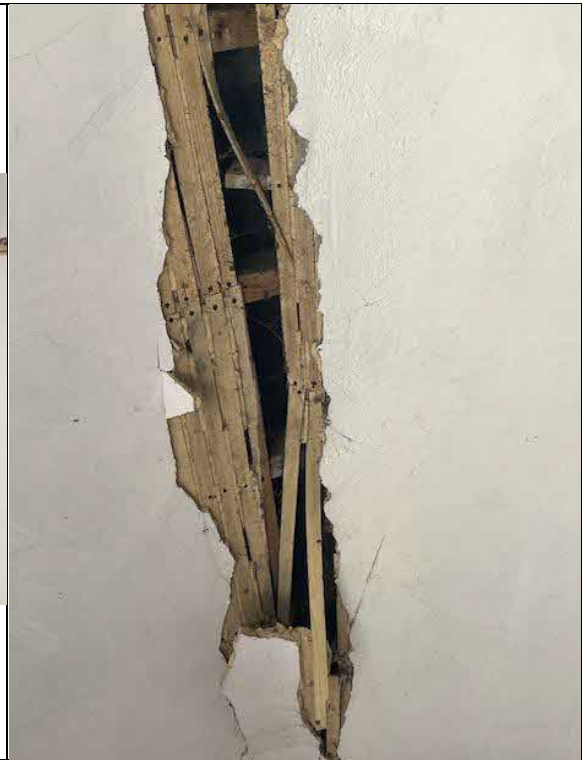
Photograph 10: Hole into roof space.(A)

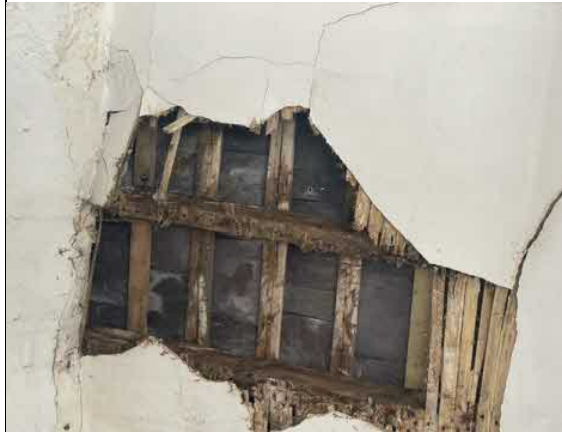
Photograph 11: Hole in structure A ceiling.

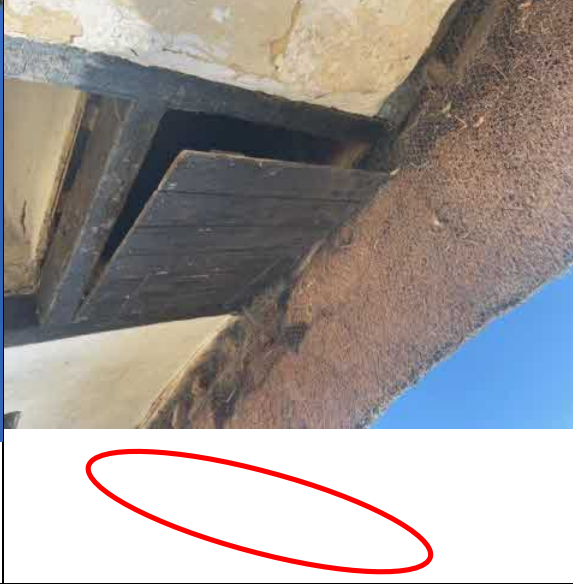
Structure B had bat roosting potential in the form of the gaps beneath some of the timber frames and the gaps between the wall and the ceiling. The structure was deemed to have moderate potential. However, the upper area was too unsafe to be inspected for evidence of bats.

<p>Photograph 13: Structure B.</p>	<p>Photograph 14: Structure B- Thatched roof and wooden window with gaps into upper area.</p>

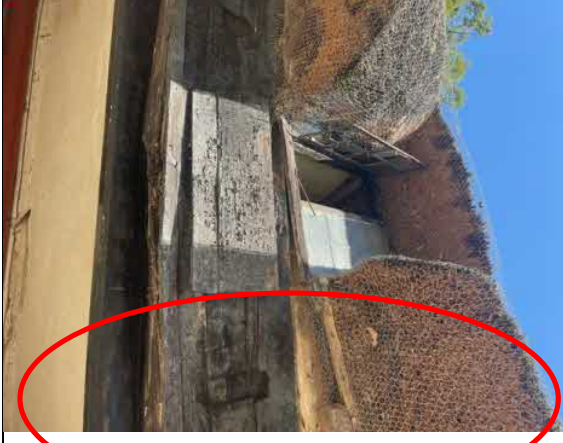
<p>Photograph 15: Gap below wooden cladding.</p>	<p>Photograph 16: Large gap between the wall and the ceiling.</p>

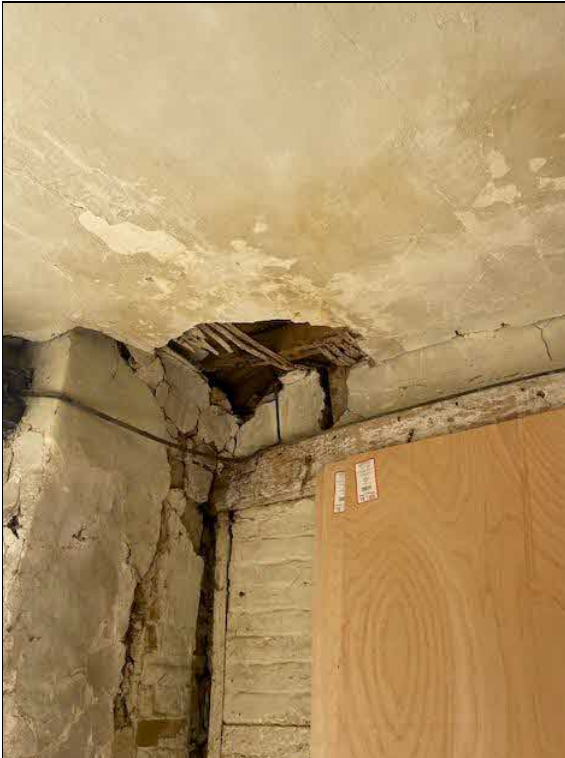
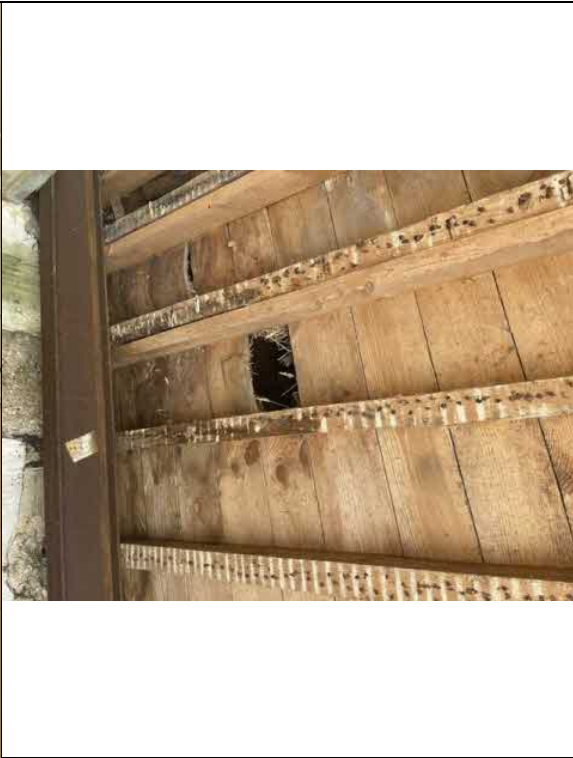
A close-up photograph of a hole in a wooden ceiling. The hole is rectangular and reveals a dark space above. The surrounding wooden planks are aged and show signs of insect damage.
<p>Photograph 17: Hole in ceiling.</p>	<p>Photograph 18: Hole in ceiling.</p>

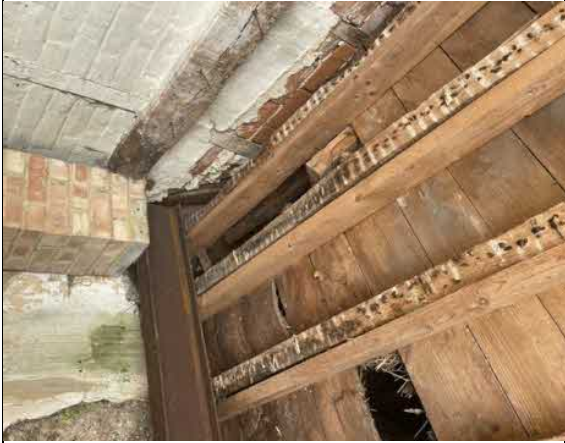
<p>Photograph 19: Ceilings in a state of disrepair with holes into upper area.</p>	<p>Photograph 20: Structure B- Interior with a wooden plank ceiling and brick and wood walls.</p>

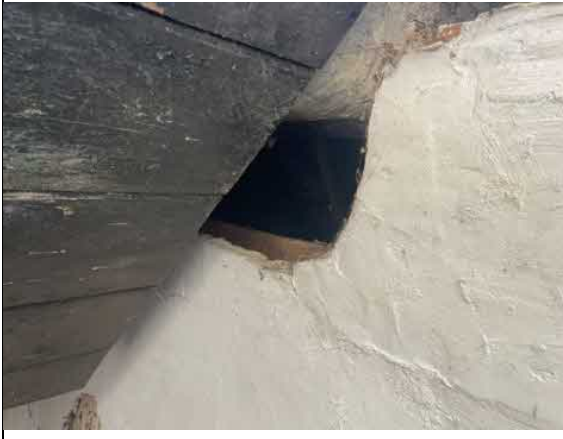
<p>Photograph 21: Hole into upper area.</p>	<p>Photograph 22: Hole into upper area- unable to inspect.</p>

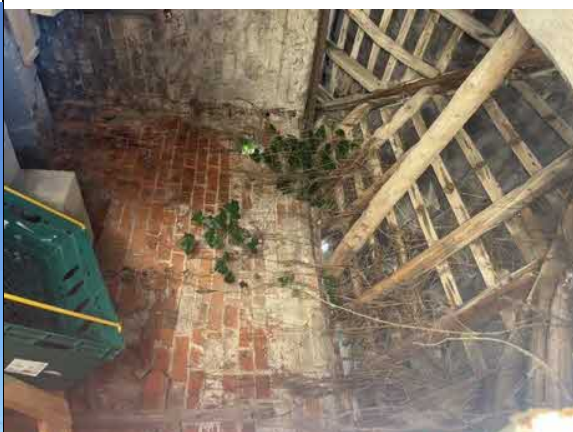
Structure C is an open simple structure with an unlined roof where both sides of the roof could be fully inspected. The structure was deemed to have negligible potential.

<p>Photograph 25: Structure C.</p>	<p>Photograph 26: Interior of structure C- An open simple structure with no roof liner.</p>

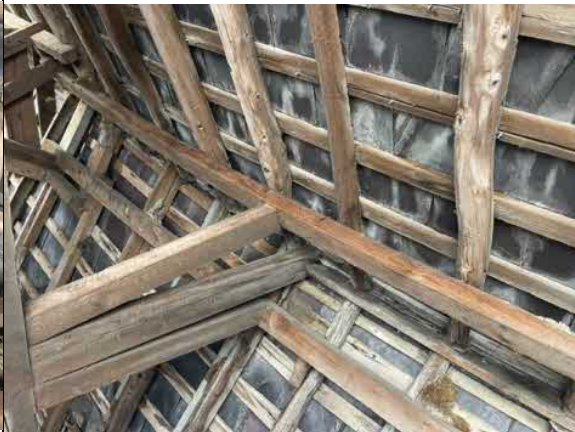
<p>Photograph 27: Structure C- Interior.</p>	<p>Photograph 28: Structure C- Roofing with no liner.</p>
