BS 5837:2012 Arboricultural Survey

Ollerton Depot, Newark Road, New Ollerton, NG22 9PZ

Presented J. Murphy & Sons Limited

Issued: December 2022

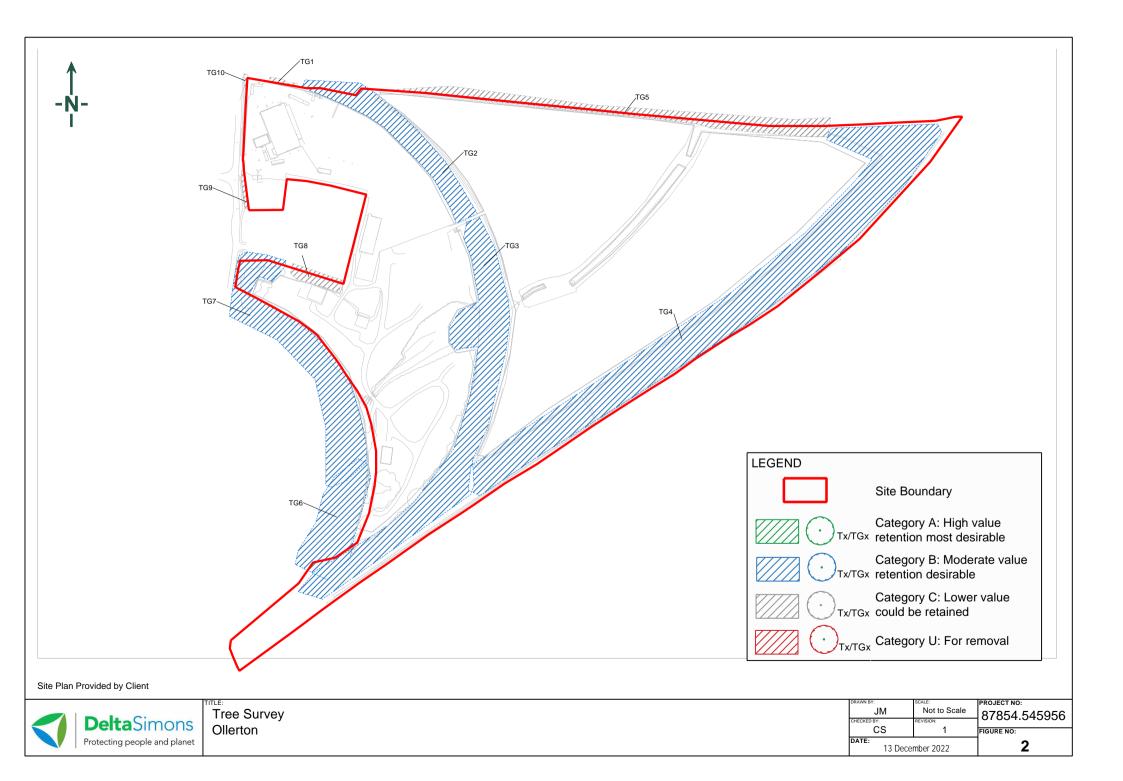
Orown Copyright All rights reserved. Esri, Intermap, NASA, NGA, USGS, Maxar, Microsoft, Esri Community Maps Contributors, Esri UK, Esri, HERE, Garmin, Foursquare, GeoTechnologies, Inc, METI/NASA, USGS Figure 2 – Tree Survey

A total of 10 Tree Groups (TG) have been identified and assessed as part of the tree survey. Most of the trees were located within the boundary fences of the Site apart from to the west, where there was a woodland belt beyond the boundary.

Most of the trees are located in large woodland groups within the Site's boundary fences. There is also a woodland group running north to south through the middle of the Site.

Most of the trees present on and adjacent to the Site are early mature or semi mature. There are also areas of young trees. None of the trees show signs of past management but they do appear to be in fair condition.

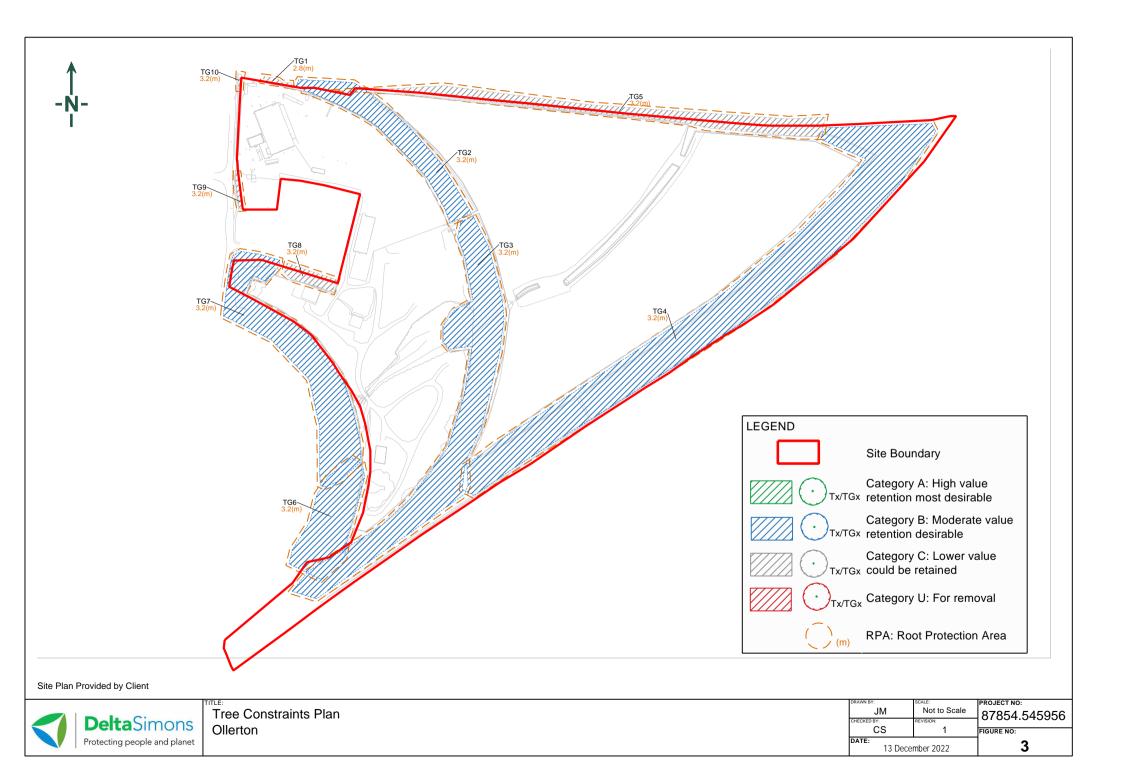
Figure 3 – Tree Constraints Plan

It appears no management has taken place to the trees present on-Site. To ensure that the root areas and canopy extremities of the individual trees and the tree groups that may be retained are not damaged, a Constraints Plan has been prepared to show the locations where protective fencing should be erected for any trees selected for retention.

All trees retained adjacent to the Site should be protected by barriers or ground protection around the calculated RPA and as indicated on any Tree Constraints Plan (TCP) that may be produced in association with the assessment;
