Design & Access Statement

Section 73 application: PF/20/0756 & LA/20/0757

9 & 10 West Raynham Road South Raynham Fakenham NR21 7HG

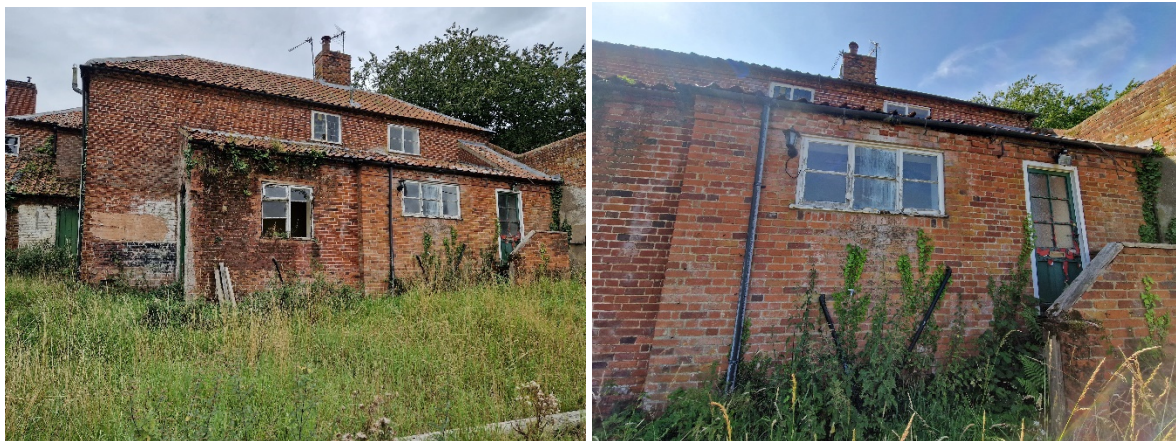
An inspection of the two cottages indicate that the cottages were originally built without the North Elevation Lean which comprises of two cojoined sections, a) to the east No. 9 the older better-looking section, and the west (former No. 10), b) a newer less attractive but structurally better arrangement. It is most likely that the western end of the lean-to was a replacement of that section due to structural issues rebuilt in a modern brick pattern not matching the rest of the property and widened slightly to afford more room.

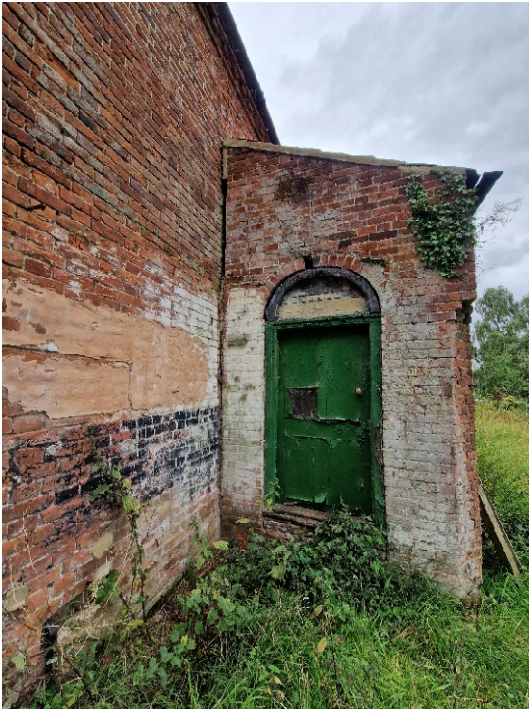
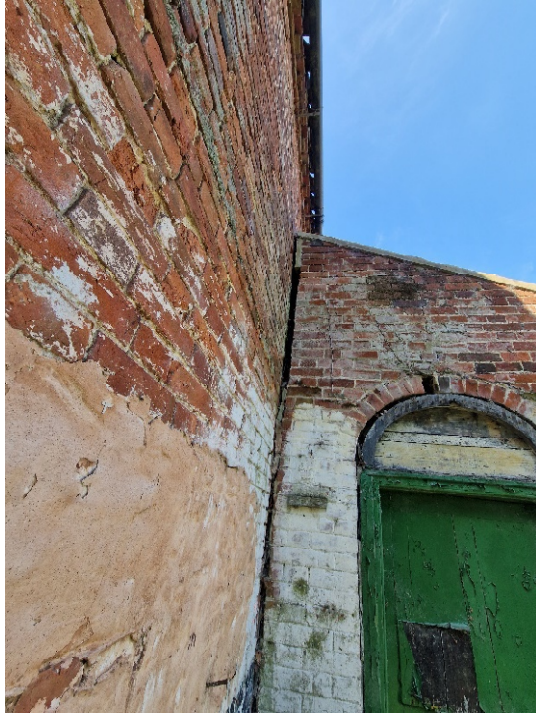
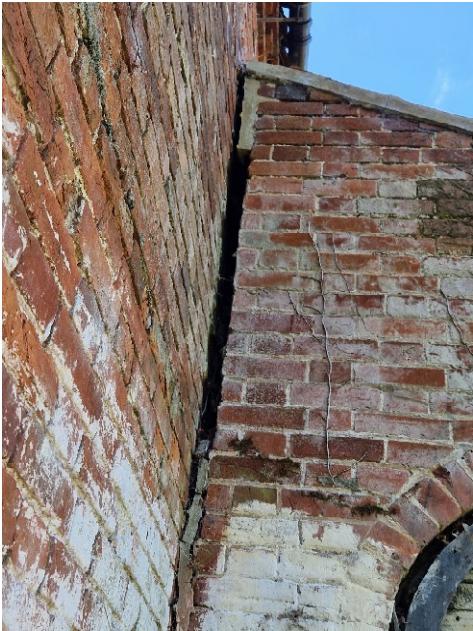
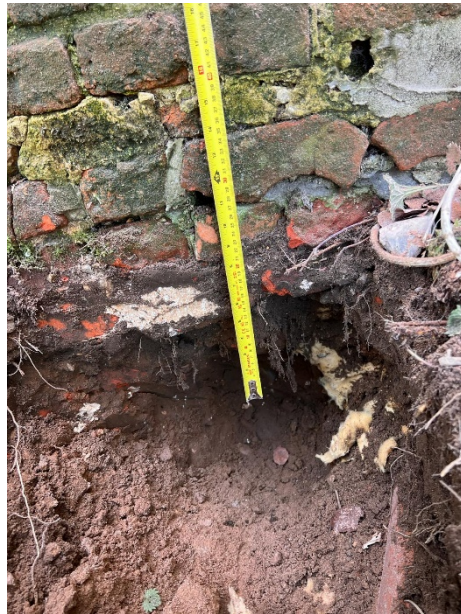
The internal floor level of the western section (b) is the same level as the main building, however, eastern section floor level is 420mm lower than the main building and is falling down due to the absence of footings; it has slipped north down the hill breaking away from the main building with a gap of about 150mm and the floor to the east inside is subsiding such that the floor is out of level, also the earth/tile structure of the floor will endure the process of repairs.

In the current condition, underpinning which has been approved to address the subsidence has an exceedingly high probability of causing collapse of the structure due to its weakened structural

integrity. Additionally, underpinning will fail to address the spalling damage to the bricks, slippage of the eastern lean-to where it has come away from the main building, and the varying height of the floor with the existing main building. Substantial additional repair and patch work will be required to the lean-to consisting of replacement of bricks where the spalling damage is extensive, repointing of the remaining areas and replacement of the roof structure.

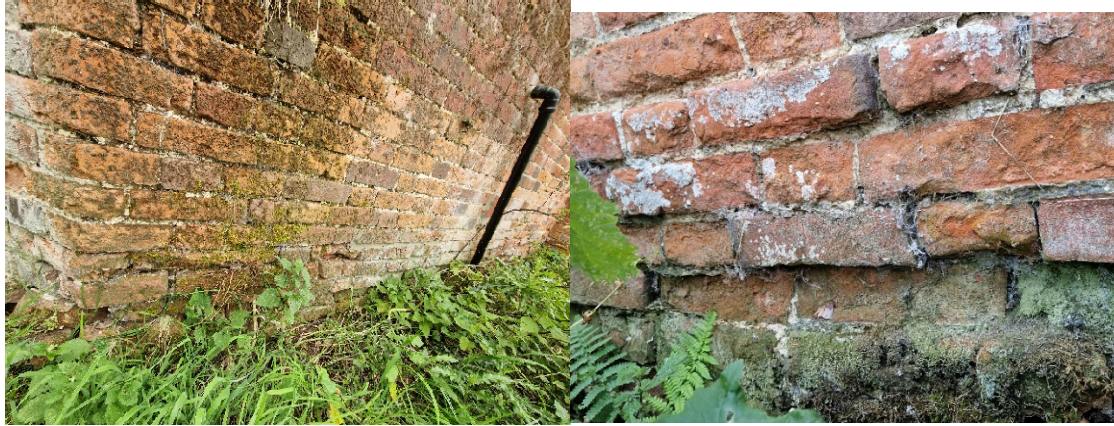
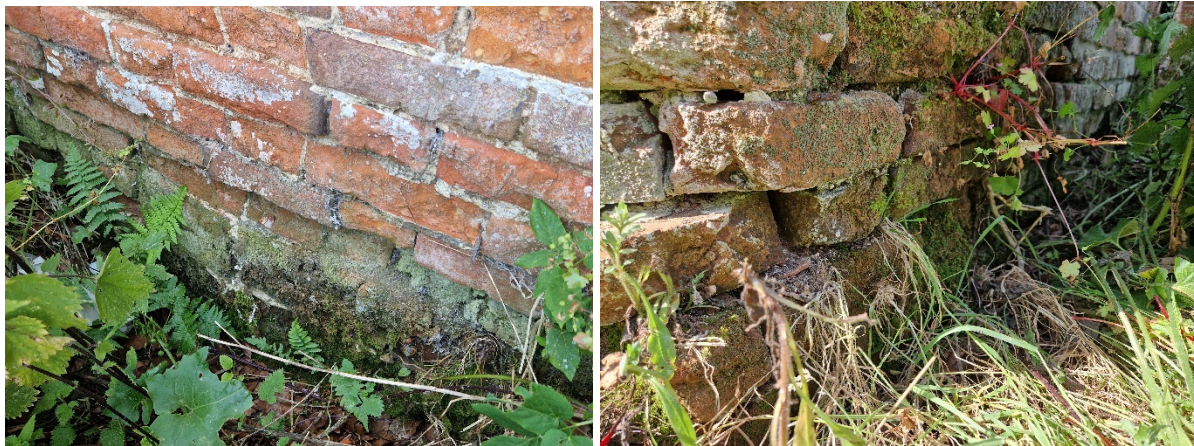
The lean-to does not have a damp course membrane, consequently the lower-level bricks are saturated with excess moisture causing spalling, evidenced by extensive flaking, and crumbling of the bricks. The spalling has damaged structural integrity, with parts of the brick & mortar falling off.

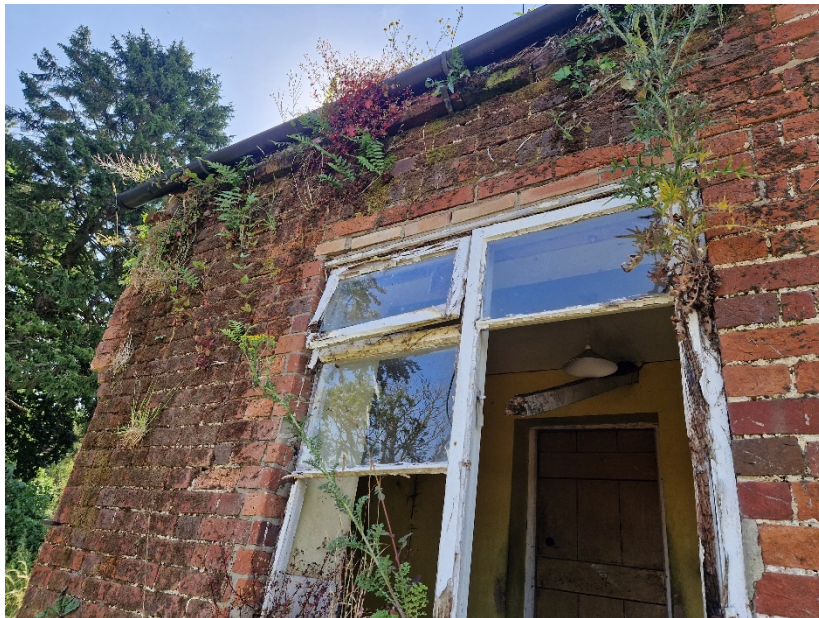
The roof structure on both sides of the lean-to has damage, with collapse visible internally, to be rebuilt.

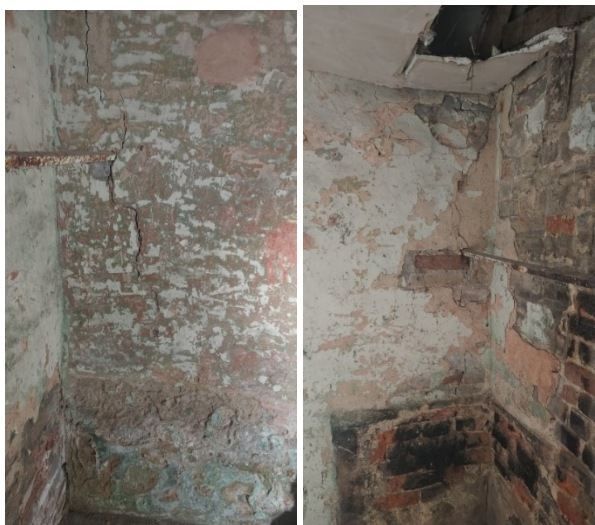
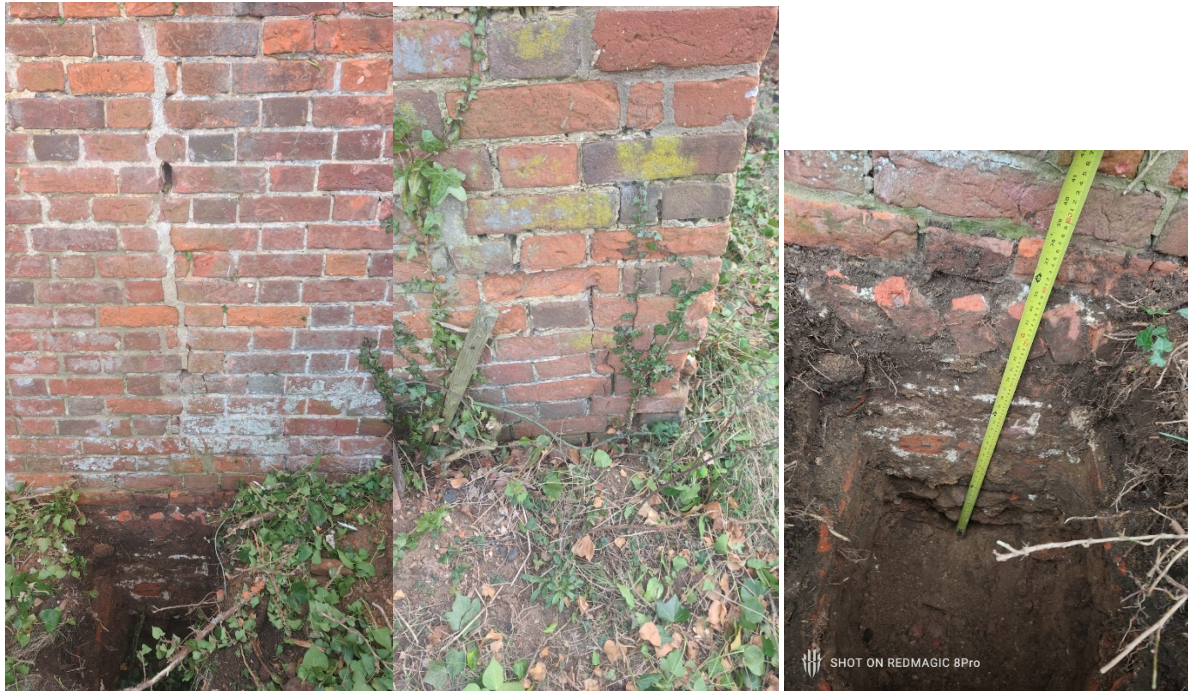
Upon investigation, the wall adjacent to the road are held with wall ties tied to the main building which has caused cracks on both structures with further cracks on the structure of the lean-to. There are no footings, and the foundations consist of stones and bricks. The roof to the lean-to requires replacement (re-using existing roof tiles). To address these issues, permission is sought to carefully demolish and rebuild the lean to on existing foundations re-using existing materials and reclaimed matching materials as required. There is heavy farm traffic using this road which is causing shaking of the lean-to and the main building, therefore rebuilding with correct foundations will help protect and stabilise the main building and prevent future structural damage
