47 FERNBANK ROAD, ASCOT

**PRELIMINARY ROOST ASSESSMENT
& NOCTURNAL BAT SURVEYS**

A Report to: Landmark Group

Date: August 2023

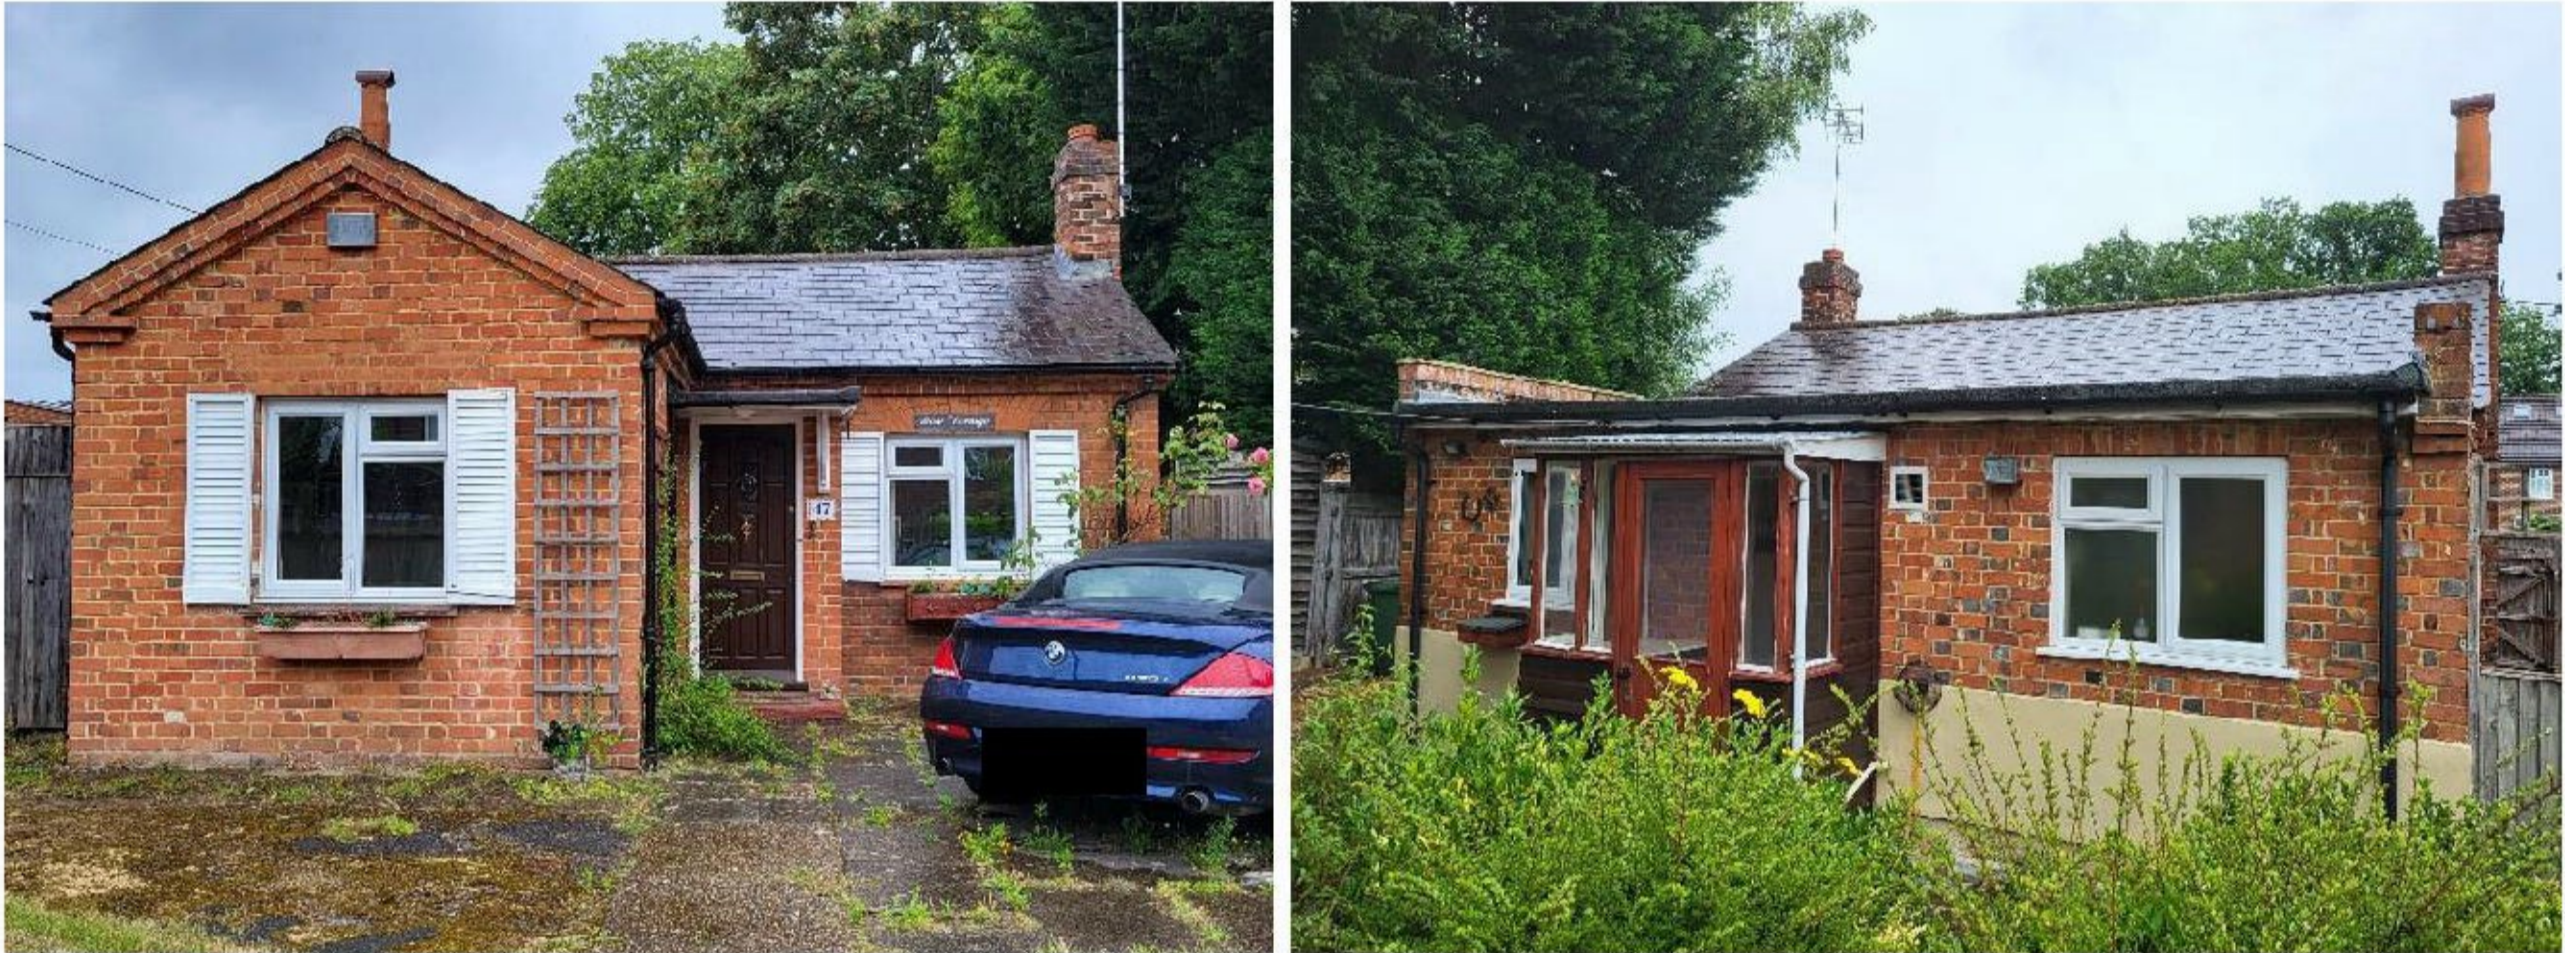
The vacant dwelling on site is a detached, single-storey, brick building with pitched roofs covered by slates. To the rear is a single-storey extension with a flat roof, covered by roofing felt. The brickwork is in a good condition with no cracks, areas of missing mortar or holes present. The roofing felt is also in a good condition with the edges being well-sealed.

Figure 2. View of the front and rear elevations of the dwelling

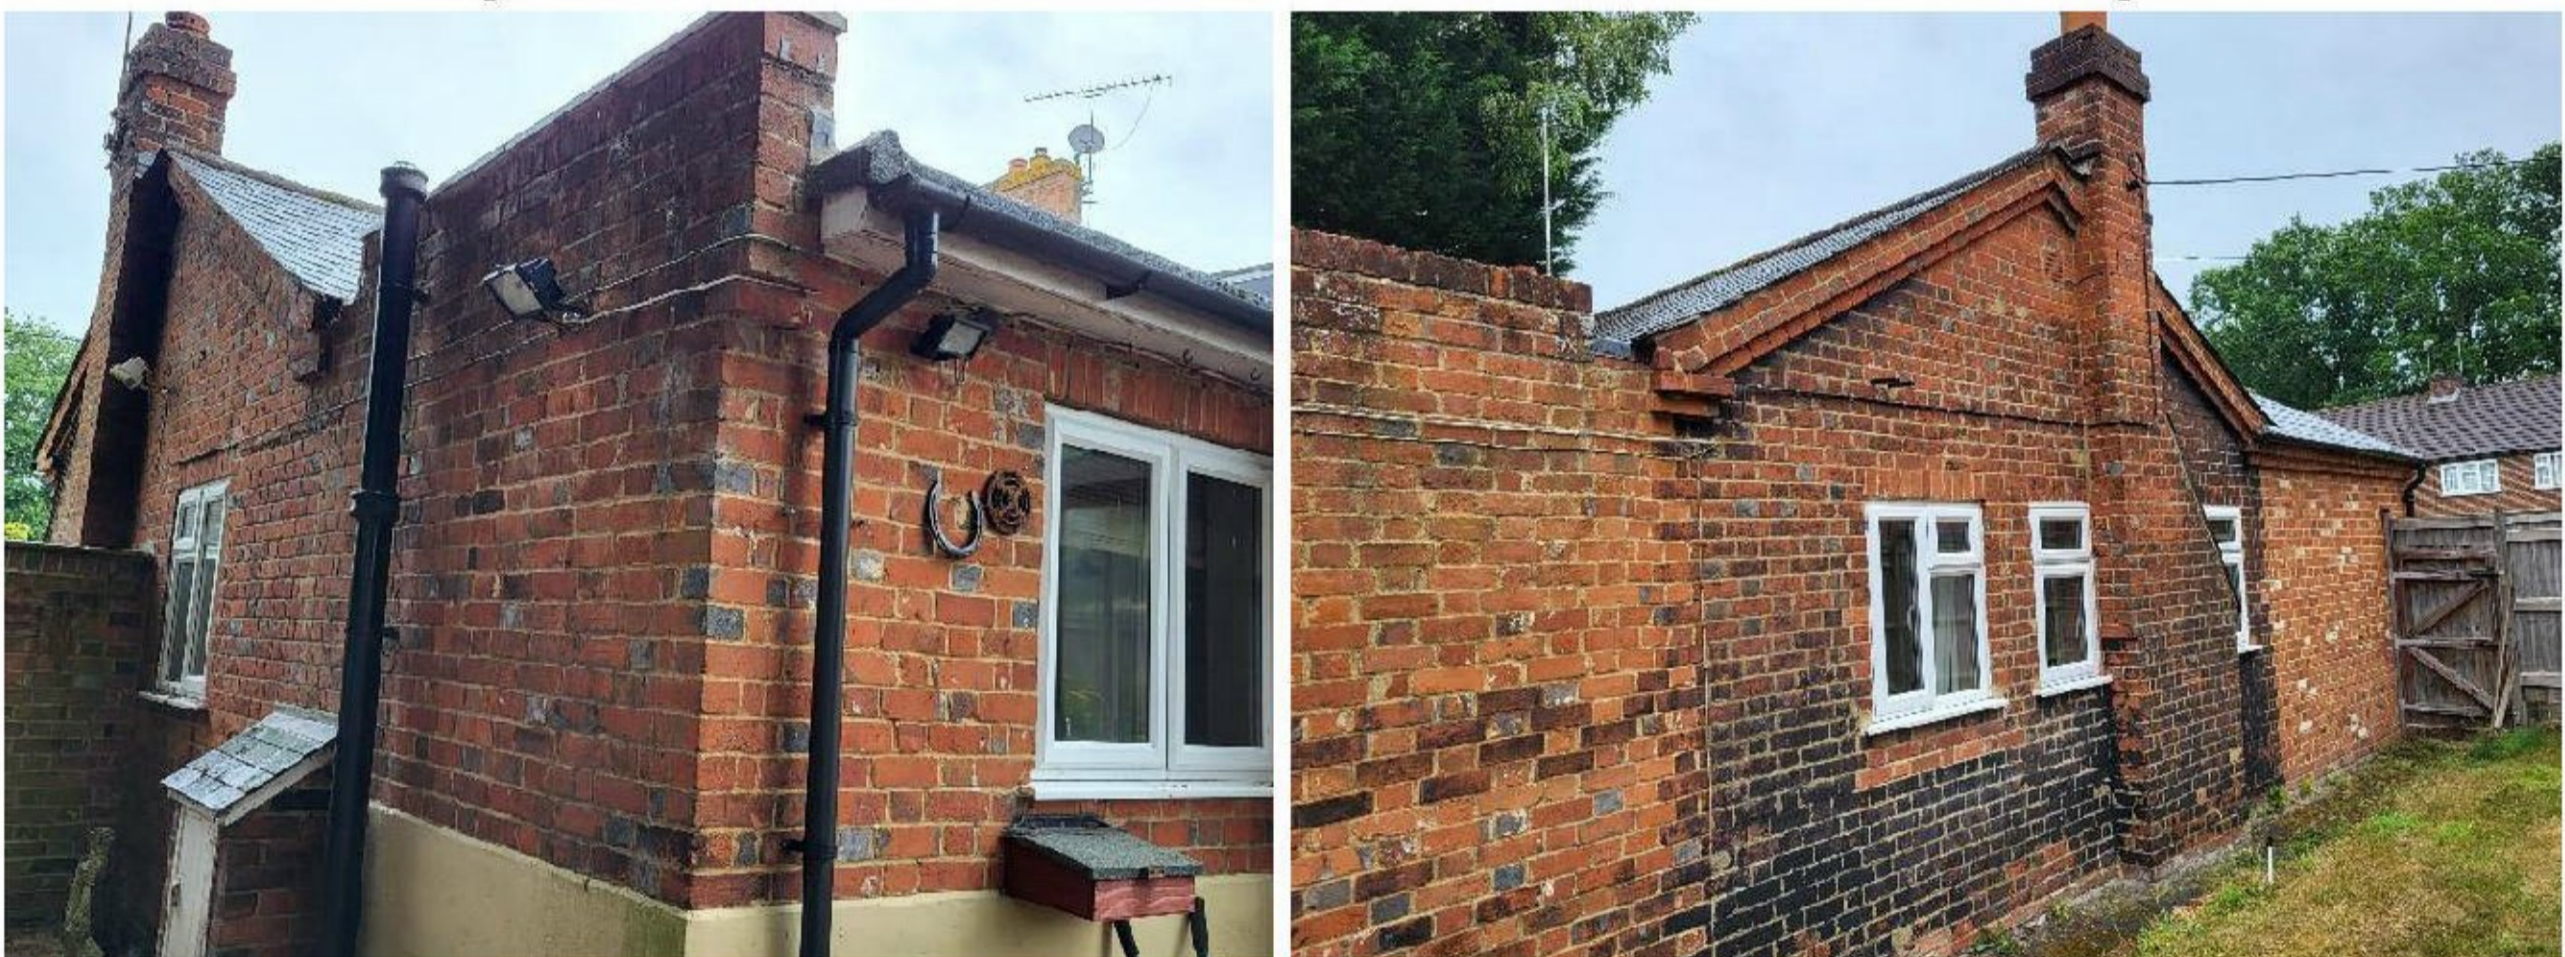
Figure 3. View of the side elevations

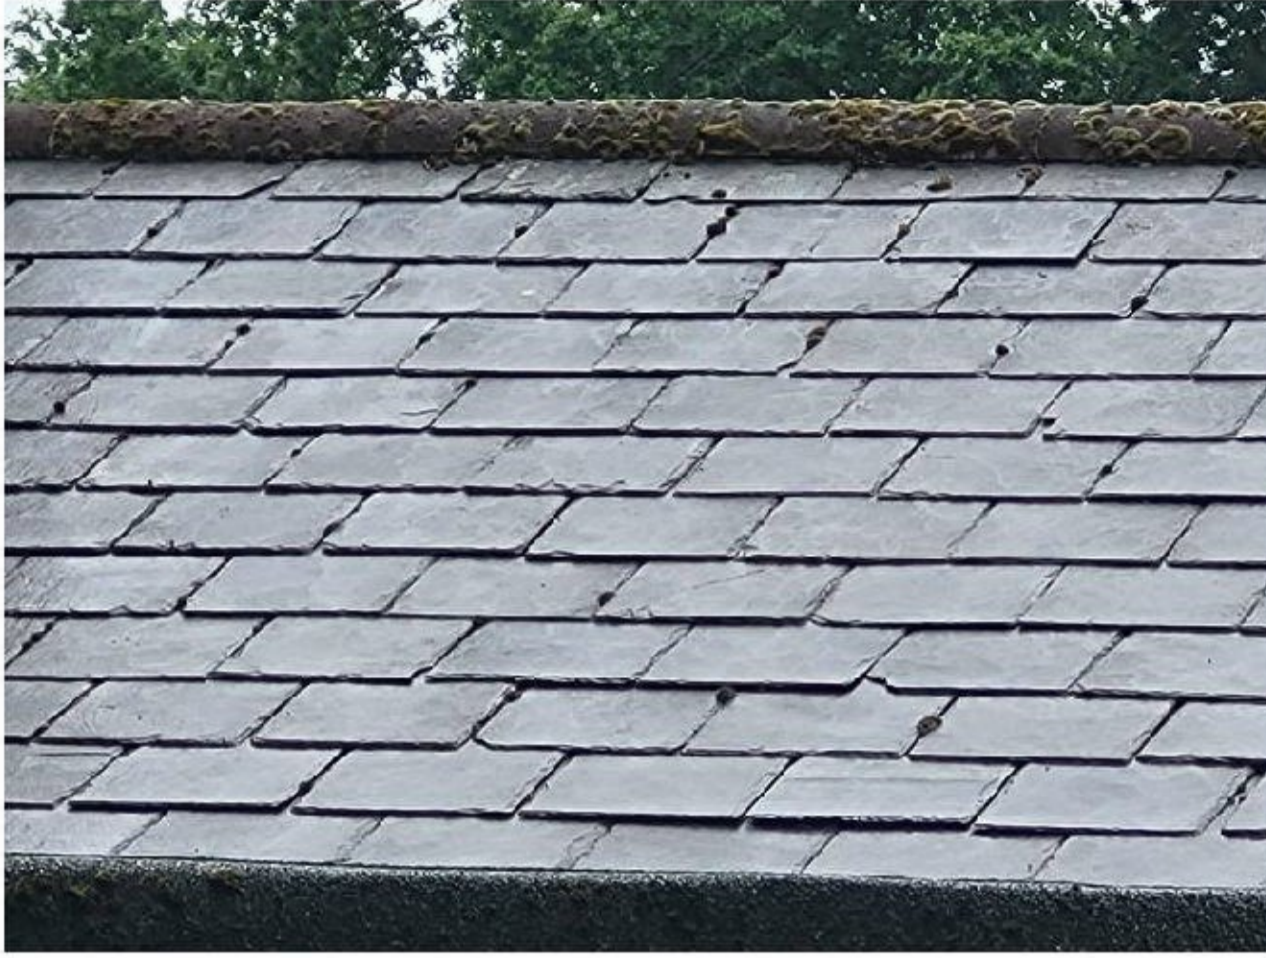
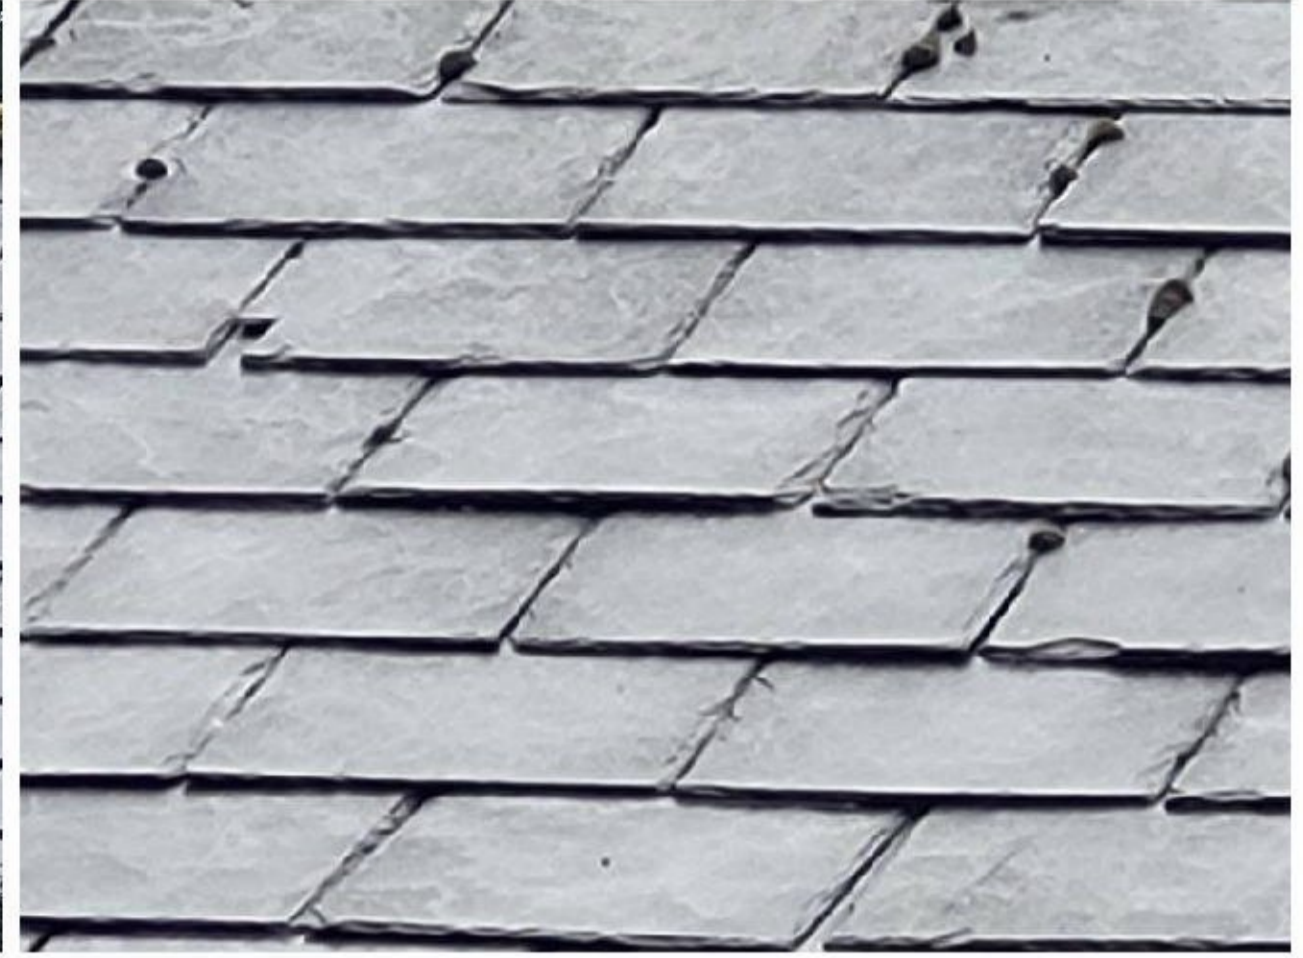
The roof slates are generally in a good condition and tightly fitted; however, a number of minor gaps are present below the roof slates. A brick chimney breast is present along the southern elevation. Any soffits along the eaves are tightly fitted, with no gaps present.

Figure 4. Example of tightly fitted roof slates

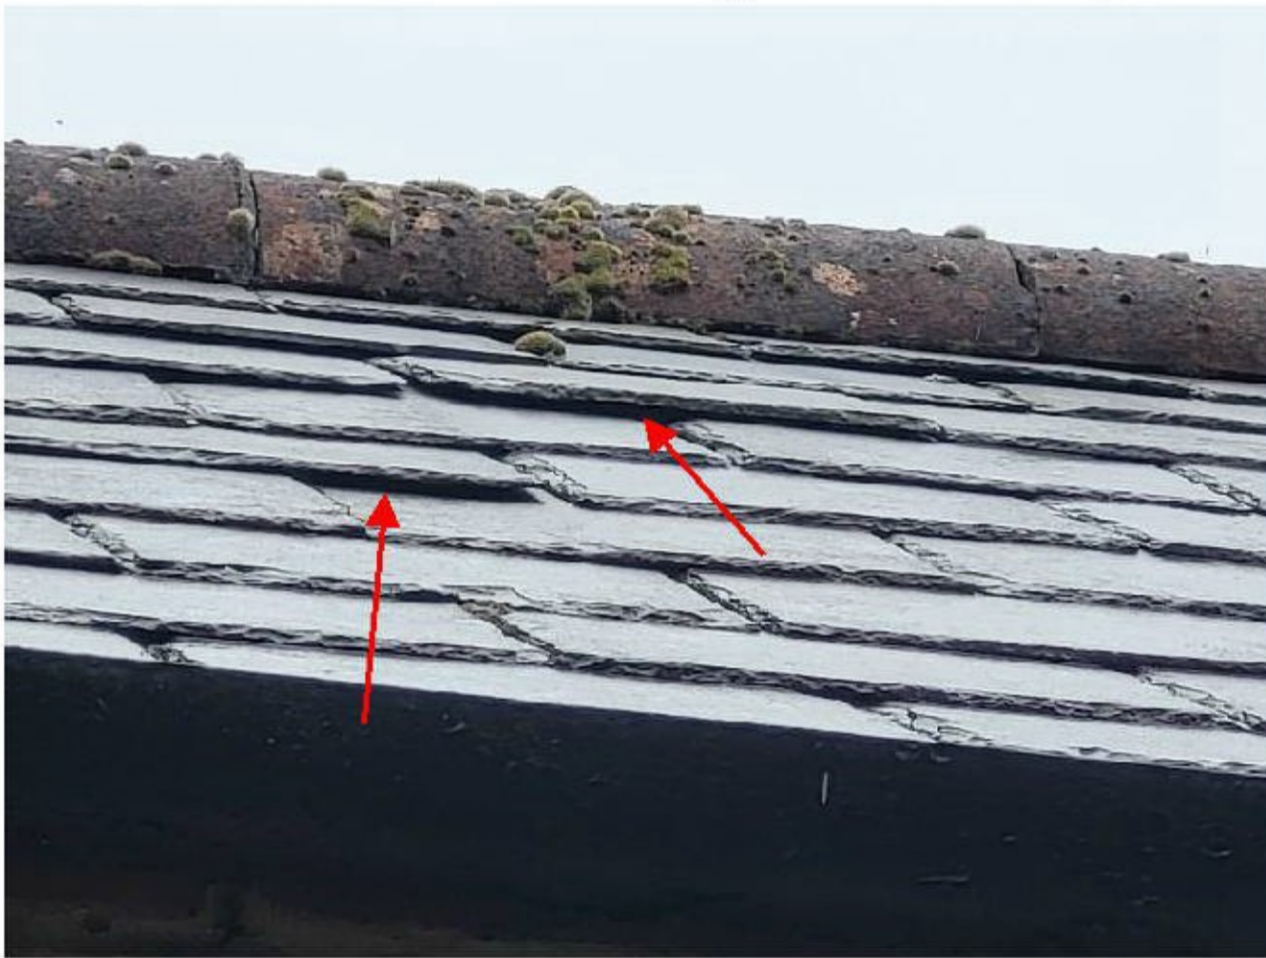
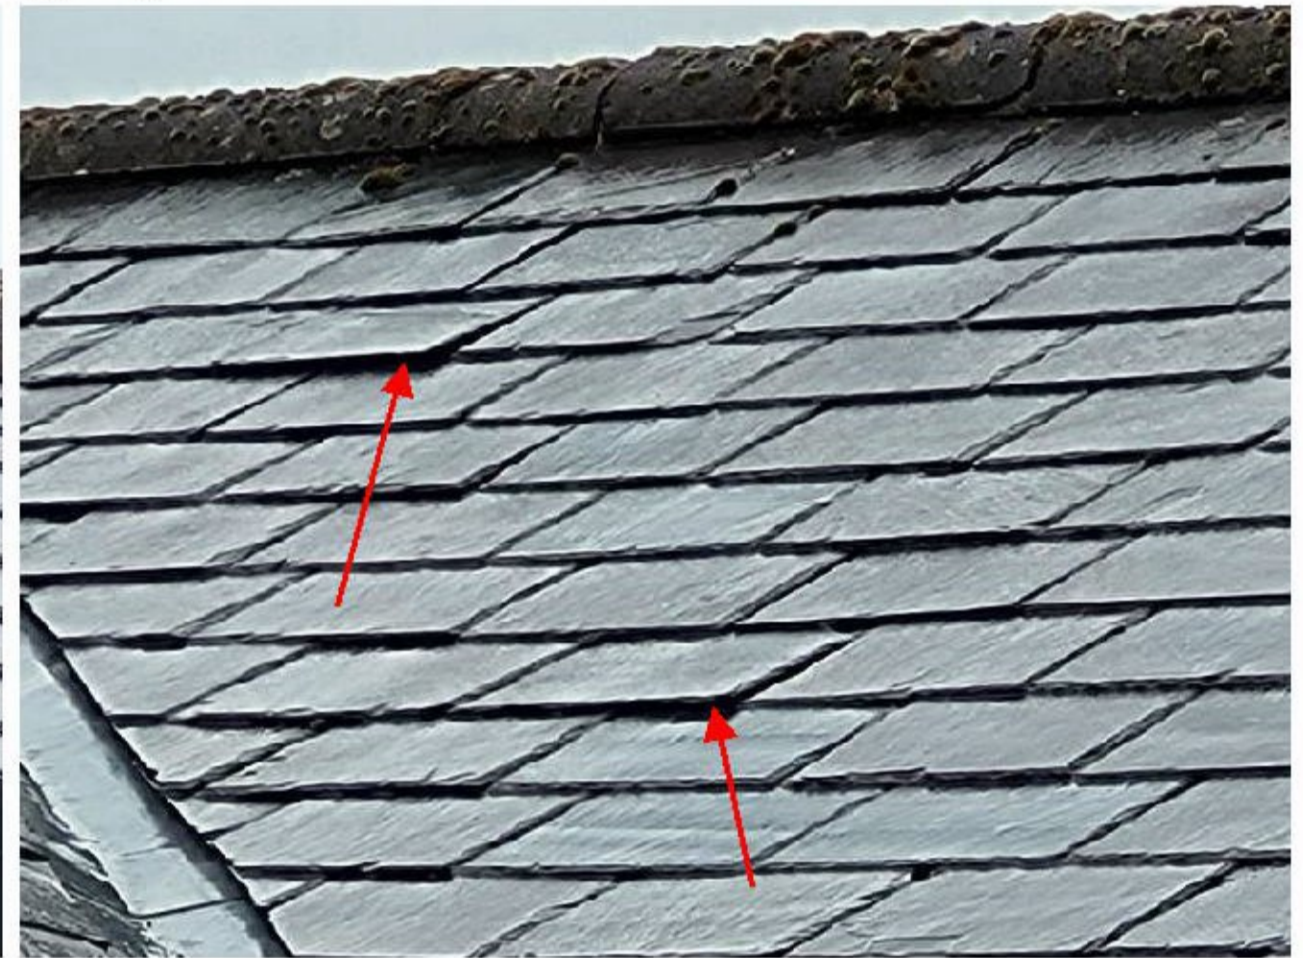
Figure 5. Example of slightly lifted roof slates

A number of potential entry points and roosting features for bats in the form of slightly lifted roof slates were recorded at the time of survey. As such, based on the external inspection, the dwelling on site is considered to be of moderate potential for bats.

As a precautionary measure, it is recommended that the works are carried out under the supervision of an experienced and licenced bat ecologist. This will entail the soft stripping of the roof slates and any other PRFs under supervision.

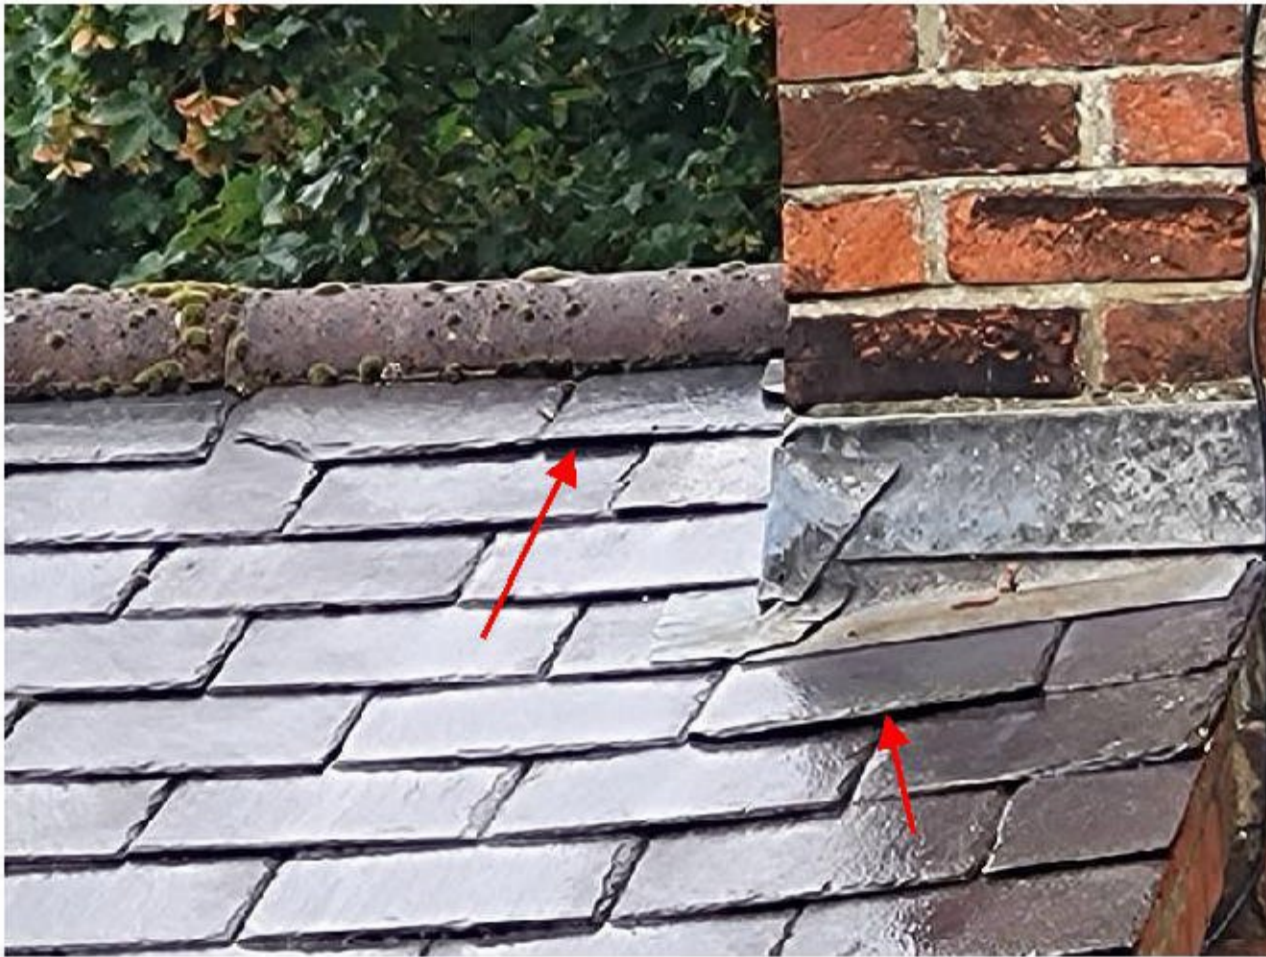
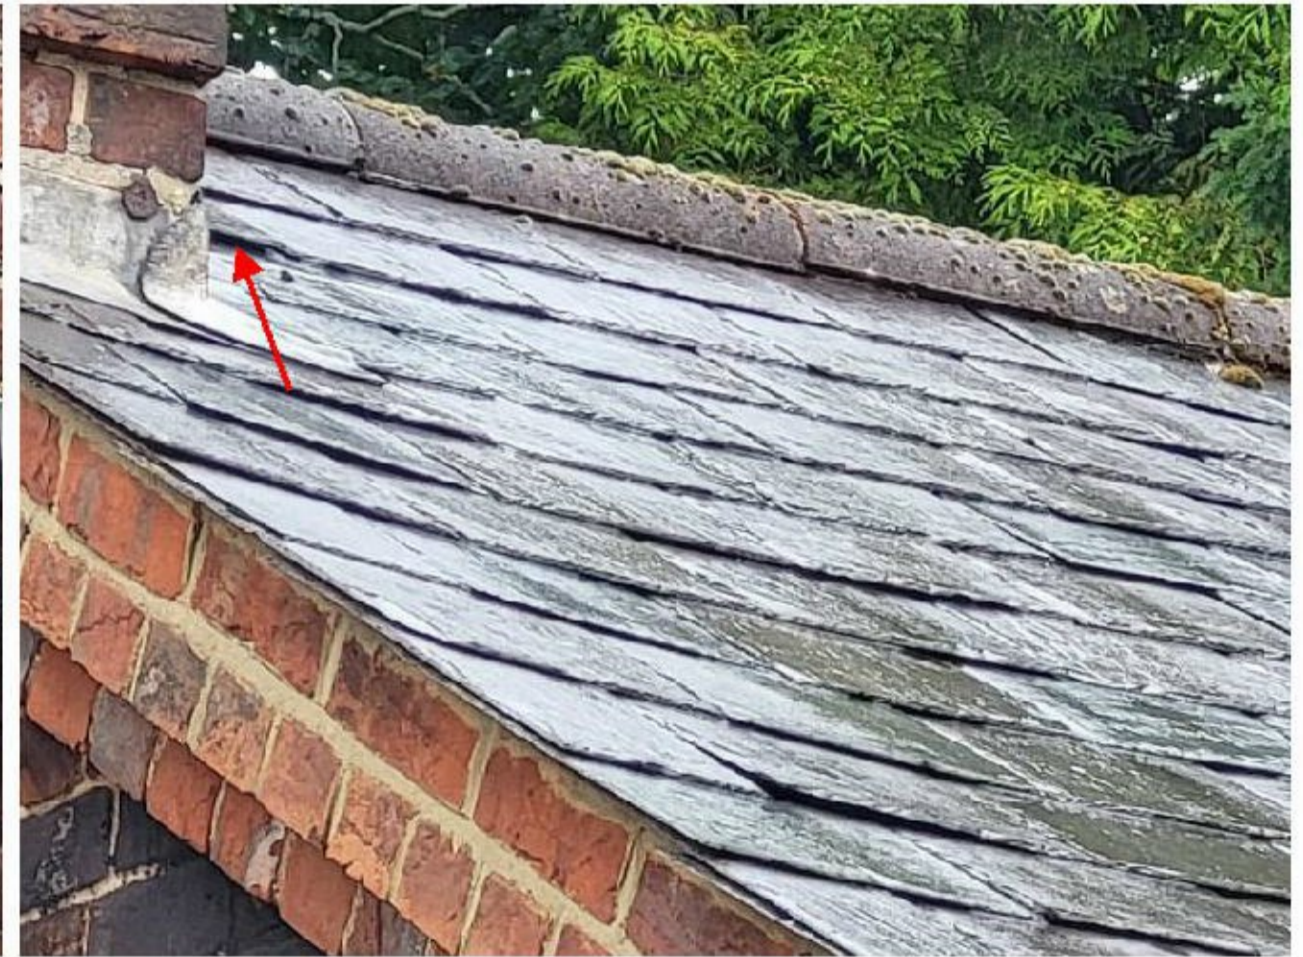
Figure 6. Example of slightly lifted roof slates

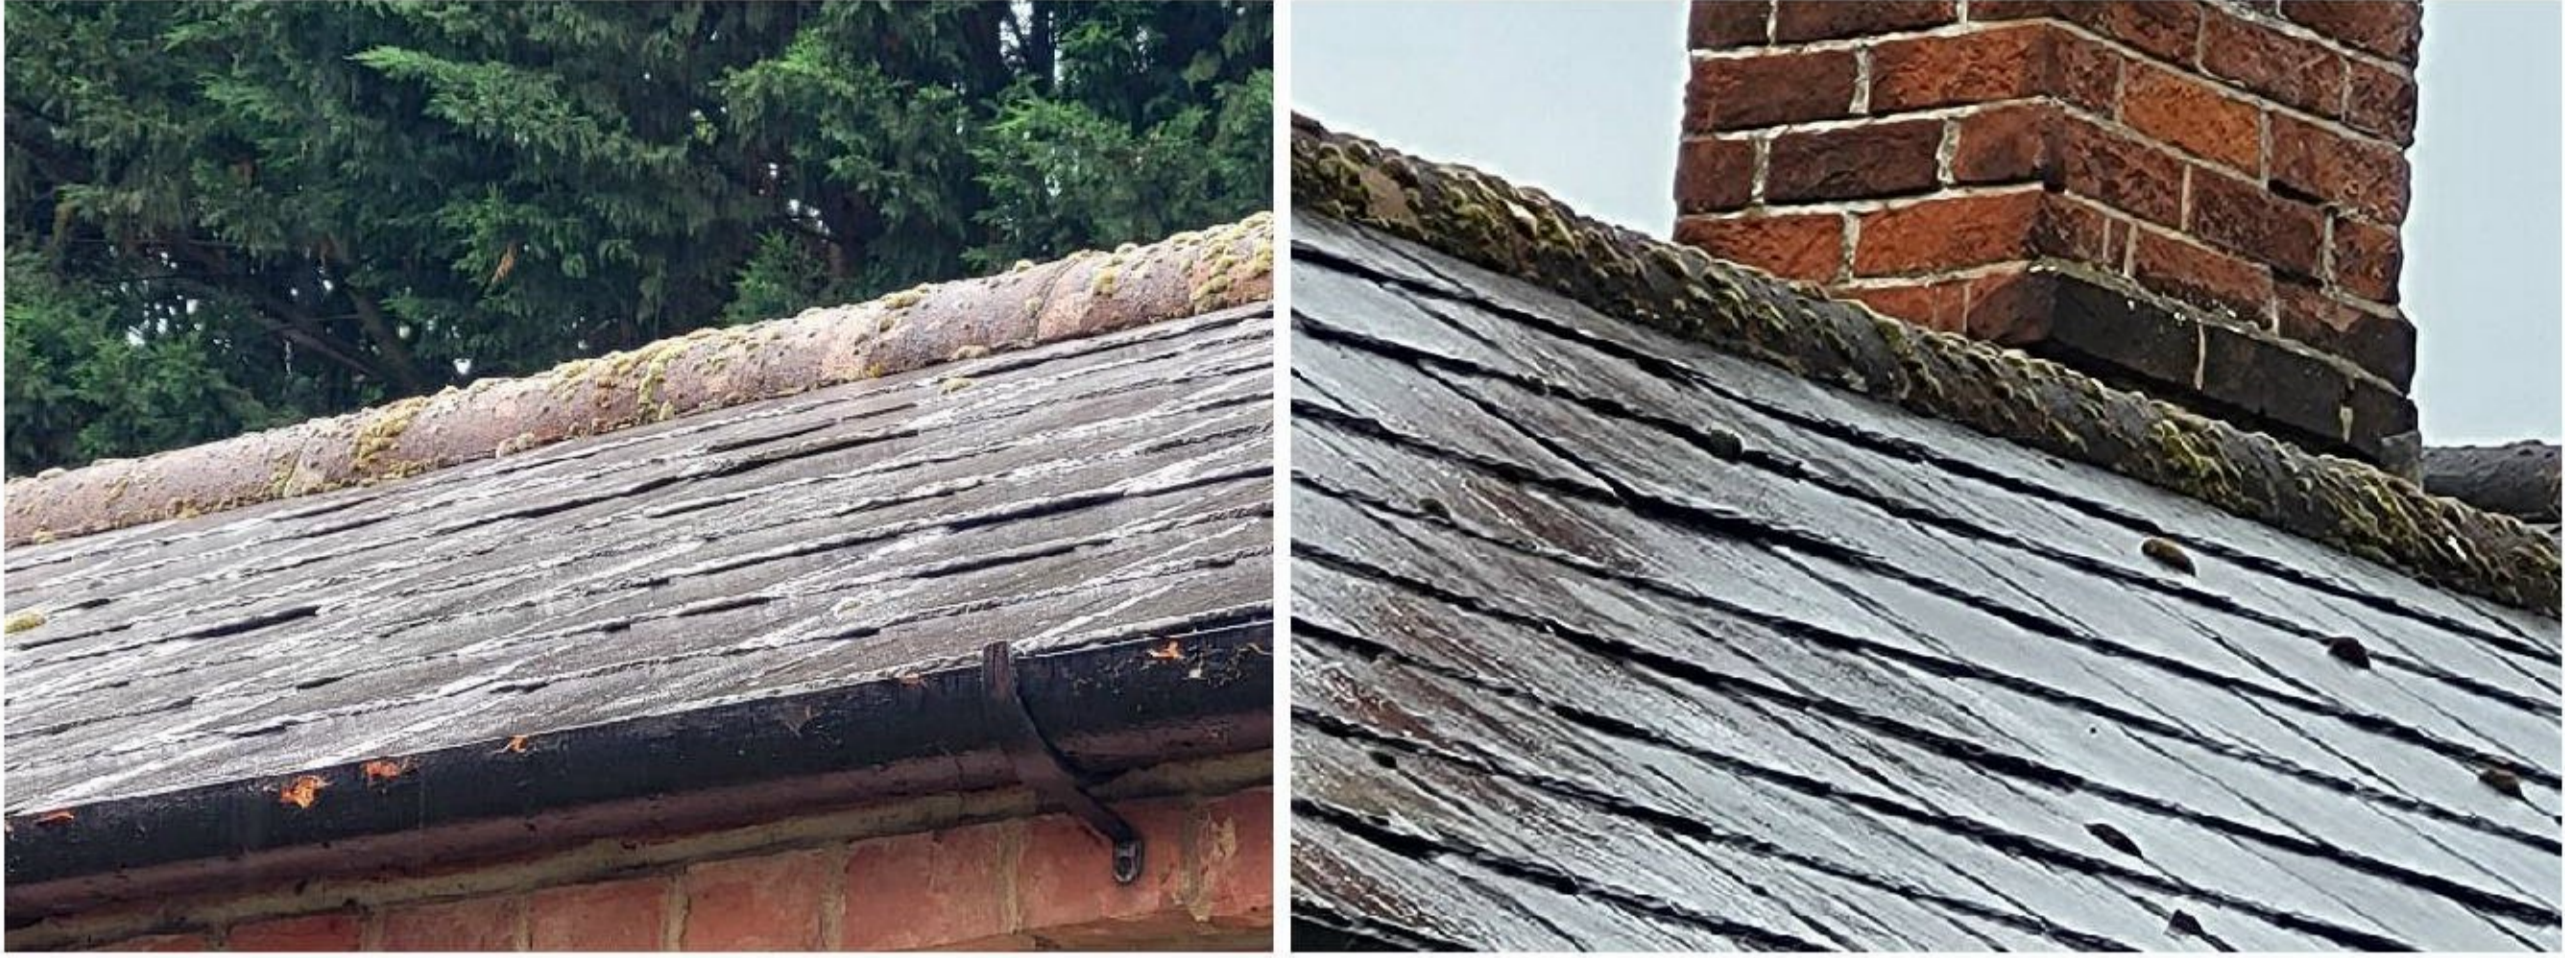
Figure 7. Example of slightly lifted roof slates

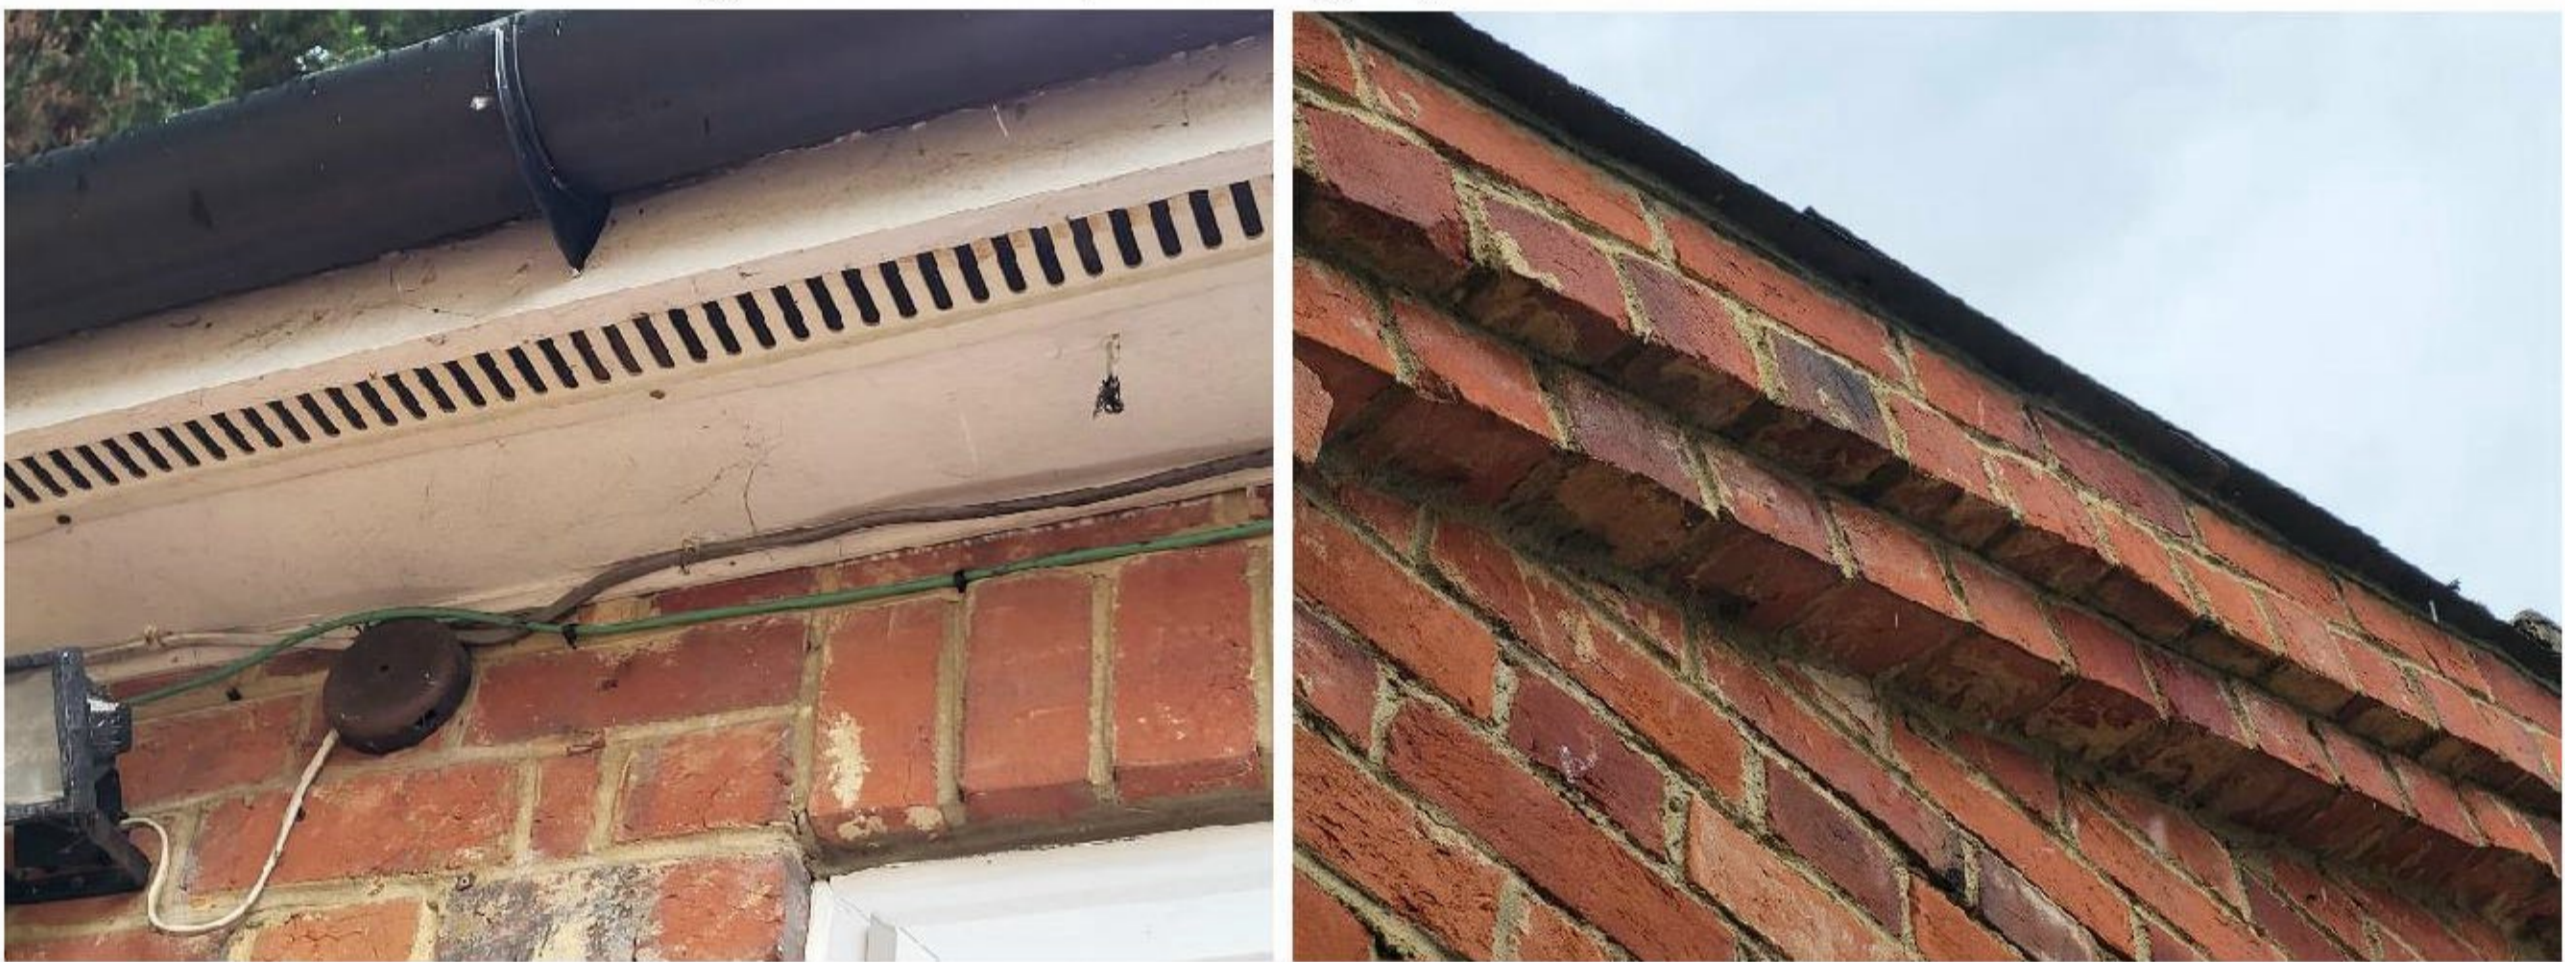
Figure 8. Example of tightly fitted soffit and the well-sealed eaves

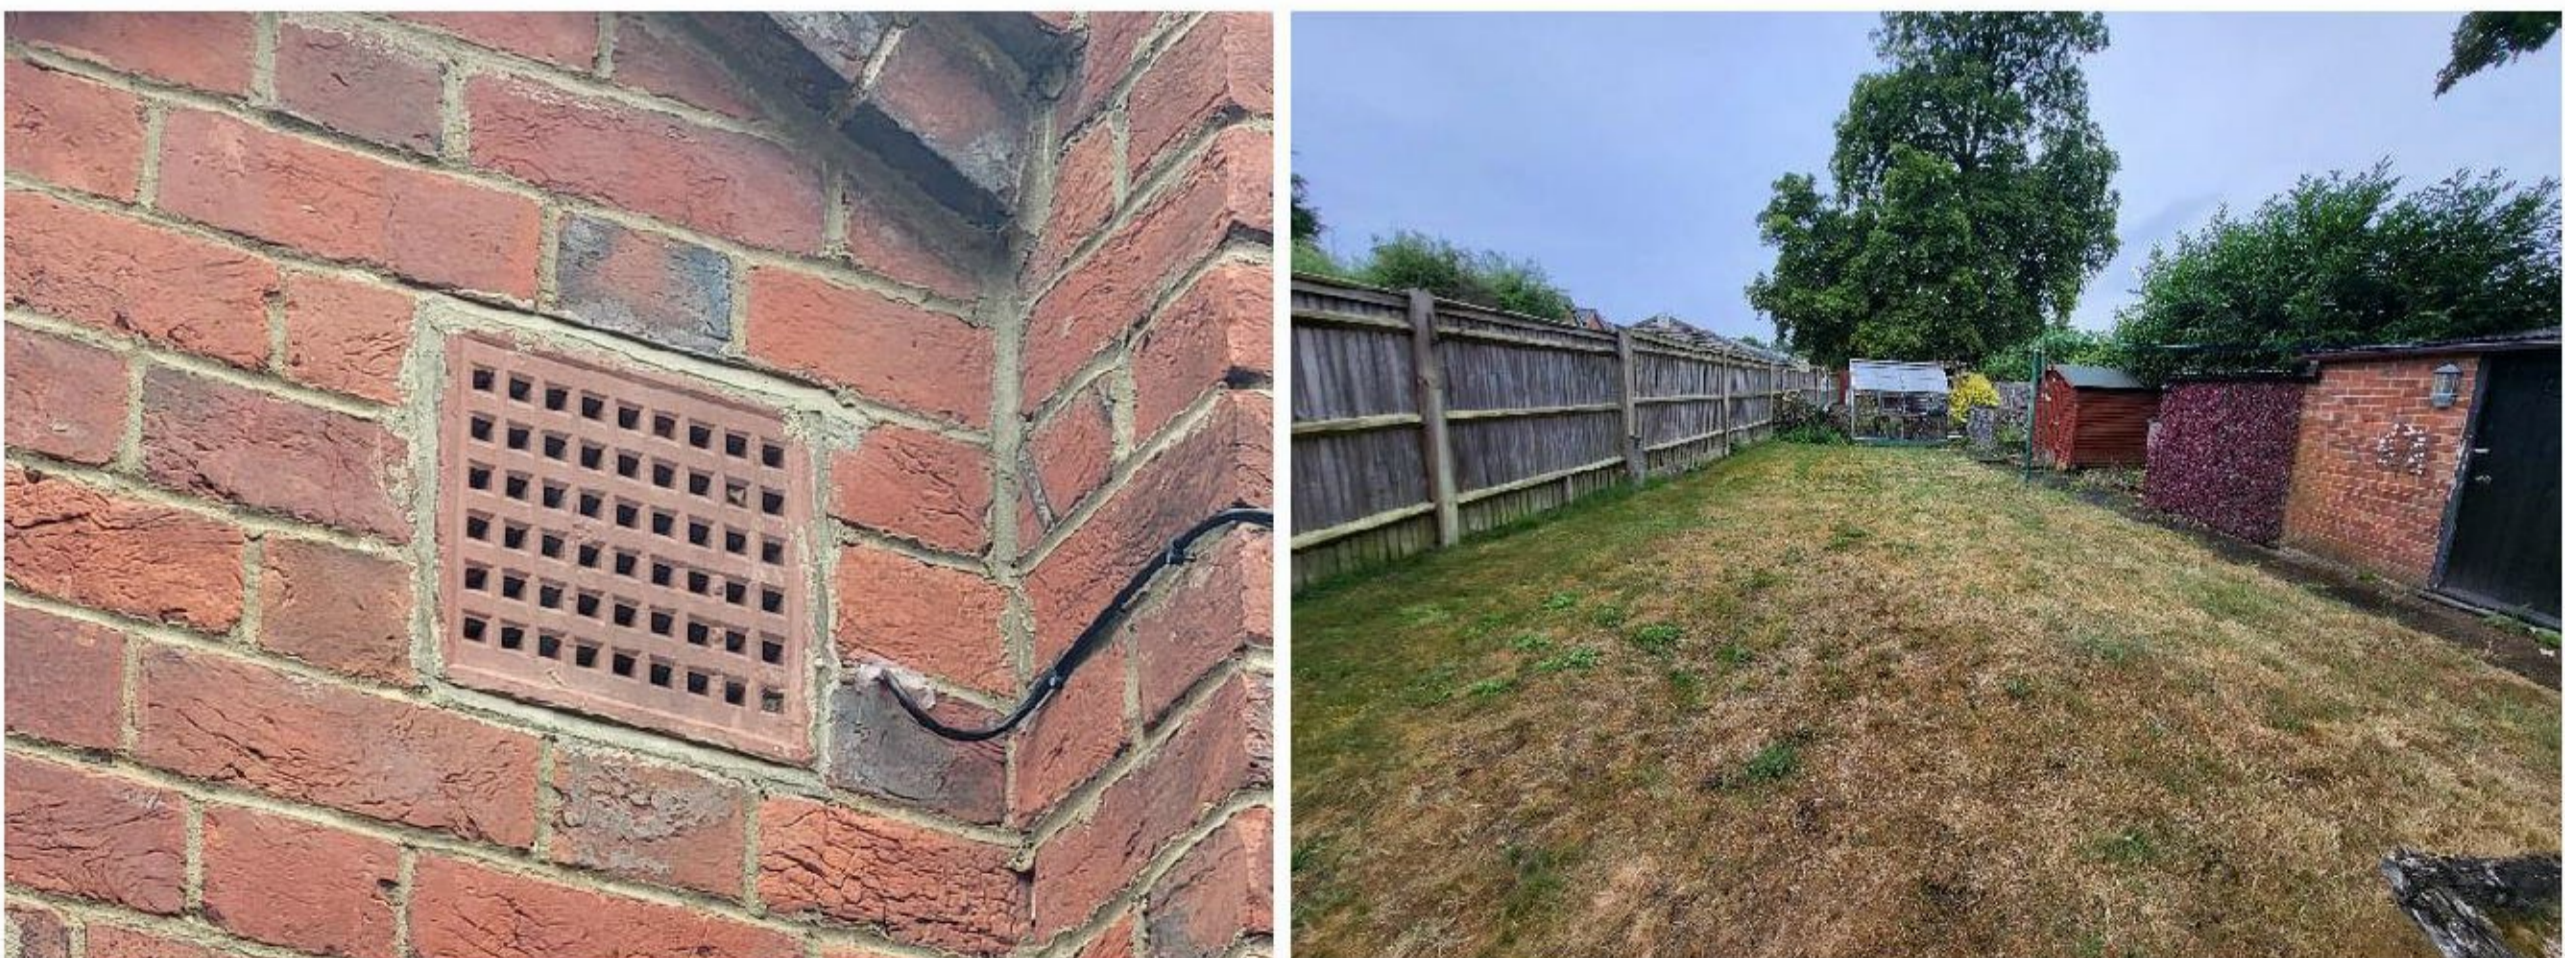
A total of two ventilation grills are present within the side gables. The garden is laid to lawn.

Figure 9. View of the ventilation grill (left) - View of the garden (right)

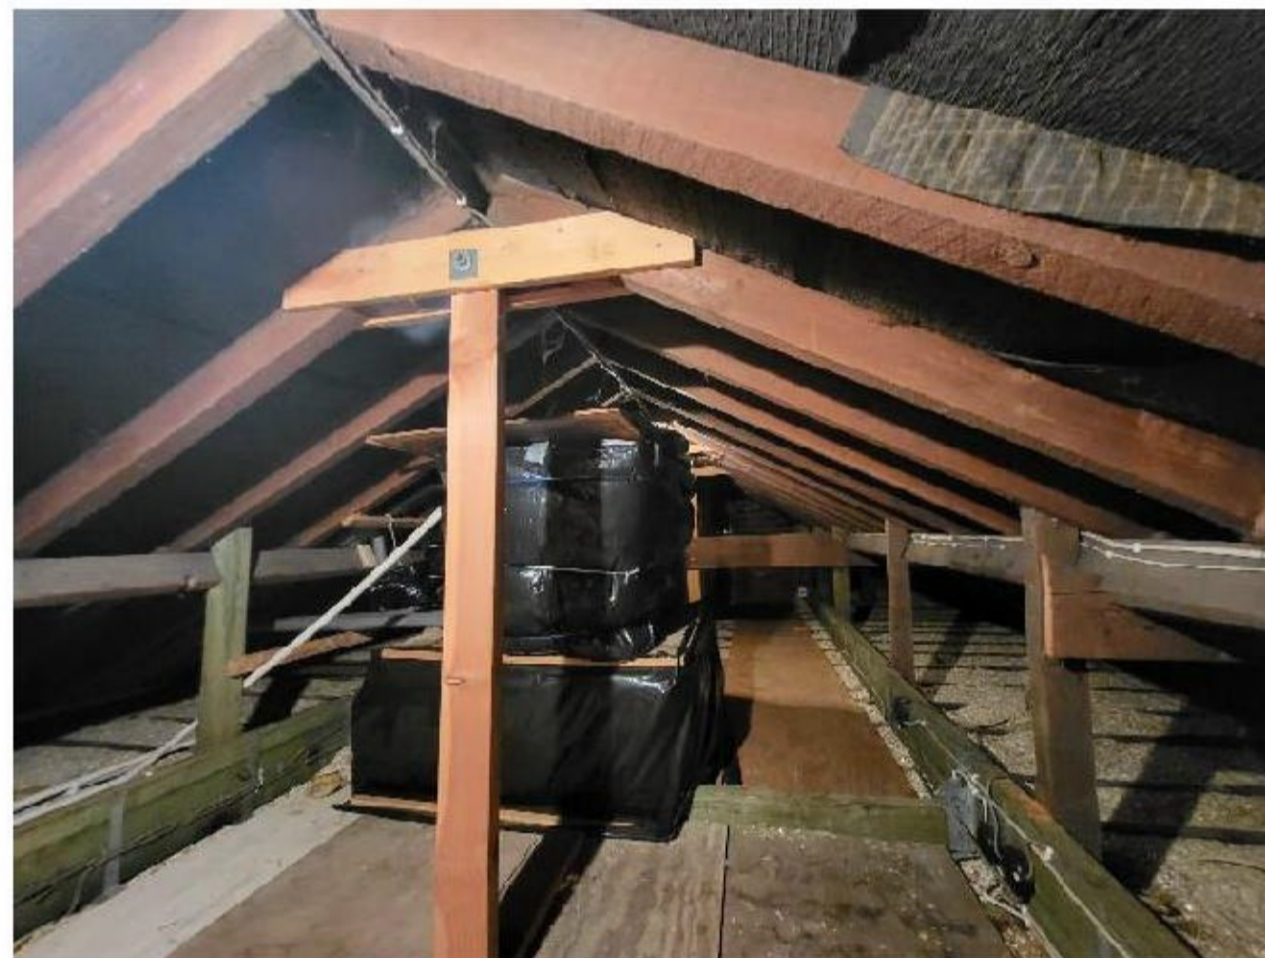
Internally, a single loft void is present. The floor to apex height is approximately 1m. The central part of the loft is boarded, and the floor is insulated with Micafil Vermiculite Loose Fill loft insulation. Black felt sarking is present between the rafters and the roof slates, which was in a good state of repair at the time of survey, with no cuts, tears or areas of sagging present. Two of the gables are of brick construction, with another gable of breezeblock construction.

Figure 10. View of the loft
