47 FERNBANK ROAD, ASCOT

**PRELIMINARY ROOST ASSESSMENT
& NOCTURNAL BAT SURVEYS**

A Report to: Landmark Group

Date: August 2023

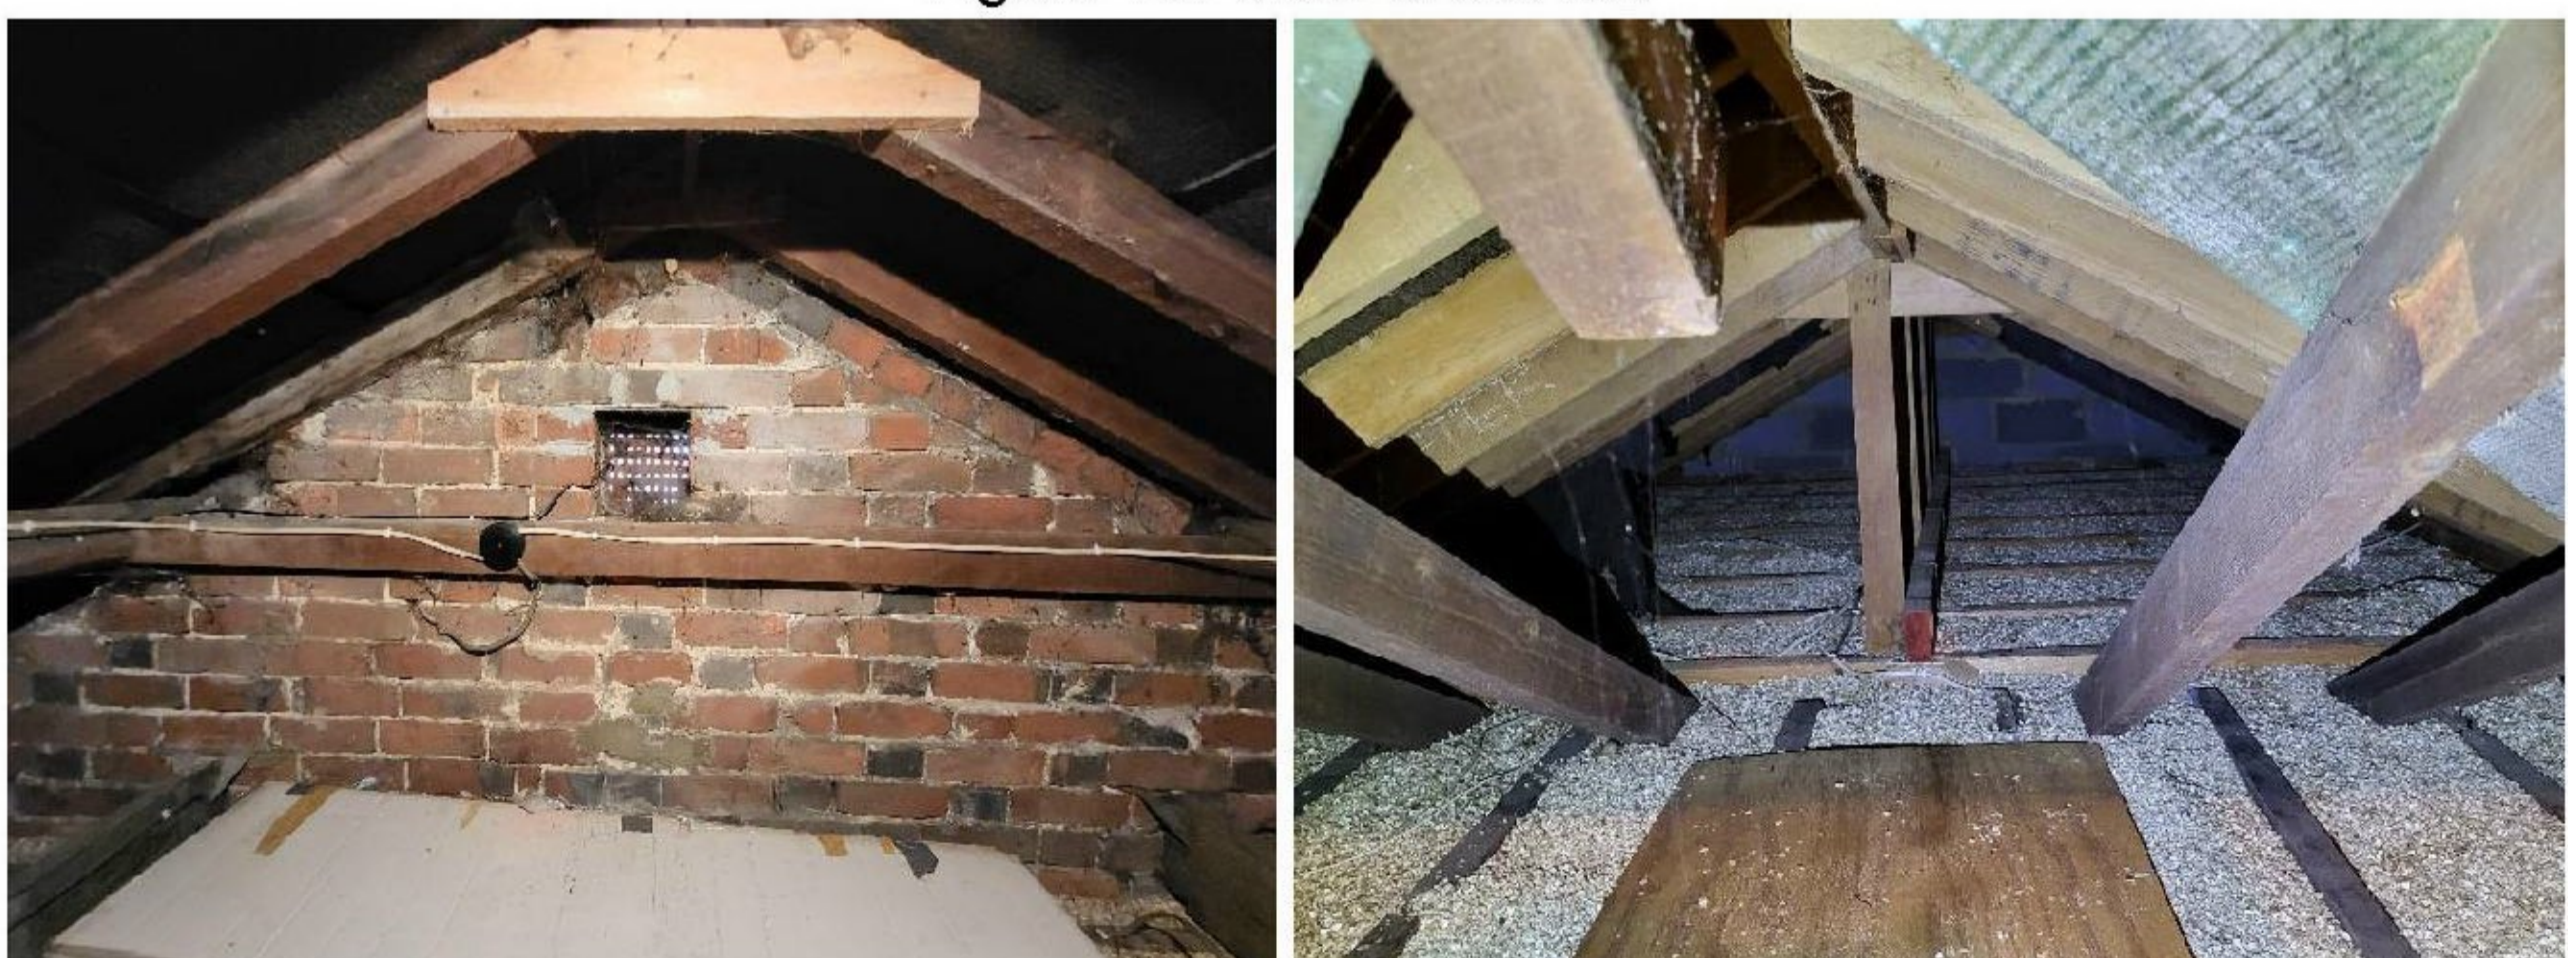
Figure 11. View of the brick and breezeblock gable-ends

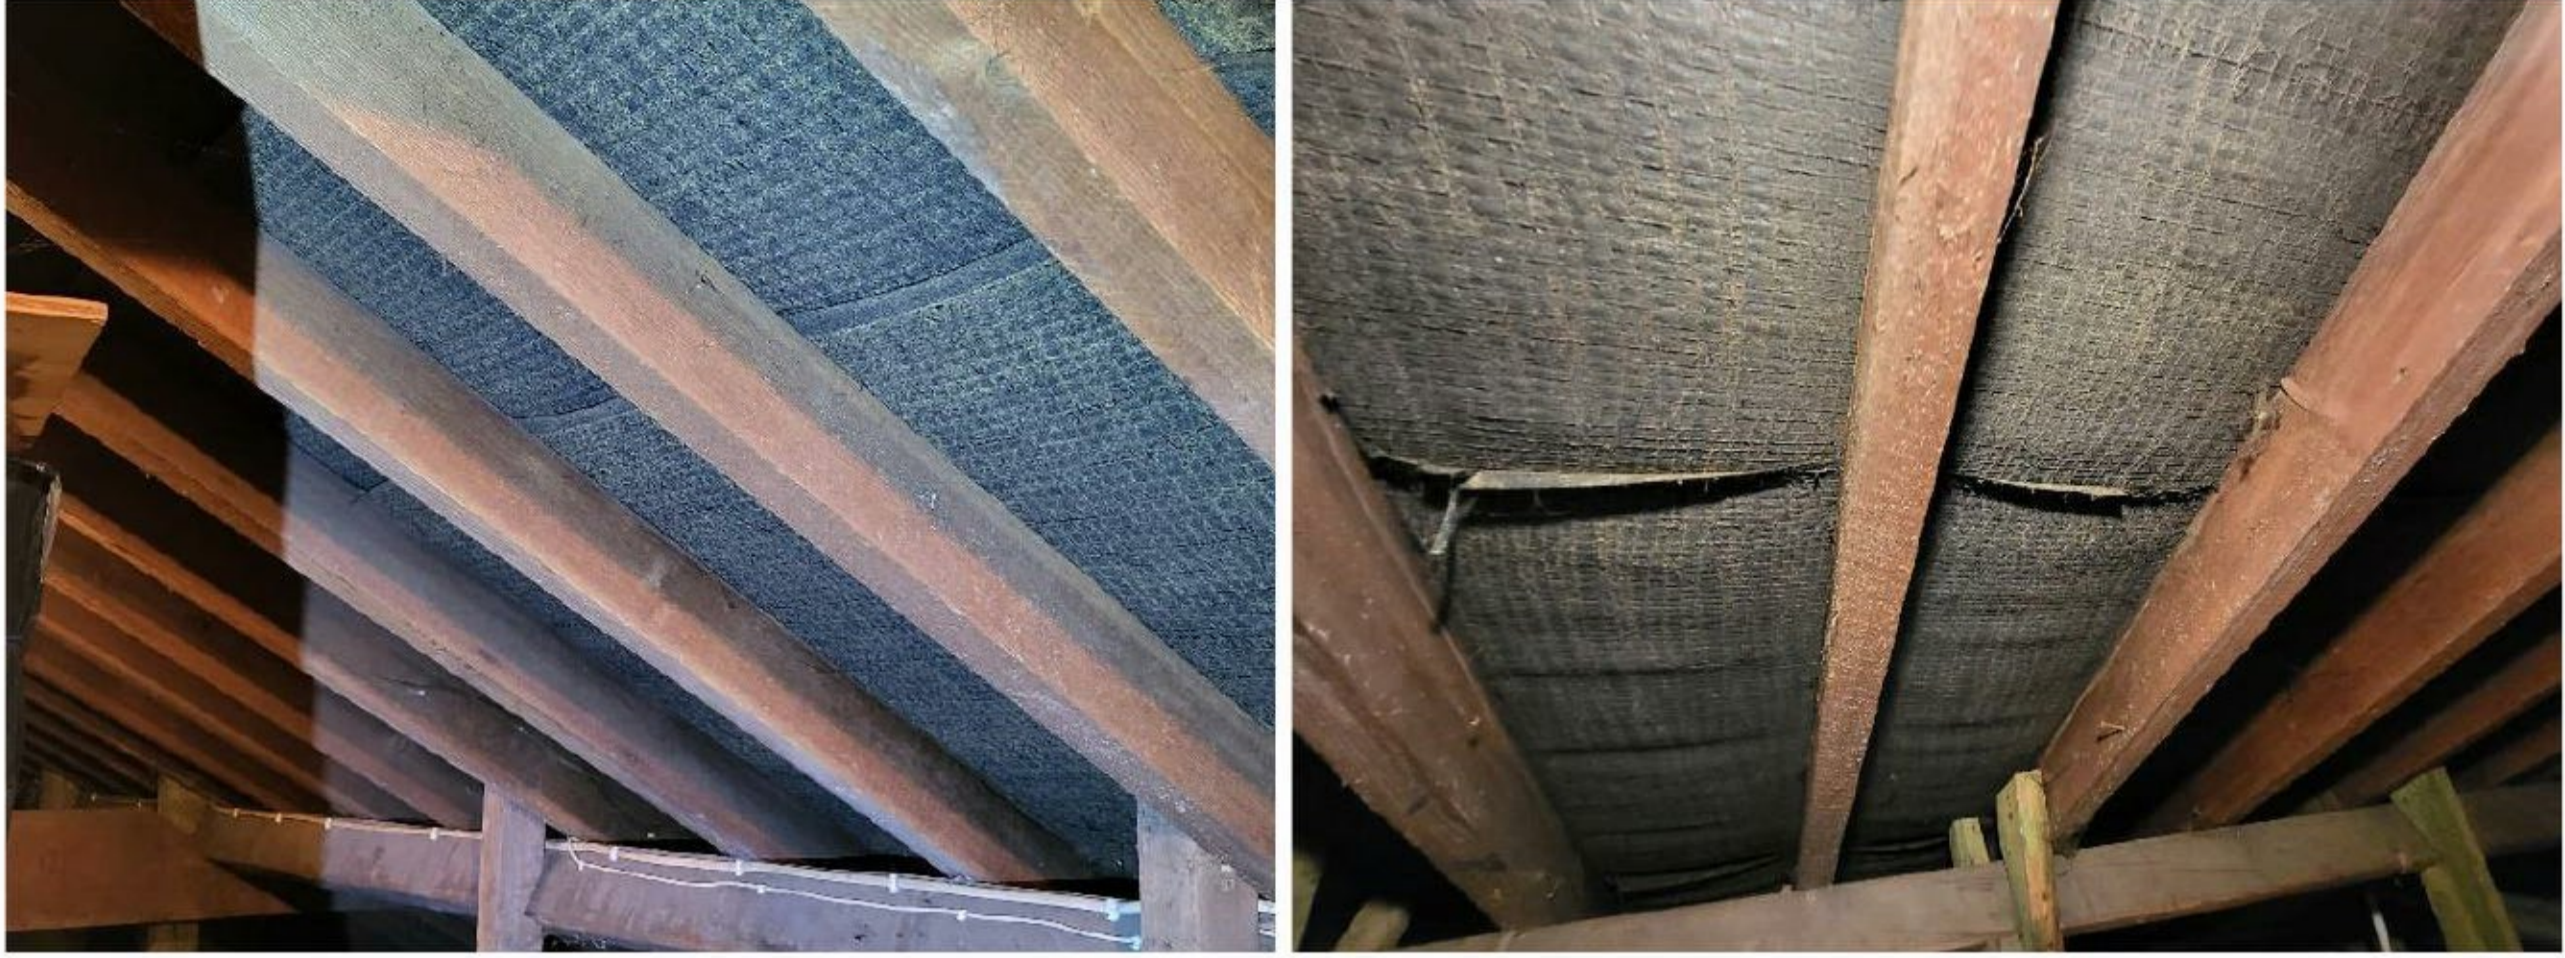
Figure 12. View of the roofing felt between rafters and slates

During the internal inspection, no evidence of roosting bats in the form of bat droppings, feeding remains, scratch marks, etc. was recorded. This however could be attributed to the presence of roofing felt being in good condition.

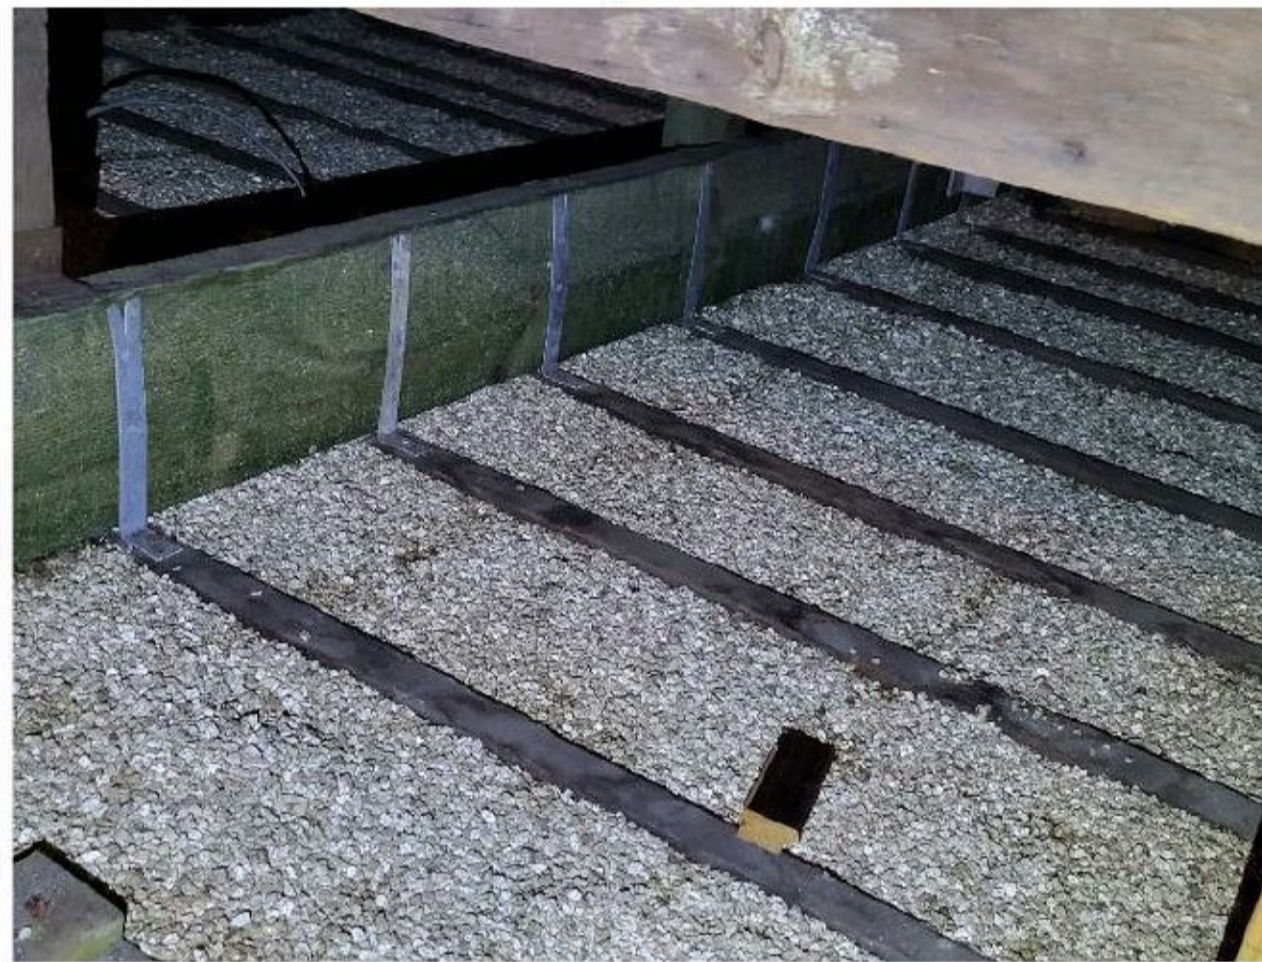
Figure 13. View of the loose fill insulation
