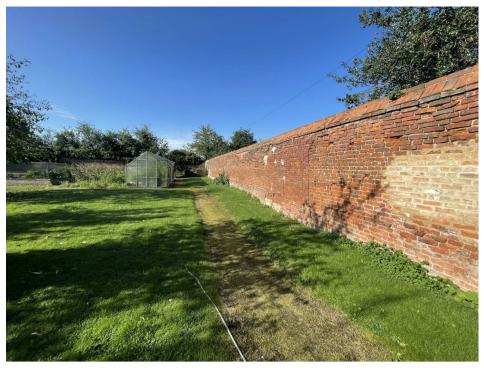
Photo 4

Looking Southwest towards the Greenhouses / proposed site for PV Panels from the entry point into the side garden.

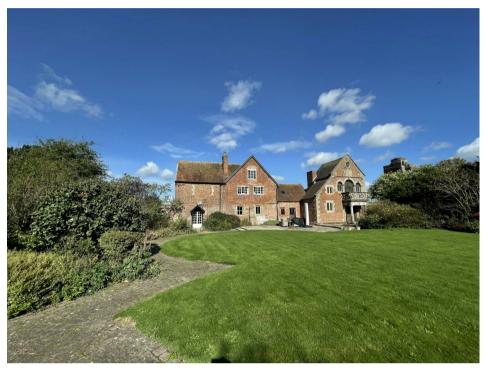
Photo 3

Looking North towards Hamstall Hall in the back part of the 'side garden'. Dense planting separates the front / back parts of this walled garden. To the right we see a remainders of the original C16 Hamstall Hall. This was the described as the "gabled bay facing south" and it is the most aesthetically pleasing (remaining) aspect of the Hamstall Hall site.

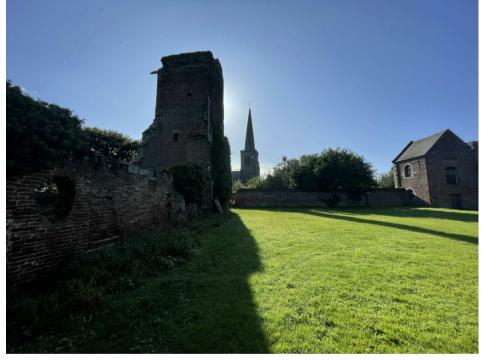
Photo 2

Within the rear garden at Hamstall Hall. Looking towards a surviving Tower from the original C16 Hamstall Hall. This grass area would have formerly been internal floor space within the Hall making it likely to hold archaeological remains and thus, an unsuitable site for the PV proposals. (Backdrop St. Michael's Church).

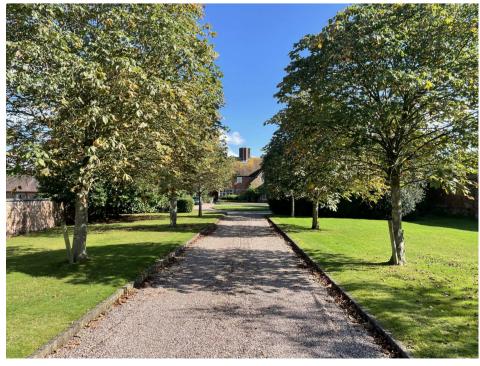
Photo 1

In the modern day this driveway leads to the principal elevation of Hamstall Hall as we see it (C21) from Blithbury Road. This is thought to date from mid C19 early C20 based on Historic Maps.

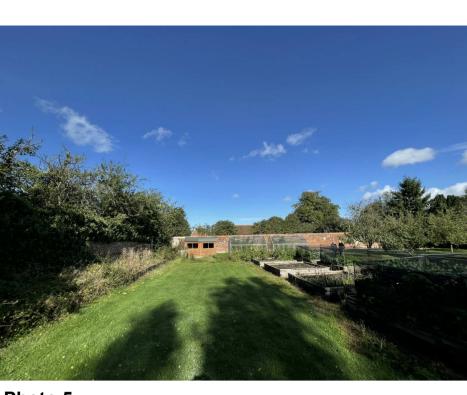
Photo 5

In the 'Walled Garden' alongside Blithbury Road. In the photo we can see some modern additions, some raised planting beds, a timber 'potting shed' and two greenhouses. The proposals are to be located alongside the greenhouses in an area which receives good levels of sunlight. (Photo taken 21-09-23 at 10:49AM).

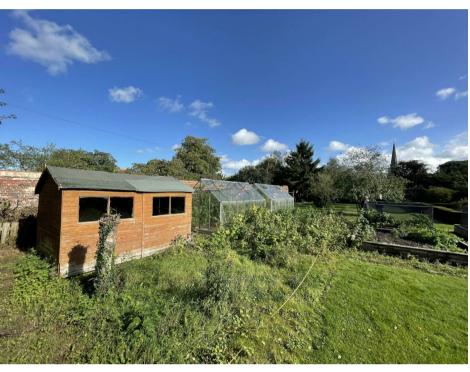
Photo 6

Closer view of 'Photo 5'. In the distance beyond the dense vegetation which separated the 'front' and 'back' areas of the 'side garden' we can see the Spire of St. Michael's Church. This photo is taken in the exact site of the proposed PV Panels. Analysis of the site has found this to be the most suitable location for these modern additions.

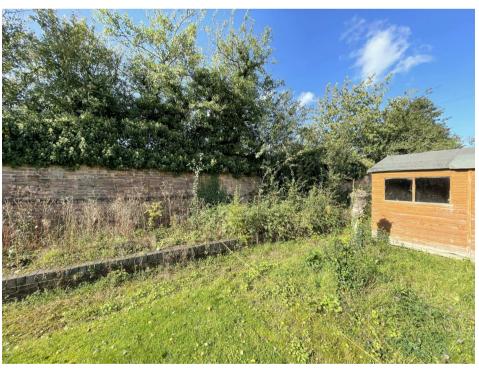
Photo 7

The 'Walls' separating the 'side garden' from Blithbury Road. These are historic red brick walls which exhibit mixed brick bonding. There is some evidence of Flemish Bond, some evidence of 'English Bond / English Garden Wall Bond, some Stretcher Bond' all capped with a decorative brick coping.

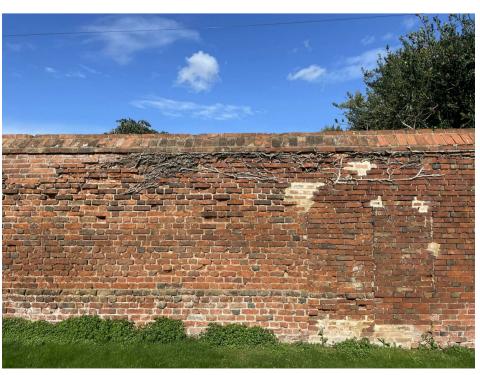
Photo 8

The 'Garden Walls' as described in 'Photo 7'. These are Grade II Listed and have evidential, historic and aesthetic significance. Condition is fair given its age, although some aspects are poor and repairs have been carried out in multiple phases.

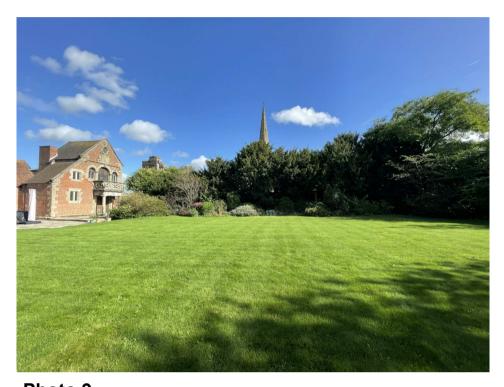
Photo 9 From the back part of the 'side garden'. In this photo we can see the original C16 bay of Hamstall Hall and the C14 Church Spire in the background. We can also see the dense vegetation which separates St. Michael's Church from the application site.

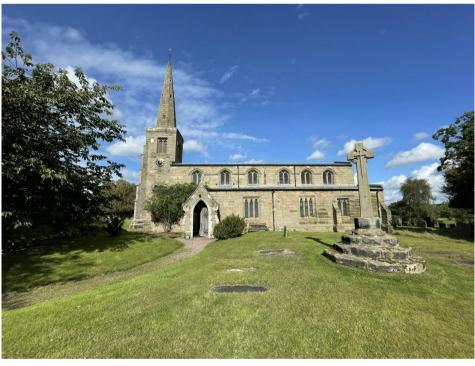
Photo 10 The Principal Elevation of St. Michael's Church (Southeast Elevation). This is well shielded by dense vegetation between the application site.
