BS5837:2012 Arboricultural Survey Impact Assessment & Arboricultural Method Statement

**Site Address:
David Lloyd Wickwoods Country Club
Shaves Wood Lane
Albourne
Hassocks
BN6 9DY**

**Robert Toll
HND Urban Forestry - ND Forestry - MArborA
Ref: RMT929 – Rev A
Site inspection date: 1st December 2023
Date report published: 2nd February 2024
Prepared for David Lloyd Clubs**

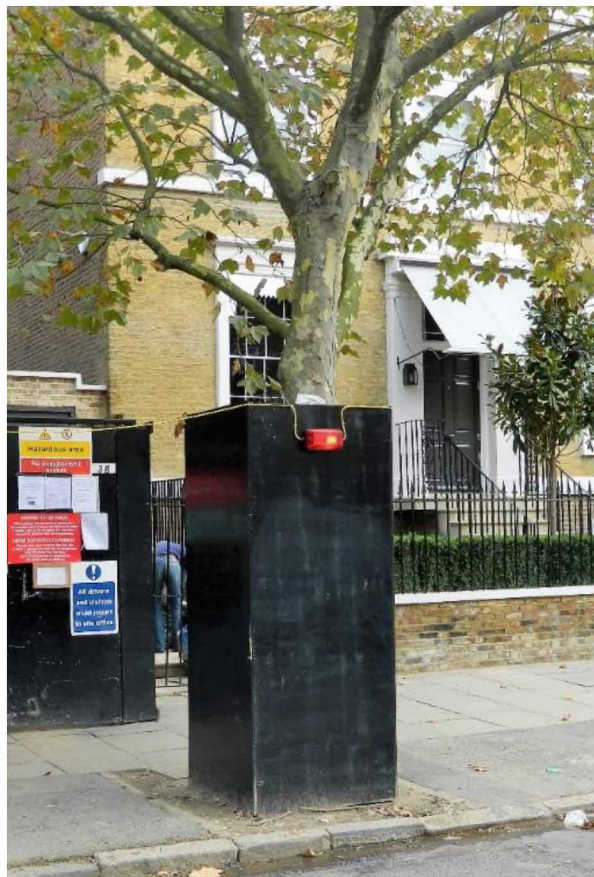
Figure 6 – Box protection for trees located in restricted areas (T49).

- 4.6 The growing position of tree T49 and the requirements for construction access requires that the trunk of this tree is protected during development. The protection will be formed of a protective wooden box erected to a height of circa three metres above ground level which will prevent impact damage.

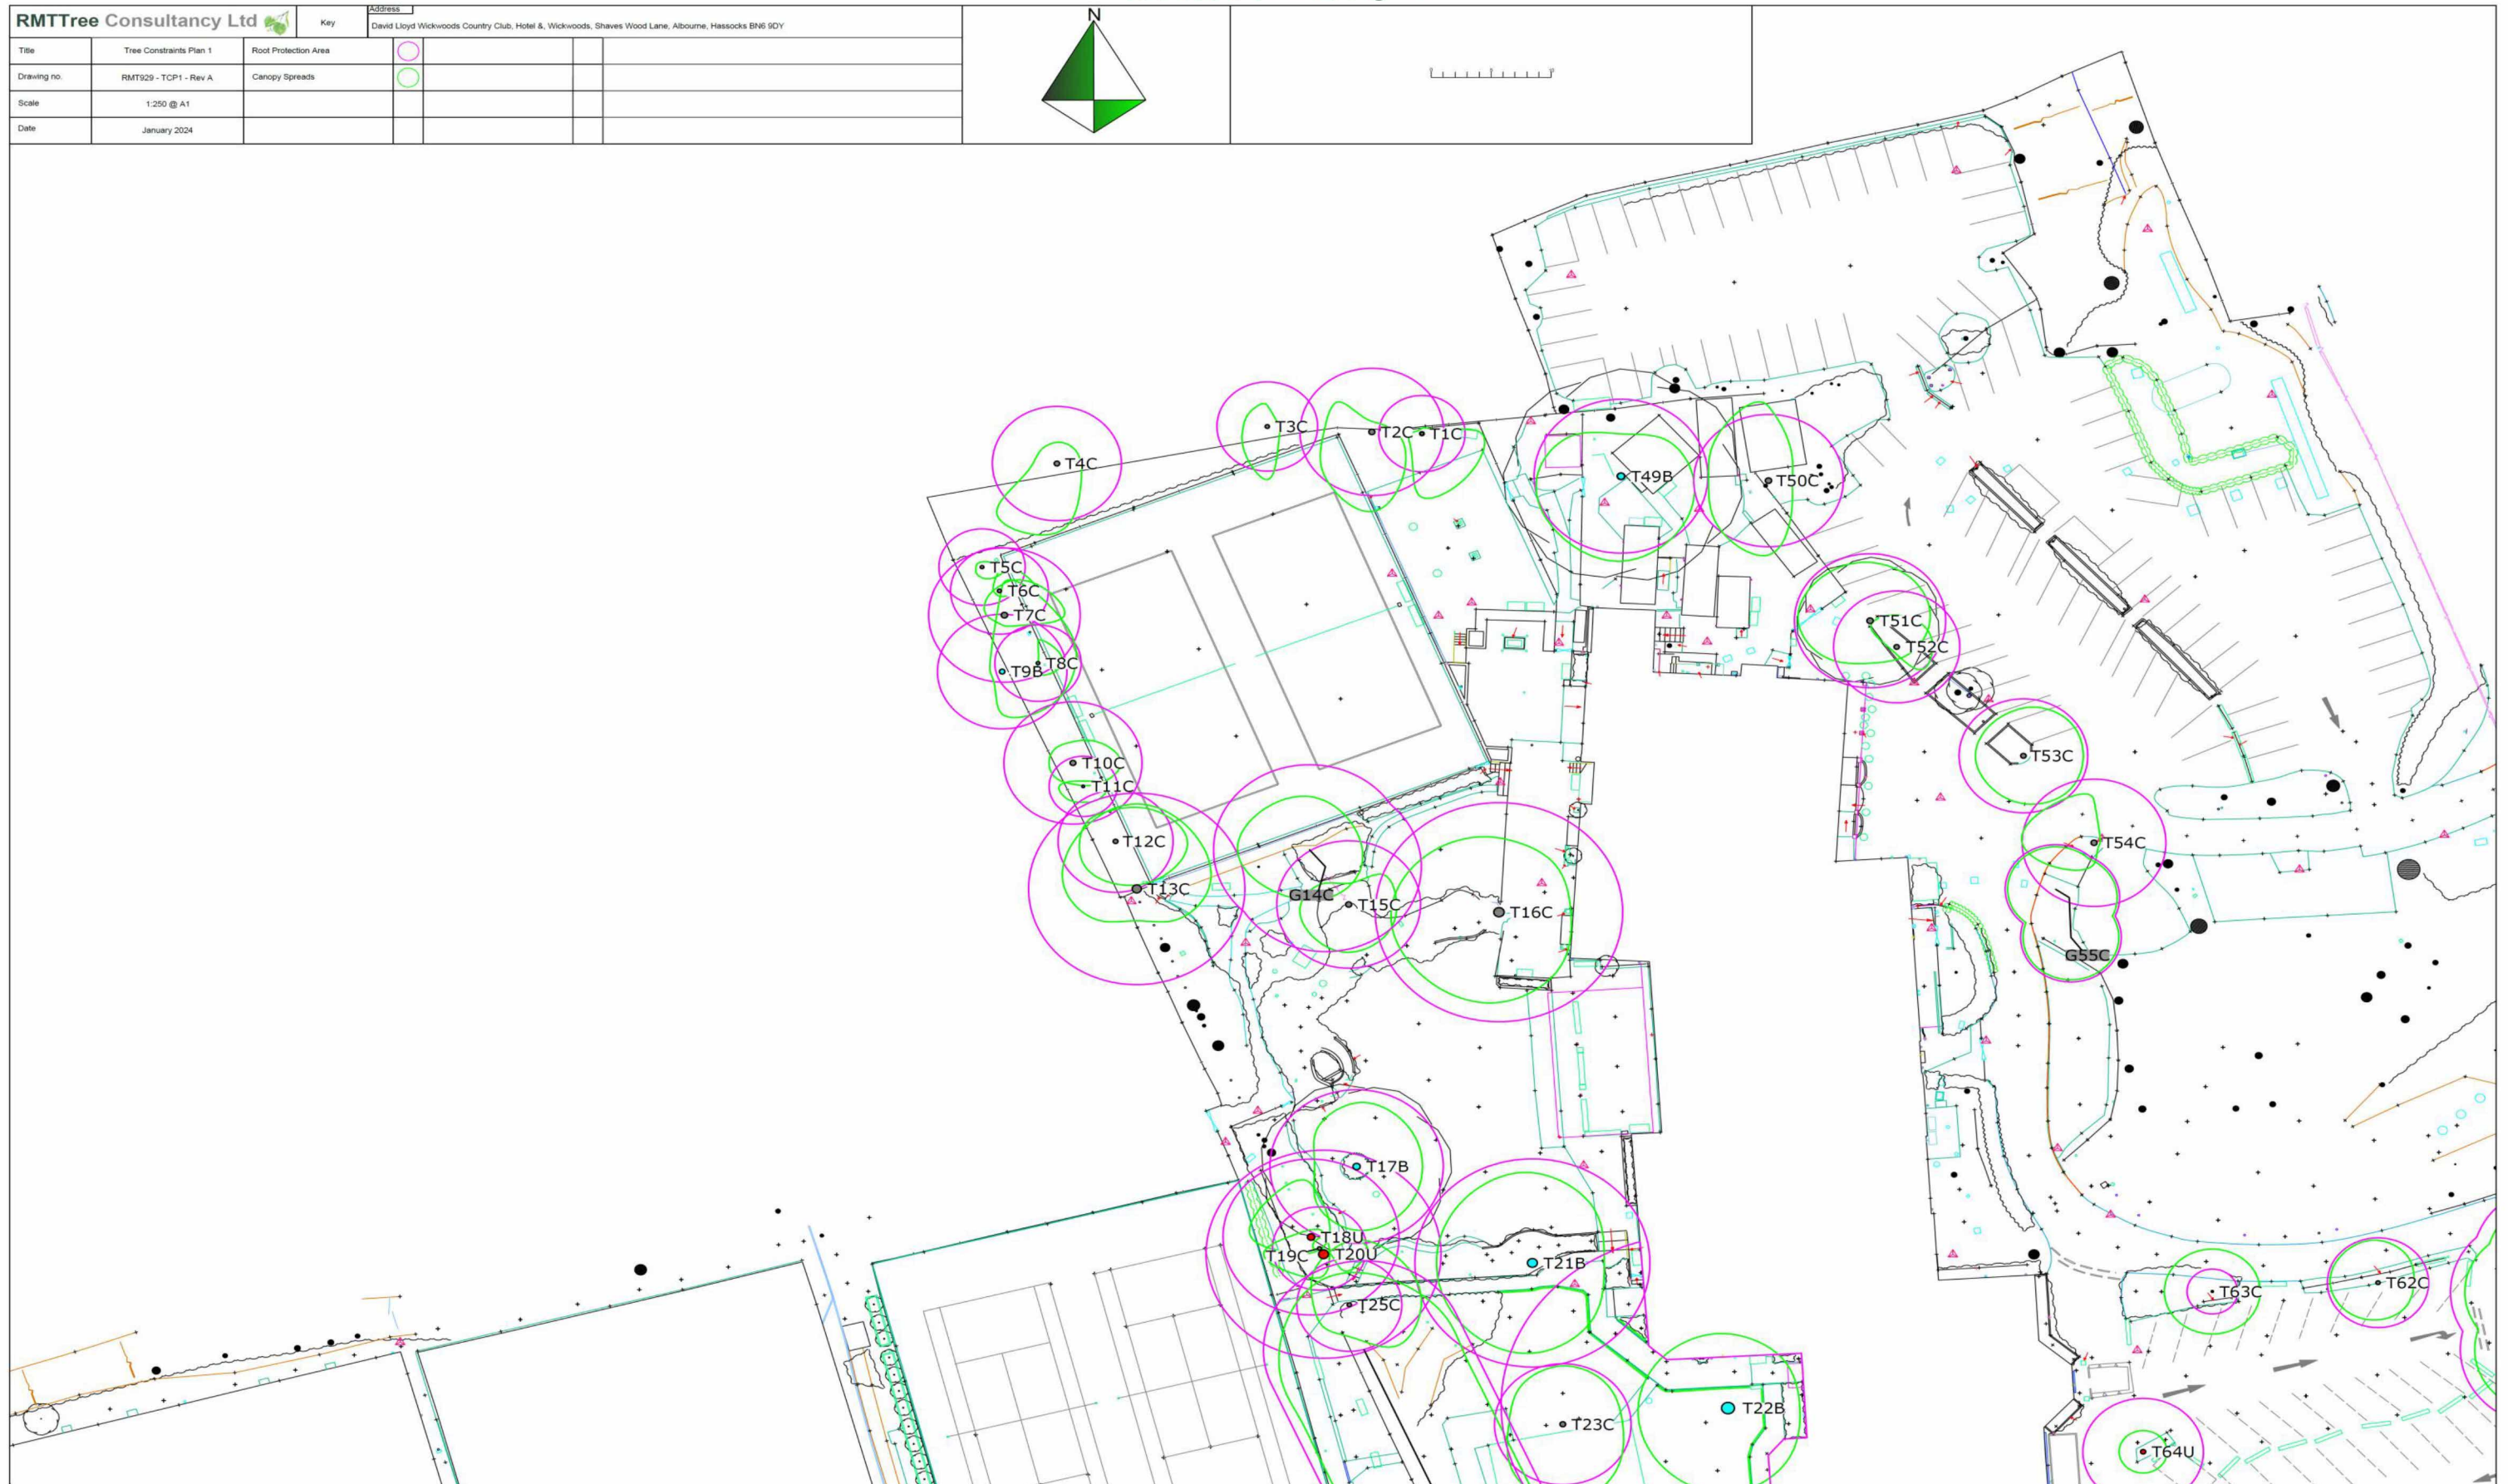
Appendix 3 – Tree Constraints Plan 1 – RMT929 – TCP1 – Rev A

Tree constraints plan (TCP) showing retained trees, tree numbers, root protection areas (magenta circles/polygons) and canopy spreads (green lines). The plan has been provided separately as a PDF at a scale of 1: 250 @ A1

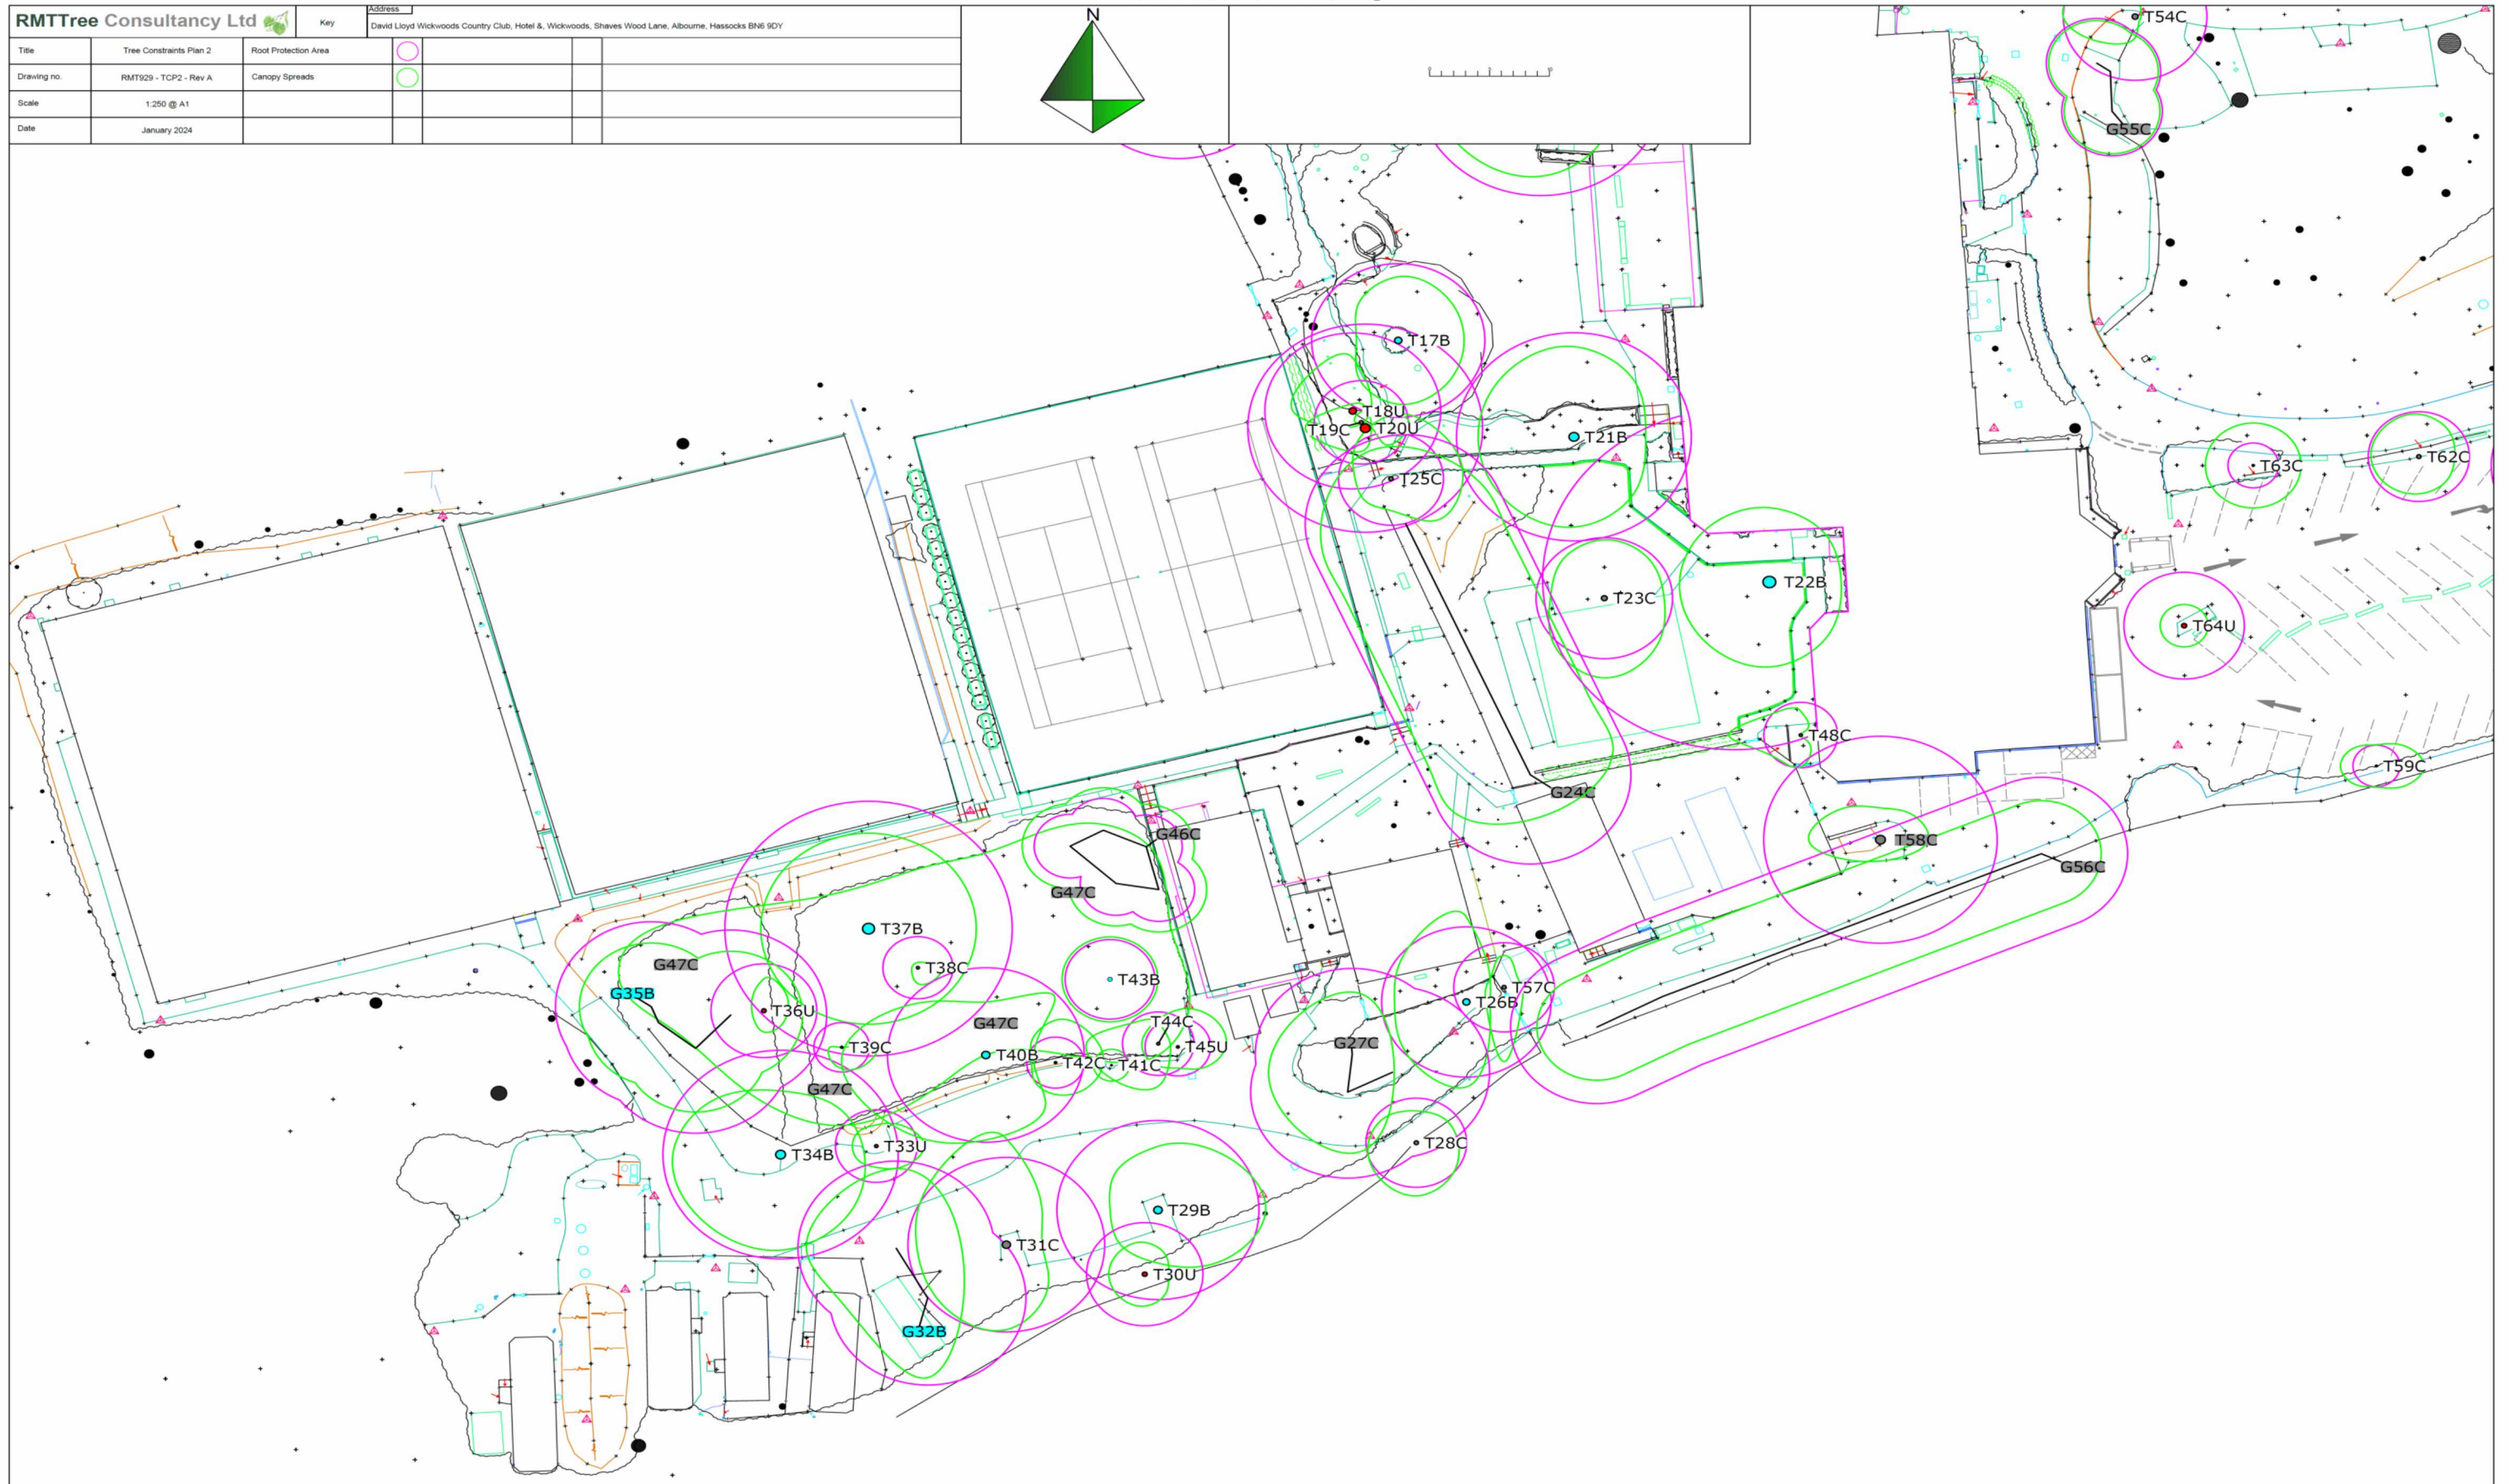
Appendix 4 – Tree Constraints Plan 2 – RMT929 – TCP2 – Rev A

Tree constraints plan (TCP) showing retained trees, tree numbers, root protection areas (magenta circles/polygons) and canopy spreads (green lines). The plan has been provided separately as a PDF at a scale of 1: 250 @ A1

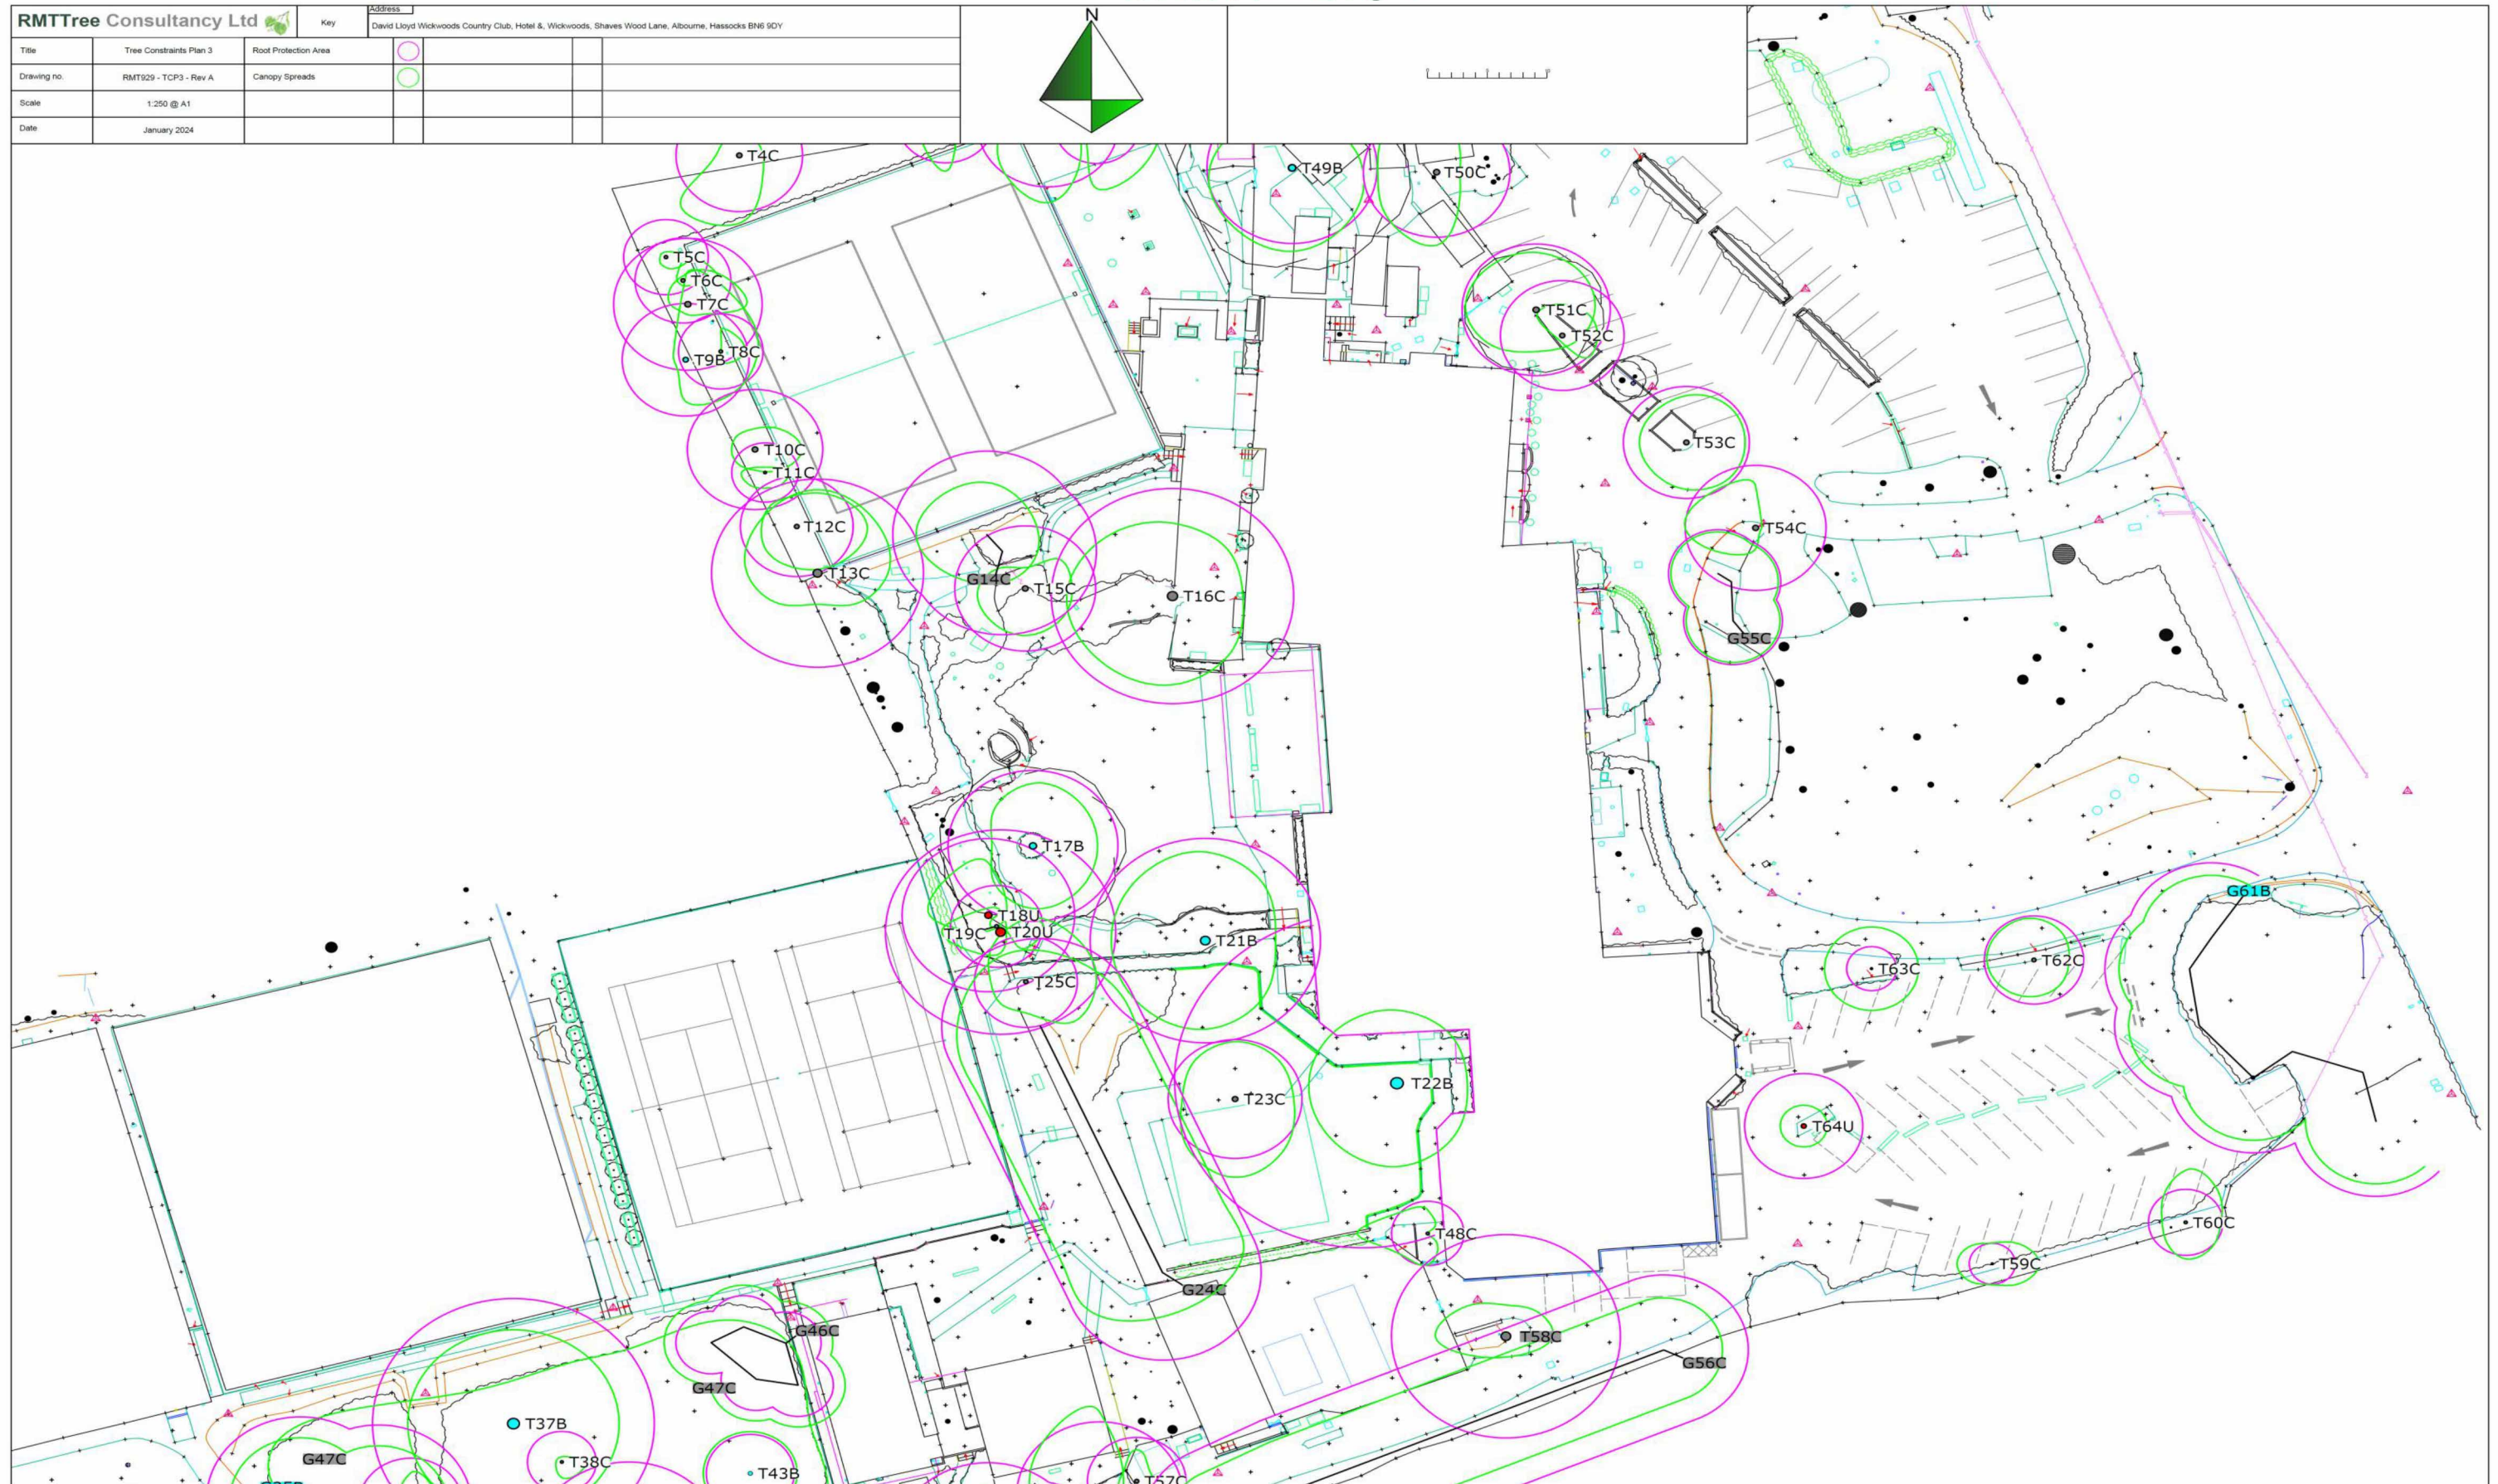
Appendix 5 – Tree Constraints Plan 3 – RMT929 – TCP3 – Rev A

Tree constraints plan (TCP) showing retained trees, tree numbers, root protection areas (magenta circles/polygons) and canopy spreads (green lines). The plan has been provided separately as a PDF at a scale of 1: 250 @ A1

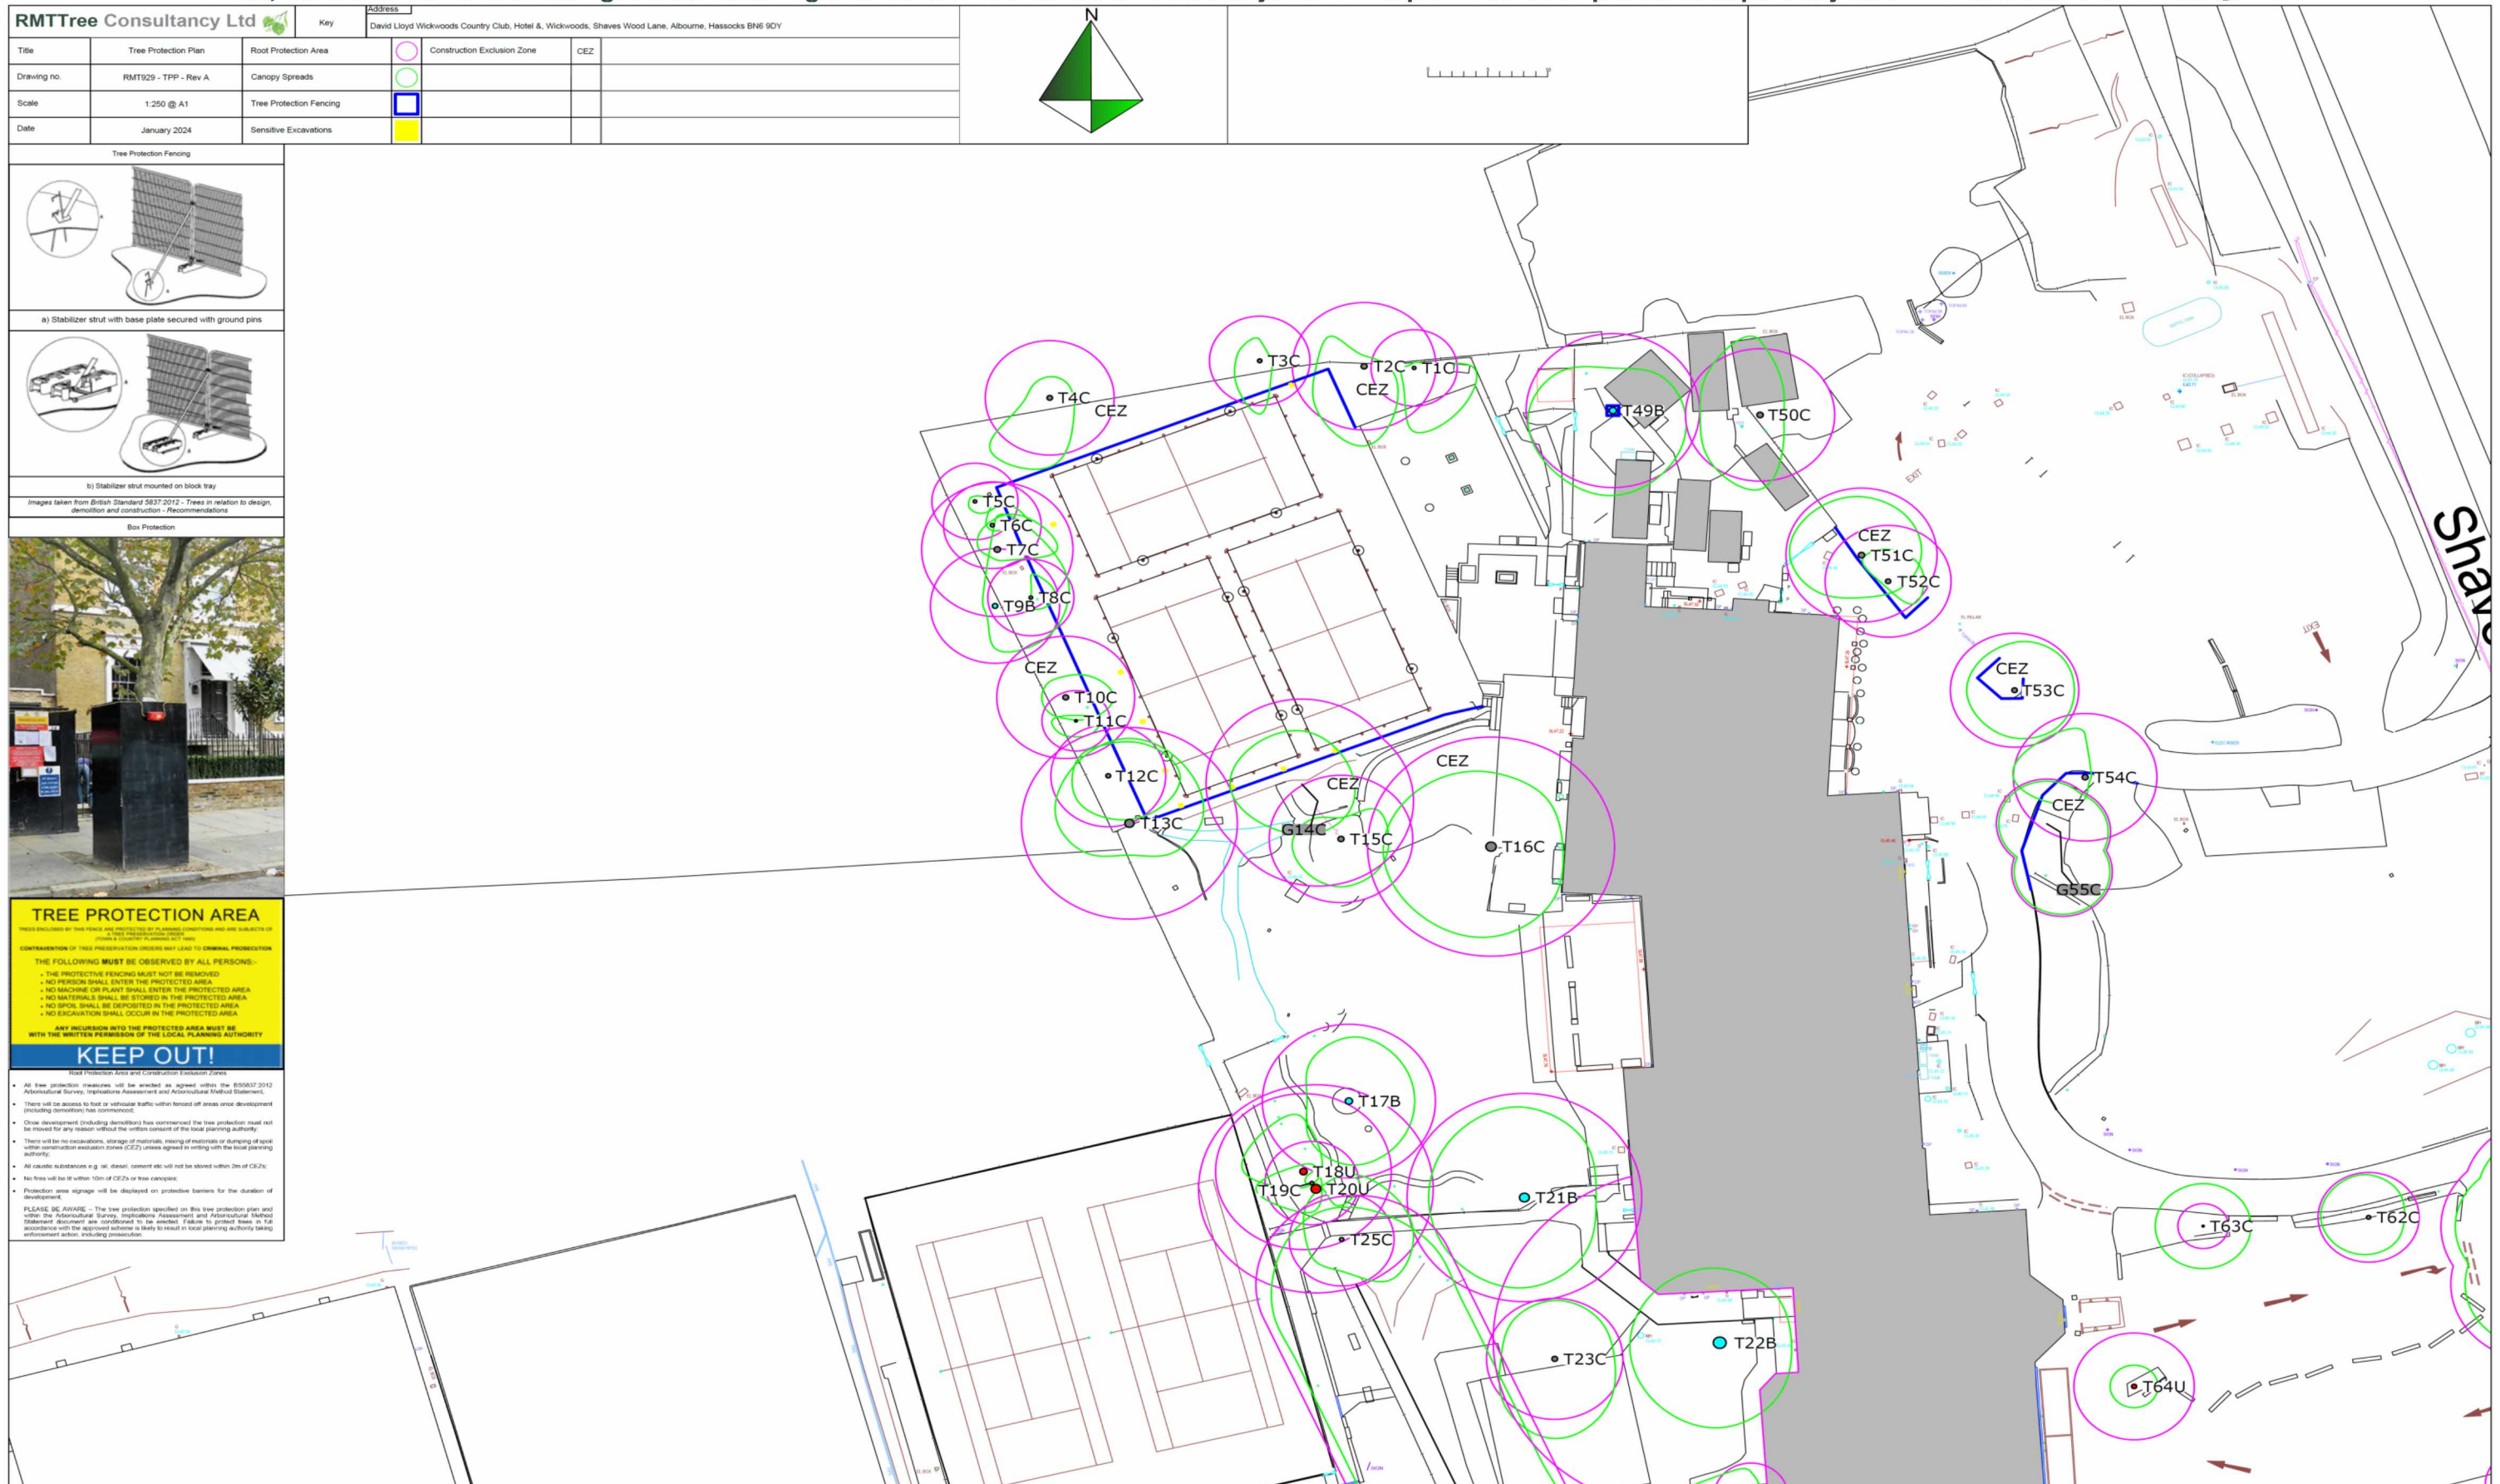
Appendix 6 – Tree Protection Plan – RMT929 – TPP – Rev A

Tree protection plan (TPP) showing retained trees, tree numbers, root protection areas (magenta circles/polygons) and canopy spreads (green lines). The location of protective fencing is shown as blue lines, sensitive demolition as light blue hatching and sensitive excavation as solid yellow. The plan has been provided separately as a PDF at a scale of 1: 250 @ A1

- 5.3 All tree protection barriers will be erected in the positions shown in **Appendix 6** and in accordance with the specifications detailed in Figures 3 and 4.

- 5.6 Areas to be sensitively excavation can be seen as solid yellow at **Appendix 6**.
- 5.7 The excavations within the RPAs of trees will be carried out using hand tools or compressed air device (Air Spade), and under the supervision of the appointed arboriculturalist. Prior to pouring concrete, the sides of holes or trenches must be lined with polythene to avoid leaching of caustic substances into the adjacent RPAs.
