**42- 44 Trooper Road, Aldbury, HP23 5RW**  
**Restoration works to northeast gable**

Heritage and Design and Access Statement to support  
Listed Building Application

11<sup>th</sup> March 2024

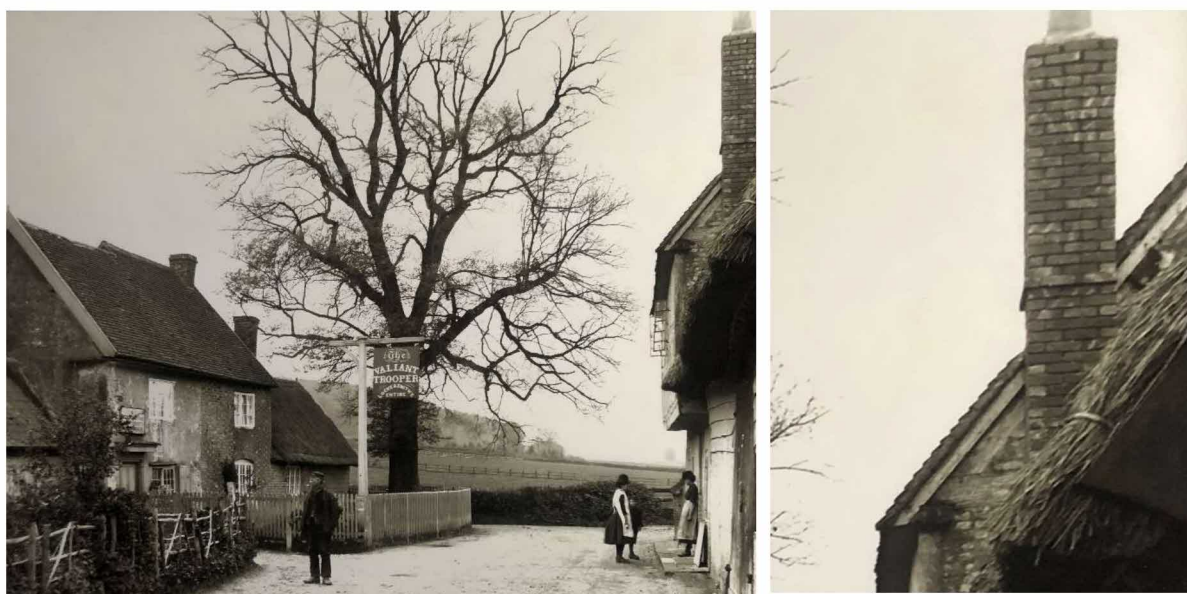
Figure 2: Left - photograph of the northeast gable of 42-44 Trooper Road, the thatched barns (now 40 Trooper Road) and the Valiant Trooper (photograph circa 1900). Right – close-up of the northeast gable where exposed brick and timbers can be observed.

Note the C19 chimney and upper section of the northeast gable can be seen. There is no rough cast concrete, and the timber frame and brickwork can be seen and appear to be in moderate to good condition.

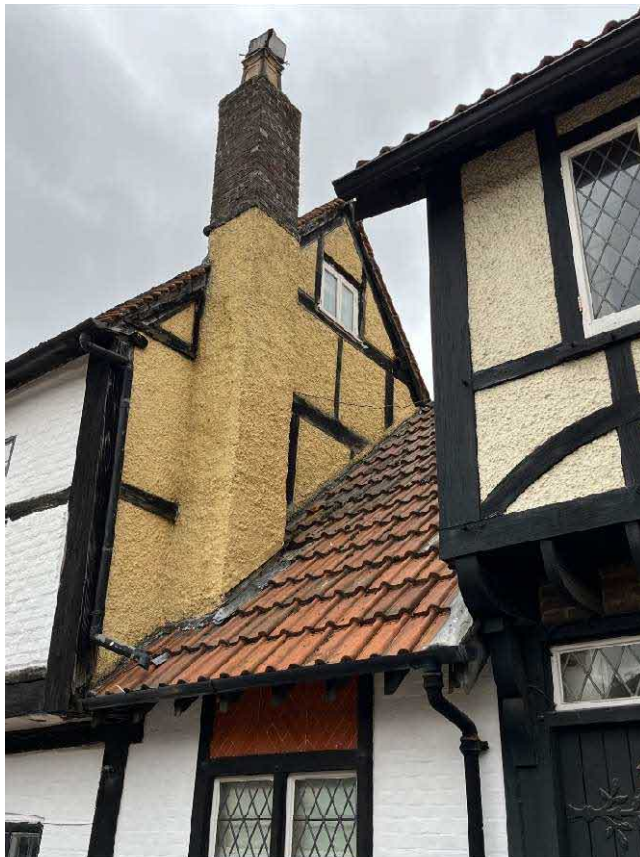
The northeast gable of 42-44 Trooper Road is visible externally from first floor level above the double roman clay tiles of the link building joining 42 Trooper Road to 40 Trooper Road. It currently has painted yellow rough cast concrete and mock tudor beams which are superficial and non-structural. Rough cast concrete is detrimental to historic fabric of the building as it not breathable and flexible.

Figure 3: rough cast concrete and mock tudor beams concealing timber frame and brick infill panels.

The justification for the works to 42-44 Trooper Road is that the owners, Mr and Mrs French have observed water ingress and damp within the property. The rough cast concrete render and mock tudor beams are modern building materials, that are excessively hard and resistant to the passage of moisture, and are incompatible with a C16 timber framed building. The replacement traditional building materials comprising non-hot-mix lime wash will add interest to 42-44 Trooper Road and contribute to its significance, whilst allowing the building to breathe.

The false beams and rough cast concrete will be carefully removed to reveal the underlying original timbers. It is worth noting the roughcast concrete was easily removed on the front elevation and it is anticipated that this will be the same for the northeast gable.

The proposed finish for all elements which had been covered with rough cast concrete, will be for a natural white hot-mixed lime wash (quicklime mixed with sand which is then slaked with water), to match the finish of the front elevation.

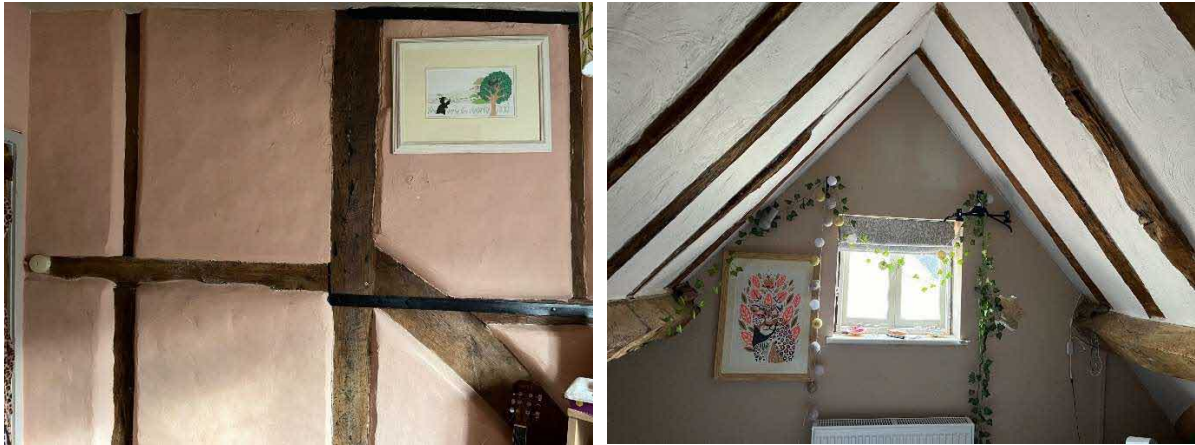
Based on historic photographs and on the internal condition of the timber beams (Figure 4) it is believed that the condition of the timber frame is moderate to good. The timber frame in the adjacent rooms have been concealed behind the internal finishes.

Figure 4: Left – exposed timber in the first floor bedroom indicate the condition of the timber beams is good. Right – attic room where the timber frame to the north east gable is concealed by internal finishes

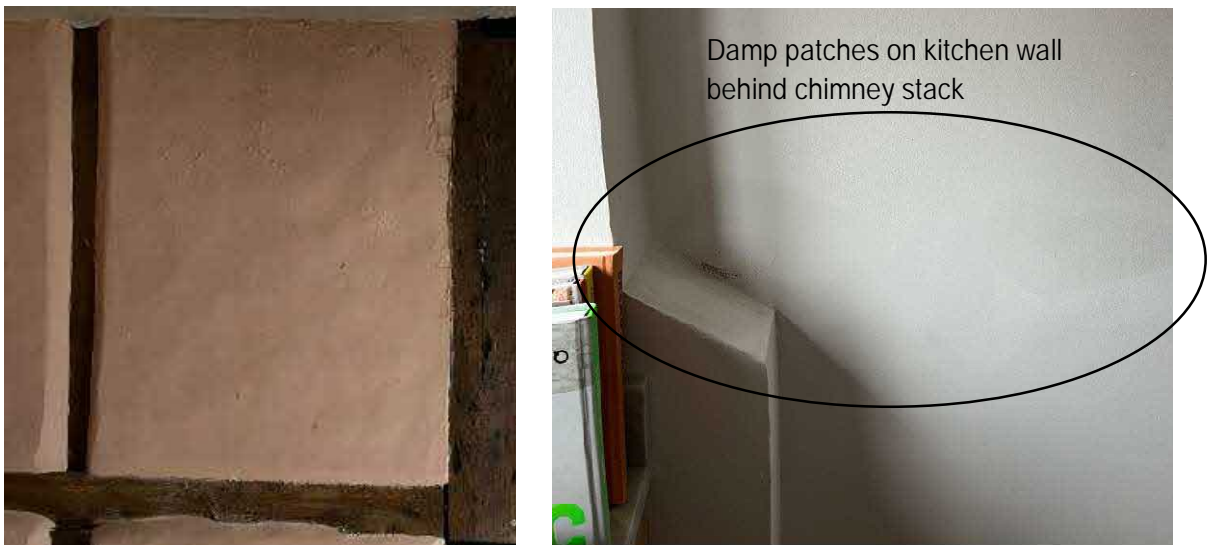
The owners have reported ingress of water to the internal walls to the kitchen (wet patches evident) and upstairs bedroom (blistering of paint), which may be linked to water ingress around the rough cast concrete, failure of the lead flashings at the interface of the link building to the main C16 building and to the partial detachment of the cowl.

Figure 4: Left – blistering of paint to first floor suggests water ingress. Right – damp patches in kitchen behind chimney stack to the northeast gable.

Any existing lead work that is found to be defective shall be replaced like for like.

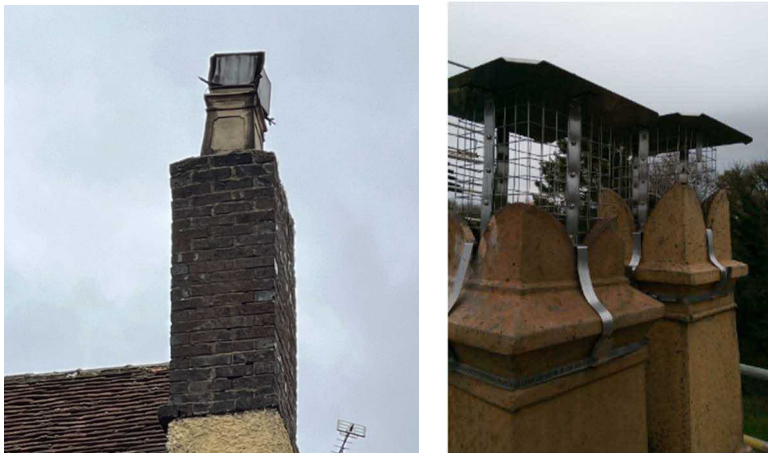
Figure 5: left - existing chimney, right - proposed stainless steel cowl to go on chimney.

The chimney cowl will be replaced with a square stainless steel cowl with bird mesh to be placed on the existing chimney pot.
