ARBORICULTURAL REPORT

BS5837 Arboricultural Impact Assessment

Nether Hall

Pakenham

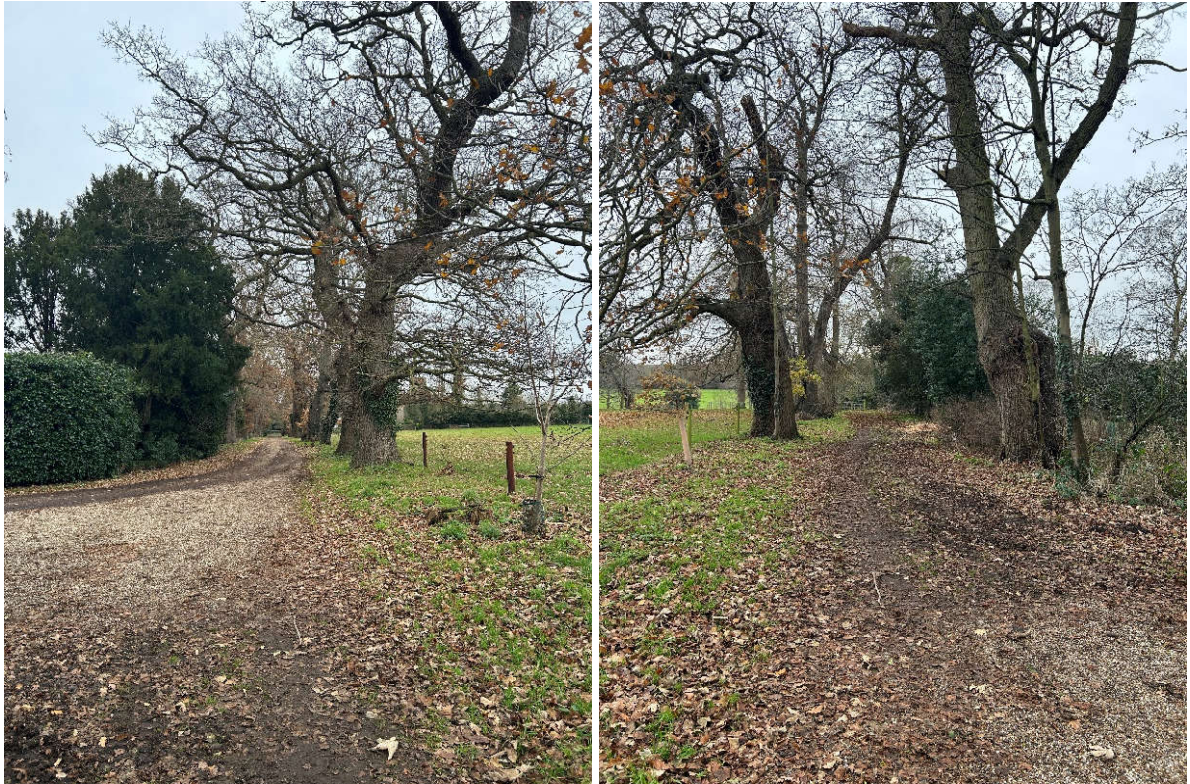
The site access/egress will be via an existing part gravel, part dirt track to the east of the site. This track is within the RPA of several trees to be retained at the site. Mitigation in the form of temporary ground protection has been recommended to minimise any compaction and contamination during construction works.

Photo 1 (left); Access track at east edge of site, looking northeast. **Photo 2 (right);** Access track at east edge of site, looking southwest.

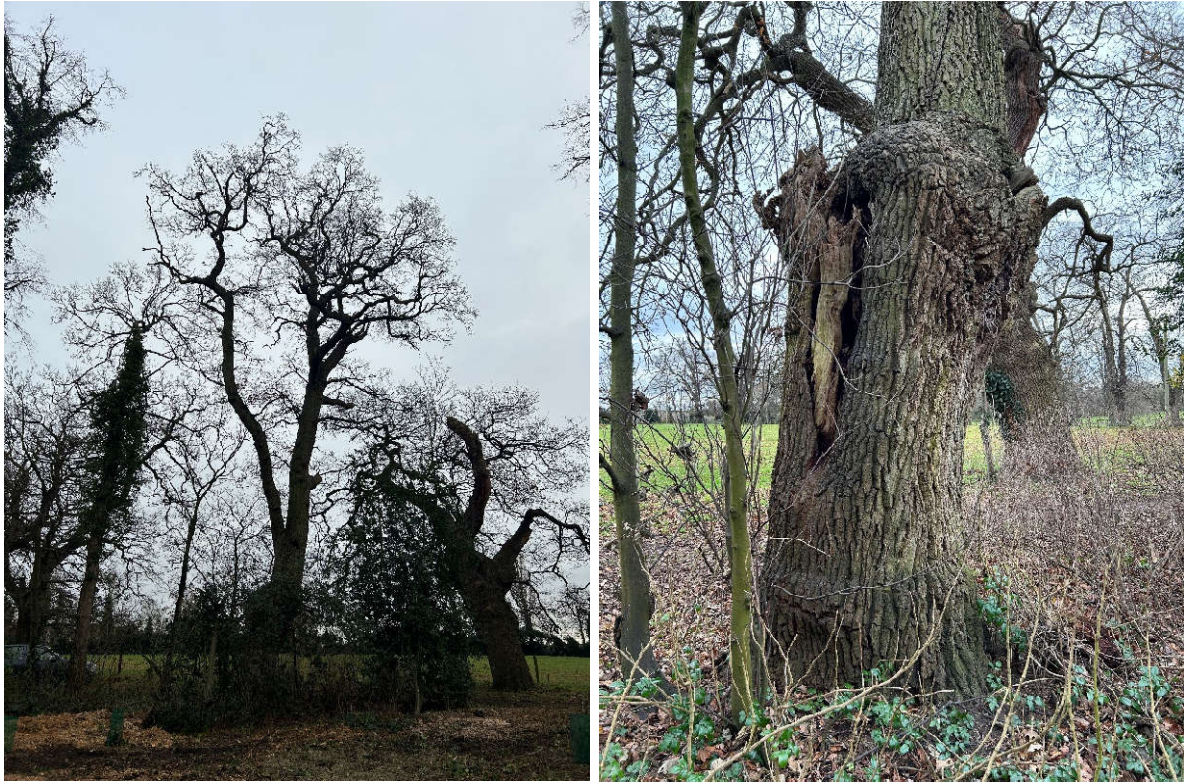
Photo 5 (left); T29 – oak. Photo 6 (right); base of T29 – oak.

5.4.1 Root investigation is recommended to determine the root morphology of trees T4 – oak, T5 – lime, T15 – yew and T29 – oak. This investigation should be carried out in a manner that is minimally disruptive to the trees at the site. Given the considerable number of trees, including some which have been recently removed, investigation using compressed air technology to expose the roots is deemed suitable as this will offer the opportunity to identify species of roots encountered, either visually, or through laboratory sample analysis where visual analysis is not sufficient. This may also be required to determine suitable routes for utility/drainage runs, if there is a requirement for them to enter the RPA of retained trees. This investigation should be carried out prior to the commencement of construction as it will provide information to inform the design of footings and construction methods used to achieve the proposed development.

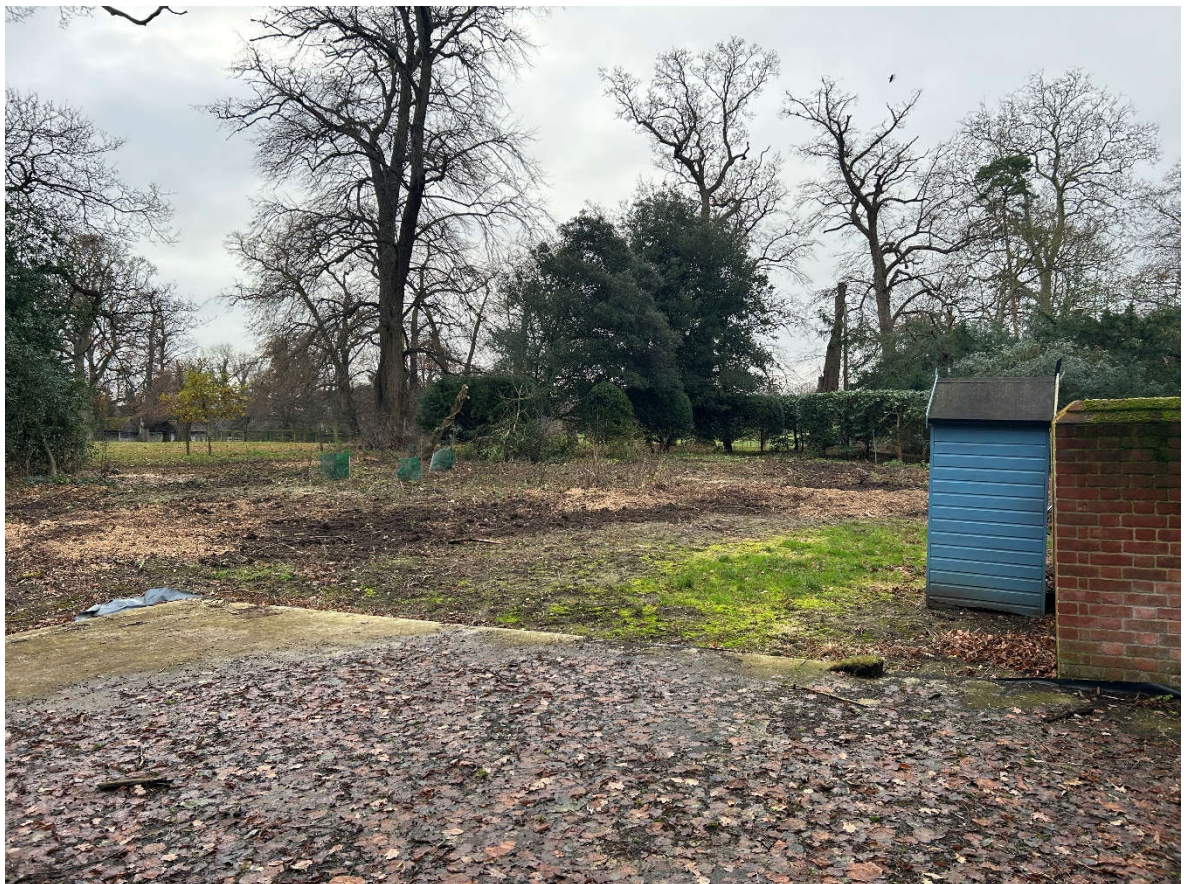
Photo 7; Central area of site viewed from north corner. Existing concrete pad in the foreground.

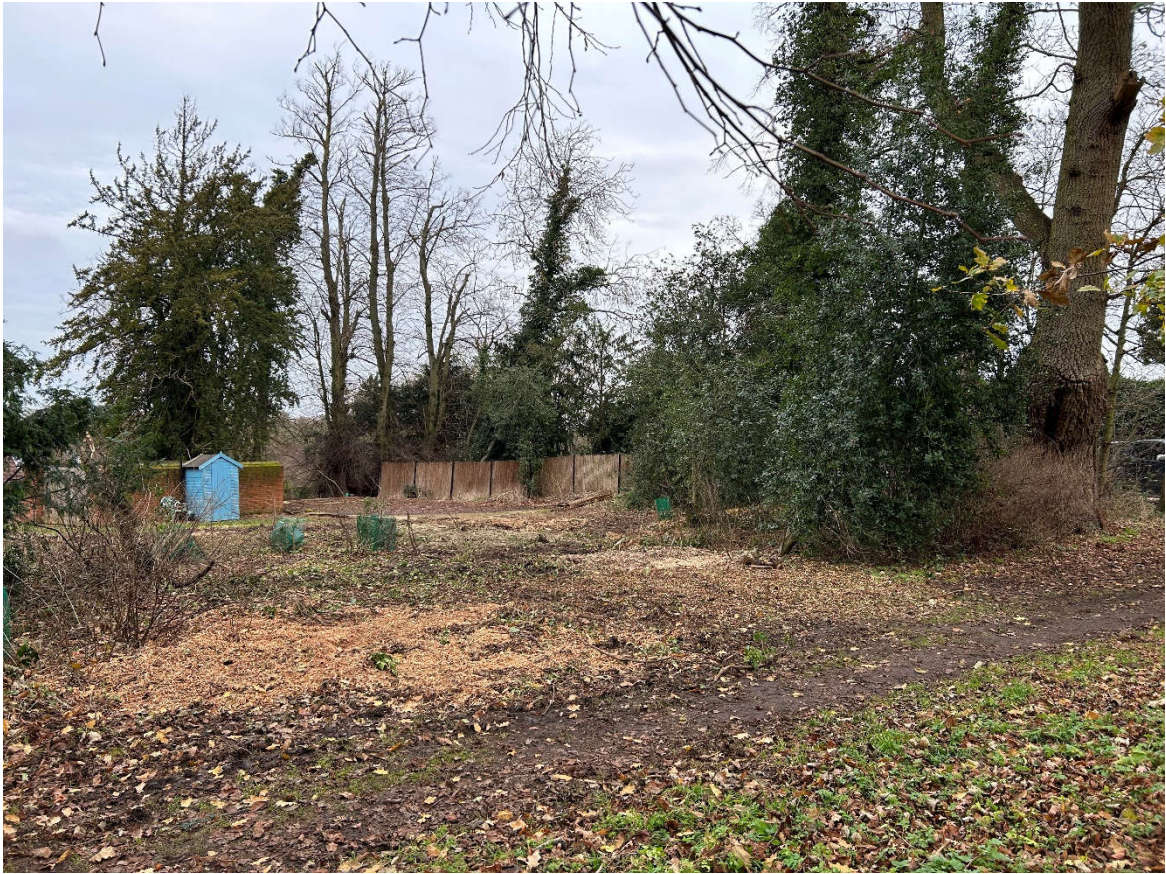
Photo 8; Access to area viewed from east.

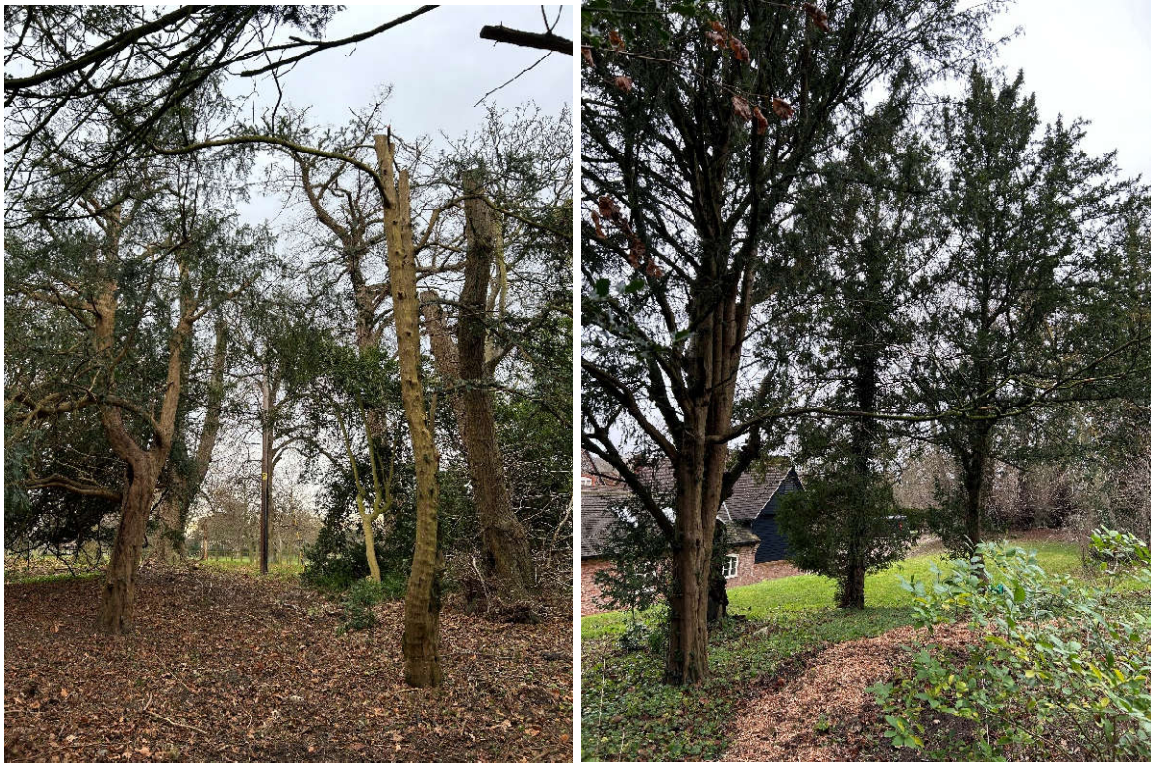
Photo 9 (left); T12-T14 – yew, with T11 – lime in rear. Photo also shows location of existing overhead power cable termination. **Photo 10 (right);** T17-T20 – yew.
