ARBORICULTURAL REPORT AND ARBORICULTURAL IMPACT ASSESSMENT to BS 5837:2012 at 45c Turfland Avenue Oldham Lancashire OL2 6EL

Client: Neil & Ann Seville

JCA Ref: 21728/DK

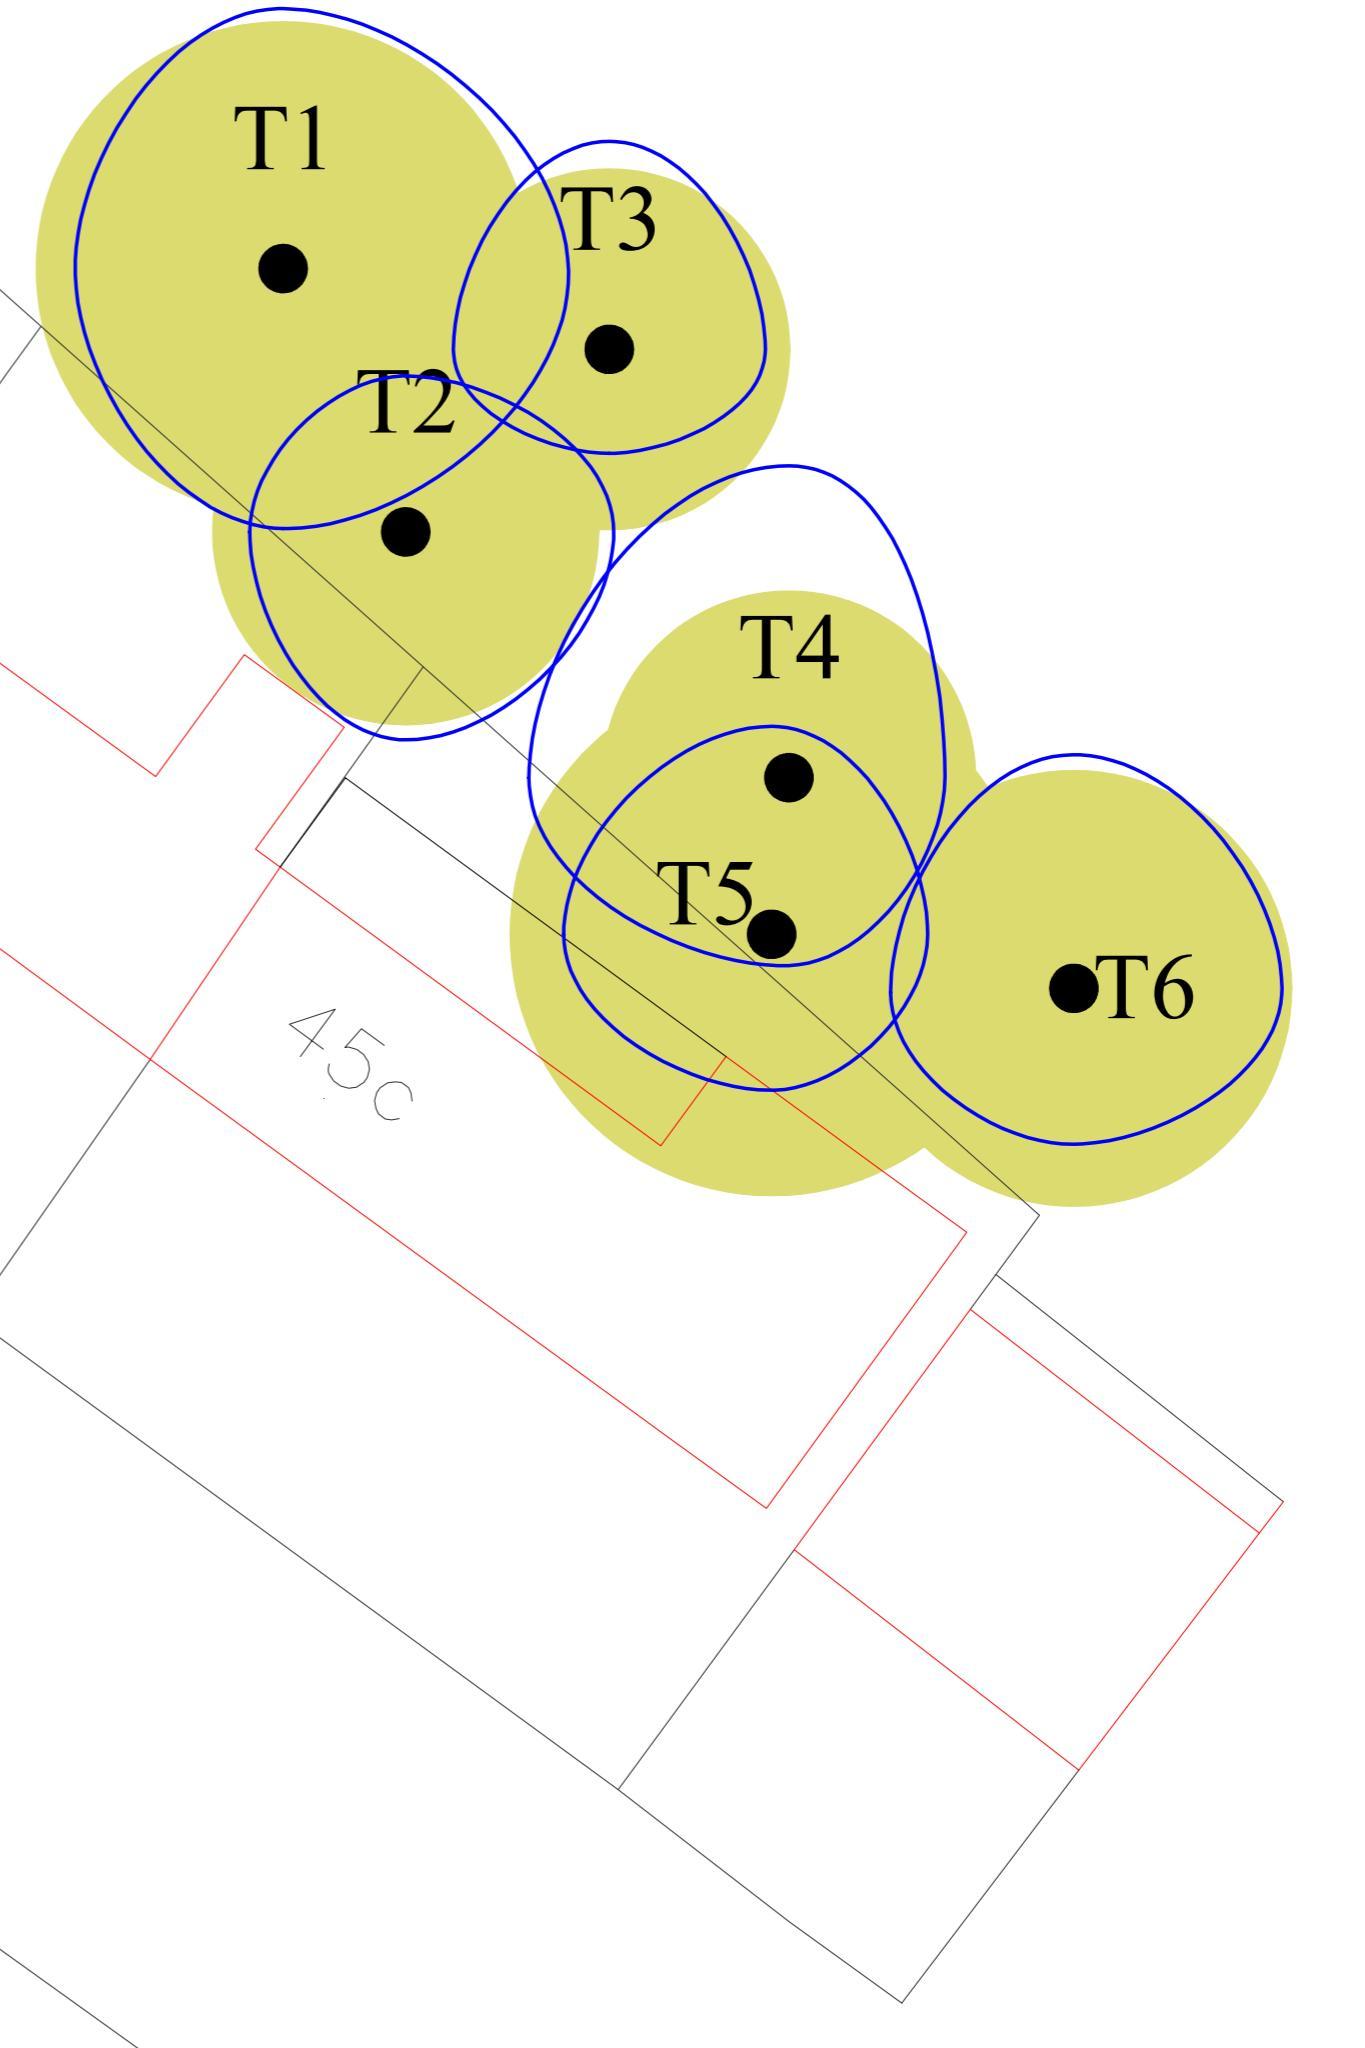
Appendix 5: Tree Constraints Plan

Root Protection Area: RPA THE ROOT PROTECTION AREA SHOULD IDEALLY REMAIN UNDISTURBED IF THE TREE IS TO BE RETAINED.

THE DEVELOPMENT PROPOSALS SHOULD THEREFORE BE DESIGNED TO AVOID THE RPA OF ANY TREE WHICH IS TO BE RETAINED.

IF IT IS NECESSARY FOR THE DEVELOPMENT TO ENCROACH INTO THE RPA OF A TREE WHICH IS TO BE RETAINED THEN SPECIALIST CONSTRUCTION TECHNIQUES AND MATERIALS MUST BE CONSIDERED.

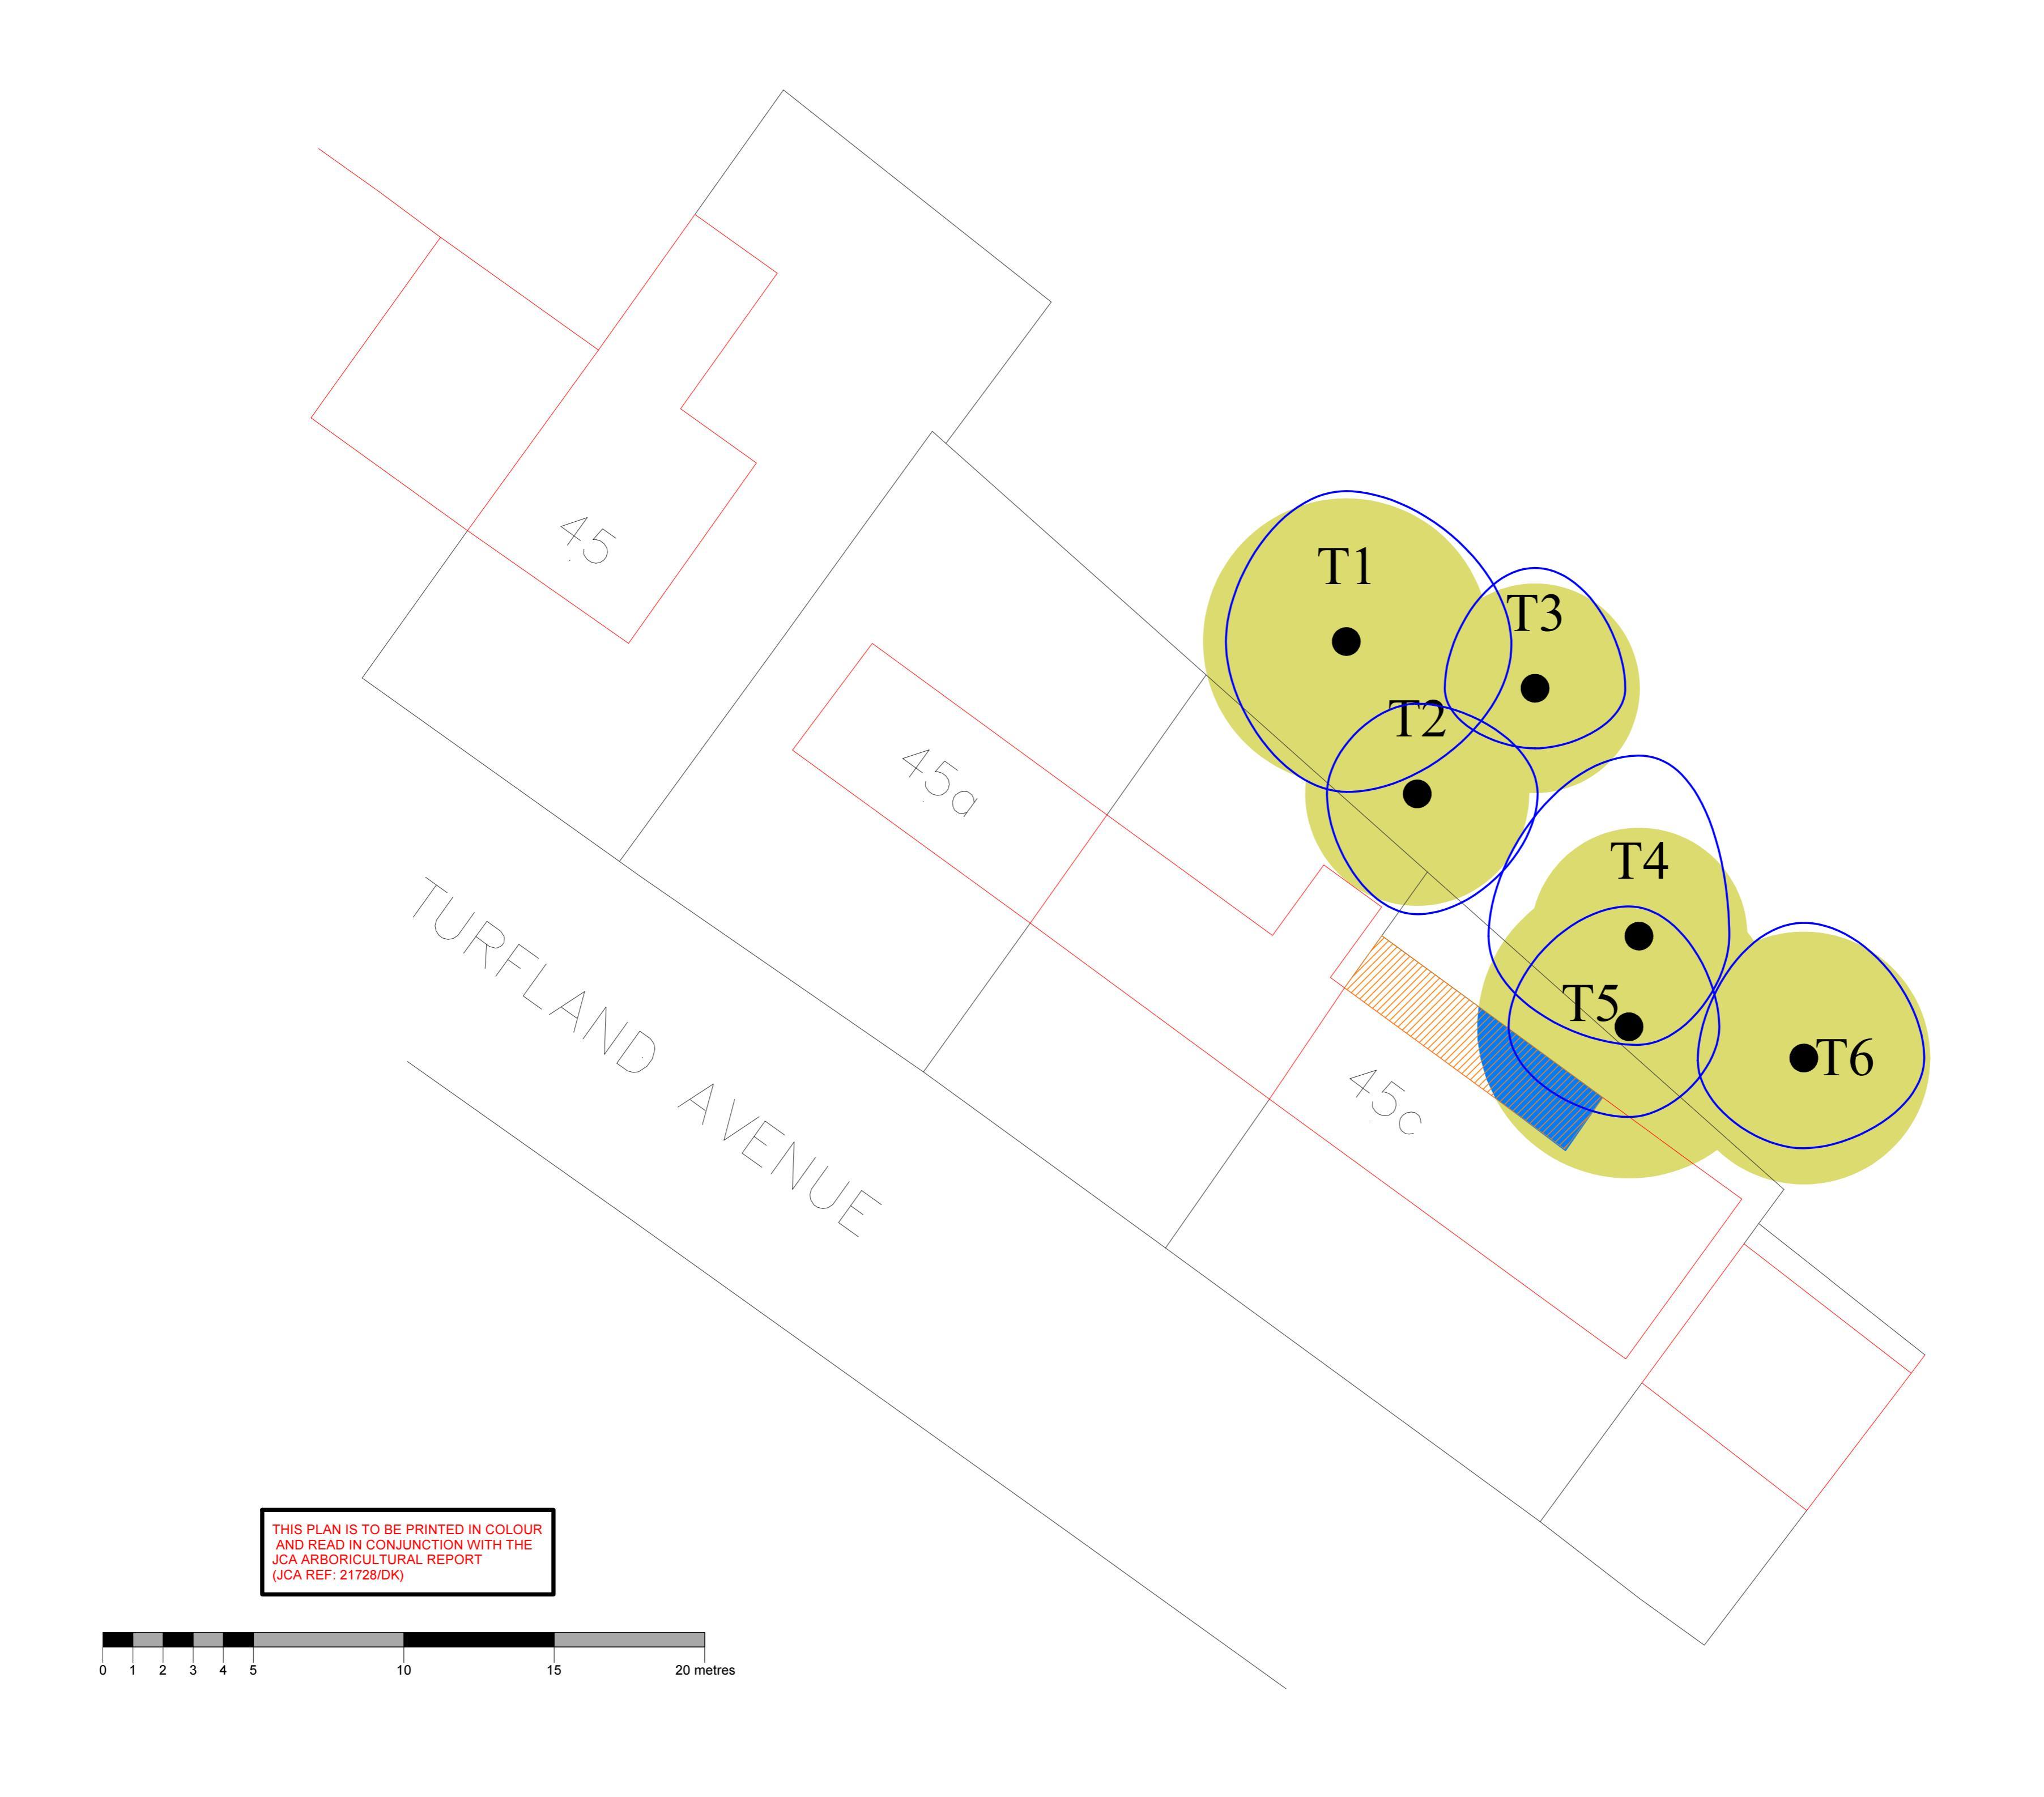
Appendix 6: Arboricultural Implications Plan

4.3.1 Where the footprint of the proposed structure passes within the RPA of one of the retained trees, root pruning maybe required, under the supervision of an appointed arboriculturist. Root pruning will accommodate the proposed structure whilst preventing any 'ripping' damage, a problem commonly associated with mechanical excavations. Root pruning is relevant to **T5**.

- 4.5.4.1 The footprint of proposed structure incurs the RPA of **T5**. In this case, because of the minimal nature of the incursion, it is considered appropriate to undertake root pruning. This will allow for the construction of the building, without causing 'ripping' damage to the roots, a problem commonly associated with mechanical excavation, whilst also preventing the need for specialist foundation designs.
- 4.5.4.2 The water demand of trees can be an important consideration when determining the appropriate foundation design. Due of this, water demands for the trees identified on this site are included in **Appendix 1**, in accordance with **NHBC chapter 4.2**.
