Historical significance statement for 78 Hewlett Road in relation to proposed basement rear external sash window replacement by a door and addition of steps to garden level

Application 24/00440/LBC and 24/00440/FUL.

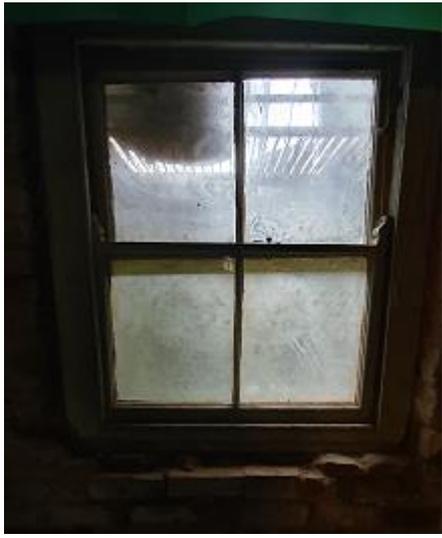
Rear basement window

- i. The basement rear sash window is 2/2 and made of wood which has been painted but otherwise poorly maintained over the years. The sash window is nonfunctional due to material rot and broken mechanism, being nailed in place and secured by a metal mesh.

- iii. The window is below ground in direct contact with an external wall with no dampness protection and has consequently suffered from extensive rot, the rear wall being very damp to the touch. Due to the direct wall to soil contact, significant dampness, and lack of any treatment it is believed that this window would deteriorate relatively rapidly.

<p>There is good reason to surmise that this is a replacement window. It does not match the small paned style of the others in the terrace.</p> <p>Due to the direct wall to soil contact and significant dampness and lack of any treatment it is believed that this window would deteriorate relatively rapidly and therefore more likely to have been replaced.</p> <p>The small opening to ground level severely restricts natural light entering the rear of the basement.</p>

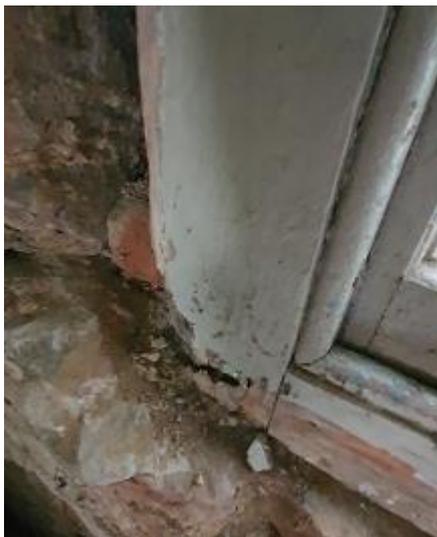
<p>The back basement wall is underground and in direct contact with the soil.</p> <p>The back wall is very damp, there is no damp protection.</p> <p>There is extensive rot all around the frame.</p> <p>The window is nonfunctional with a broken mechanism.</p>

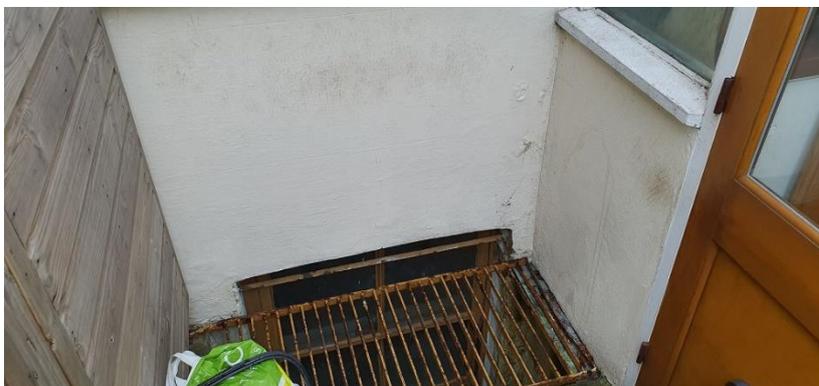
<p>Exterior photo showing view down into the window.</p> <p>The curve of the shallow arch lintel can be seen.</p>
