PROPOSED ENTRANCE - NORTH ELEVATION
SCALE 1:50 @ A3

St Martin Church	PROPOSED NORTH DOOR
Mar 23	
Ref - 22CHURCHRENEWALS06

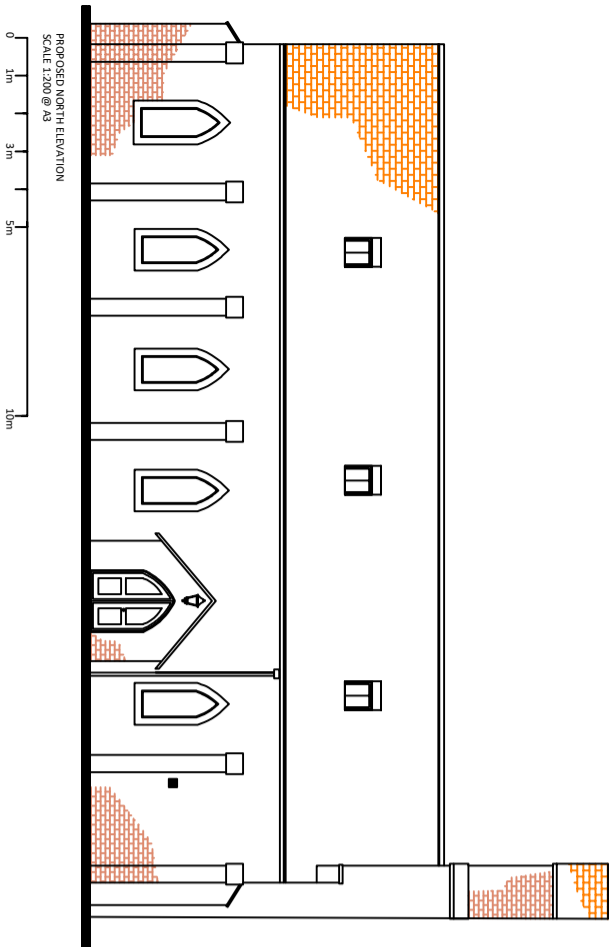
Existing Doors formed from plywood and in poor condition. Doors are not original (ply), so a repair would not be ideal. Replace with solid timber doors and new glazing (double to match existing), painted black. New door handle and locks. New black ironmongery to match existing.
