The Lodge
2 Dykes End
Collingham
Nottinghamshire

Potential Bat Roost Assessment Report

Issue Date: March 2024

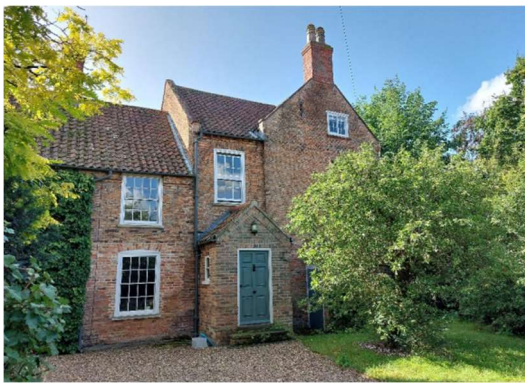
Front (northern aspect) of property.

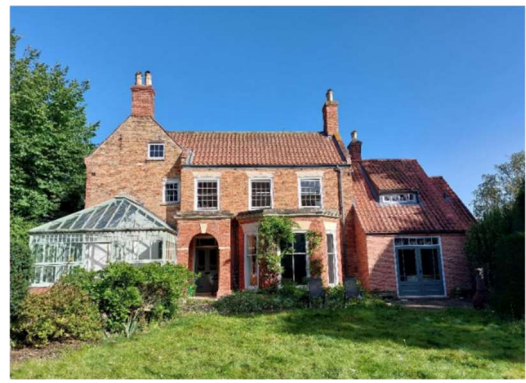
Rear (southern aspect) of property with glass house and bay window.

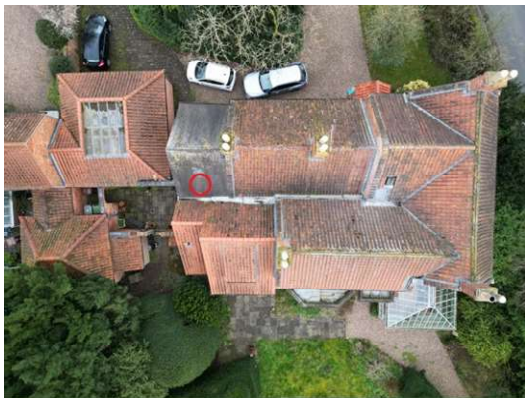
- 3.6 Only part of the property contained a roof void with other sections converted as internal living areas. The roof void was split into sections with the largest area featuring underfelt on the underside of the clay tiles. However, the smaller section with slate tiles (location of new slate vent) was not covered and the existing tiles in this location had been sealed underneath with mortar. As such no potential access points which could be used by bats were noted in this location.

Location of proposed slate vent (marked in red). No PRFs noted and tiles sealed with mortar underneath.

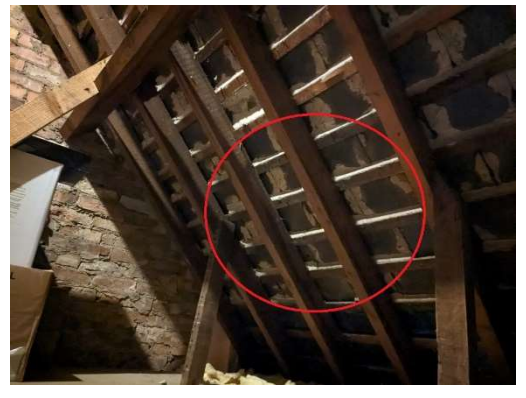
Internal roof void. Underside of slate roof at location of proposed roof vent. No potential access points or evidence of bats in this void.

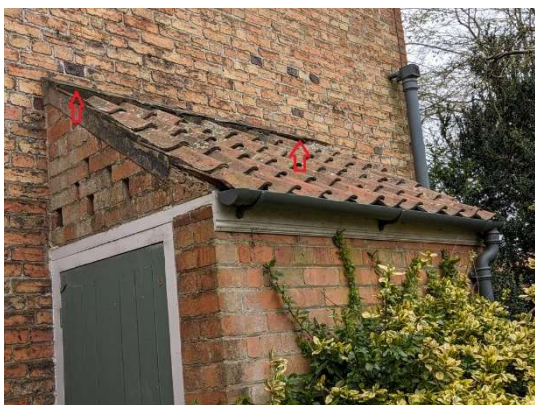
- 3.10 A section of tiles along the roof of the cellar access was raised slightly along its length with some mortar infilling which had become loose. This will be replaced as part of the works. The tiles in this location had lifted slightly in several places and with missing/loose mortar this had resulted in shallow

crevices beneath. These could easily be inspected from ground level and the features were unsuitable for roosting bats and offered no access to the cellar area below this area of the building.

Cellar access door. Tiles along wall to be replaced. Shallow crevices unsuitable as PRFs.

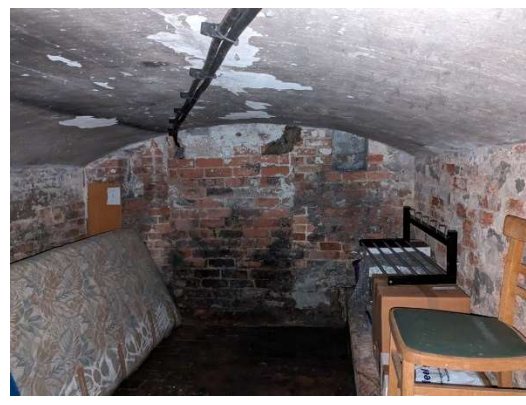
- 3.7 Cellar: The cellar was small and split into two sections. Both were well sealed from the exterior with no obvious potential access points. No evidence of bats was noted during the internal inspection and this area was considered unsuitable for use by hibernating bats given the lack of suitable access points and internal roosting features.

Internal view of small cellar. No obvious access points and well-sealed. No evidence of bats.

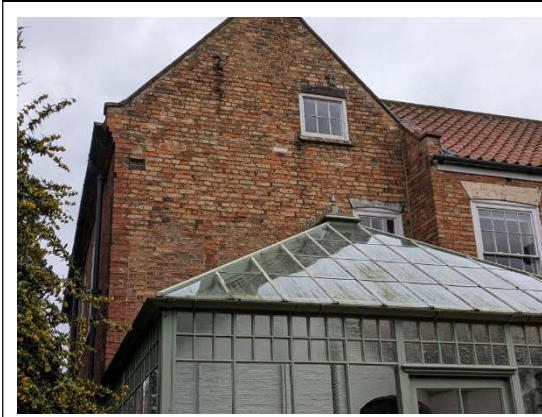
- 3.11 The existing external brickwork on the property was already well pointed with nothing but superficial shallow gaps noted in all areas subject to repointing works.
- 3.12 Potential external access points/PRFs which could be used by roosting bats were generally very limited within the property. However, there was potential for some gaps or crevices at the eastern gable particularly at the apex. This was difficult to assess from ground level given the presence of barge boards. Given that this area and the adjacent roof is located well away from any of the proposed work areas it will not be affected during this round of works. However, if any future works are planned for the eastern section of the house/roof then further surveys to establish presence/absence of bats maybe required.

Area of brick work to be repointed near glasshouse. No PRFs present in this area.

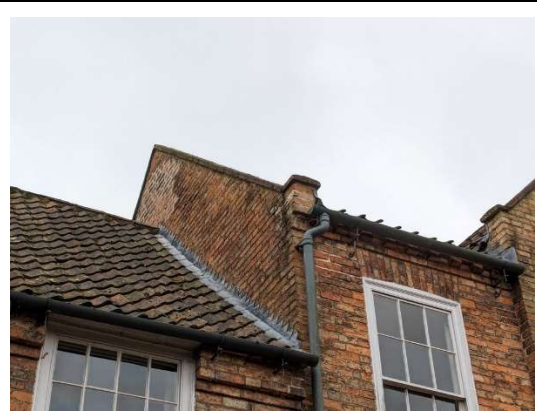
- 3.9 No internal or external evidence of bats was found associated with the building and the areas subject to proposed works. The roof of the dwelling was in good condition with no obvious gaps along the ridge tiles or under the coping stones. Existing lead flashing where present was also tightly sealed as were the clay and slate tiles on the various sections of the roof.

Coping stones to be replaced along gable. No PRFs under stones or adjacent lead flashing which was very well sealed.
