28th November, 2023
Our Ref: AR/4090-L4/jq

Woodbury, 28 Sandhurst Road, Crowthorne, Berkshire RG45 7HS
Re-positioned garage - BFC Ref: 21/00249/FUL

Site Plan - Proposed Garage and Drive Extension

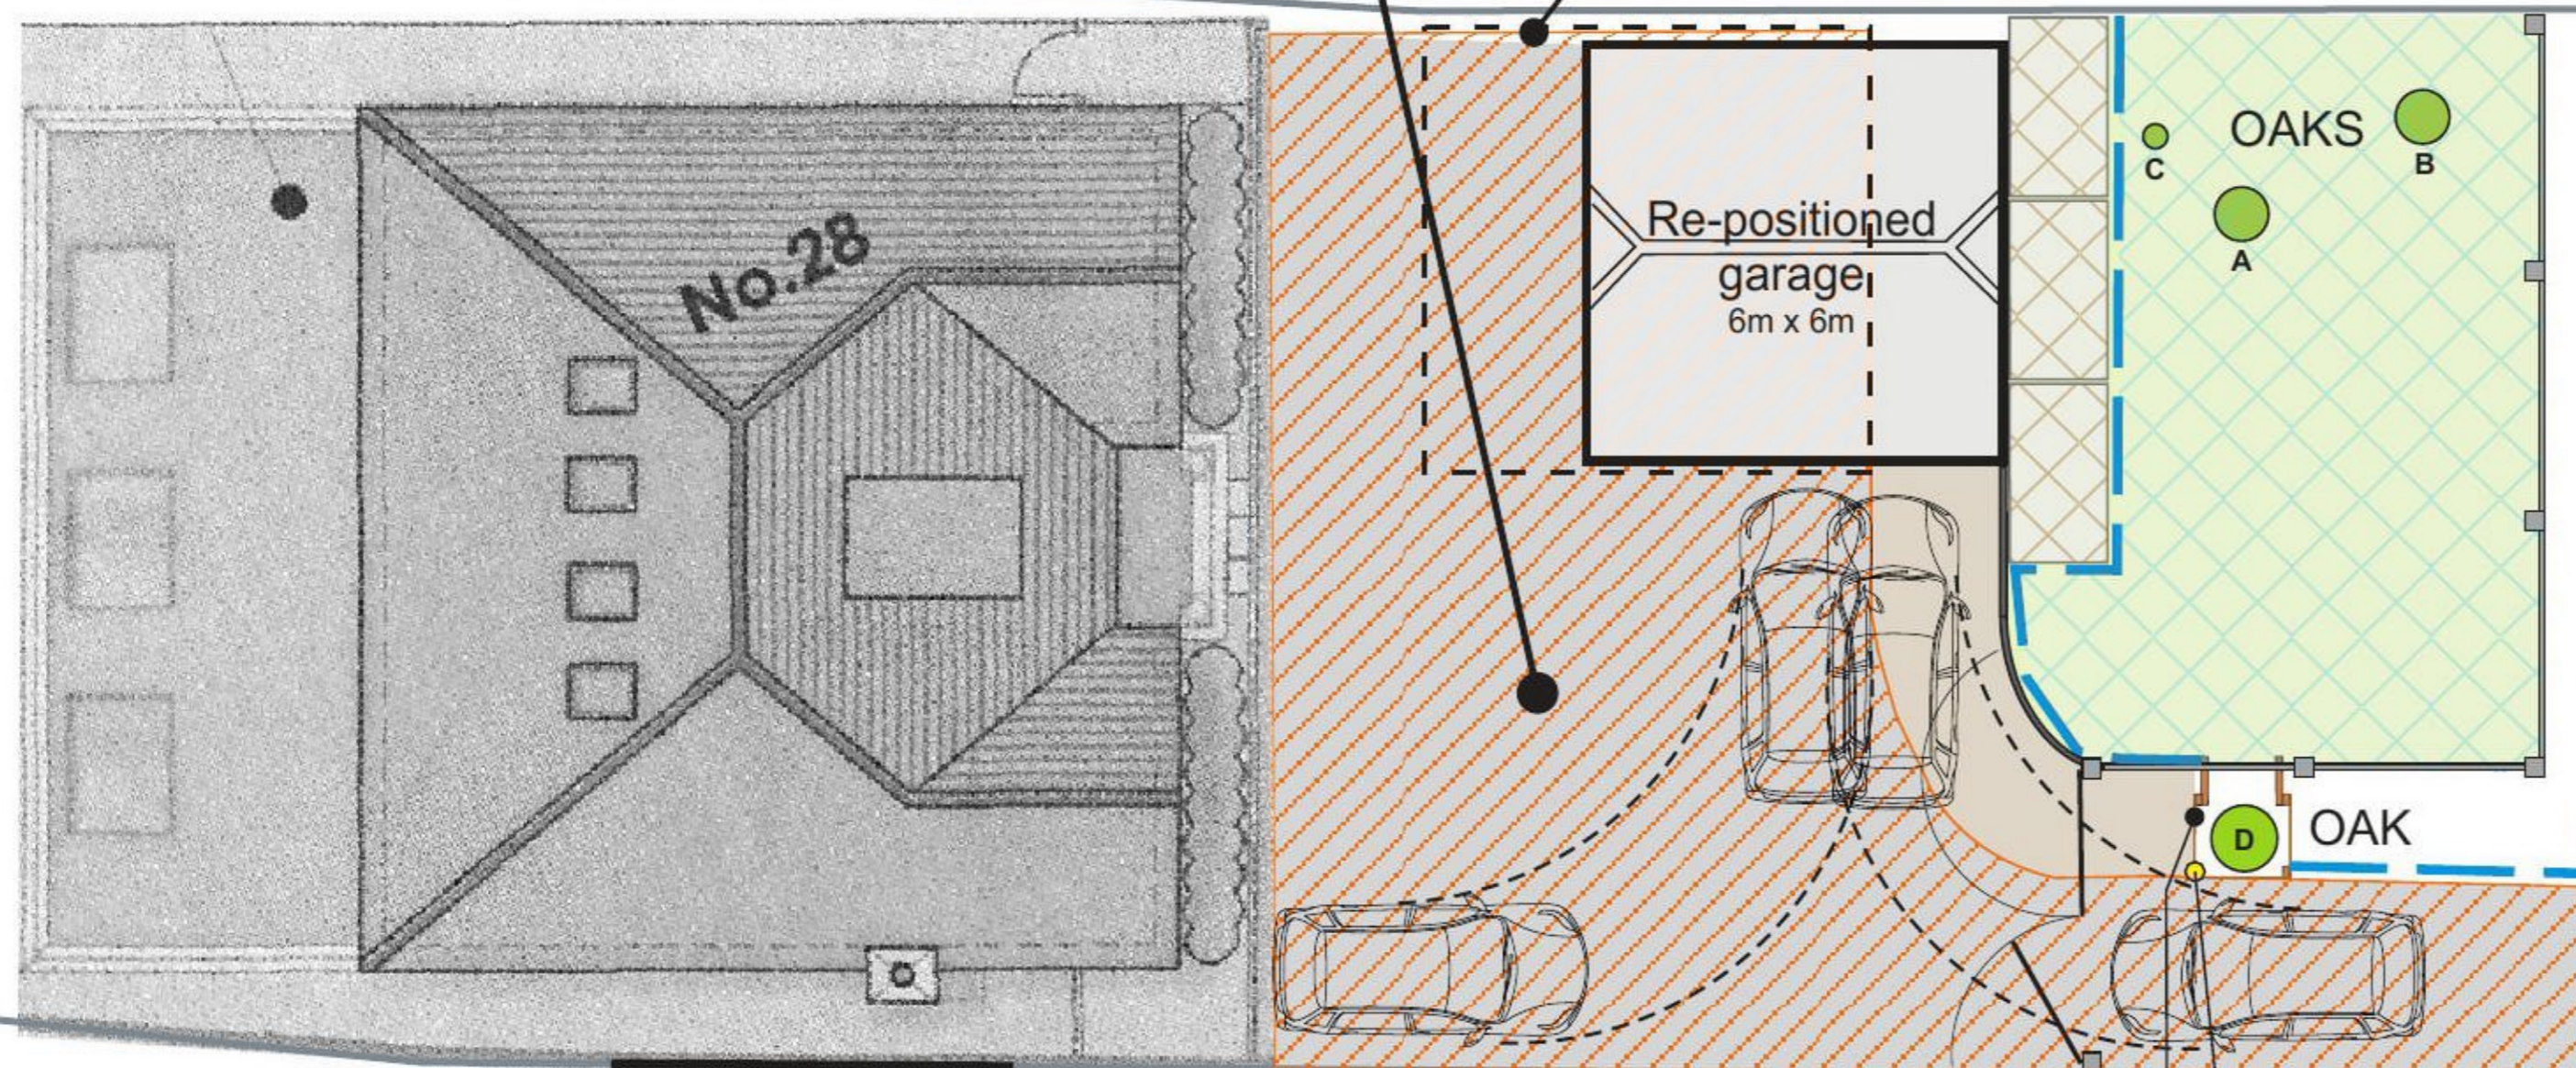
New garage position allows for 3-point turns in and out of garage for entry and exit in forward gear to the main road (two vehicles won't move simultaneously!)

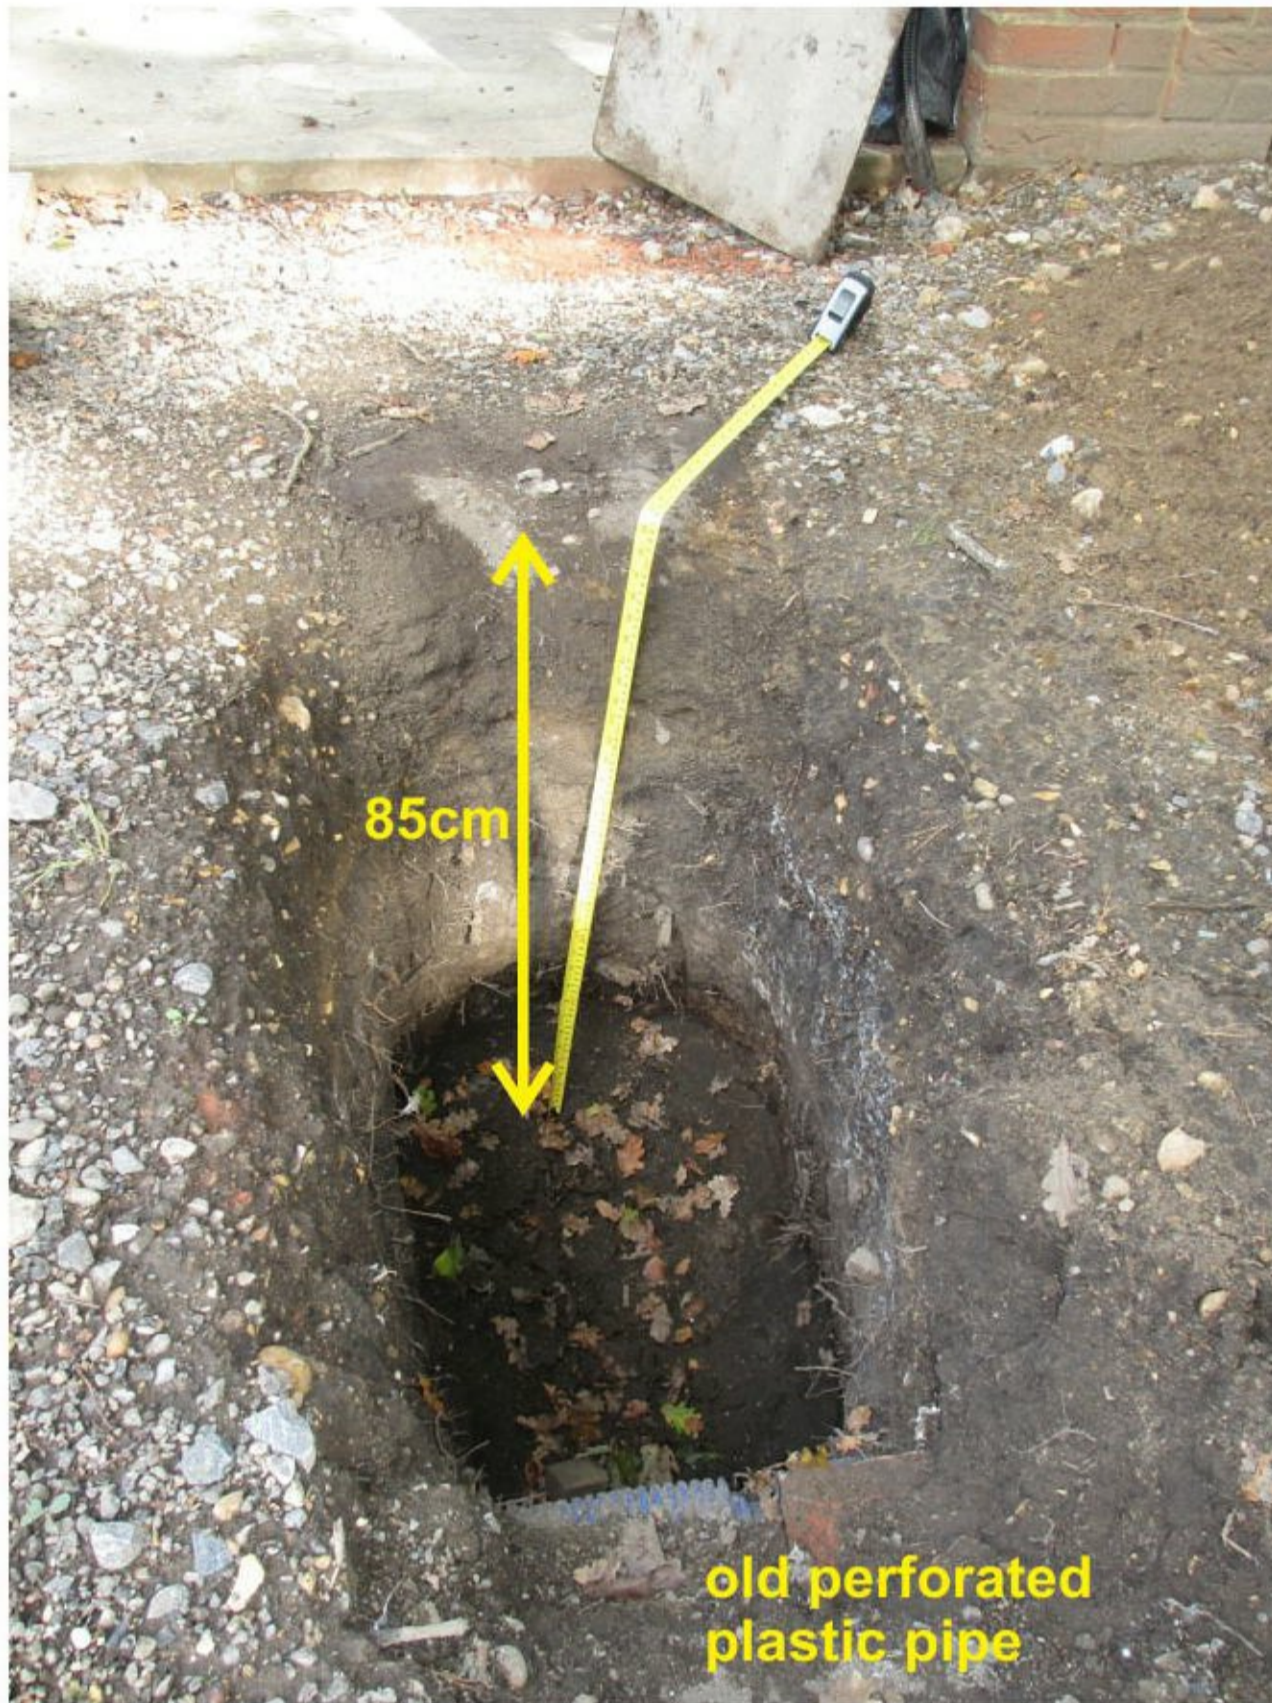
Photograph 1. Trial Hole 1

Photograph 1 (Appendix B) shows fibrous roots below the upper soil about halfway down the hole.

I understand that the floor slab that has been installed is about 65 centimetres in thickness and is proud of the adjacent soil surface by some 8 centimetres (photograph 1 Appendix B) - this is to allow for the No-Dig drive surface level to match that of the garage floor (allowing for a surface scrape to clear loose material). If one takes account of the surface build-up (photographs 2 and 3 Appendix B) of approximately 25 centimetres, then the intrusion of the slab into the original underlying soil is some 30-35 centimetres. These can only be approximations, but the conclusion is that the oaks will not be subjected to any significantly detrimental harm.

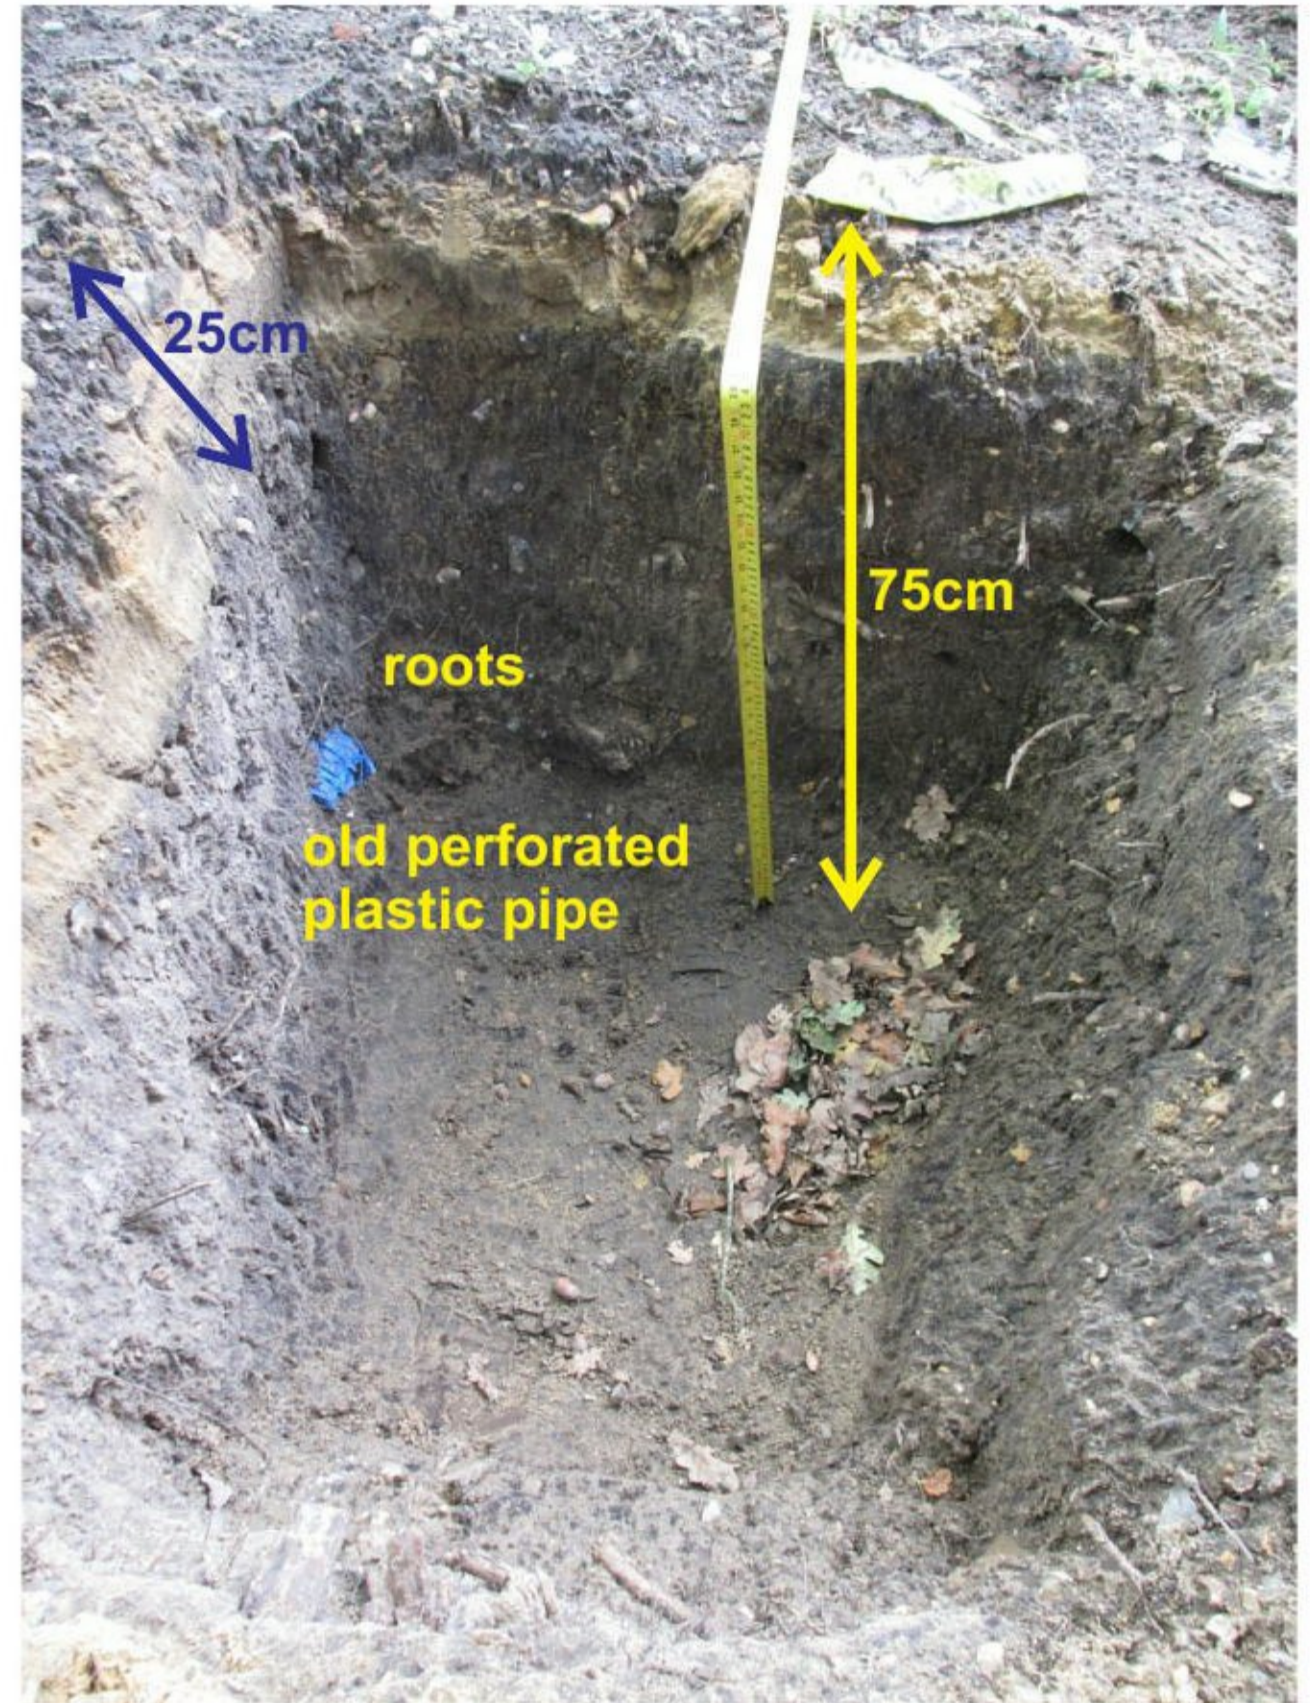
Photograph 2. Trial Hole 2 looking away from the oaks

The trial holes' positions are marked at Appendix A and photographs I took of them are at Appendix B. These show the friable coarse-grained soil (Camberley Sand Formation) and very few roots. This suggests that the root systems extend relatively deep. This is consistent with the intense surfacing and construction in the trees' immediate vicinity, and it is clear that the soil has been disturbed in the upper horizons. This is evident from the two (redundant) perforated plastic pipes present, and the build-up of the soil level as indicated in photographs 2 and 3 (Appendix B) of Trial Hole 2. Photograph 3 in particular shows old tie bars in the soil and a horizontal root below.
