BS 5837: 2012 Arboricultural Report

Site Address:	Land east of Cranwell Road Driffield Road YO25 6UH	Client:	Martin Bengtsson
Report Ref:	CWRD01-22	Report Date:	17th August 2022
Author:	Laurence Smith BSc (Hons) Arb, M Arbor A	Signed:	<i>Laurence Smith</i>

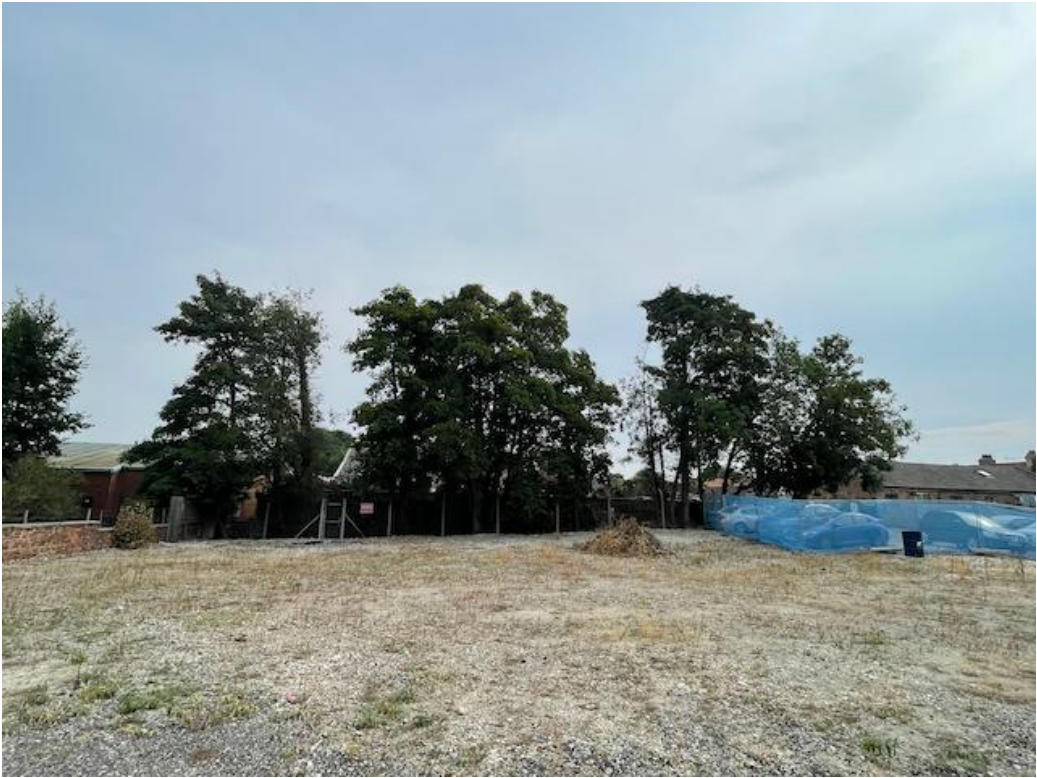
Figure 1. Row of trees when viewed from inside the site.

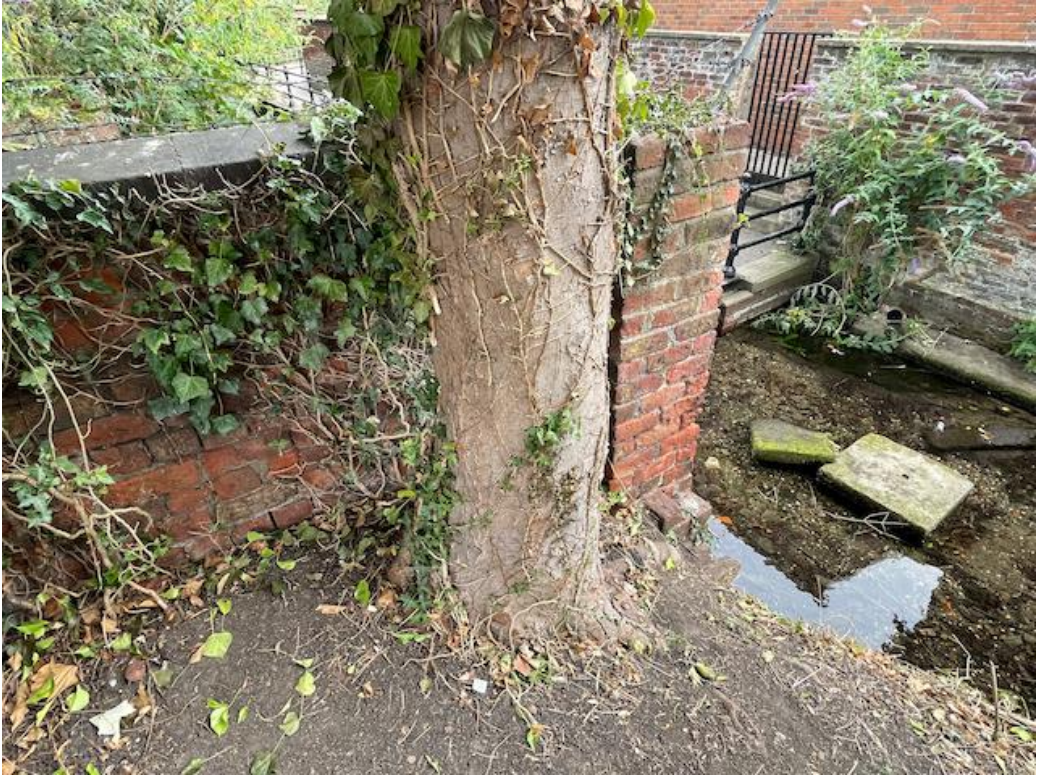
Figure 2. T373 located close to the boundary wall.

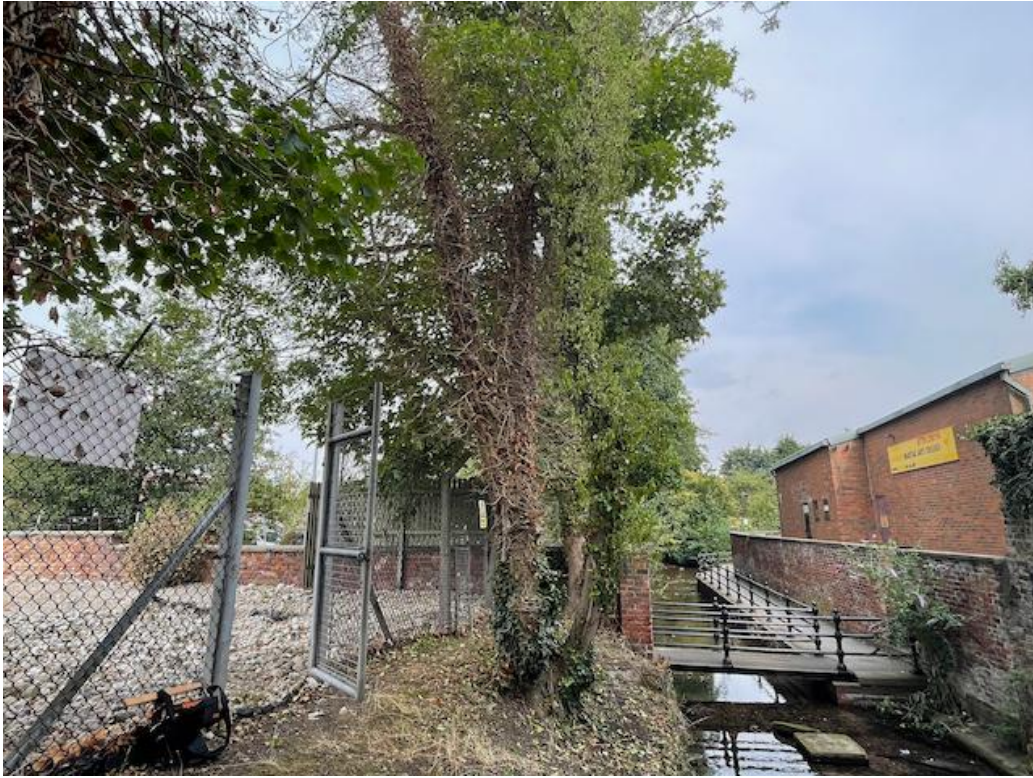
Figure 3. T375 located centrally on the bank.

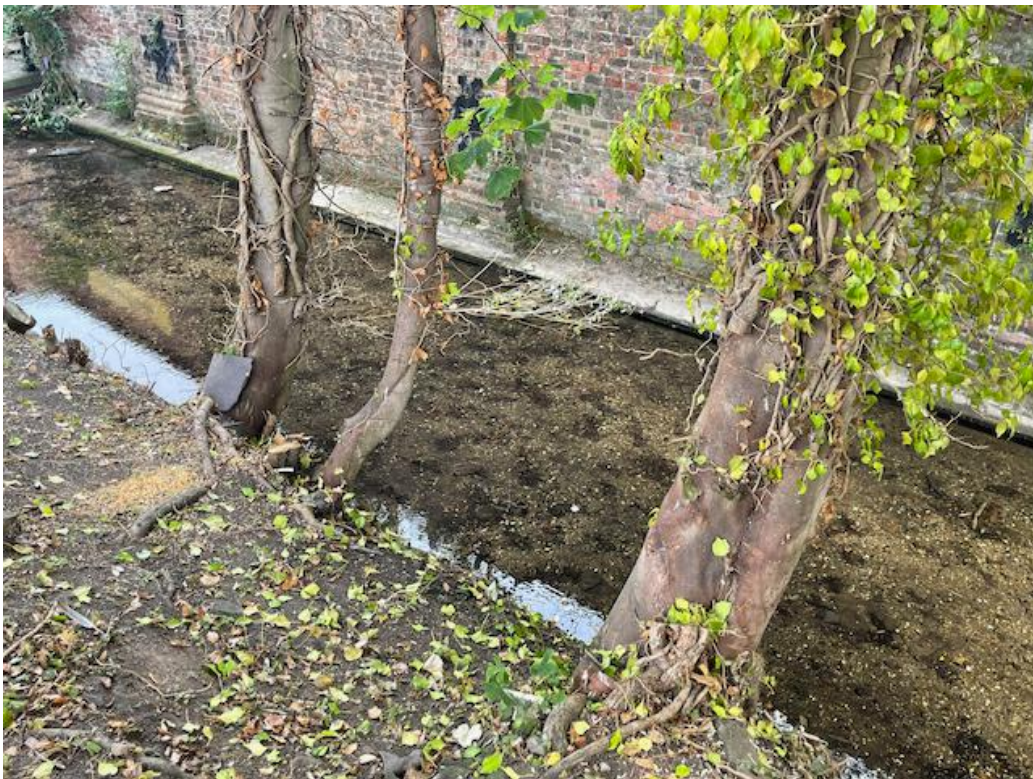
A number of these trees have an imbalance in root-plate to stem size, suggesting that a number of the smaller specimens are regeneration growth from old stumps. This is particularly evident in G377, T378, T381 and G383. While not significant in itself, this does increase the possibility of decay in the lower stem or root-plate and that they have previously been cut back to ground level.

Figure 4. G377 (left) and T378 (right) both located onto of the brick retaining wall.

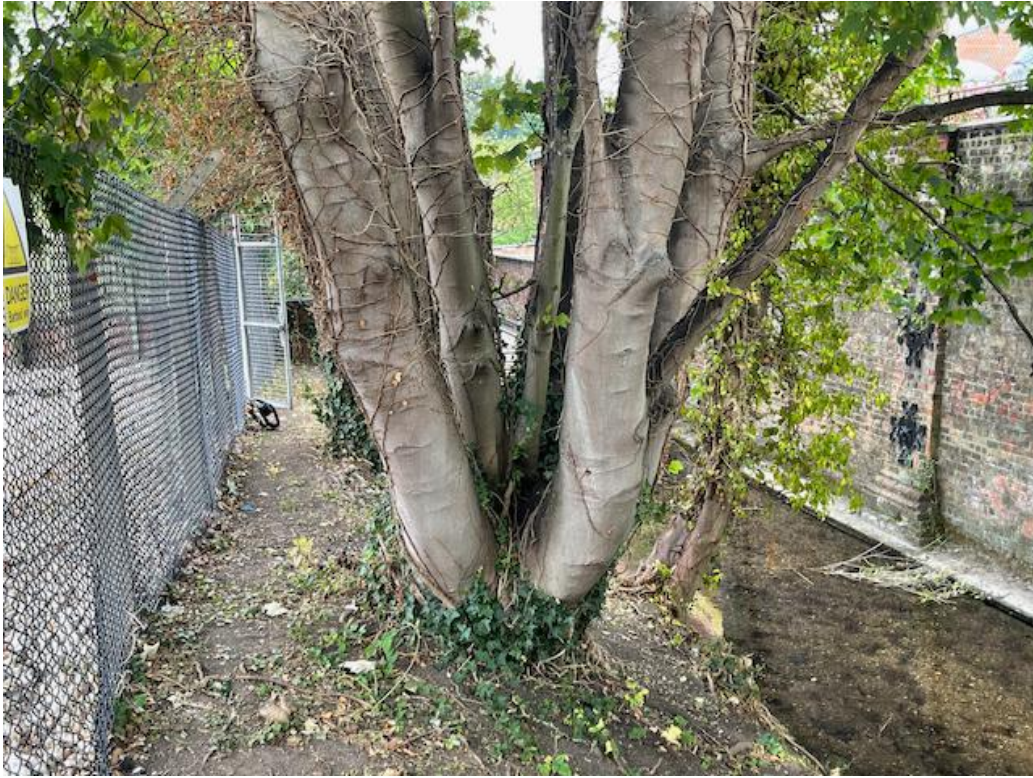
Figure 5. T379 with multiple stems.

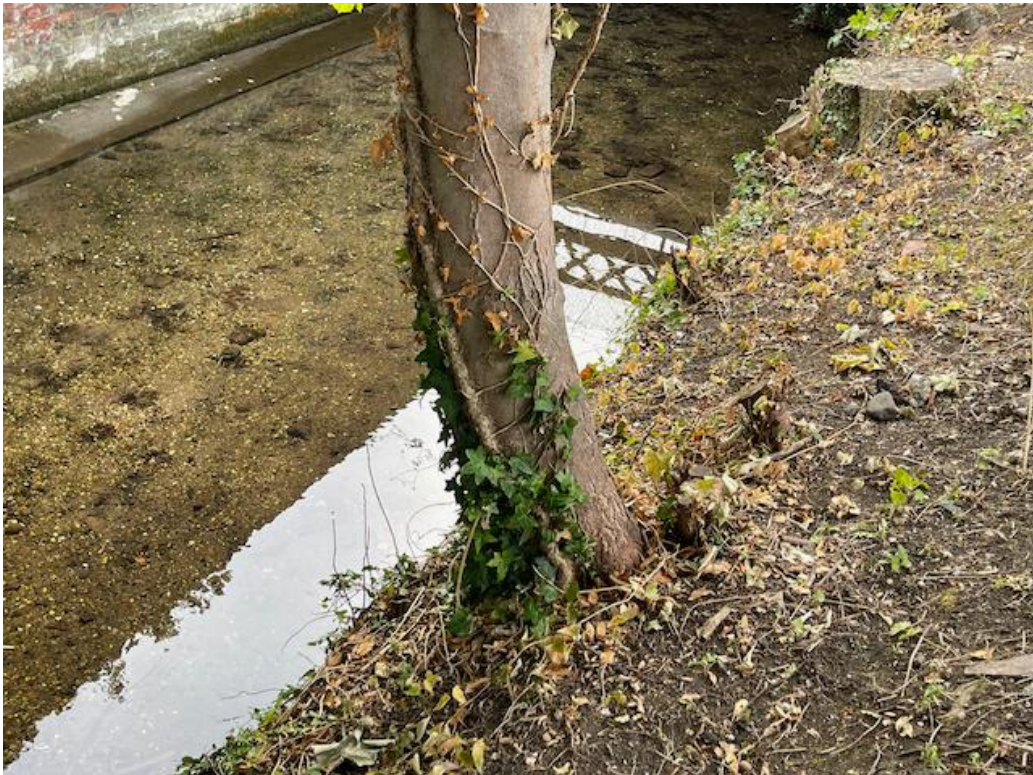
Figure 6. T380 located close to the retaining brick wall.

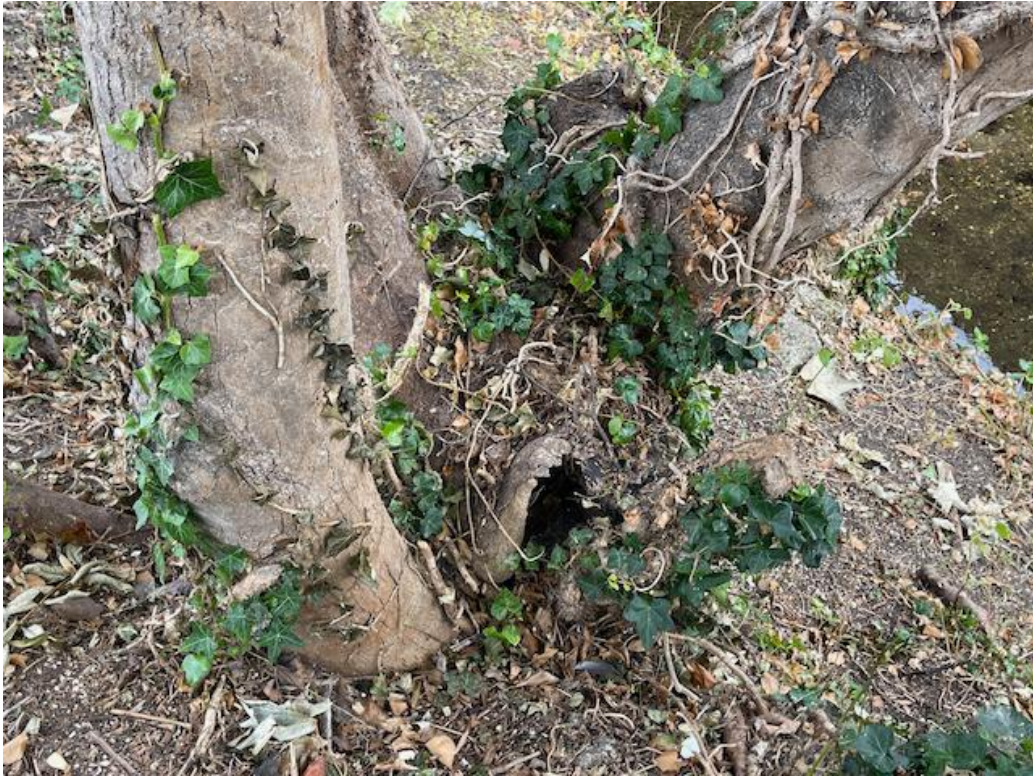
Figure 7. The base of T381 with younger stems growing from a single root-plate.

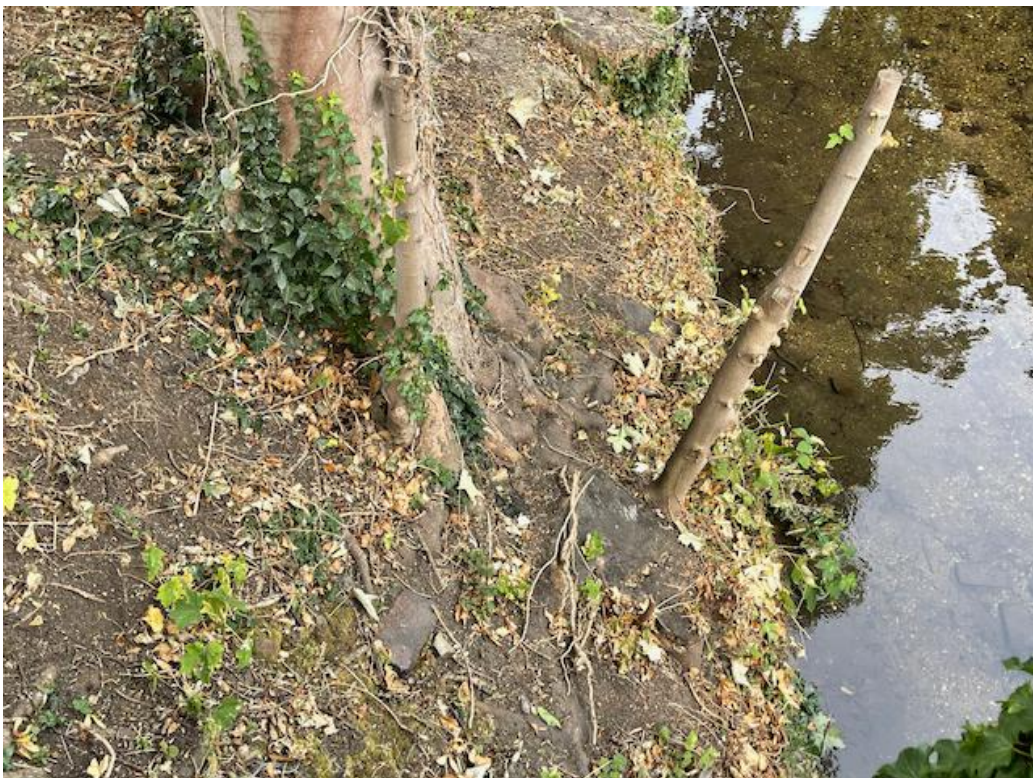
T382	Mature	Sycamore	15	480	2, 4, 3.5, 5.5	9 W	4	Good	Ivy recently severed. Tall upright stem in good condition. Surface roots extend down to the retaining wall.	None	20>	B2	6
G383	Semi Mature	Ash	12	290, 280, 160	0.5, 5, 7, 6	2 S (stem)	3	Poor	3 stems two of which are part of one tree with decay cavities at the base from large limb removals. Third stem leans out at 45 degrees to the south. Canopies displaying low vigour and dieback due to Ash dieback.	Fell	10<	U	3.5
T384	Early Mature	Cherry	8.5	300	2, 5, 4.5, 2	4 S	2	Fair	Stem leans to the south east with a historic wound at 1m. Secondary hardening at the wound is failing leading to cavitation. Potential failure site in later life. Witch's broom development in the suppressed crown.	None	10>	C2	3.5
T385	Early Mature	Sycamore	13	350	2, 3, 6.5, 4.5	2 S	2	Good	Historically suppressed by overhead Ash has lead to the development of a leaning stem with an asymmetrical canopy. Stem clad in Ivy and pressed against the boundary fencing.	None	10>	C2	4

Figure 8. The base of T382 with surface roots extending down to the brick retaining wall.

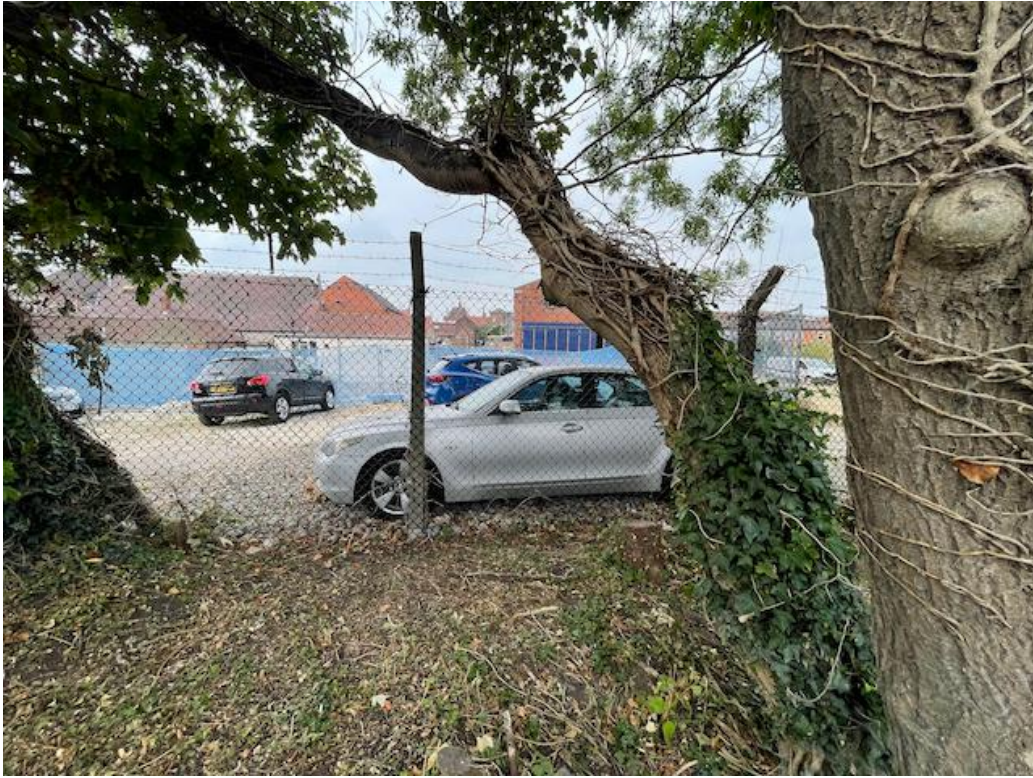
Figure 9. One of the stems of G383 with a significant lean.

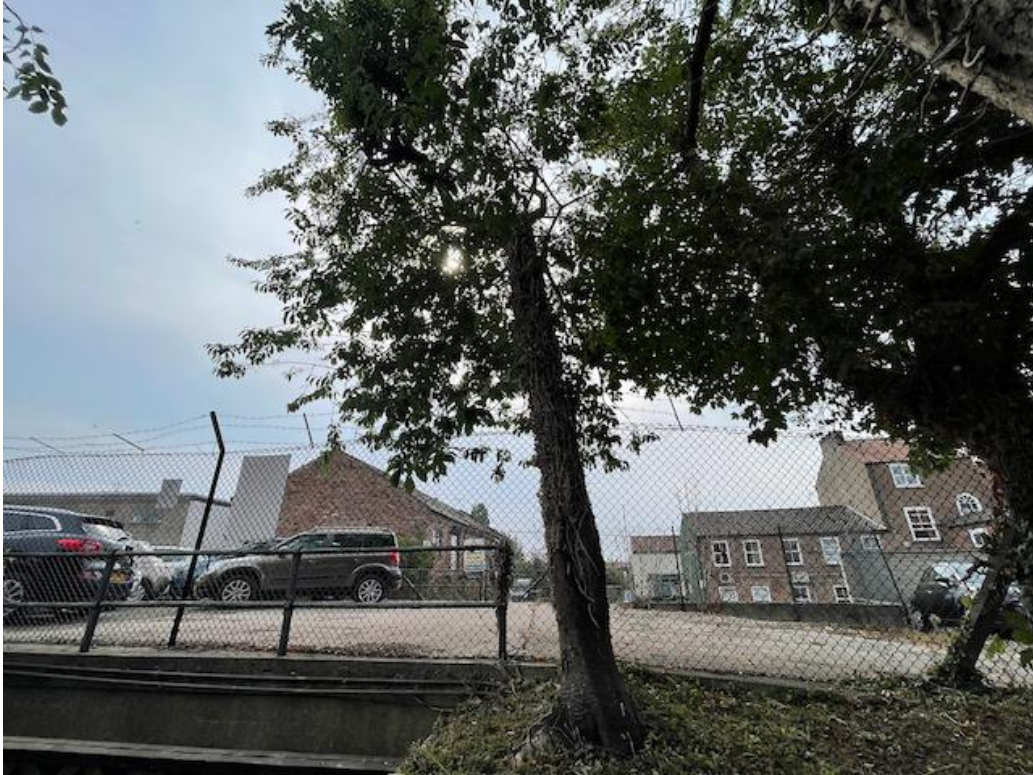
Figure 10. T384 displaying a suppressed canopy.

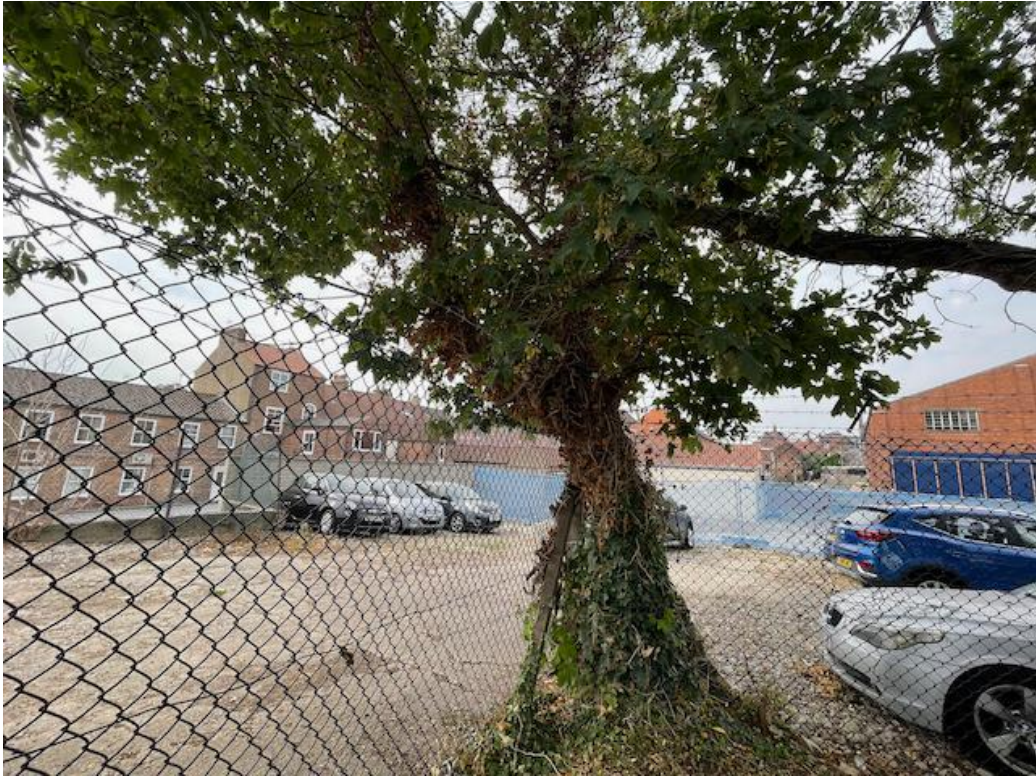
Figure 11. T385 located against the boundary fencing.
