BS5837:2012 Tree Survey
 Garden at Keepers Cottage
 Far End
 Boothby Graffoe
 Lincolnshire
 NGR SK98202 59371

Report prepared by: C Barker	Date Issued: 20 February 2024
	Reviewed by: KLB	Report Version: V1
	Report ref: P2865 /0224 /01	C B E Consulting Highbank, 5 Grantham Road, Navenby Lincoln. LN5 0JJ. Telephone (01522) 810086. www.cbeconsulting.co.uk

BS5837 Tree Survey, Land

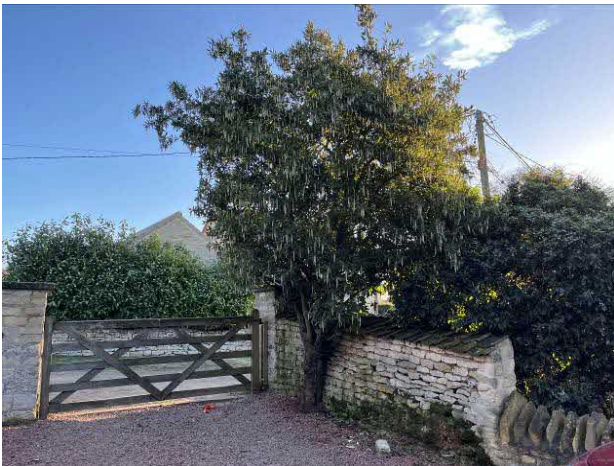
Silk Tassel T1

T1 is a Silk Tassel Bush, this grows into a small tree and this is positioned on the south side of the existing access. The canopy of this tree has been trimmed on the north side to avoid it becoming a constraint to the access. This small tree has been placed into Category C2.

Ref	Tree	Category	Impact of development
1	Silk Tassel Bush	C2	Not impacted. Canopy poses no constraint and the RPA is already under the existing hardstanding.
G2	Leylandii	C2	Recommended for removal due to the proximity of the existing building.
3	Cooking Apple	C2	This tree could be retained but apparently it is now cropping poorly and it would be prudent to consider removing this and replacing it with a new specimen tree in another location within the garden.
4	Leylandii	C2	Not impacted. The lifted columnar crown poses no constraint. The RPA on the eastern side is already protected by an existing concrete pad and hardstanding.
5	Leylandii	C2	Not impacted. The lifted columnar crown poses no constraint. The RPA on the eastern side is already protected by an existing concrete pad and hardstanding.
6	Cherry	B2	Not impacted. Sufficiently far from the existing building and protected by T4 and T5 which lie between this tree and the building to be converted.

T1, T4 and T7 are positioned sufficiently far from the existing building to be converted that it is highly unlikely there will be any impact on these trees and they can be retained. All three trees have the RPA's protected by the existing driveway but it would be prudent to position protective fencing around the trunks, particularly T7, to ensure there are no accidental collisions whilst materials are being delivered for the work.

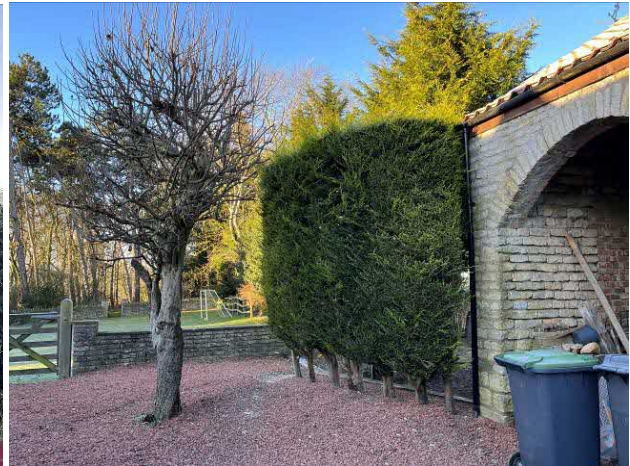
Leylandii G2 (right) and Apple T3 (left)

Group G2 is a tightly trimmed and shaped Leylandii screen close to the south western corner of the existing building and **Cooking Apple T3** is positioned close to this group, to the south, at the edge of the existing driveway. Both are placed within Category C2.

It is a reasonable assumption that the trees of lower quality close to the existing building (G2 and T3) may need to be removed to provide sufficient space for access and works to be completed. Leylandii G2 is a closely trimmed and topped conifer screen of negligible landscape value so the removal of this will have no noticeable impact on canopy cover or visual amenity in this location. Removal of Apple T3 may not be necessary to facilitate the works but this tree is positioned within the centre of the driveway area and as it provides little useful fruit consideration should be given to removing this and replacing it with a tree elsewhere within the garden.

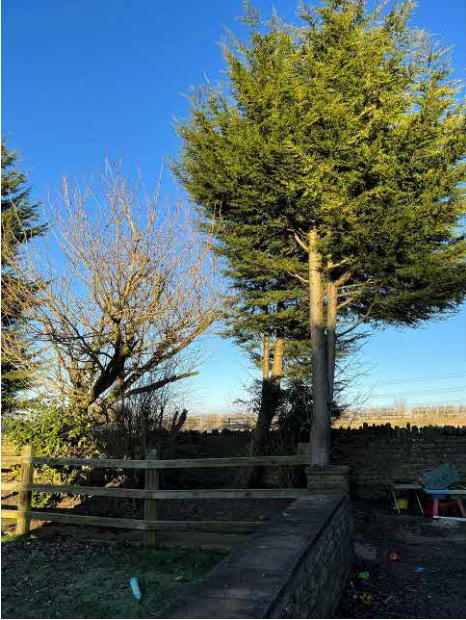
T4/T5 and Cherry T6

Trees T4 and T5 are Leylandii situated 6m from the west gable end of the existing building. Both trees have been crown lifted and have negligible low canopy to provide screening as a result. The RPA of T4 is significantly encroached by an existing concrete pad and hardstanding lying between the tree and the existing building. It is unlikely there has been any significant root developed on the eastern side of the tree under the concrete pad. Both trees are placed within Category C2.

Further to the west is **Cherry T6** which is a small tree supporting a trimmed, broadly ascending crown along the northern edge of the garden. This tree has sufficient space to mature and appears in good health and it has therefore been placed within Category B2.

T5	Leylandii <i>Cupressocyparis leylandii</i>	8	265	N-2 S-1 E-1 W-1	3	SM	10+	F	Trunk and canopy leans north east. Lifted columnar crown. No structural faults visible from ground level but lean is of concern.		C2	3.1
T6	Cherry <i>Prunus avium</i>	5	285gl	N-2 S-3 E-3 W-2	2	SM	20	G	Trimmed and broadly ascending crown. No structural faults visible from ground level		B2	3.4

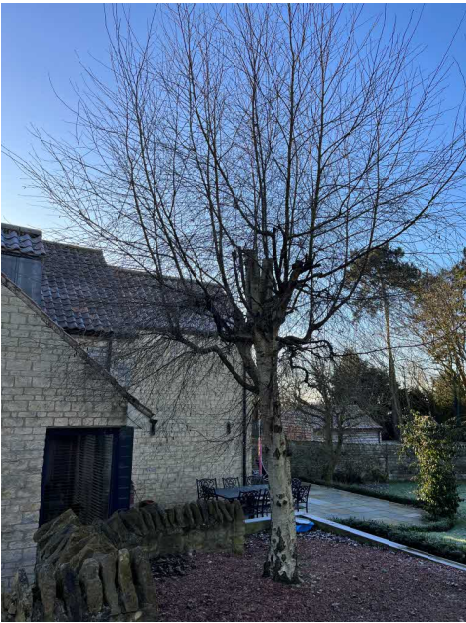
Pollarded Birch T7

Birch T7 is a pollarded specimen tree situated on the southern edge of the driveway, closer to the house and garden. This tree has been previously reduced to minimise shade and leaf drop over the garden and driveway area. The tree is regenerating vigorously and now supports a tight, lightly branching crown. This tree is placed within Category B2.

7	Birch	B2	Not impacted. Crown is pollarded and provides no constraint. RPA is sufficiently far from the building to be converted to avoid any harm and already lies underneath the driveway.

Tree No	Species	Ht (m)	Stem Diam mm@ 1.5m	Canopy Spread (m)	Height of Crown Clearance	Age Class	Est yrs	Overall Condition	Structural condition	Recommendations	BS 5837 Category	RPA Radius (m)
T7	Birch <i>Betula pendula</i>	7	240	N-2 S-3 E-3 W-3	2	SM	20	G	Pollarded and regenerating a tight, lightly branching, small canopy. No structural faults visible from ground level		B2	2.8
