THE FARM - GOPSHILL LANE, GRETTON, GLOS. GL54 5ET
BUILDING 'B' ROOF STRUCTURE PLAN.
21: 1935: 17A OCTOBER 2023 1:50
DENIS L RAYTON TEL 01242 620818

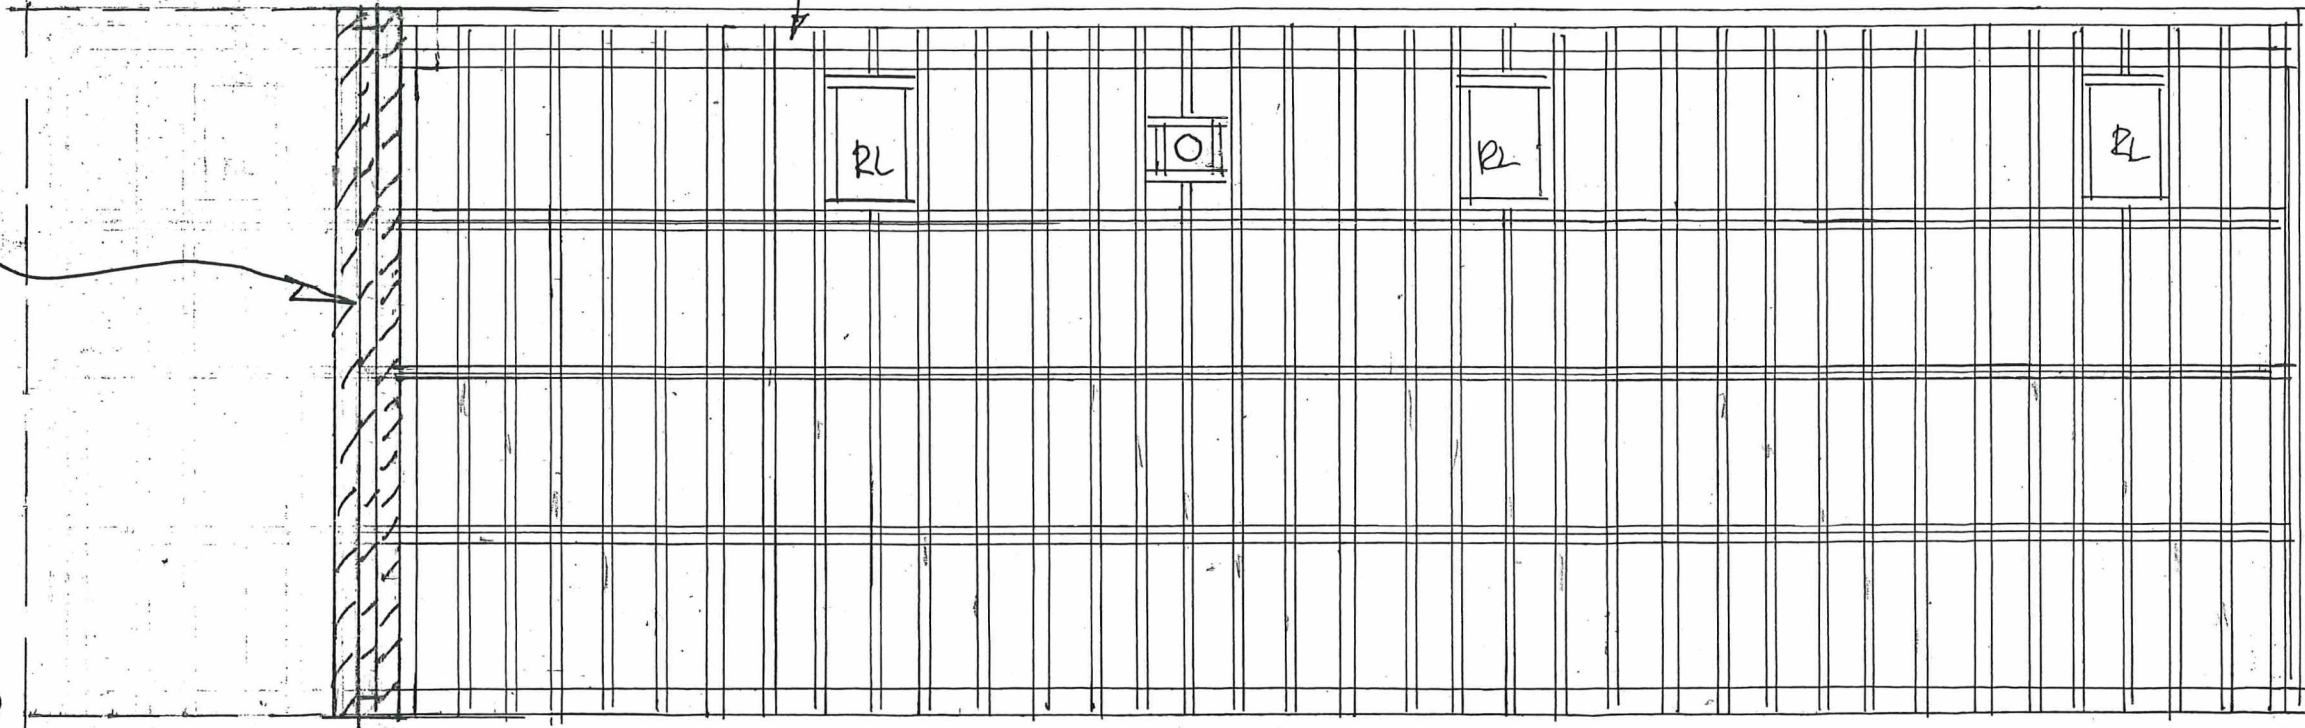
End bay collapsed fully

oak wallplate retained

Purlins retained

Ridge board retained

existing continuous oak beam retained

* note all roof timbers are generally in reasonable condition and if any members are to be replaced then existing timbers from collapsed bay will be used

A West end bay collapsed / nat stone gable end wall rebuilt in new position } Feb 2024

All existing oak members forming roof to be inspected + defective members replaced and connected as detailed on drawings

rebuild wall in conc. block core with nat stone both sides + S/B wall ties (also total thickness) (new position)
