Y FELIN, OSWESTRY

Preliminary Roost Assessment & Nocturnal Bat Survey Report

September 2023

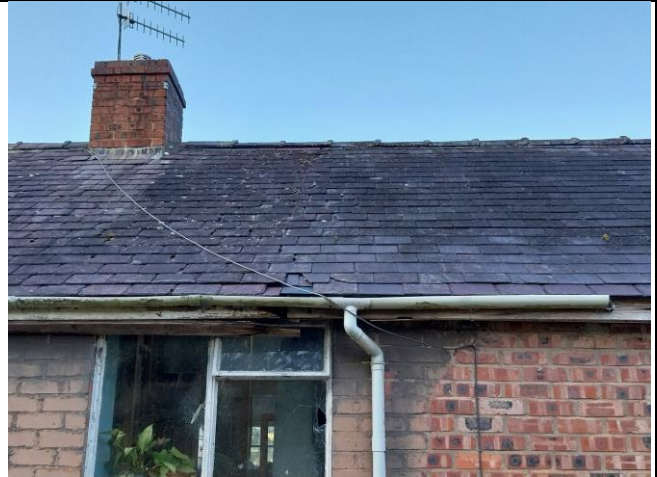
- 3.1.7. The roof featured lifted ridge tiles, with missing and lifted slate tiles observed in multiple locations.
- 3.1.8. Internally the loft area of the building comprised timber beam and wood board flooring, which was broken in several places, allowing some natural light into the loft space. The roofing comprised timber sarking and bitumen felt lining on the east and west aspects, which was intact and well-sealed. The south wall contained numerous gaps and holes allowing access, and a small amount of natural light within the loft space. The north area of the loft could not be assessed entirely due to the internal red brick chimney stack. A large quantity of droppings was observed across the loft floor, the majority of which were found to be mouse droppings. A small number of historic bat droppings were identified, but no feeding remains could be seen from the limited vantage point of the surveyor.

Lifted ridge tiles, and missing and lifted tiles on western roof elevation.

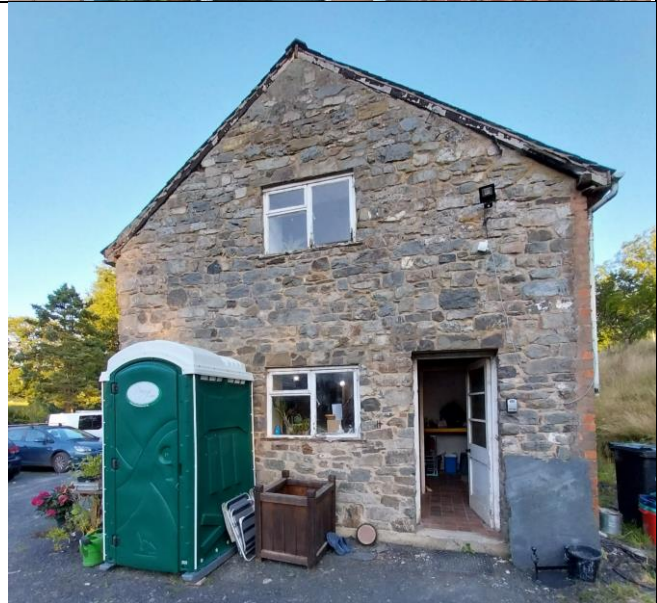
- 3.1.5. The north elevation comprised better-sealed stone, with a well-sealed door and windows. Gaps in the barge board were present at both corners of the elevation, with an additional access point provided by the broken end of a timber beam. A gap was present in the mortar at the apex, although the rest of the mortar appeared in moderate condition.

North elevation.

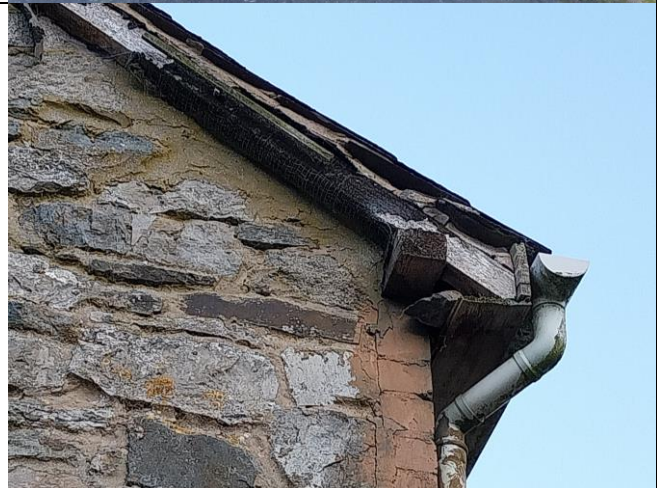
Gaps in barge boards and mortar on the northwest corner.

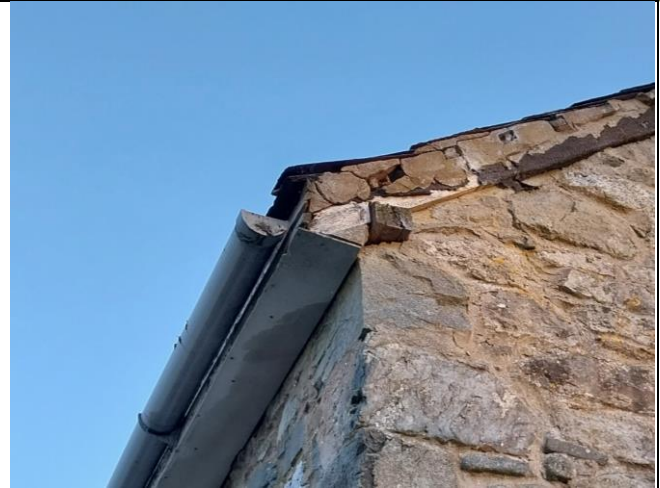
Gaps in barge boards and hole due to broken timber beam on northeast corner.

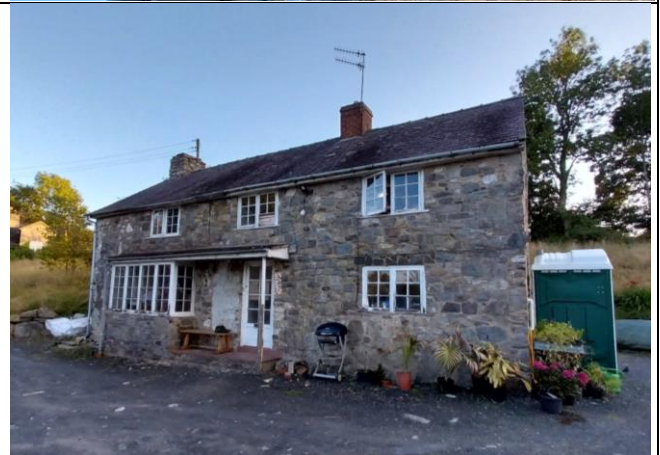
- 3.1.6. The east elevation featured a porch with a slate tile roof and wooden panel lining. Several of the slate tiles were lifted. The stone wall appeared to be in predominantly good condition, although a large crack in the centre of the façade was present. This may prove too small to allow access. Gaps were present in the wooden soffits, and the wooden window frames appeared rotten in several places.

East elevation.

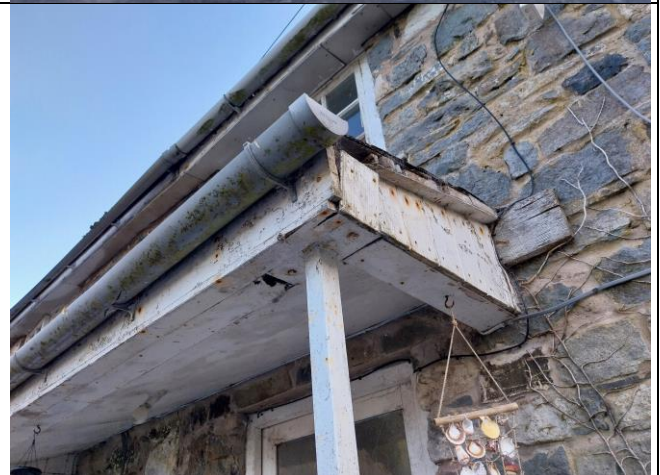
Gaps in wood panels of porch.

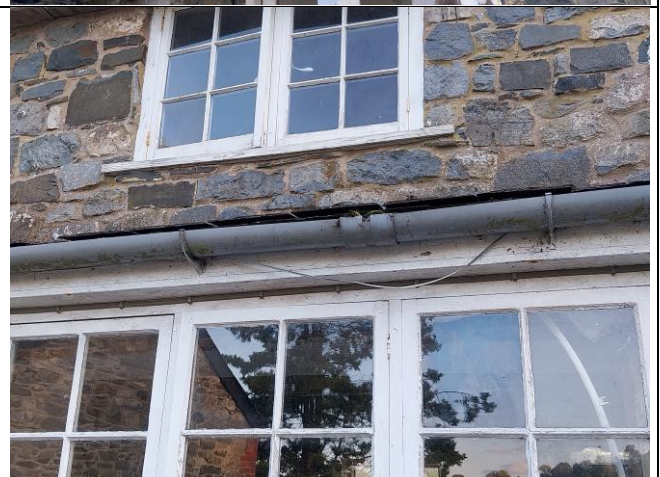
Lifted tiles on porch.

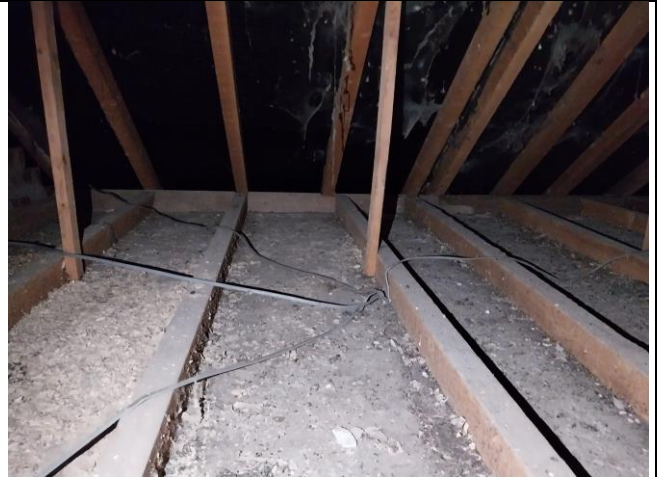
Interior loft space, featuring bitumen felt lining and timber beams.

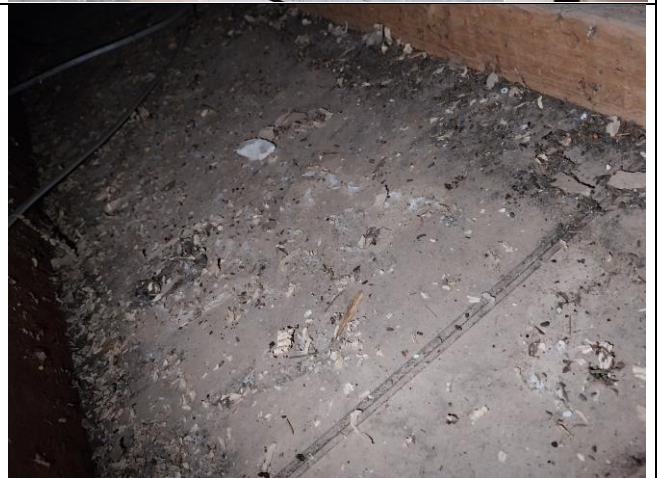
Mouse and bat droppings on loft floor.

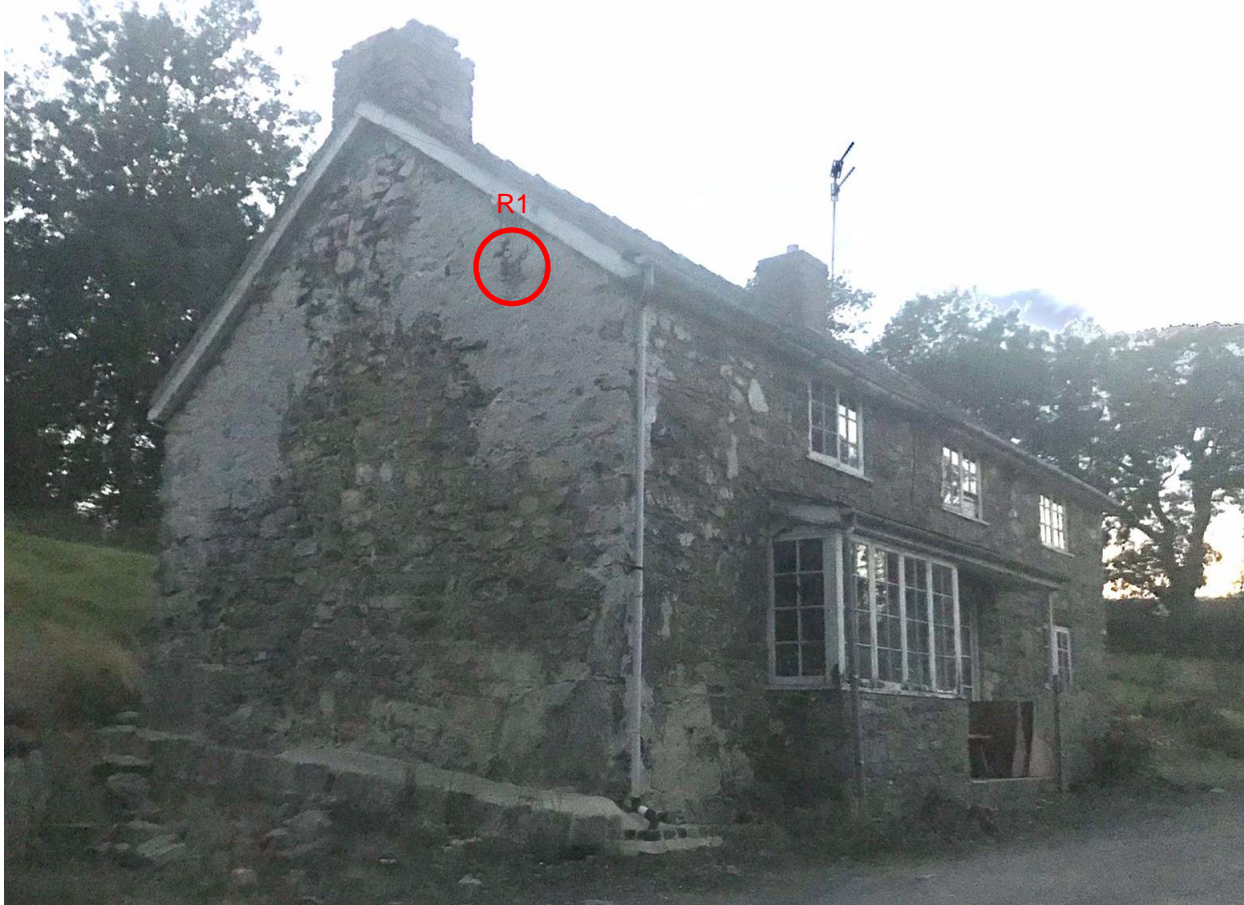
Figure 3.1 Roost Locations

3.2.3. One roost location was observed throughout the survey. This was recorded at 21:39 (approximately eleven minutes after sunset) and was a soprano pipistrelle observed emerging from the east side of the stonework on the south aspect by VP2 (R1). See Figure 3.1.

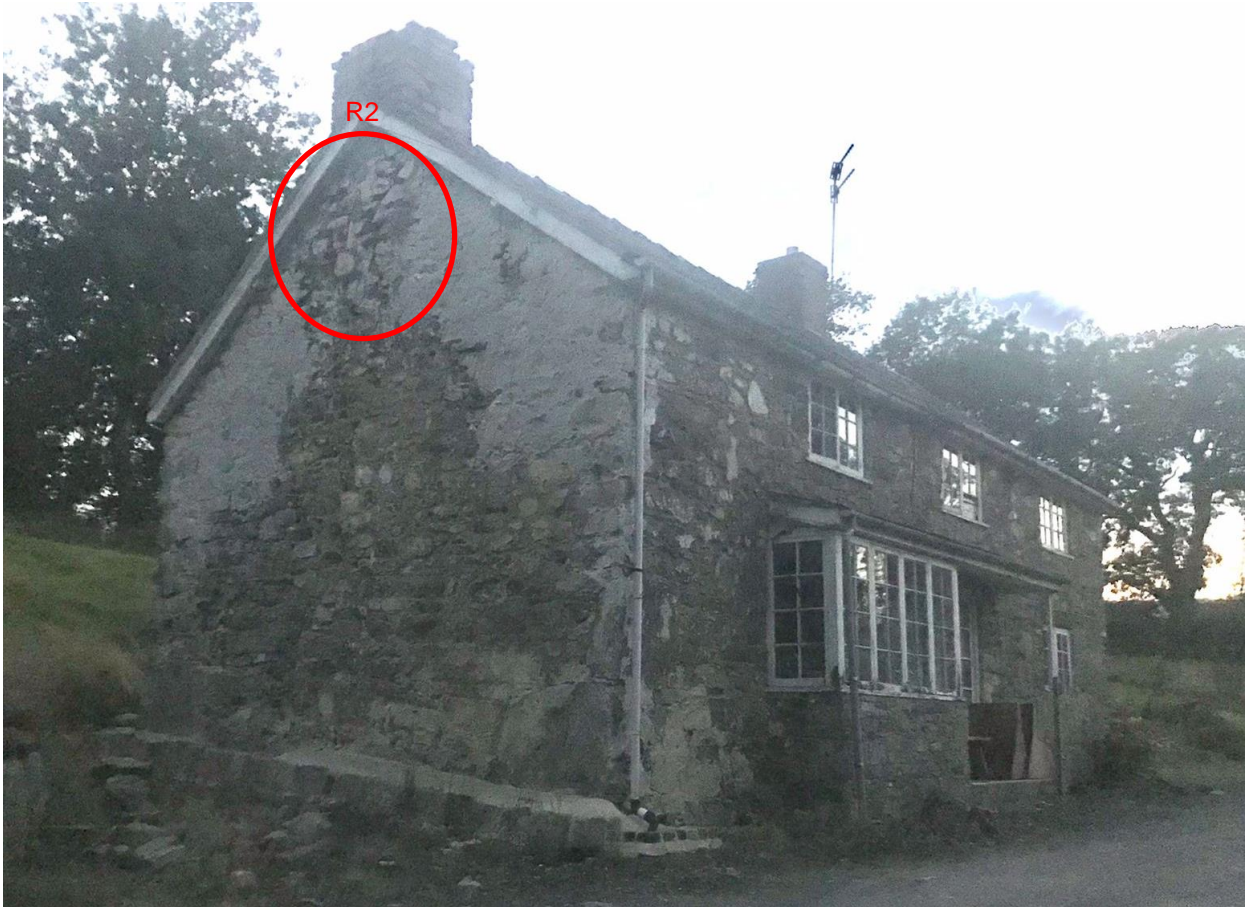
Figure 3.2 Roost Locations

- 3.3.3. Three roost locations were observed throughout the survey. The first roost was recorded at 21:11 (approximately sixteen minutes after sunset) by VP4 (R2). A single common pipistrelle emerged from the upper central area of the south aspect. A second common pipistrelle was observed emerging from this same location a 21:23. See Figure 3.2.

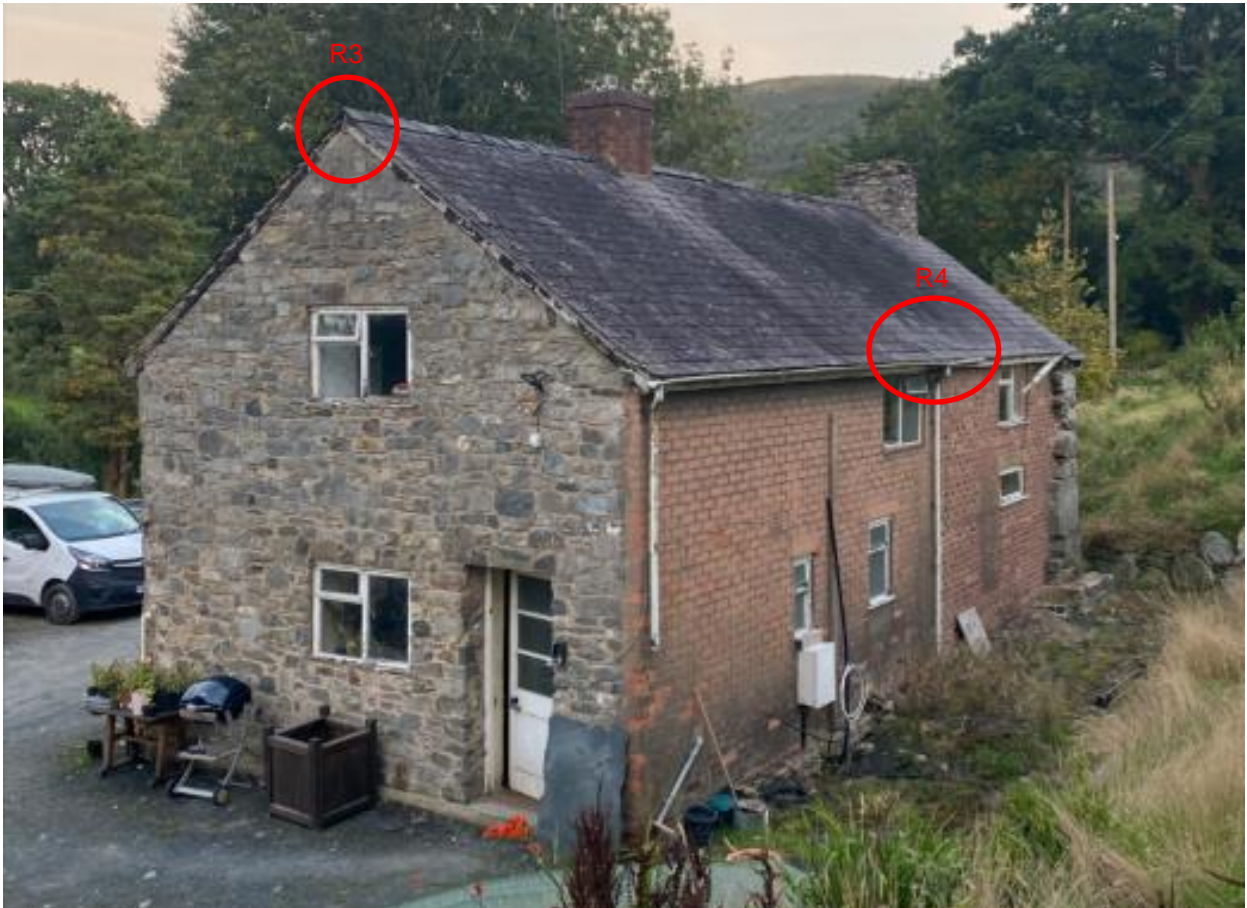
Figure 3.3 Roost Locations

The second roost was recorded at 21:28 (approximately thirty-three minutes after sunset) by VP3 (R3). A single common pipistrelle was observed emerging from the gable apex of the north aspect. The third roost was also recorded at 21:28 by VP3 (R4). A single common pipistrelle was observed emerging from the lifted tile area above the guttering in the centre of the west aspect. See Figure 3.3.

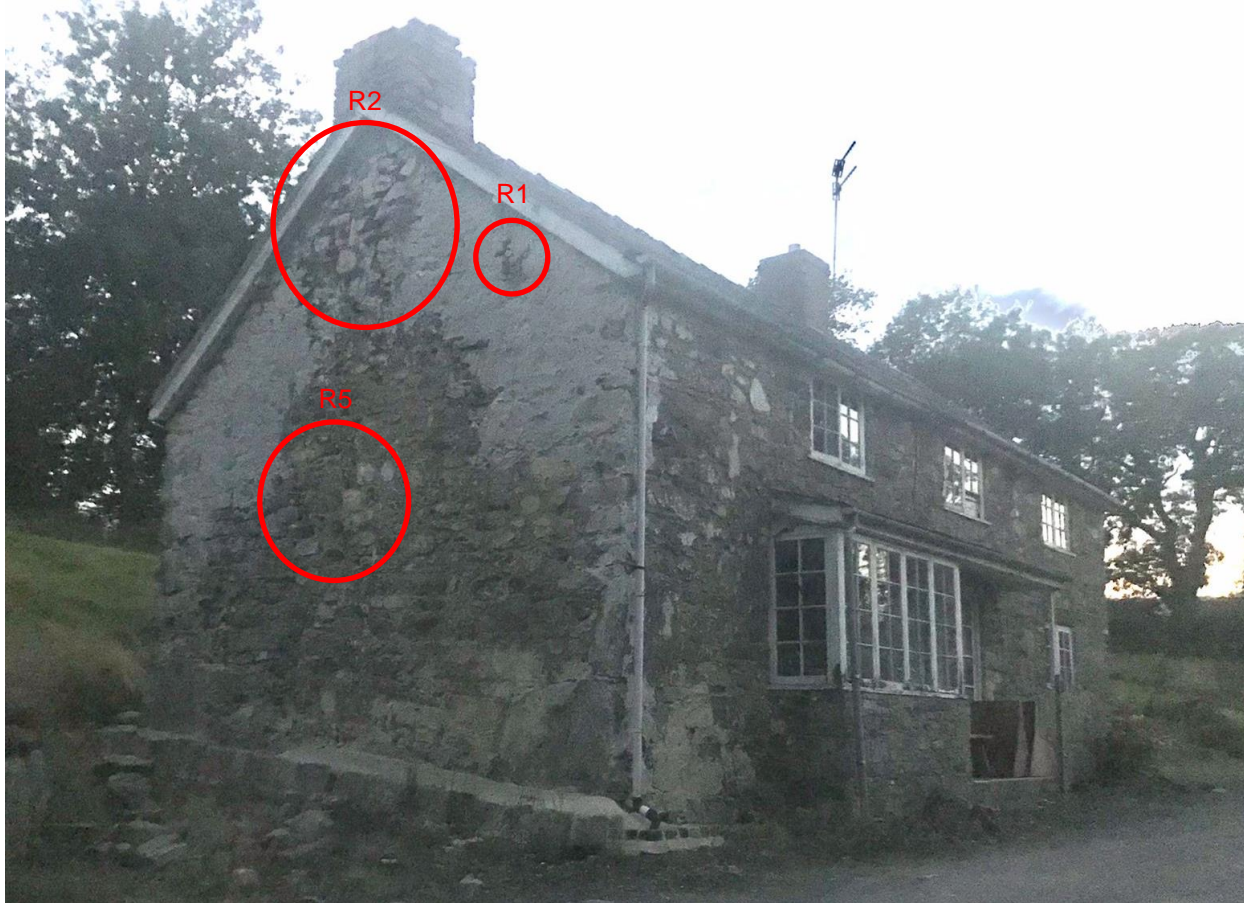
Figure 3.4 Roost Locations

- 3.4.3. Five roost locations were observed throughout the survey. The first roost was recorded at 20:20 (approximately thirty minutes after sunset) by VP4 (R2). Three common pipistrelle bats were observed emerging from the central area of the south aspect. The second roost was recorded at 21:28 (approximately thirty-eight minutes after sunset) by VP4 (R5). Two common pipistrelle bats were observed emerging from a lower central area of the south aspect. The third roost was also recorded at 21:28 by VP4 (R1). One common pipistrelle was observed emerging from the east side of the stonework on the south aspect. See Figure 3.4.

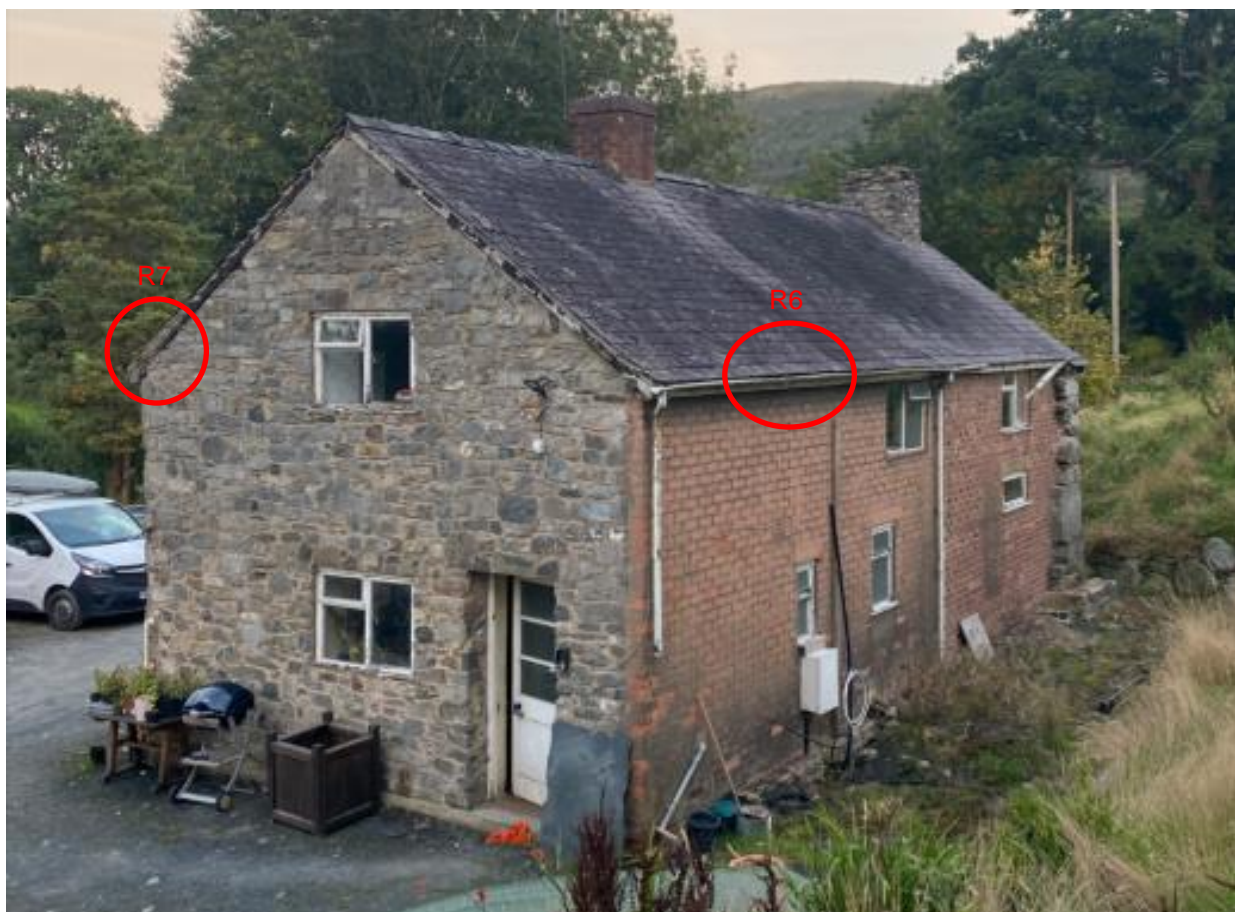
Figure 3.5 Roost Locations

- 3.4.4. The fourth roost was recorded at 20:29 (approximately thirty-nine minutes after sunset) by VP3 (R6). One soprano pipistrelle was observed emerging from the lifted tile area above the guttering to the north side of the west aspect. The fifth roost was recorded at 20:35 (approximately forty-five minutes after sunset) by VP3 (R7). One common pipistrelle was observed emerging from the east corner of the north aspect. See Figure 3.5.
