Fabric Repair & Downtaking

Fabric Repairs

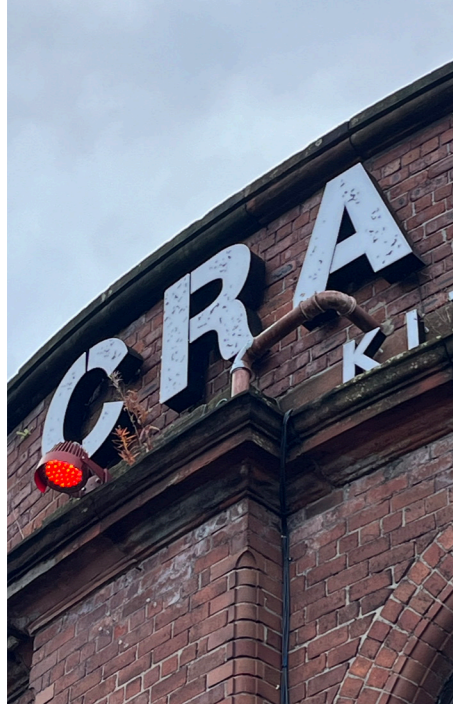
Image top left:
example of vegetation growth and redundant services

- Remove all redundant services (including but not limited to alarm boxes, light fittings etc.), repair and make good brickwork where necessary
- Remove all redundant signage, repair and make good brickwork where necessary

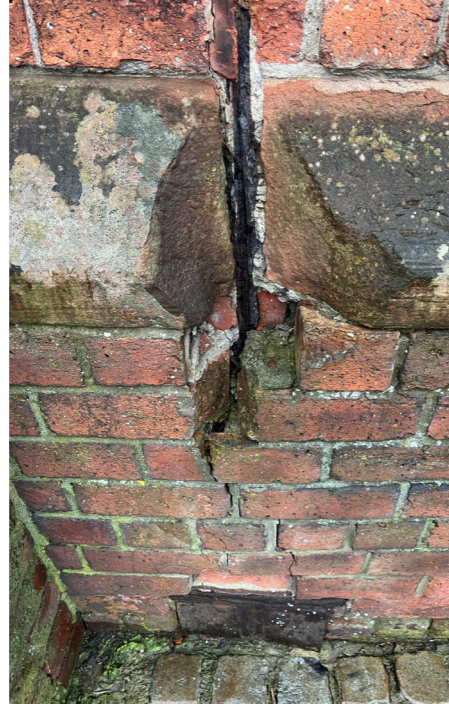
Image top middle:
example of weathering damage to stonework and brickwork

- Carry out a non-abrasive cleaning of the external brick and stonework to remove all moss, algae, and vegetation as required.
- Existing stone bands at dado level, eaves and cope level will receive a de-scale to remove all loose and friable stonework back to a sound base and will then be finished with a light carborundum rub to remove all possible water traps to the de-scaled areas.

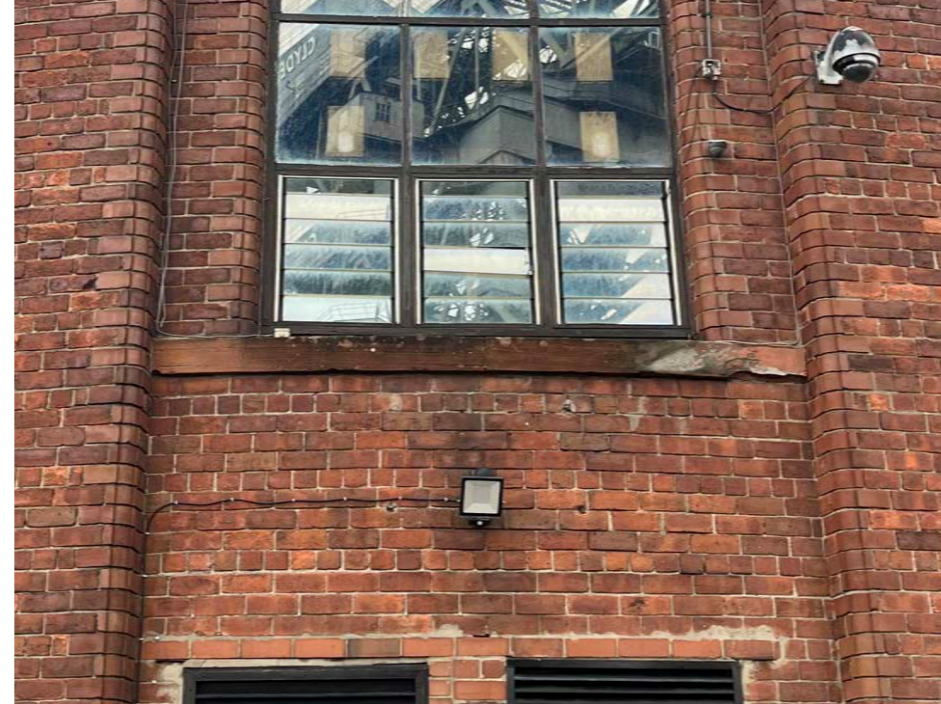
Image top right:
general condition of brickwork and stone details

- Existing brickwork will be assessed and where deemed necessary all defective beds and joints will be raked out and then re-pointed in a sympathetically gauged lime mortar, in colour to match existing.

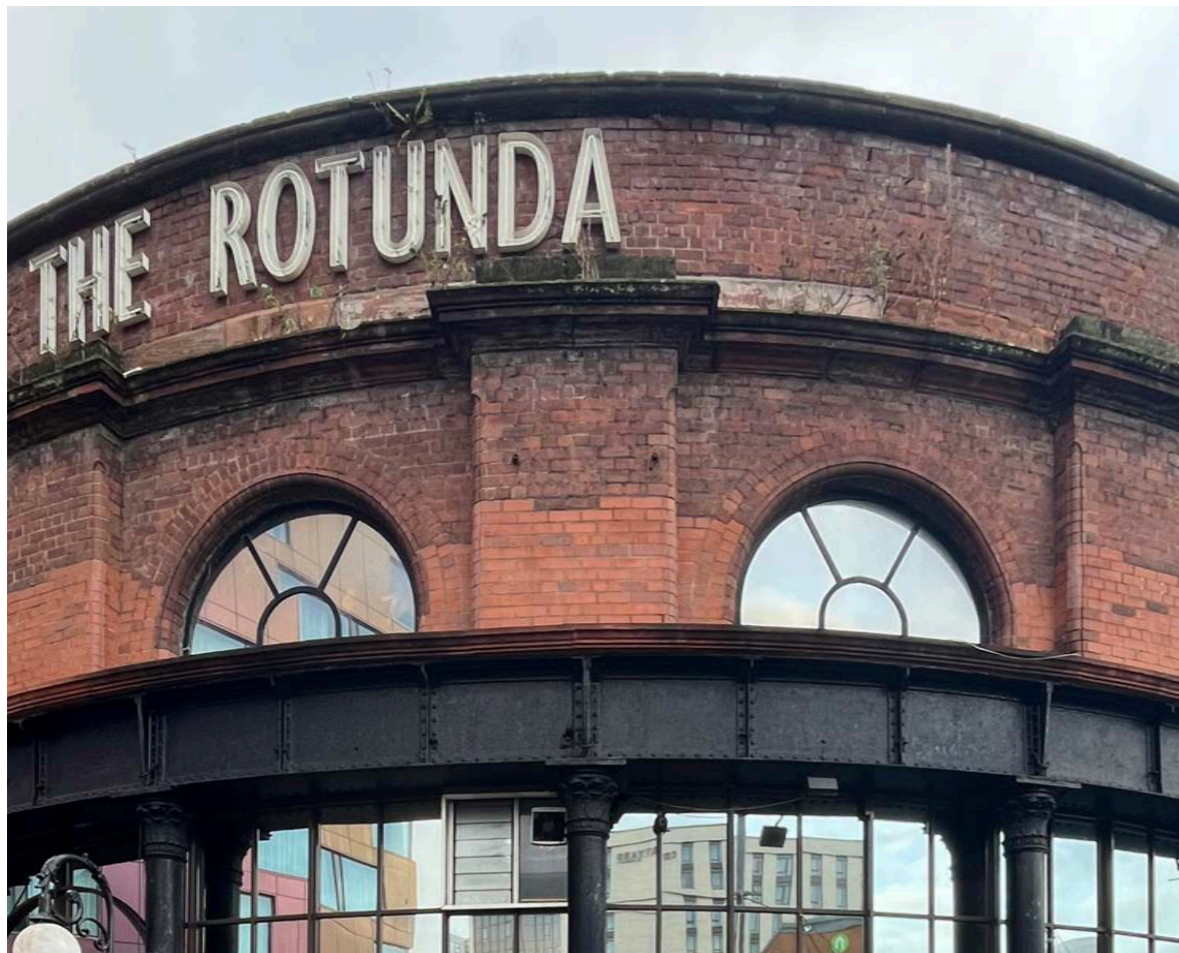
Image bottom left:
example of vegetation growth and previous brickwork repairs

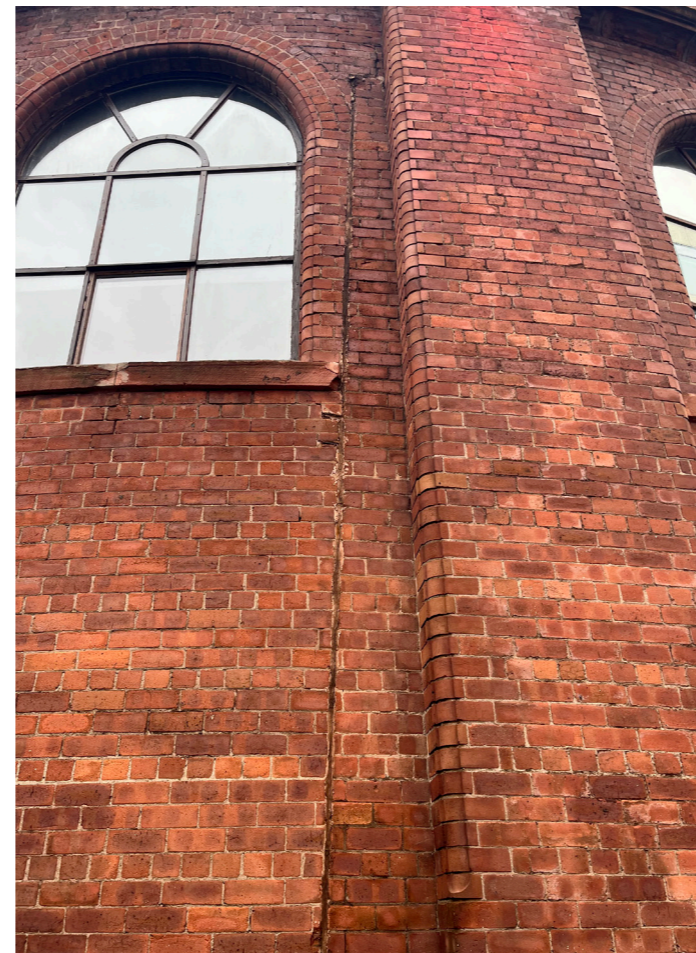
Image bottom right: example of historic structural joint and subsequent weathering damage

- Potential structural movement damage (two previously repaired cracks are visible in bay 2 and bay 9 – refer to drawings) to be assessed and repaired if required.

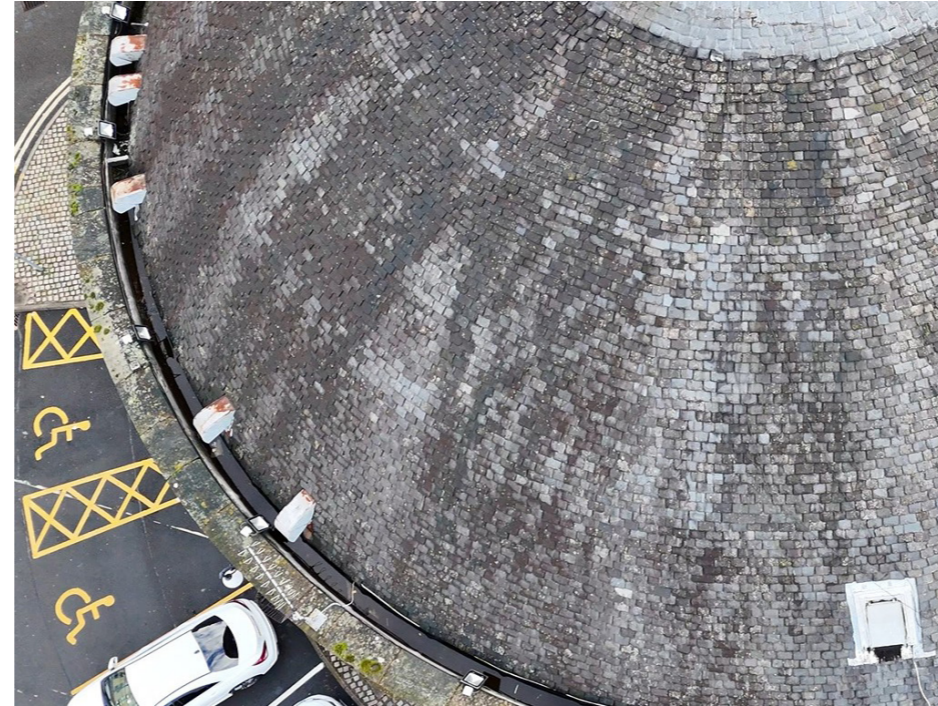
Image top left: aerial view of existing roof
Image top right: existing service penetrations and standing water in gutters
Image bottom left: general condition of existing roof
Image bottom right: existing weathervane (assumed not original)

** The new service outlet/inlet terminations are located at the lowest edge of roof behind the brick/stone parapet. Visually they will be coloured to match the slate to minimise their visual impact as much as possible. The number of grill required will be confirmed following further technical design.

- Gutters will be stripped, substrate reviewed and replaced as required, insulated and relined with lead, dressed up and under the slate edge
- Install lead flashing to the stone cope at the wall head. It is our proposal that the gutter lead lining be dressed up and over the coping.
- The projecting stone ledge at stone corbel level will receive leadwork flashing
- Leadwork flashing to be installed below the stone cornice and above the curved cast-iron beam above the historical vehicle entrances
- Other stone ledges to be assessed on-site for leadwork flashing requirement
- Any service penetrations that exist, will be suitably dressed with lead flashings as needed, in a traditional detail.

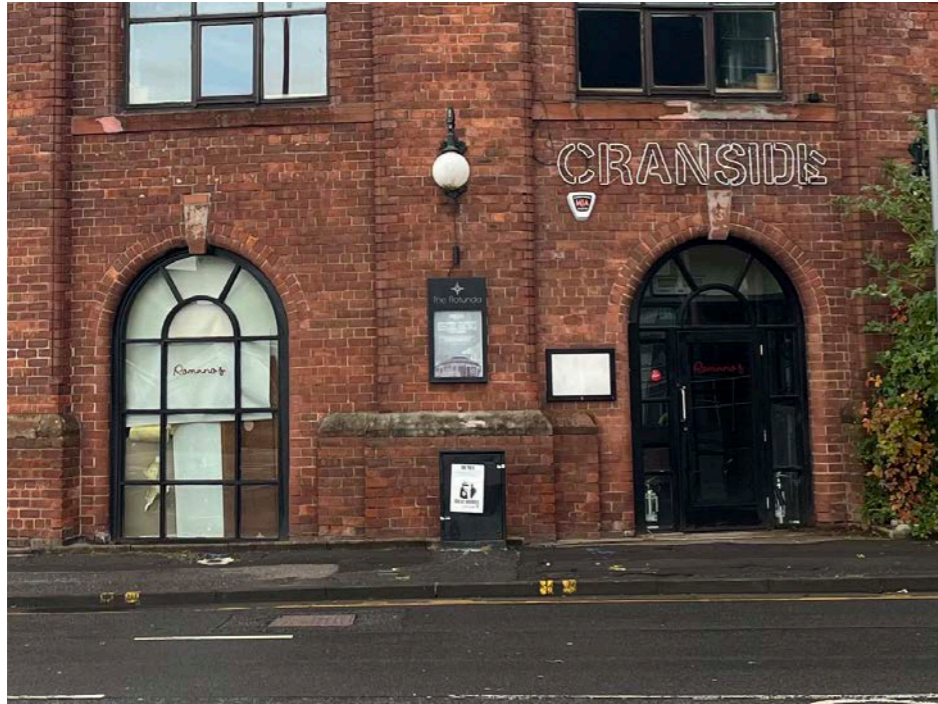
Image top left: former pedestrian access doors.

All existing windows (including the two former pedestrian tunnel access doors) are to be replaced on a like-for-like basis with modern double glazed windows which match the existing fenestration pattern.

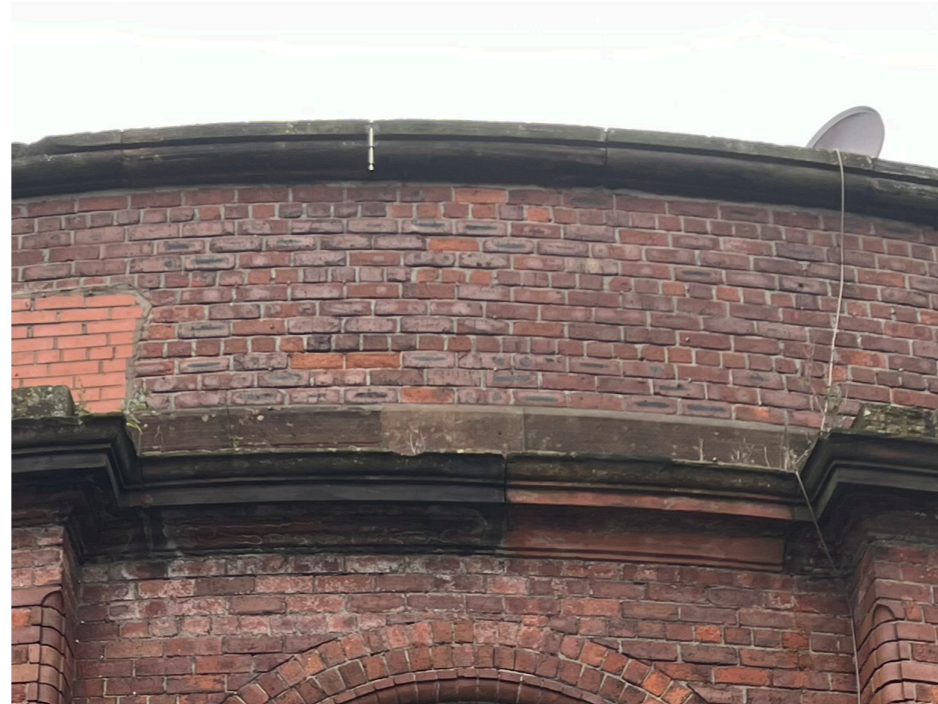
There are a number of areas that are currently unprotected from standing water and by extension, possible water damage. It is proposed to undertake the following works:

Image top right: stonework requiring flashing protection

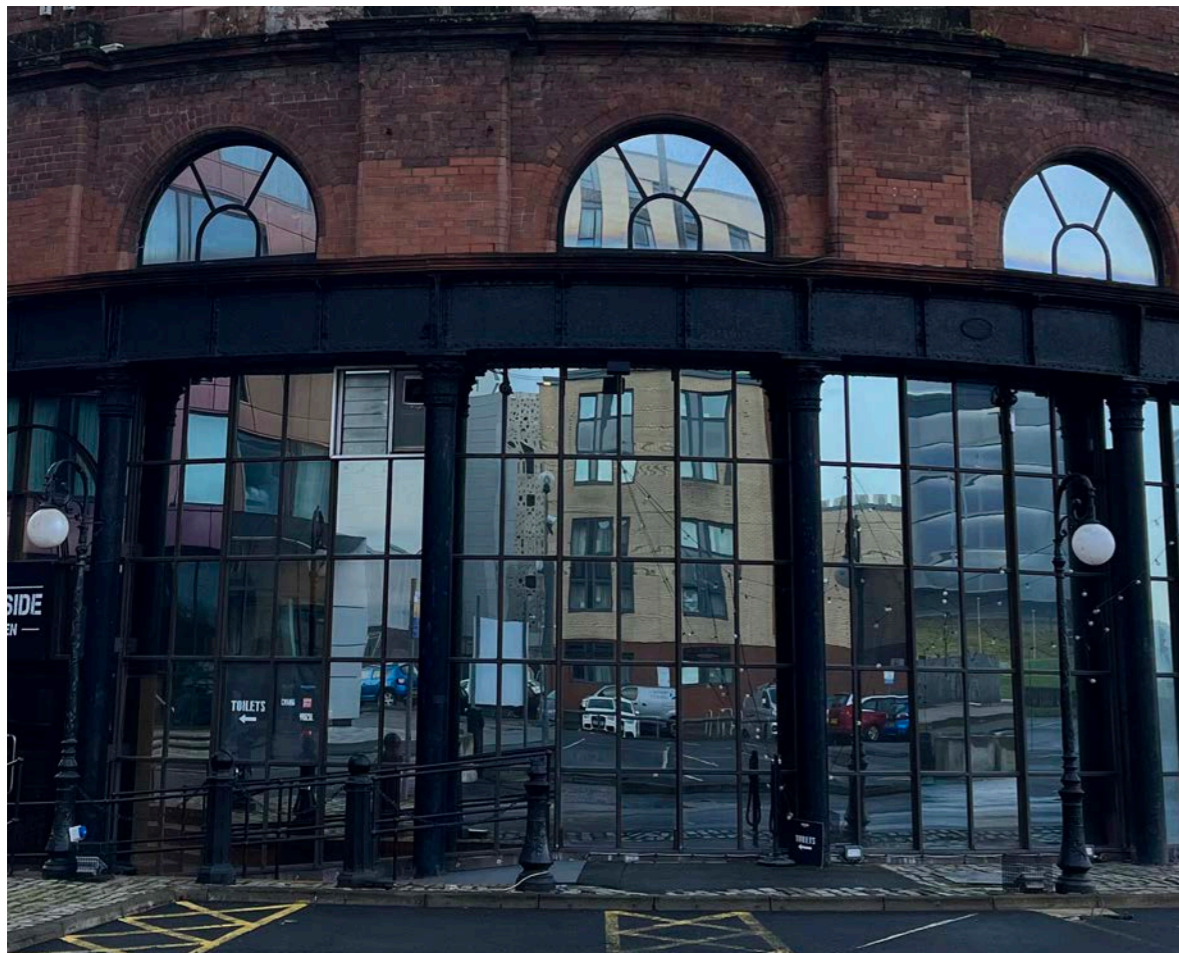
Image bottom left: former vehicle entrance glazed screen

The large glazed screen (located at the historic vehicle entrance) is to be removed and replaced with a new design (refer to proposed elevations).

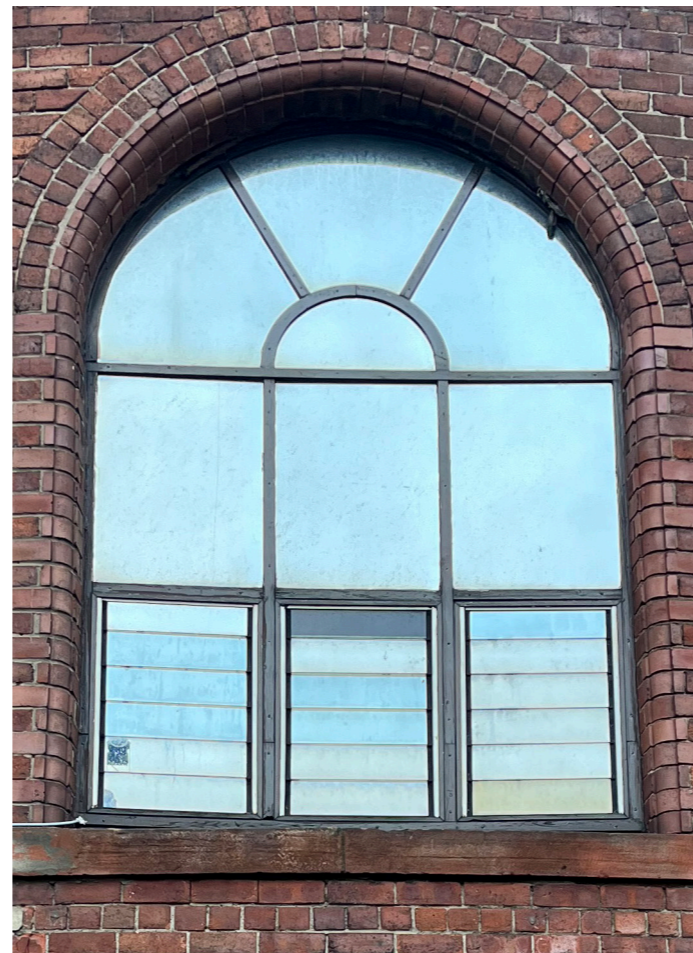
Image bottom right: typical existing window
