**ASSESSMENT OF SURFACE WATER MANAGEMENT
(SURFACE WATER DISCHARGE TO LAND)
FOR
RESIDENTIAL DEVELOPMENT AT ROTHERHAM TOP FARM,
PRESTON ROAD, WHITTLE LE WOODS,
CHORLEY, PR6 7PG.**

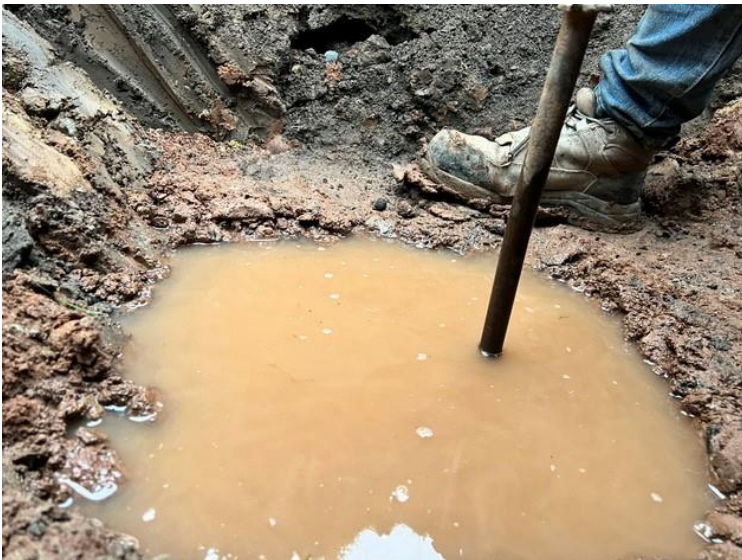
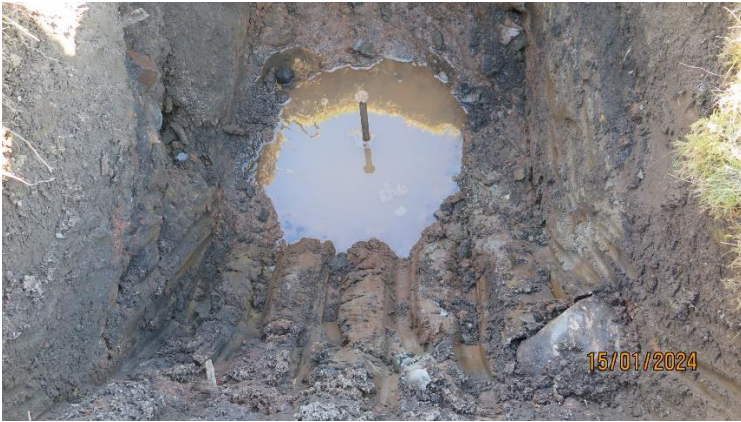
As a result of the clay conditions a small-scale test was undertaken in accordance with BRE365 with a further 300x300x300 excavation to the bottom of the trial pit. The clay at this point being soft to firm. The 300mm deep hole was filled with water and left 24 hours. At 24 hours the water level had not reduced. See Pics 1-3.

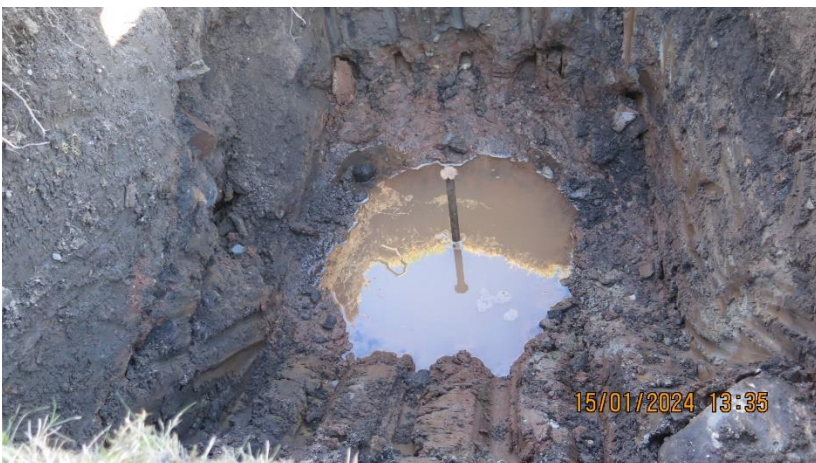
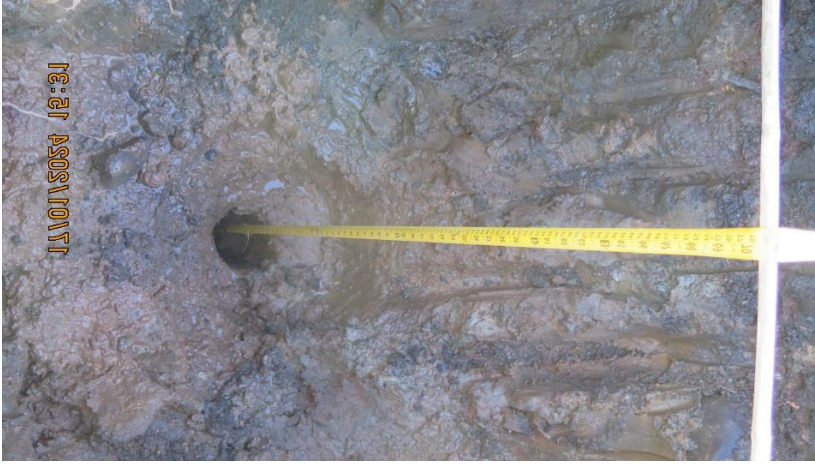
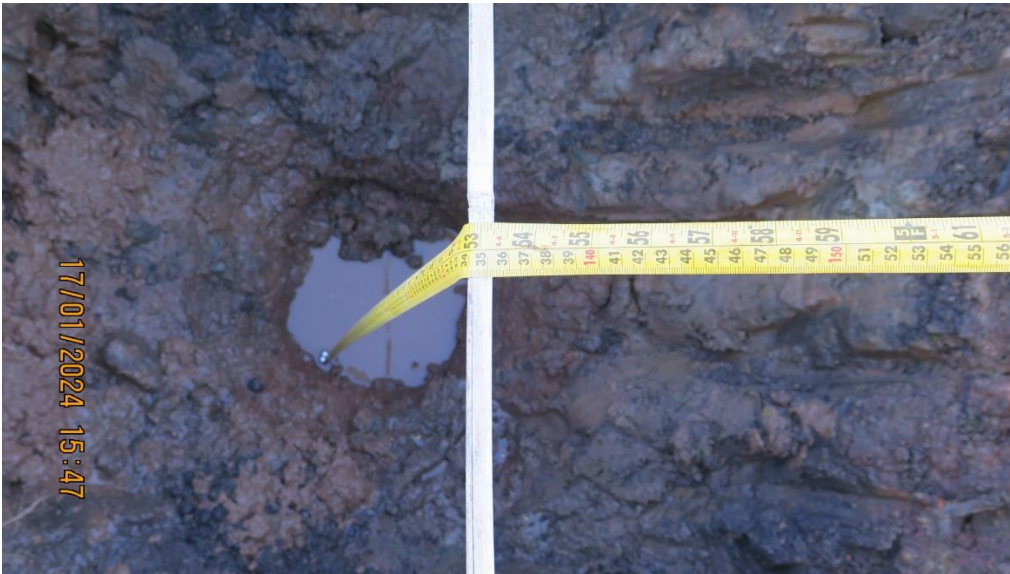
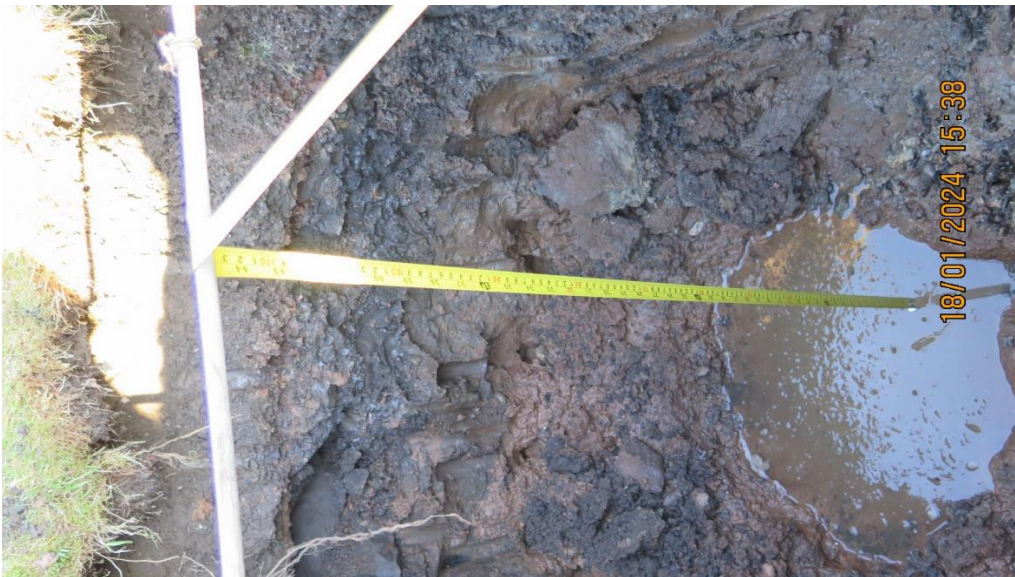
After 2 days the hole was cleared of water and the 300mm deep hole extended, by mechanical auger, down to 1.8m below ground level and a further test undertaken. After 24 hours the water level had increased by 100mm. This may be a result of the water table. See Pics 4-8. The pictures show the waterline at the beginning of the test at 1350mm below ground level. 24 hours later the water line was at 1150mm below ground level.

Given the clay present for the whole excavation the results were expected and added weight to the ground not being suitable for land irrigation.

The carrying out of a trench test was not undertaken given the nature of the subsoil conditions encountered and the results obtained by the lesser test. The excavation identifying that any trench soakaway would have no permeability to the trench sides for at least a 1.8m depth. It is presumed that the water table at this current time could be at a depth of 4m.
