**ASSESSMENT OF SURFACE WATER MANAGEMENT  
(SURFACE WATER DISCHARGE TO LAND)  
FOR  
RESIDENTIAL DEVELOPMENT AT ROTHERHAM TOP FARM,  
PRESTON ROAD, WHITTLE LE WOODS,  
CHORLEY, PR6 7PG.**

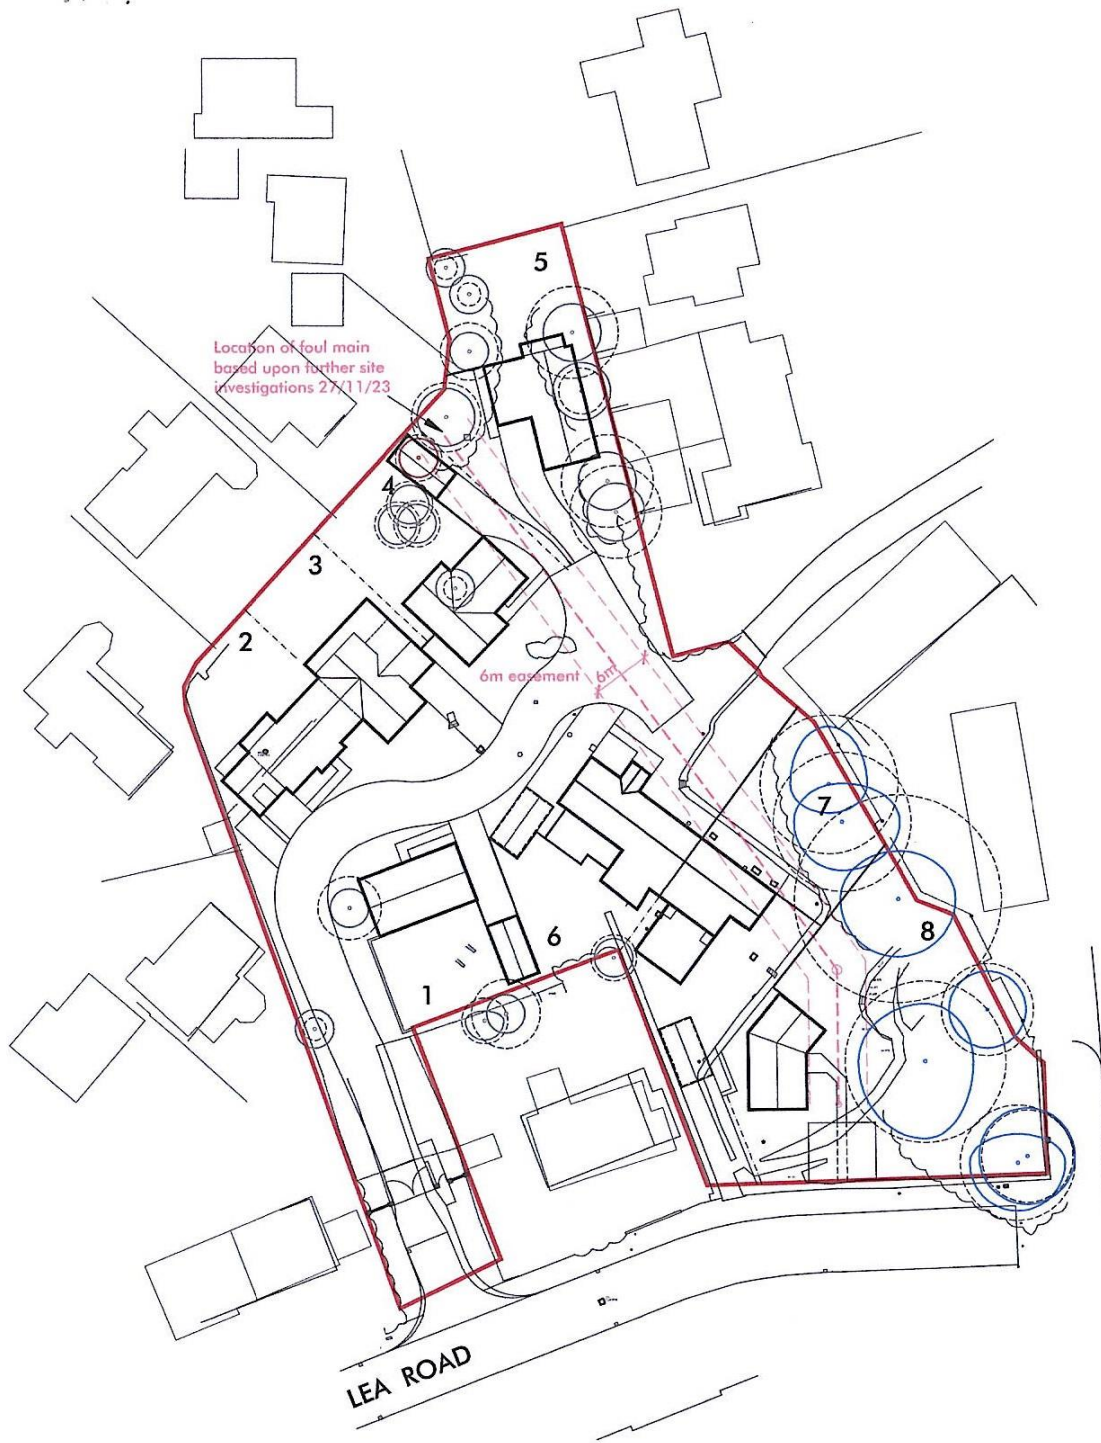
Fig.2

Figure 2 shows the foundation constraint with a green broken line.

The current recommendation is for soakaways to be a minimum 2.5m from any site boundary. This is indicated with a red broken line on See Fig 2.

Excavations within the Tree Protection Zones are not permitted and this will impact on the positioning of any soakaway. These are indicated with a purple solid line on Fig 2.

Building Regulations requires that soakaways are located a minimum 5.0m from any road. Indicated with a blue broken line on Fig 2.

The cumulative impact of the site constraints can be clearly seen on Fig2 and the only areas not impacted by constraints, and thus able to facilitate soakaways are shown in a light blue hatch.

The existing sewer and its associated easement are highlighted in a light brown hatch on Fig 2.

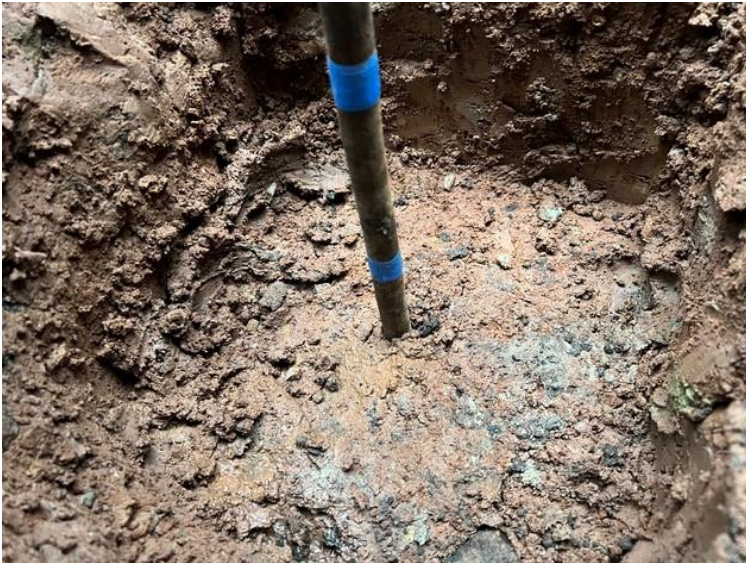
**Pic 1**

As a result of the clay conditions a small-scale test was undertaken in accordance with BRE365 with a further 300x300x300 excavation to the bottom of the trial pit. The clay at this point was soft to firm. The 300mm deep hole was filled with water and left 24 hours. At 24 hours the water level had not reduced. See Pics 1-3.

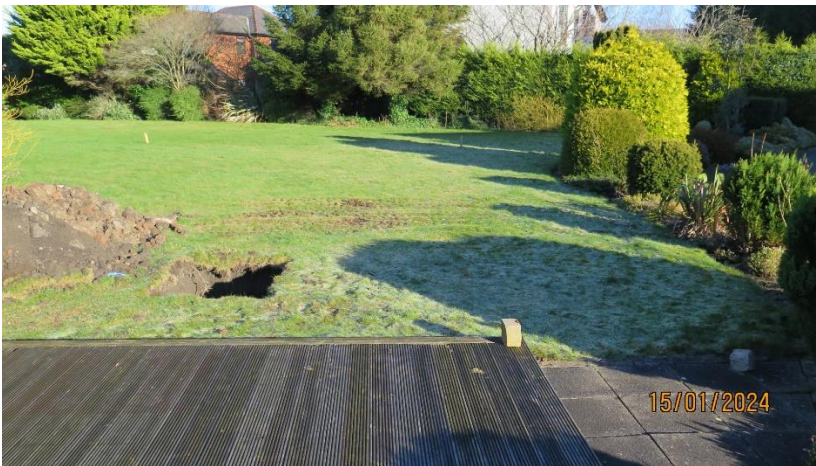
**Pic 4**

After 2 days the hole was cleared of water and the 300mm deep hole extended, by mechanical auger, down to 1.8m below ground level and a further test undertaken. After 24 hours the water level had increased by 100mm. This may be a result of the water table. See Pics 4-8. The pictures show the waterline at the beginning of the test at 1350mm below ground level. 24 hours later the water line was at 1150mm below ground level.

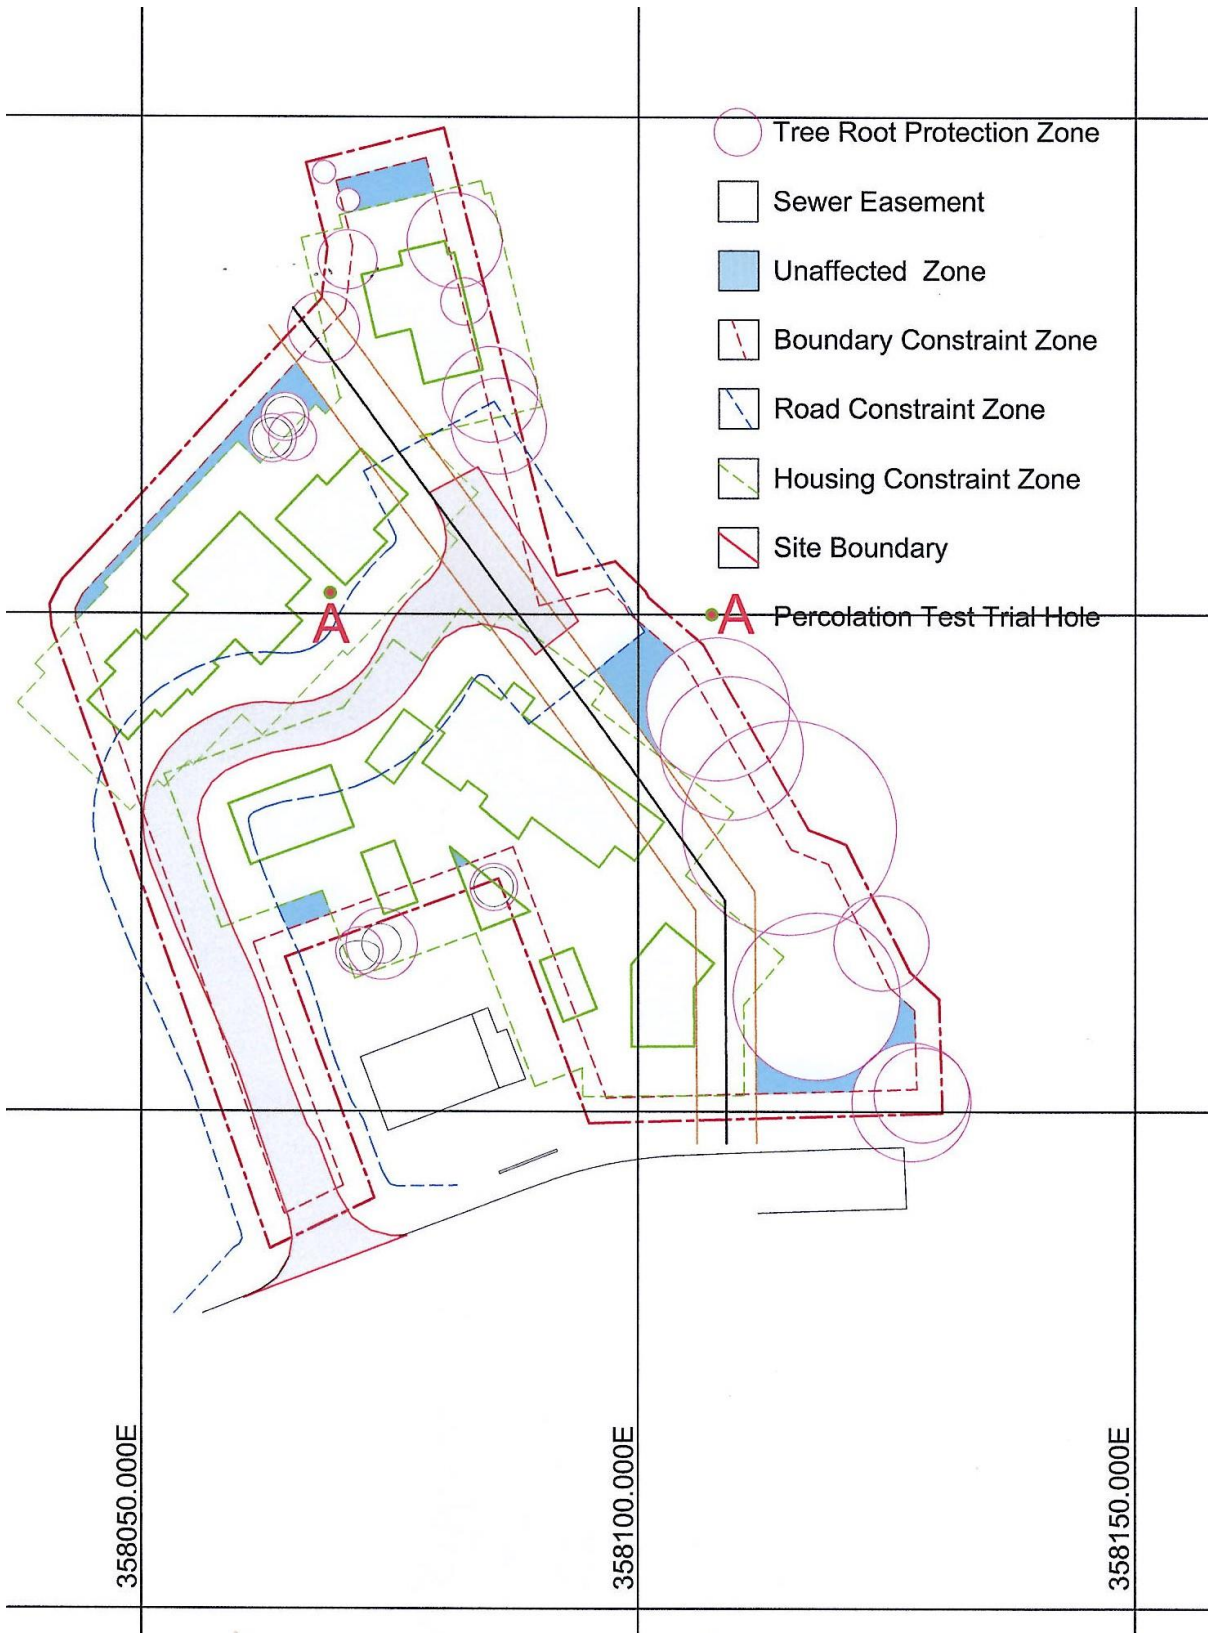
Fig 3.

A trial hole was excavated, "A" on the Plan Fig 3 (page 10) down to a depth of 1.8m where the upper 400mm is soil layer and the lower 1.4m being clay with no change in the strata to that depth. Left open the hole filled to 1.5m below ground level with water.

Figure 3. shows the impact of the collated dimensional constraints imposed on the location of any soakaway and it can be seen that the area available for a soakaway is limited. A token percolation test in conformity with BRE 365 has been attempted however as a result of the clay subsoils and ground water, the test proved negative.

At this time, I can only conclude that the site is not suitable for the surface water drainage being discharged to land. There are no nearby water courses to facilitate surface water discharge and I would conclude that the next option to investigate would be by way of the onsite combined sewer. Consultation with United Utilities should be undertaken to further this possible option in accordance with the hierarchy for sustainable drainage systems.
