ARBORICULTURAL IMPACT ASSESSMENT REPORT

229 London Road, Wickford

CBS Developments

DATE: March 2024

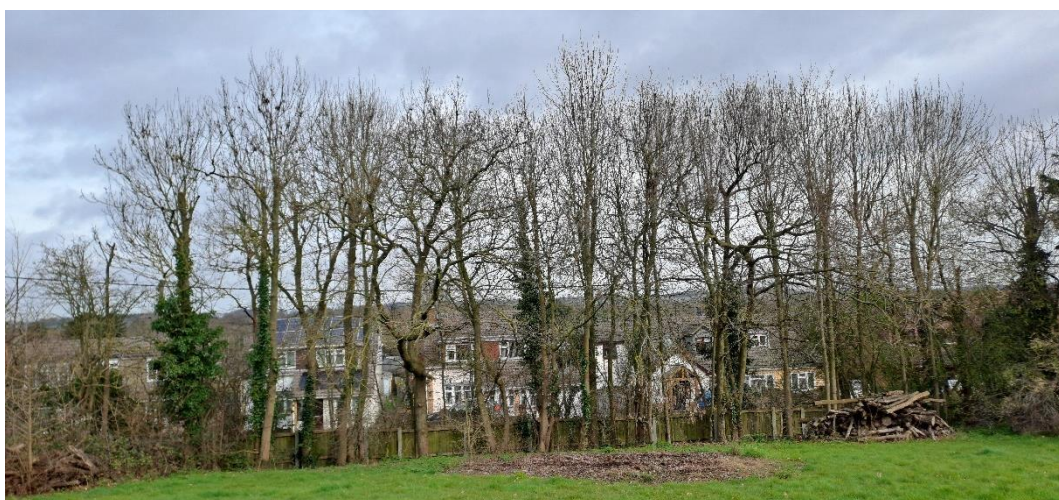
Photo 1 – general view looking north

- 4.3. *Trees on the road frontage (northern boundary):* The trees on the raised bank comprise a line of semi-mature trees which are mostly self sown. They are very close together, resulting in poor stem taper and asymmetric crown spreads. Whilst they provide collective screening and greenery up to 14m in height, many are in a poor condition. This is in part due to the species mix as the majority comprises ash (suffering with ash dieback disease) and elms (infected with Dutch Elm Disease – many of which are dead). The ash and elms have been topped in the past, resulting in decay at the pruning wounds and weakly attached branches. Within this group are plums in a poor condition (notably T11 which has partially collapsed), and oaks (T18, T19, T20) which have very distorted crowns weighted south due to the overcrowding. To the east of the group is G9, a dense conifer group 10m high which has been topped at 8m resulting in large dead branches in the inner canopy. To the west of the group is a dense thicket of bramble with dead and dying elm trees.

All trees on the northern boundary will be removed to enable necessary ground remodeling for the access. As previously discussed, the majority of the trees are in a very poor condition and some are dead and/or hazardous for reasons detailed in the tree survey sheets. All trees and scrub on the eastern boundary will also be removed. The middle and northern section is due to their poor quality, the potential for the ash to outgrow their situation near number 245 (unless they contract ash dieback disease) and to enable construction of the nearest plot. The scrub G32 is being removed to make good use of the garden space and to enable space for new sustainable landscaping with a greater longevity. Trees to be removed are shown red on the tree protection plan SHA 1776 TPP at appendix 3 and tree works are listed in full in the tree surgery schedule at appendix 4.

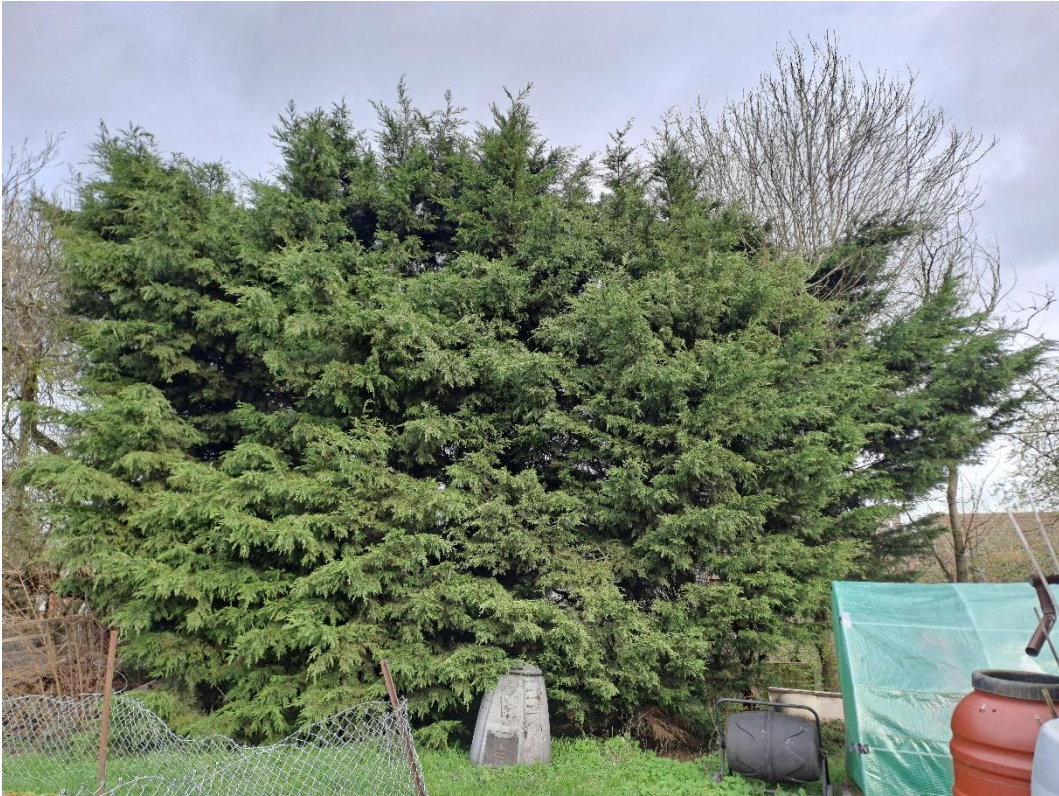
Photo 2 – G9 looking north

Tree Number	Botanical Name (Common name)	Age	Dia (mm)	Stems	Height (crown height)	Ult ht (m)	N	E	S	W	Cond	Life Exp	BS Cat	RPR (m)	RPA (m ²)	Comments	Recommendations
G9	X Cupressocyparis leylandii (Leyland Cypress)	EM	400	1	10(0)	18	2.5	2.5	2.5	2.5	Poor	10+	C2	4.8	72.39	Poor shape & form. Forms a dense screen. Part of linear group. Ivy on tree. Dieback in crown. Broken branches in crown. Major deadwood in crown. Unbalanced crown shape. Crown distorted due to group pressure. This line of trees has been topped at 8m resulting in inner dead crowns with large dead branches in inner canopy. Average dimensions given.	
T10	Fraxinus excelsior (Ash)	M	270 150	2	14(8)	18	3	2.5	1.5	3	Poor	<10	U	3.71	43.25	Poor shape & form. Declining. Ivy on tree. Unable to inspect stem due to Ivy. Decay present on stem. Fungal brackets visible on stem. Major deadwood in crown. Unbalanced crown shape. Crown distorted due to group pressure. Poor past pruning resulting in sub optimal crown architecture. Inonotus hispidus on southern side of trunk. Likely to be a column of decay from previous topping at 9m. Smaller stem is dead. Risk of failure into the road.	Remove tree and root.

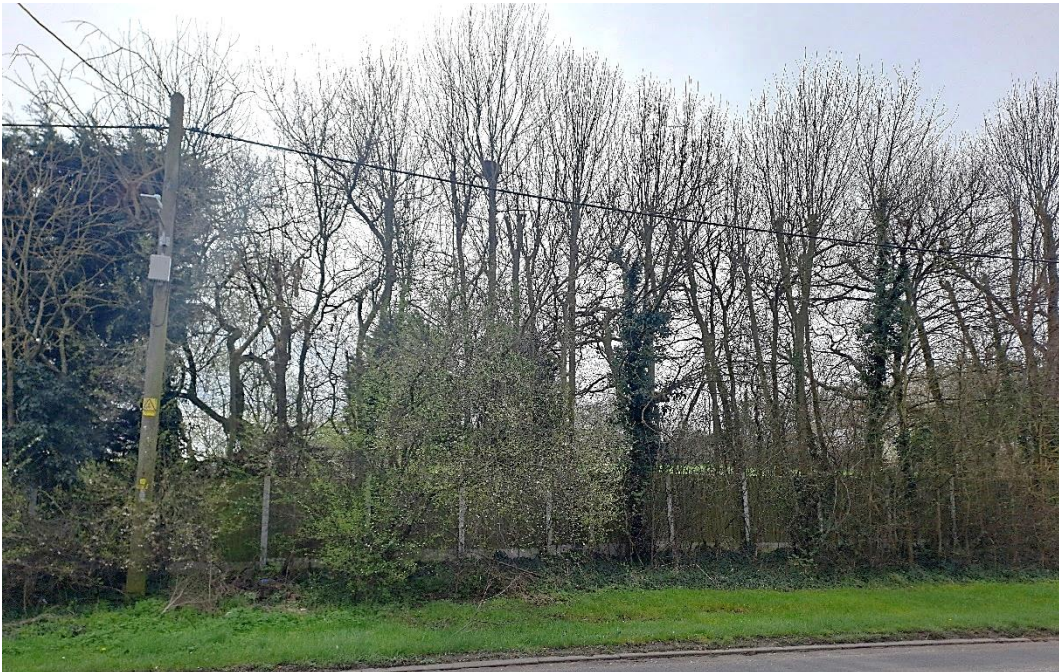
Photo 3– looking south from London Road. Note the Highway verge with mixed scrub (G51)

Tree Number	Botanical Name (Common name)	Age	Dia (mm)	Stems	Height (crown height)	Ult ht (m)	N	E	S	W	Cond	Life Exp	BS Cat	RPR (m)	RPA (m ²)	Comments	Recommendations
G51	Ulmus procera (English Elm), Prunus spinosa (Blackthorn)	SM	150	1	8(0)	8	1	1	1	1	Poor	<10	C2	1.8	10.18	Offsite tree. Thicket of blackthorn which is dense in some areas and patchy in others average 4m high. Dead and dying elms are a hazard to the road.

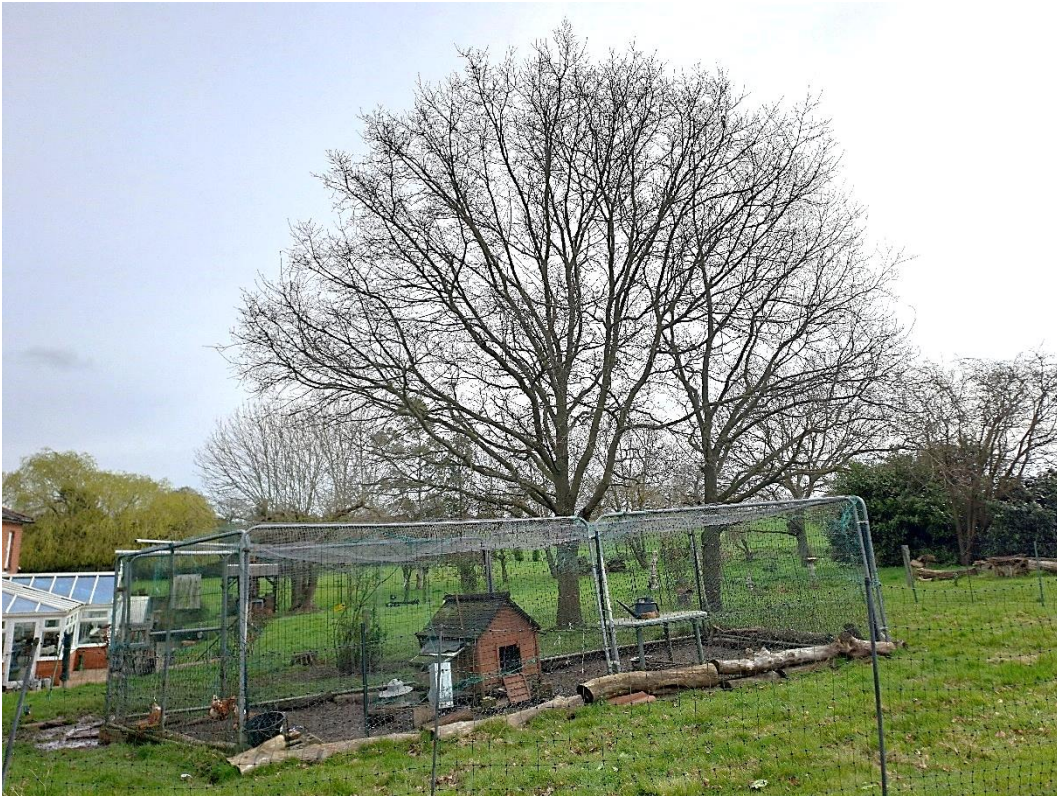
Photo 5– looking east at the two offsite oaks T45 and T46 in the rear garden

Tree Number	Botanical Name (Common name)	Age	Dia (mm)	Stems	Height (crown height)	Ult ht (m)	N	E	S	W	Cond	Life Exp	BS Cat	RPR (m)	RPA (m ²)	Comments	Recommendations
T46	Quercus robur (Common Oak)	SM	350	1	10(2)	20	6	6	3	6	Good	40+	B2	4.2	55.42	Good form and condition. Unbalanced crown shape.Observed from outside chicken area. Dominant tree of the two.	
T47	Prunus domestica (Damson)	M	200 300	2	6(1.5)	7	4.5	4.5	4	4	Poor	<10	U	4.33	58.91	Poor shape & form. Decay present on stem. Cavity on stem. Epicormics on stem. Stem divides below 1.5m. Broken branches in crown. Major deadwood in crown.The two stems are significantly decayed on the western side up to 3m. Good vitality.	
T48	Prunus avium (Wild Cherry)	SM	150	2	6(1)	18	3.5	4.5	4.5	4.5	Fair	20+	C2	2.54	20.27	Reasonable form and condition. Epicormics on stem. Stem divides below 1.5m.Good vitality.	
T49	Malus (Apple)	M	230	1	6(1)	8	2.5	2.5	2.5	2.5	Fair	10+	C2	2.76	23.93	Leaning West. Epicormics on stem. Broken branches in crown. Major deadwood in crown. Unbalanced crown shape.Heavy lean. Mistletoe. Large dead branch West. Old stubs.

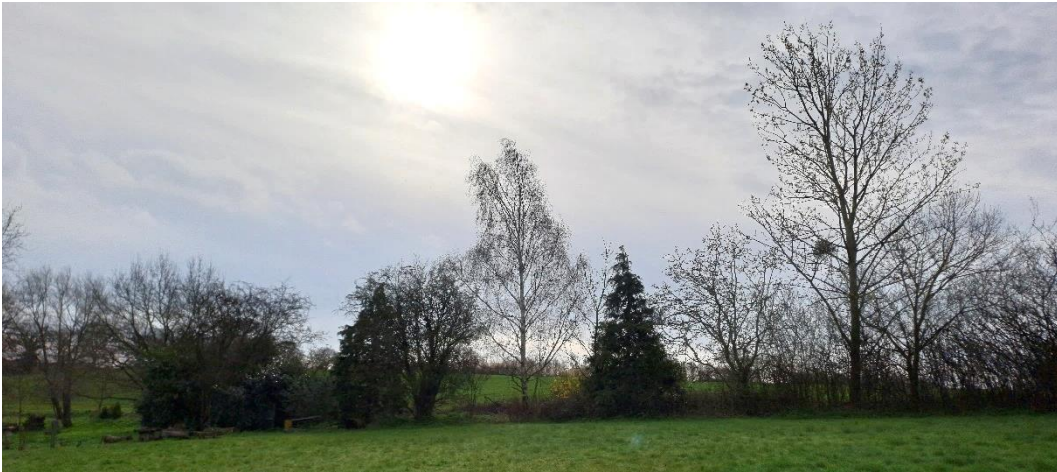
Photo 6– looking south

4.5. *Trees on the southern side:* The collective vegetation provides an attractive filtered screen between the site and agricultural land to the south. The prominent trees are two Leyland cypress (T34 and T35), a poplar T38 and a birch T42. An informal group of blackthorn between 1 – 5m is growing amongst the line of trees.

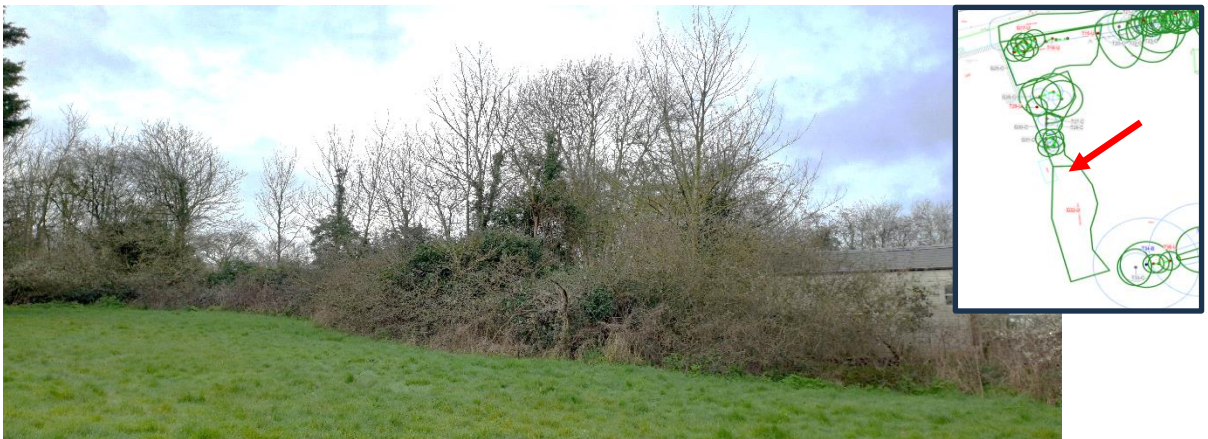
4.6. *Trees on the western side:* The north-western corner is dense bramble with dead and dying elms. To the middle of the boundary, close to the neighbouring property, is a dense group of ash saplings (G26), blackthorn, and elder. T29 holly is in a hazardous condition with a risk of failure.

Photo 7– looking west at the scrub with occasional ash and elm, with taller offsite trees to the rear

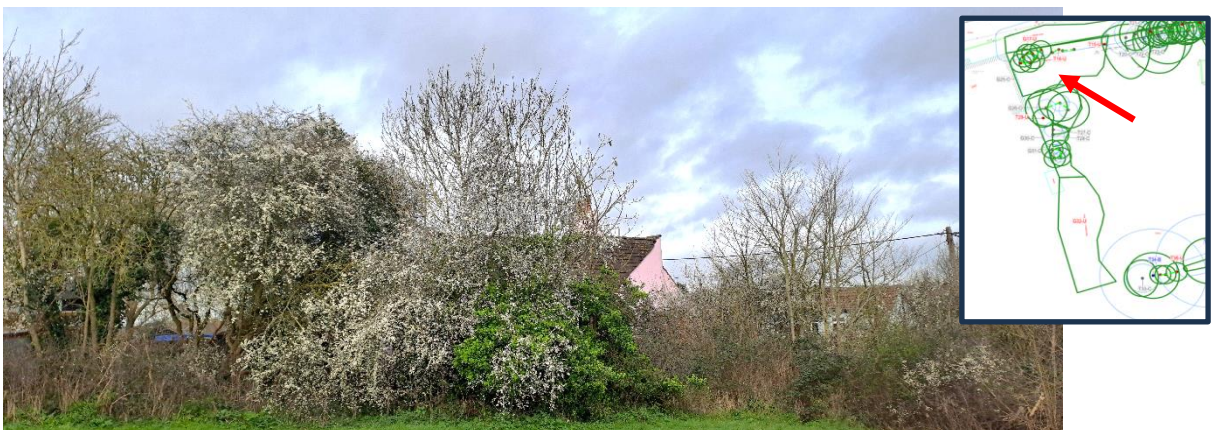
Photo 8– looking west at the north-western corner
