BS5837 Arboricultural Impact Assessment

21 The Headway, Ewell, KT17 1UN

Job Reference: 03638Rv2

July 2022

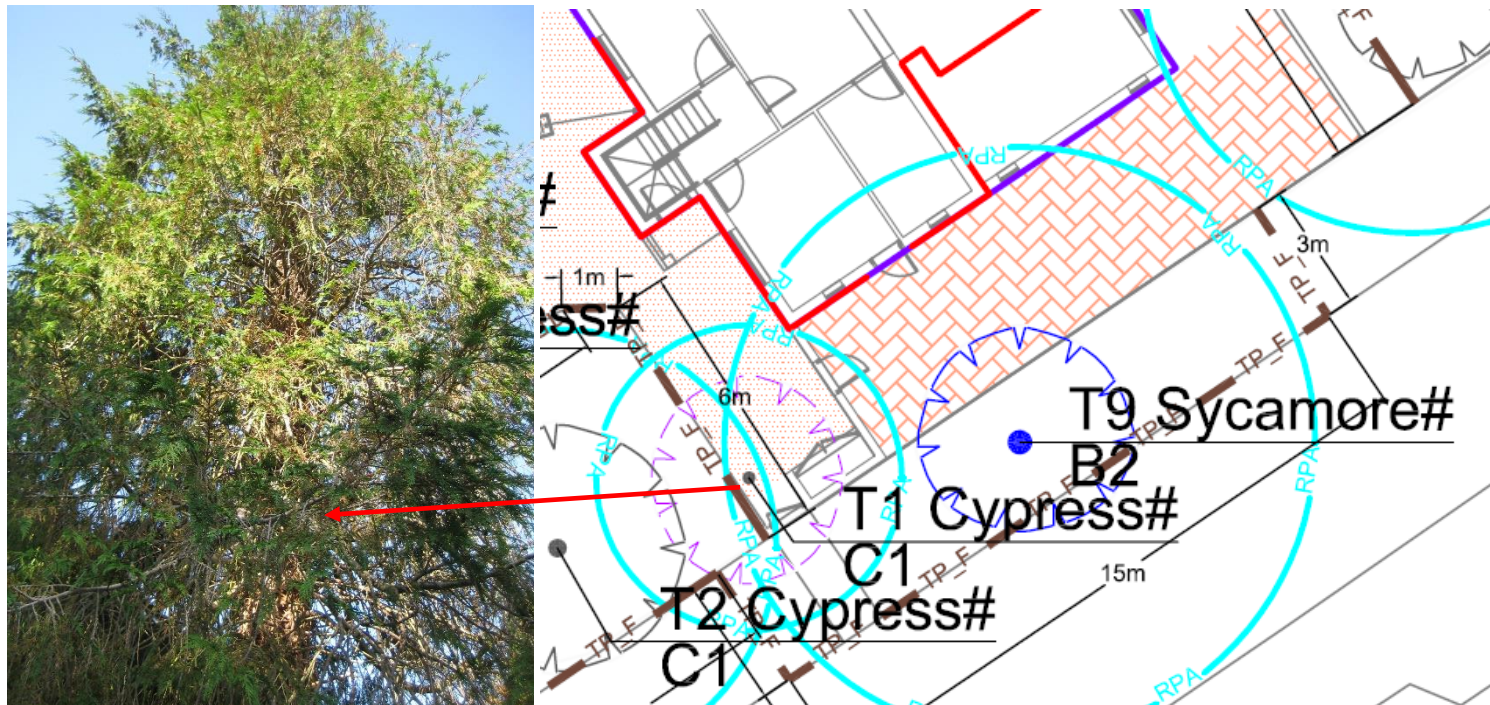
5.3.1 The proposal results in the removal of T1 (Cypress) where canopy thinning is already evident. It seems very unlikely the council would consider the tree appropriate for inclusion within a new TPO.

Fig 7 – T1 is proposed for removal

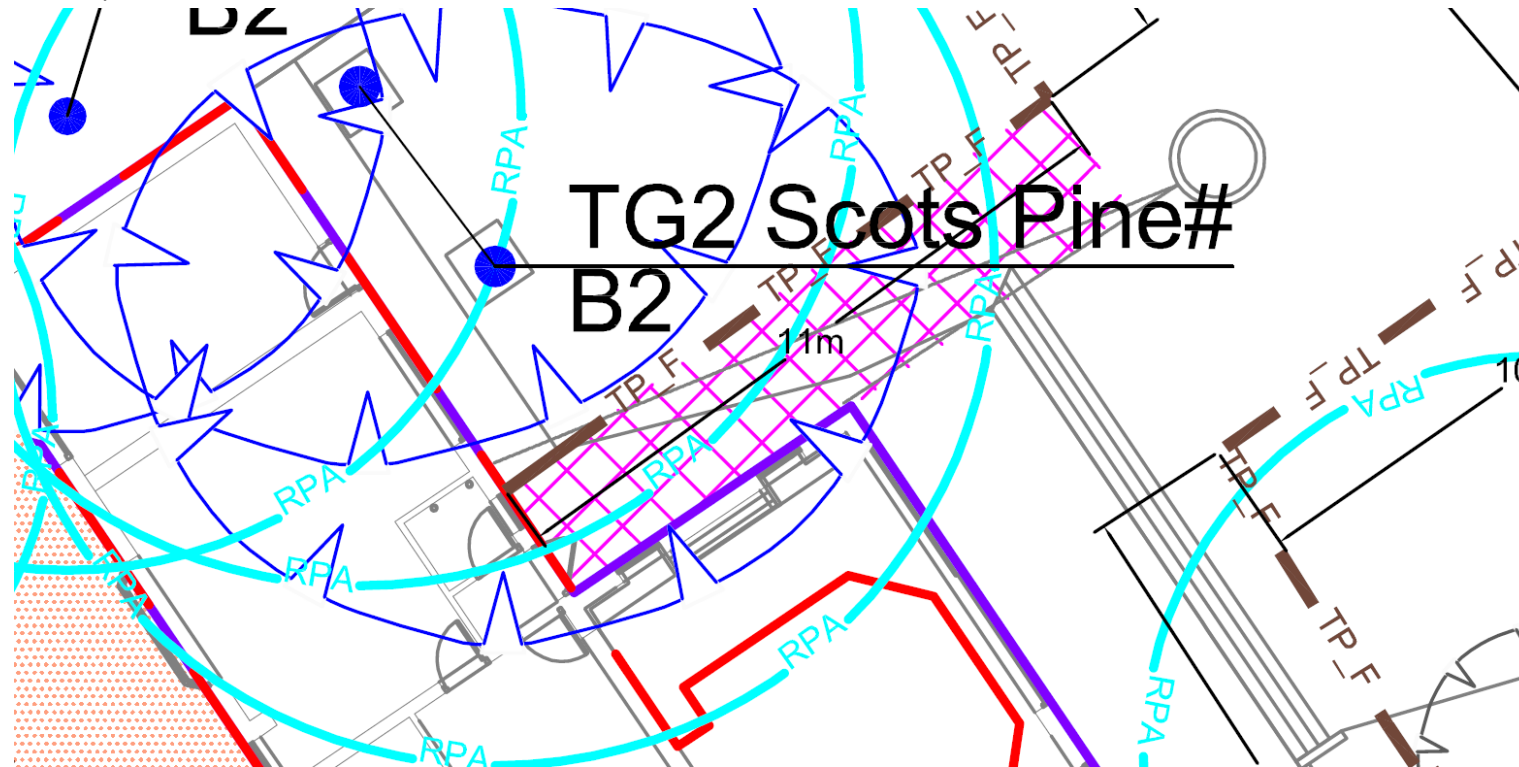
Fig 13 – The soakaway chamber is located completely outside the RPA of TG2. Efforts at installation will be made to move the pipework further from the trees but any excavation to install will be undertaken by hand. The open excavation will be photographed. (Note: client to make contractor aware)

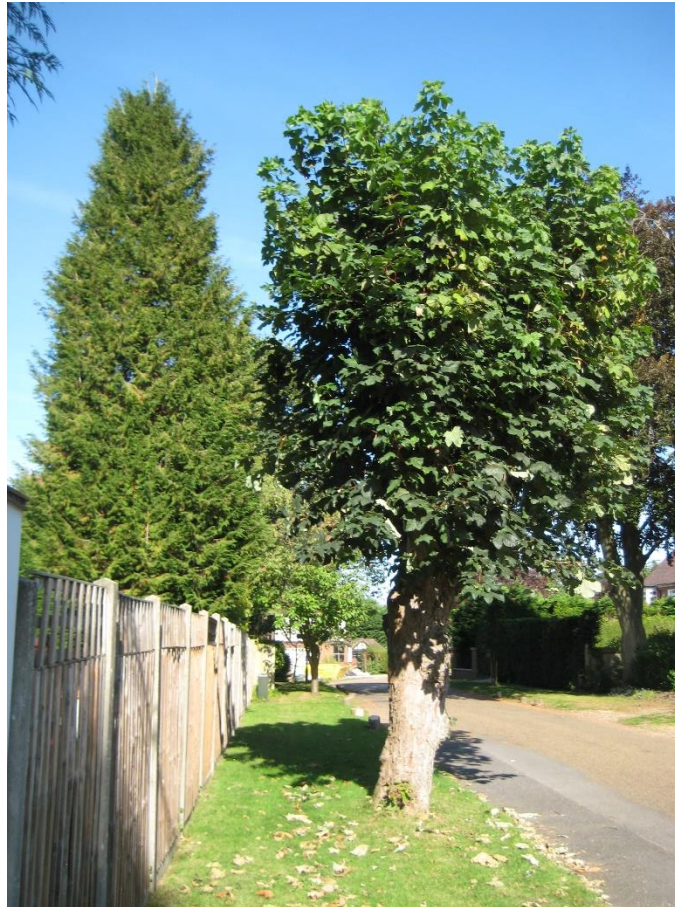
Image 1 – T9 relative to existing boundary. This tree is under repeat pollard management

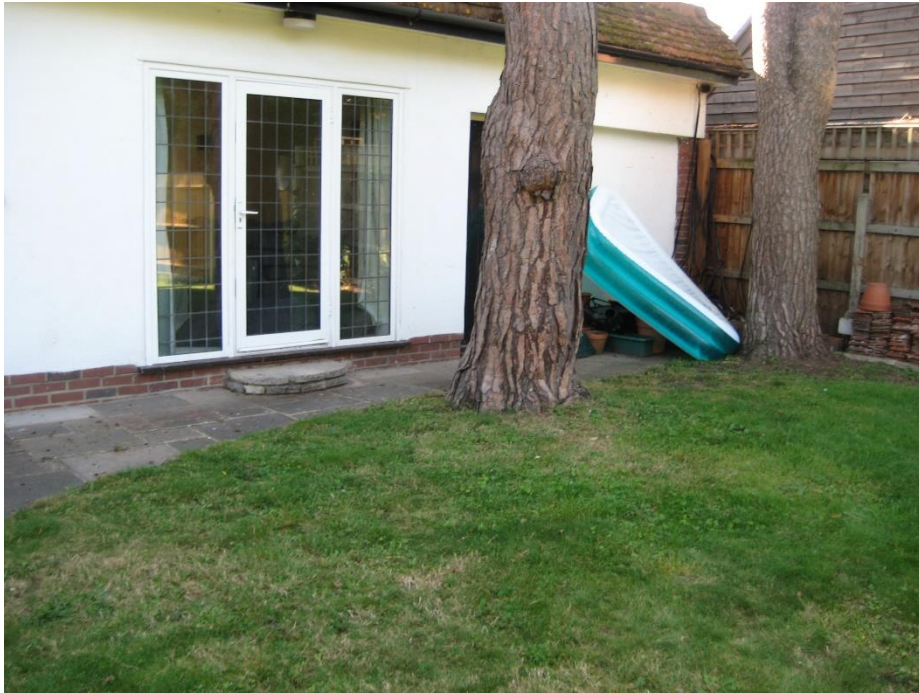
Image 2 – The lower stem relationship of TG2 to the existing property

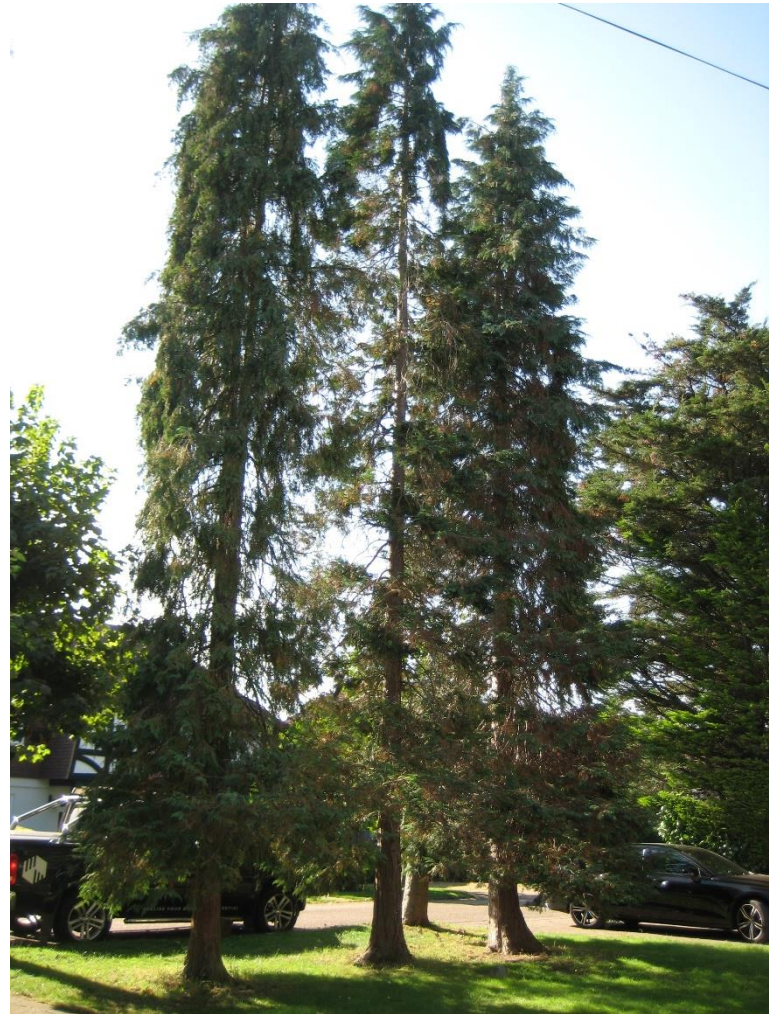
Image 3 – Looking towards T4, T5 & T6
