**Statement of significance and Heritage statement  
for the replacement windows to the front elevation, a small single storey rear and side  
extension and minor internal alterations  
at  
1 Albany Villas (left side), Salcombe Road, Sidmouth, EX10 8PW**

March 2023

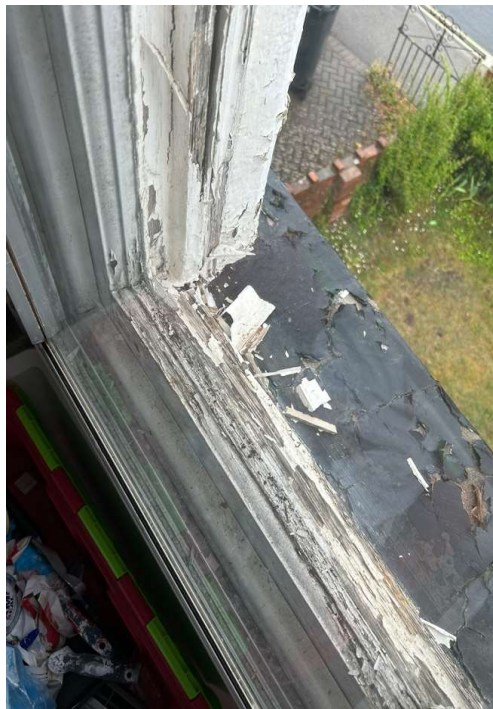
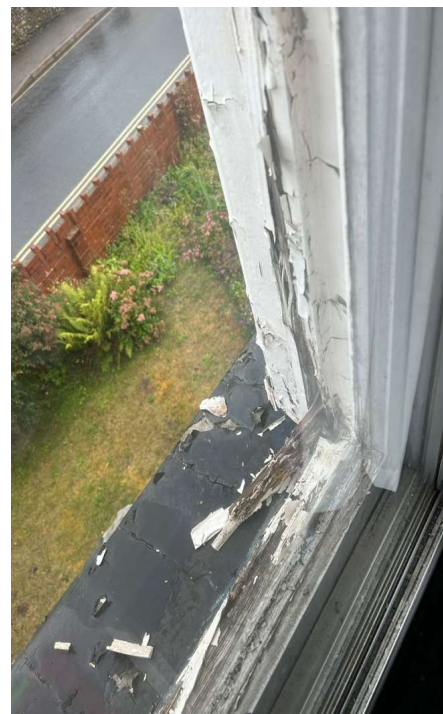
The front elevation of this building faces due south and therefore receives the prevailing winds and rain. These windows, and especially the sills, have rotted and been repaired on many occasions. They are now beyond repair and require replacement (see joinery report below). At the rear of the building, on the more sheltered elevation, the windows although in a poor condition, are repairable and therefore do not require replacement.

In my expert opinion all windows on the front elevation, ground, 1<sup>st</sup> & second floors are  
beyond repair and need replacing.

Window condition

This proposal is to carefully remove and replace all of the timber windows and the door on the front elevation, replacing them with new windows to exactly match the original design including using single glazing fitted with external putty. The windows to the rear elevation will be repaired, leaving in place as much of the original timber as possible.

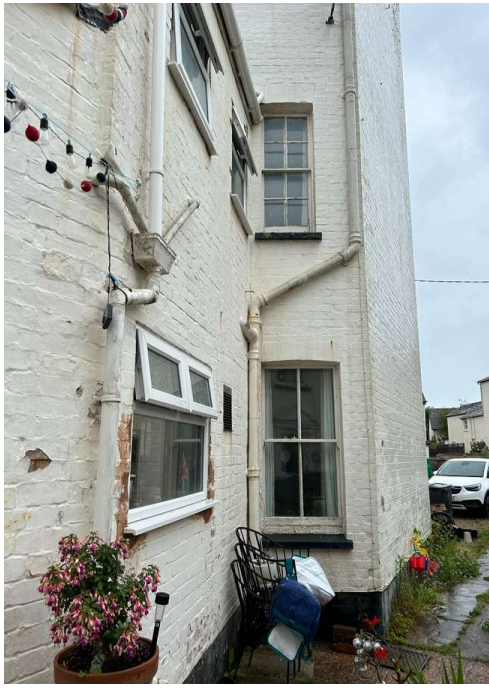
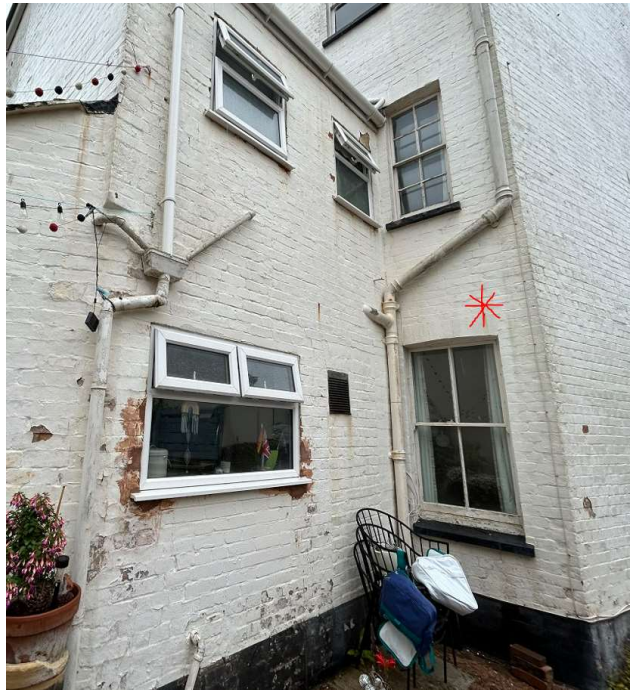
Location of extension with dining room window (\*) to be relocated

This extension will block up the only window providing light into the existing dining room. Therefore we intend to remove this window and reuse it cutting it into the gable wall as the attached plans.

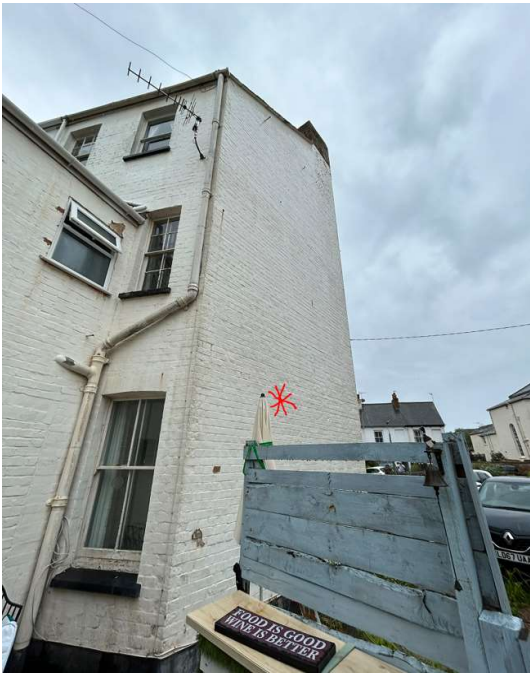
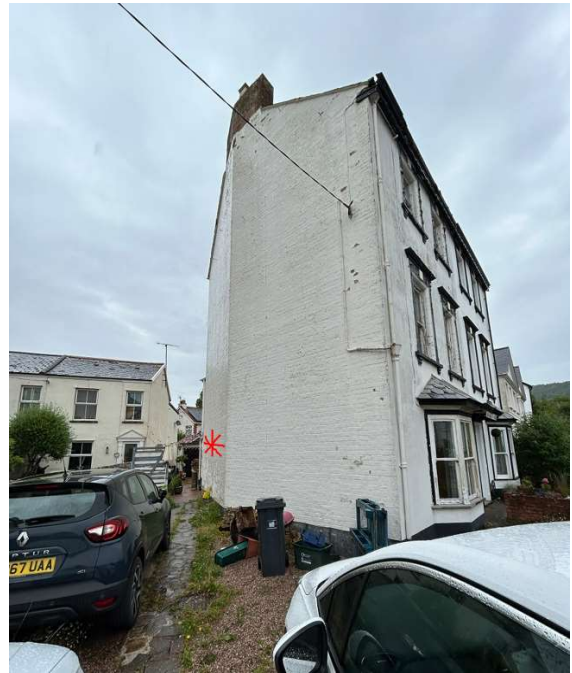
Location of relocated dining room window (\*)
