2313 Pembroke College – Old Quad Project

**Design & Access Statement**

Walters & Cohen Architects

15 March 2024

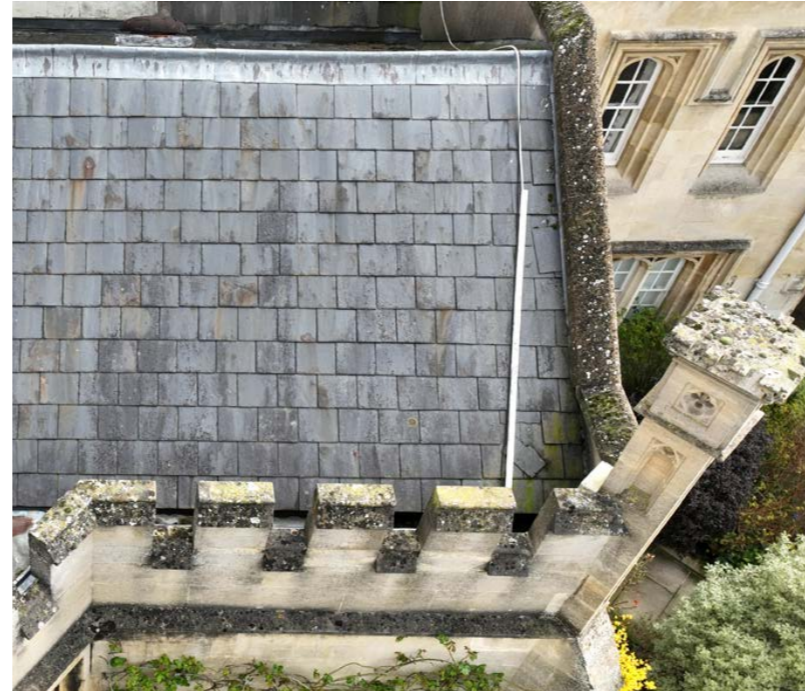
Image from drone survey showing slipped tiles to roof of Broadgates Hall

Many of the external repairs which are required are like-for like and do not require listed building consent. These works include minor roof repairs, redecoration and maintenance of rainwater goods, and repairs to the windows.

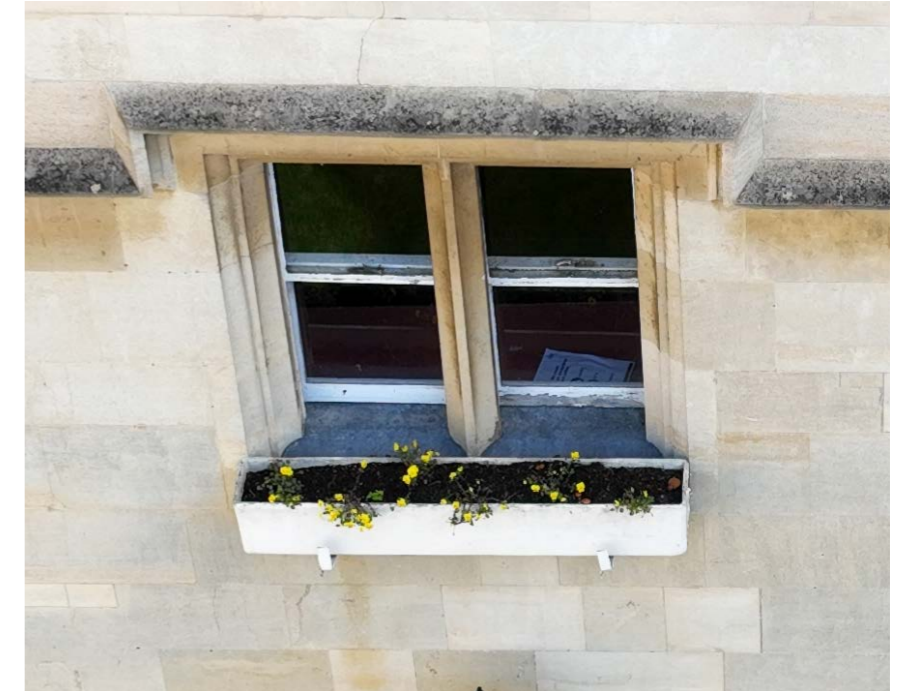
Drone survey image of typical sash window in Old Quad, showing need for redecoration

The repair works for the windows are described in detail in the window schedule (2313-PR-5100) in order to give context to the secondary glazing proposals. This schedule of works has been developed based on a detailed condition survey, produced by Bidwells. The proposals include redecoration, restoration of windows which are painted shut or otherwise inoperable, repairs to ironmongery and replacement of cracked panes.

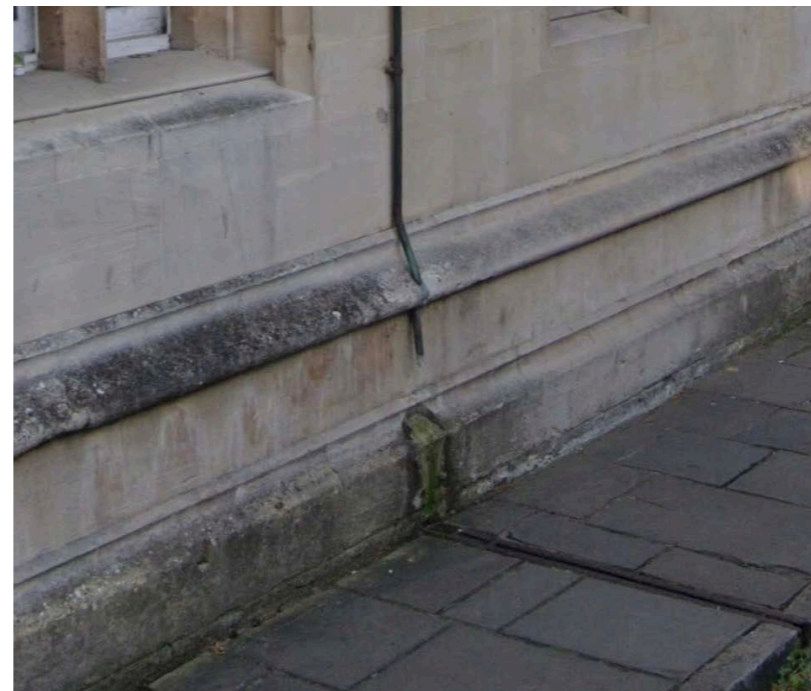
A rainwater pipe on the north elevation requires a short extension in order to prevent soiling and saturation of the stonework. The repair will be made with like-for-like materials.

Rainwater pipe requires extending to prevent soiling / saturation of stonework

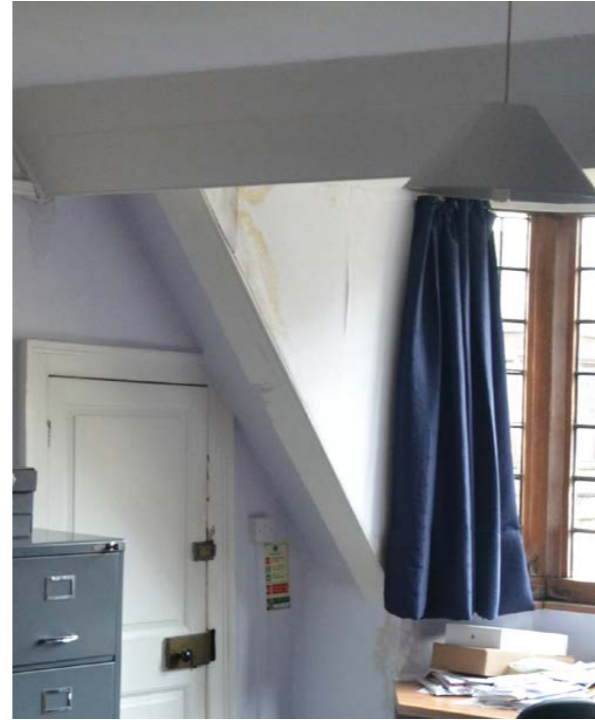
The large timber dormers facing into Old Quad are in particularly poor condition. There is evidence of water ingress through the windows themselves as well as at the junctions between the cheeks and roof of the dormer and the slate roof, and the sills and lower portion of the windows are badly rotten externally.

Staining indicating internal water ingress at junctions around dormer windows

After careful consideration, it is proposed that the dormers be replaced rather than repaired. The following factors have been considered:

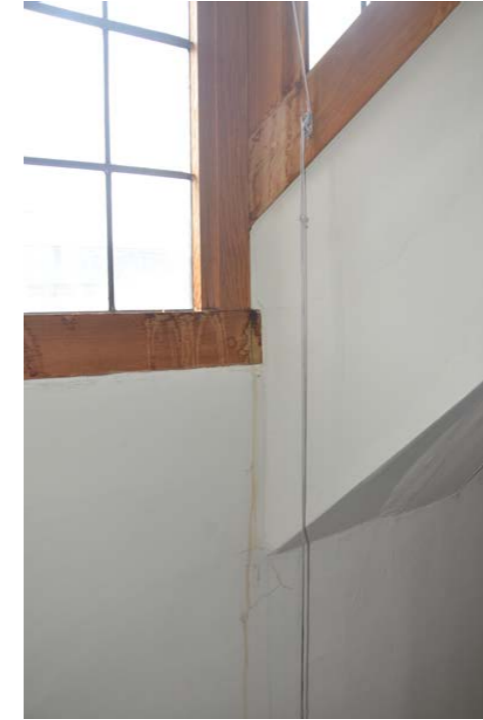
Staining indicating internal water ingress around window panes

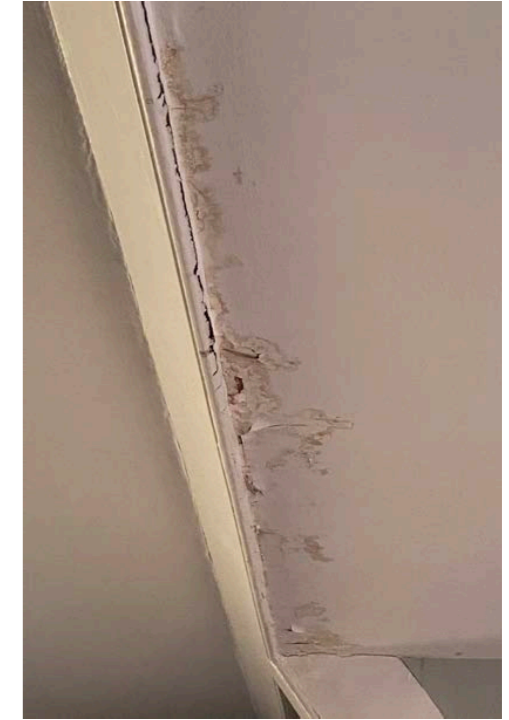
Evidence of water ingress at junction between dormer and roof

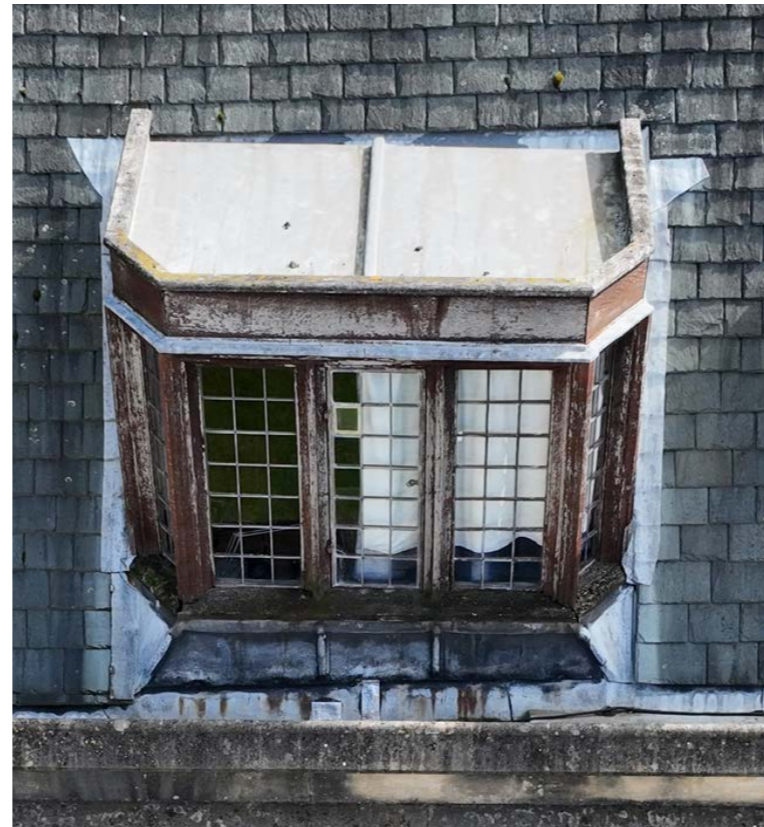
Drone survey image of large timber dormer in Old Quad, showing severe rot to the sill and lower part of the structure and poor protection of parapet detail

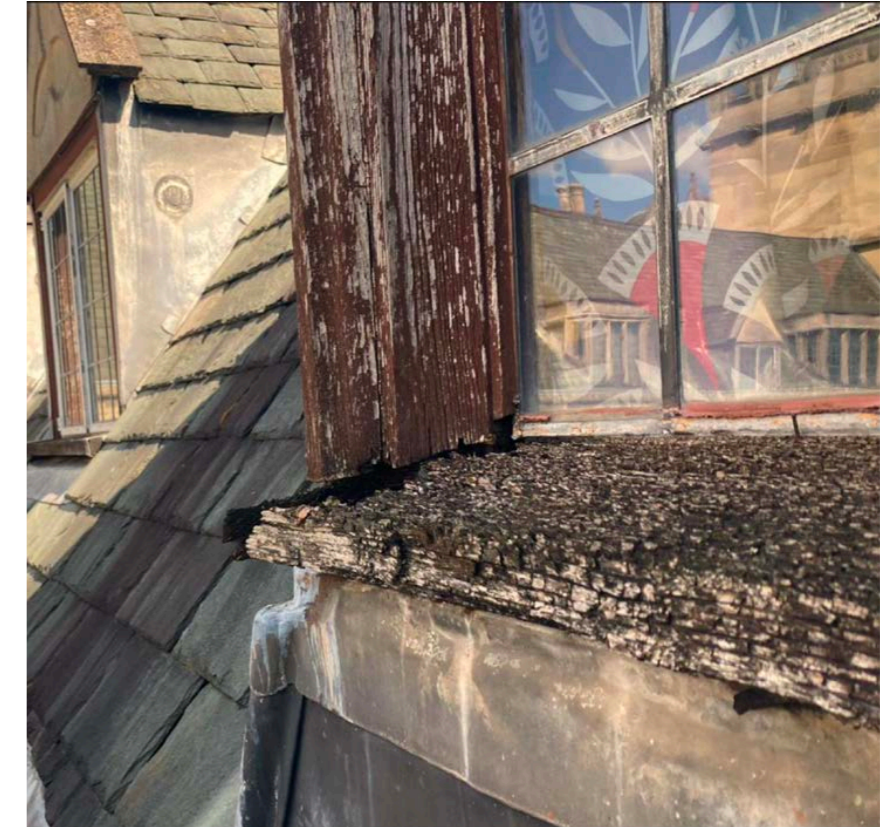
Close up showing severe section loss and deep fissures to sill

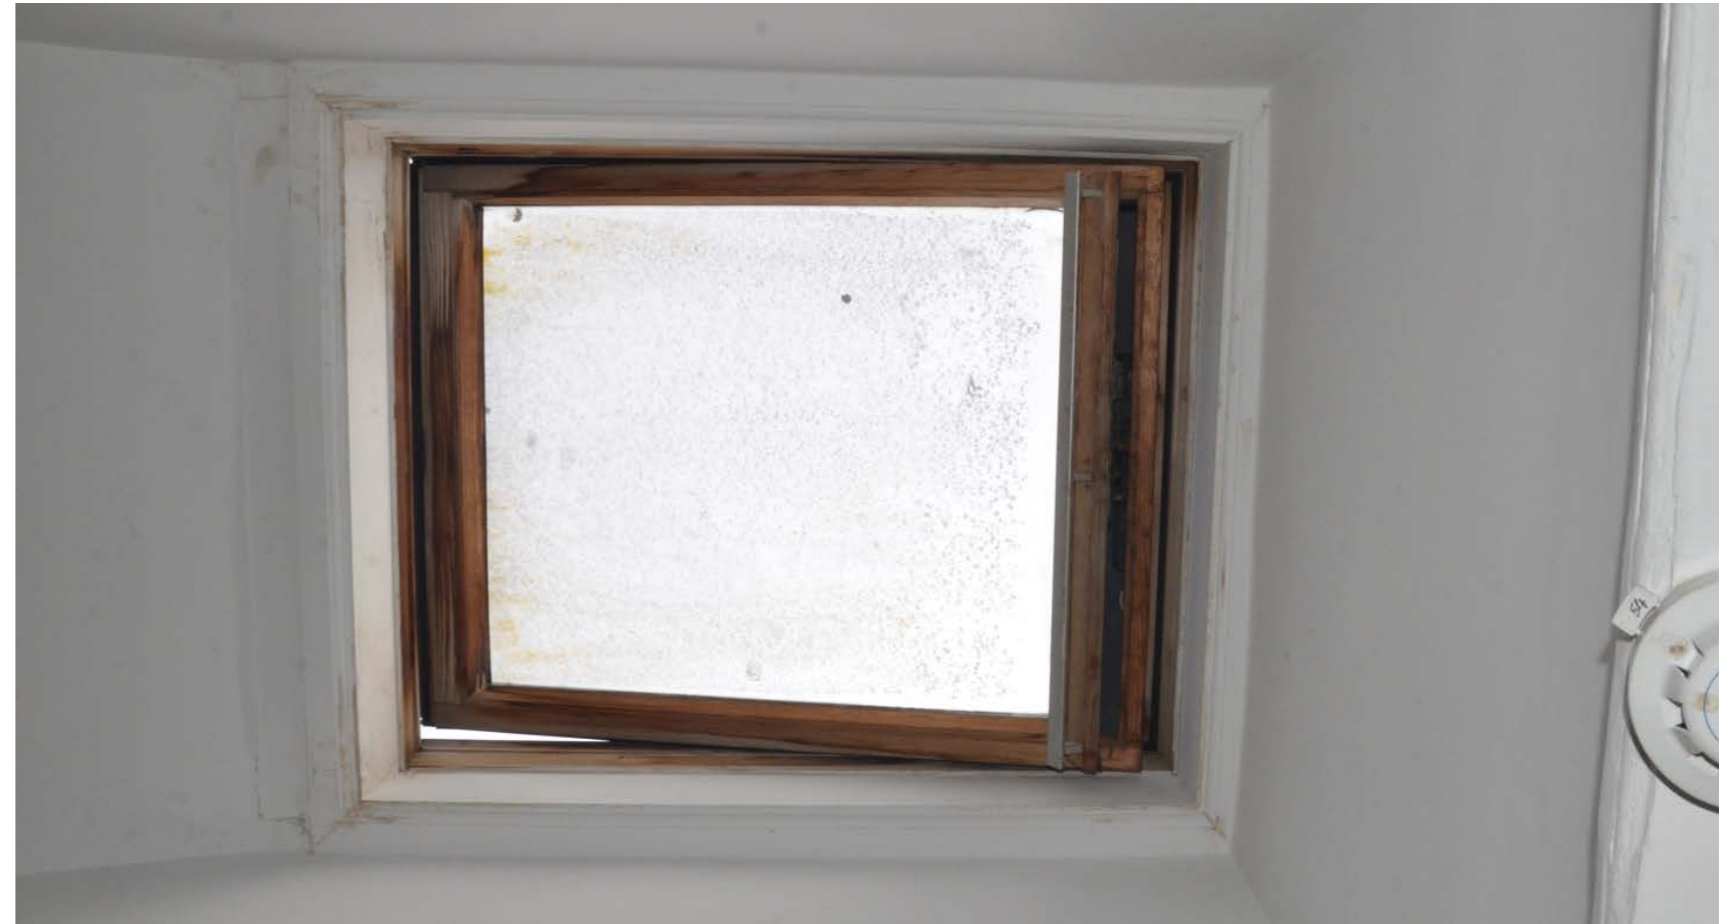
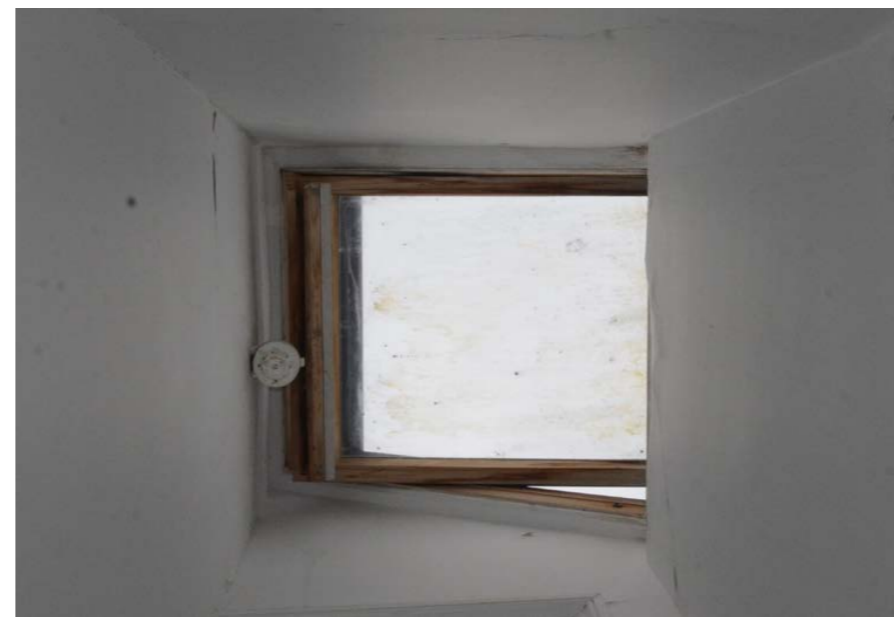
Rooflight Type 1 covers modern timber / aluminium composite rooflights. These do not have any heritage significance. There are two of these rooflights, and they are located within the circulation of Staircase 8. Both rooflights are water damaged internally and it is proposed that they be replaced.

Rooflight Type 1 within Staircase 8 circulation

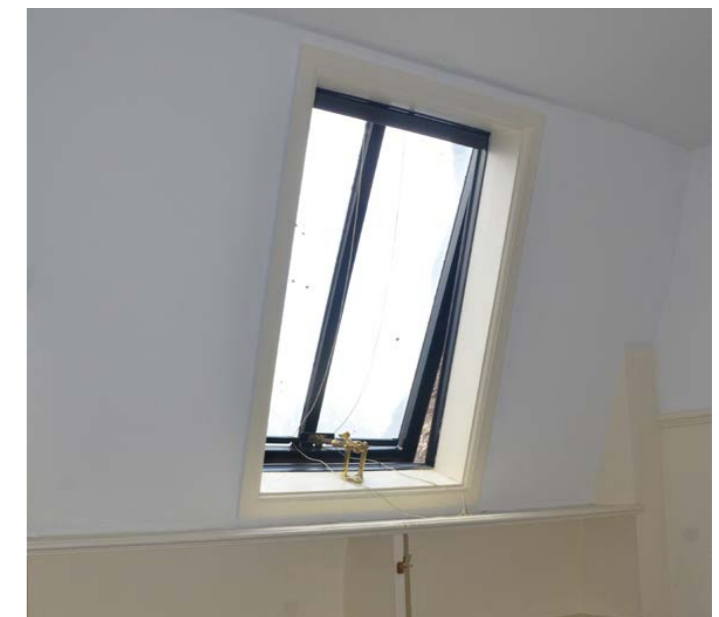
Rooflight Type 2 covers modern metal-framed rooflights. There are three of these rooflights, located within bedrooms in Staircase 8. These rooflights are double glazed and appear to be in good condition, so it is proposed that they be retained.

Rooflight Type 2 within bedroom at top floor of Staircase 8

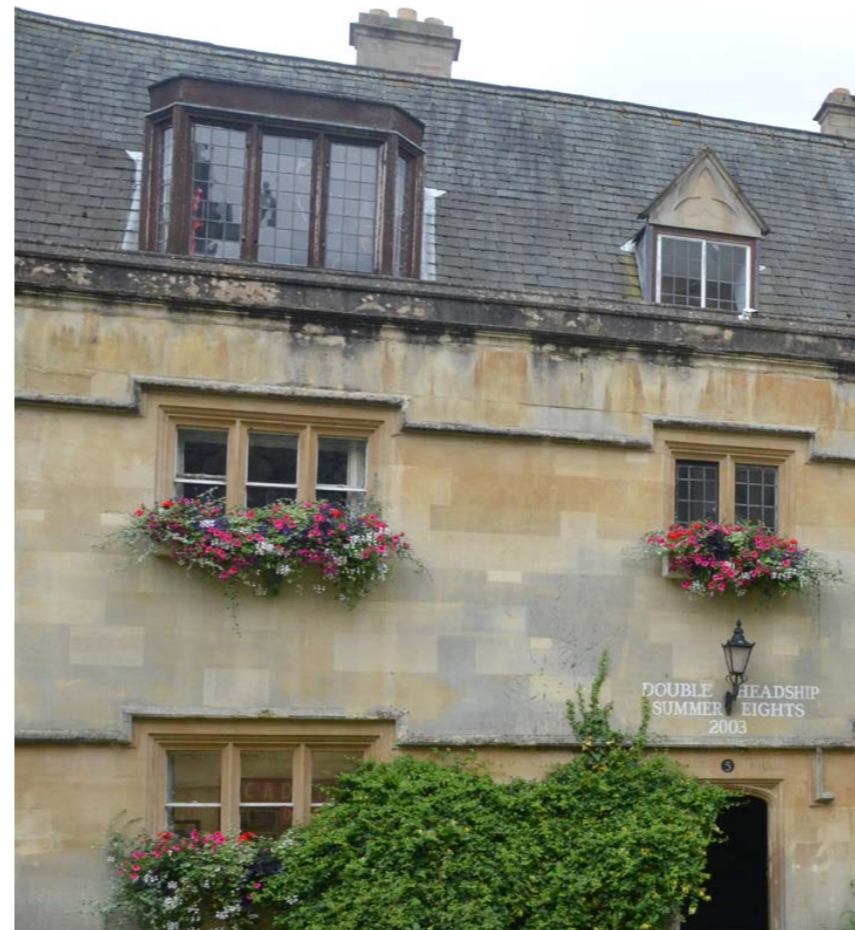
The stonework within Old Quad and the SCR Staircase has atmospheric staining and water staining. It is proposed that this is carefully cleaned. A cleaning methodology will be developed at a later stage with an appropriate contractor. The methodology will be tested on a trial area before being applied to the rest of the facade.

Staining to stone parapet around Old Quad

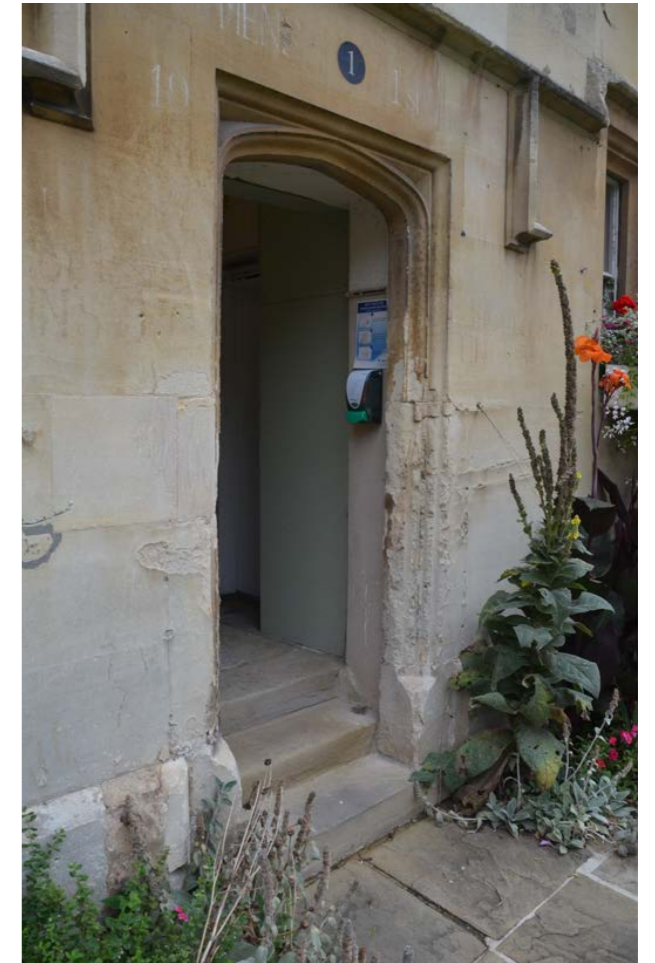
Erosion of stonework around Staircase 1 door

There are also various areas where stonework has been eroded by weathering. It is proposed that erosion at low level around the entrances to staircases (particularly Staircase 1) will not be repaired, because repairs are not structurally necessary and it is best to avoid replacing the historic stonework. However, blown faces at high level will require local repairs to avoid any risk of masonry falling from height. There are already a significant number of patch repairs to stonework, so it is proposed that the additional blown faces be repaired in the same manner.

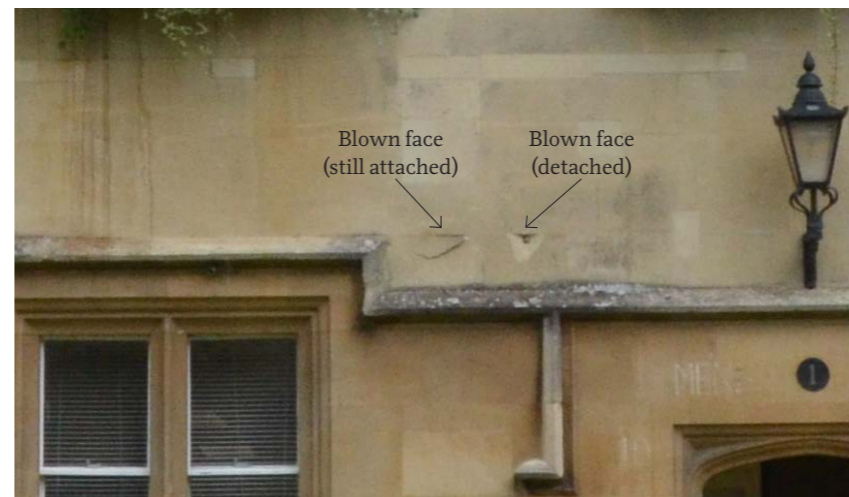
Examples of blown faces

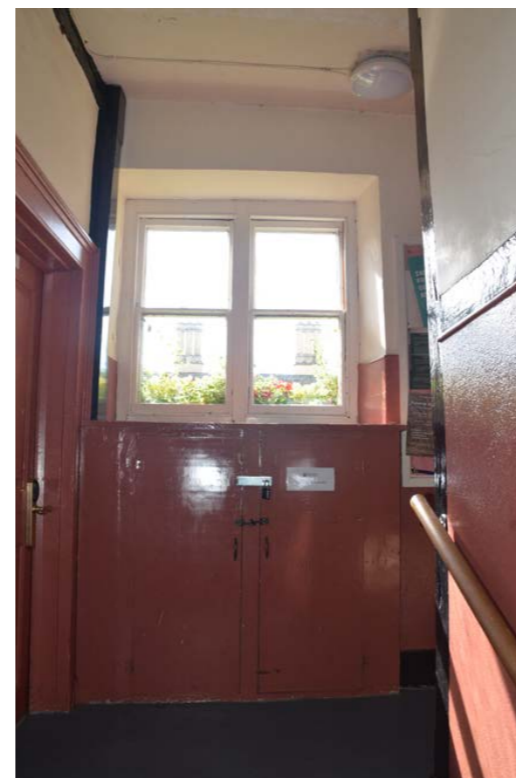
Scouts’ cleaning cupboard in Staircase 3

In various locations, there are scouts cleaning cupboards within staircases. These are of modern construction. Low level cupboards will be removed. Full height cupboards can be replaced with fire rated partitions and doors.

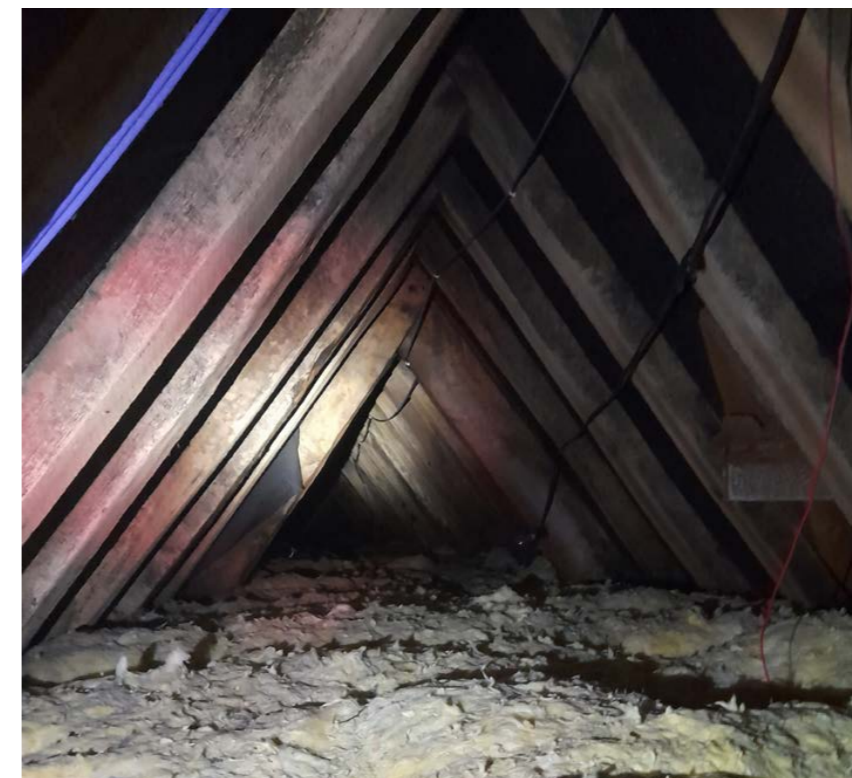
The loft void is currently completely open and interconnected between Staircases 3-7. This creates a possible route for fire spread. It is proposed that two new plasterboard partitions should be installed to provide fire compartmentation. This measure will protect the historic fabric from damage, and would be reversible if necessary.

Continuous loft void

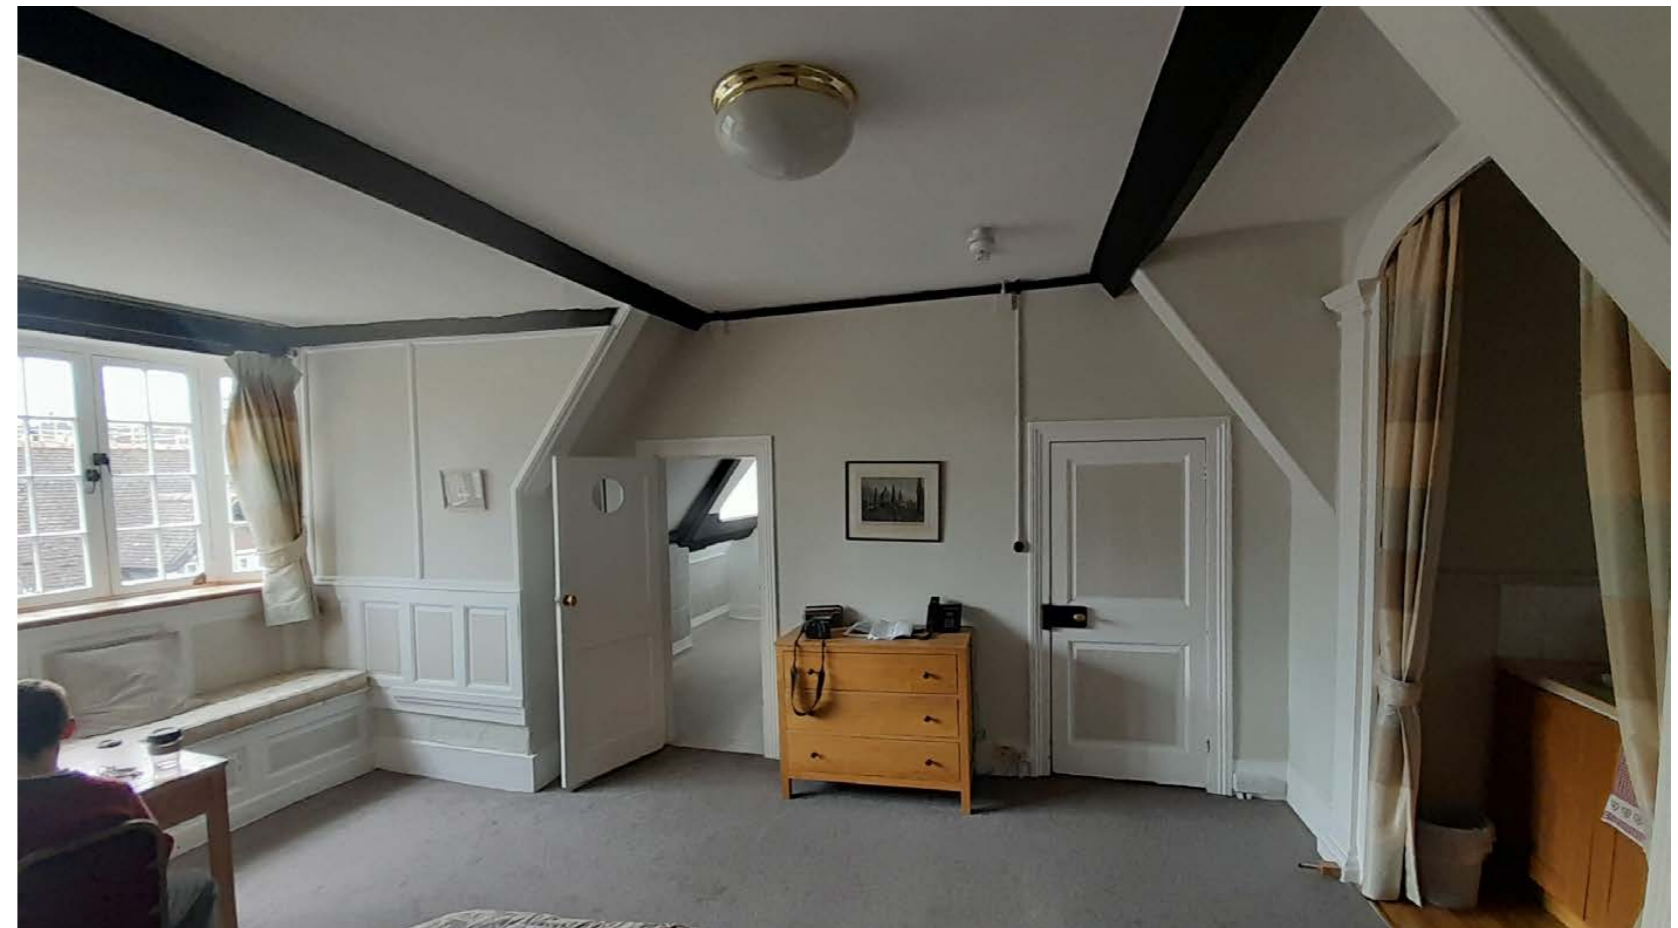
Guest bedroom 4.6, isolated at the top of a staircase of offices

For fire safety reasons, the guest room at the top of Staircase 4 (4.6) needs to be removed. The College has requested that this be replaced with a room of equivalent status and quality. Room 2.1 has been identified as a suitable location. The large size of this room and the presence of historic timber panelling make it a suitable replacement for room 4.6 as a 'prestige' guest room. Room 2.1 is a greatly preferable location from a fire safety perspective, because it is closer to ground level and is within a staircase with fire doors.

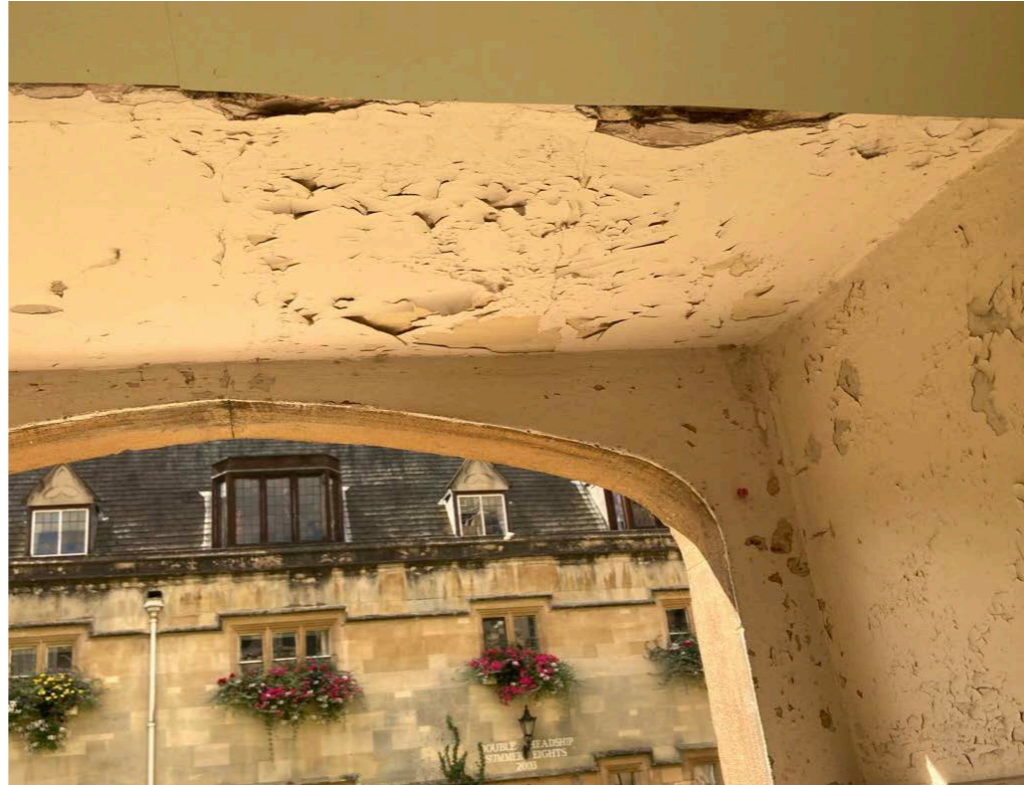
Weathering above door entrance, which has exposed the timber lintel

The structural repairs are detailed in full in the Structural Investigation Report.

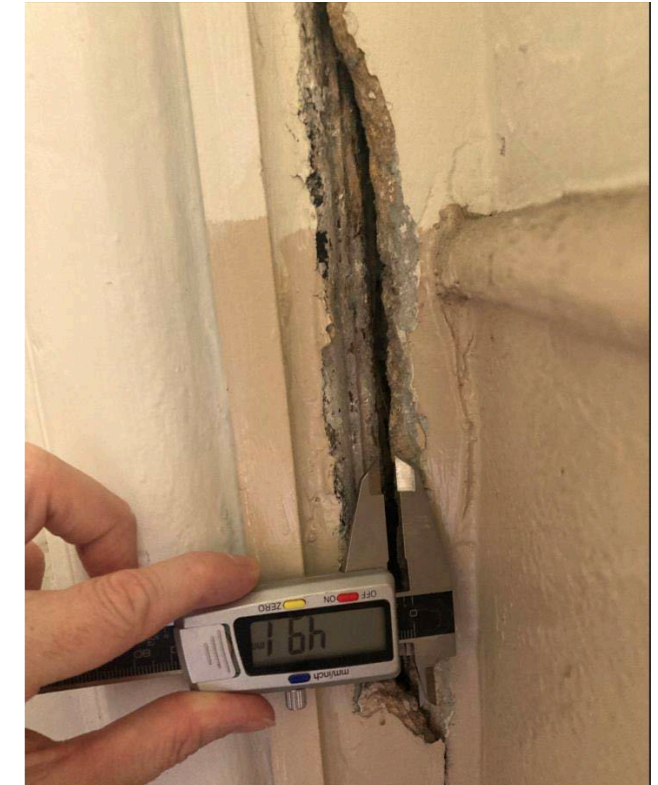
Staircase 4 - deep crack between internal and external walls

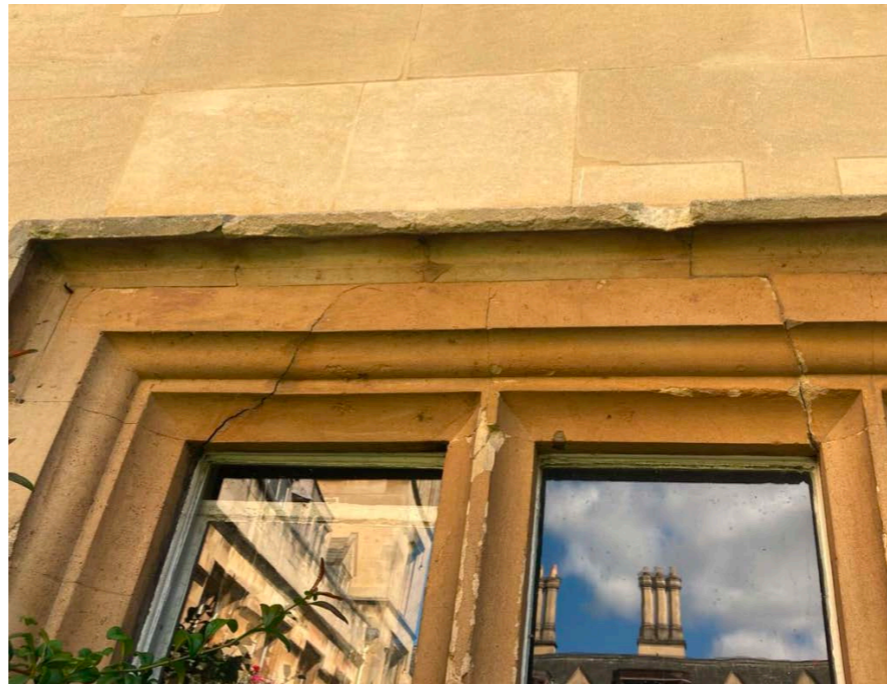
Crack in external stonework

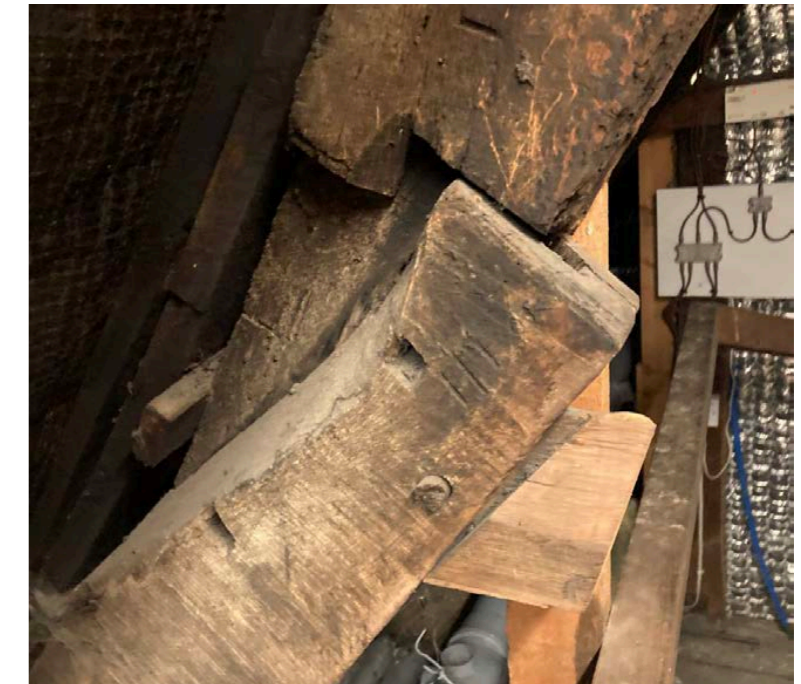
Damaged rafter within loft above Staircase 2

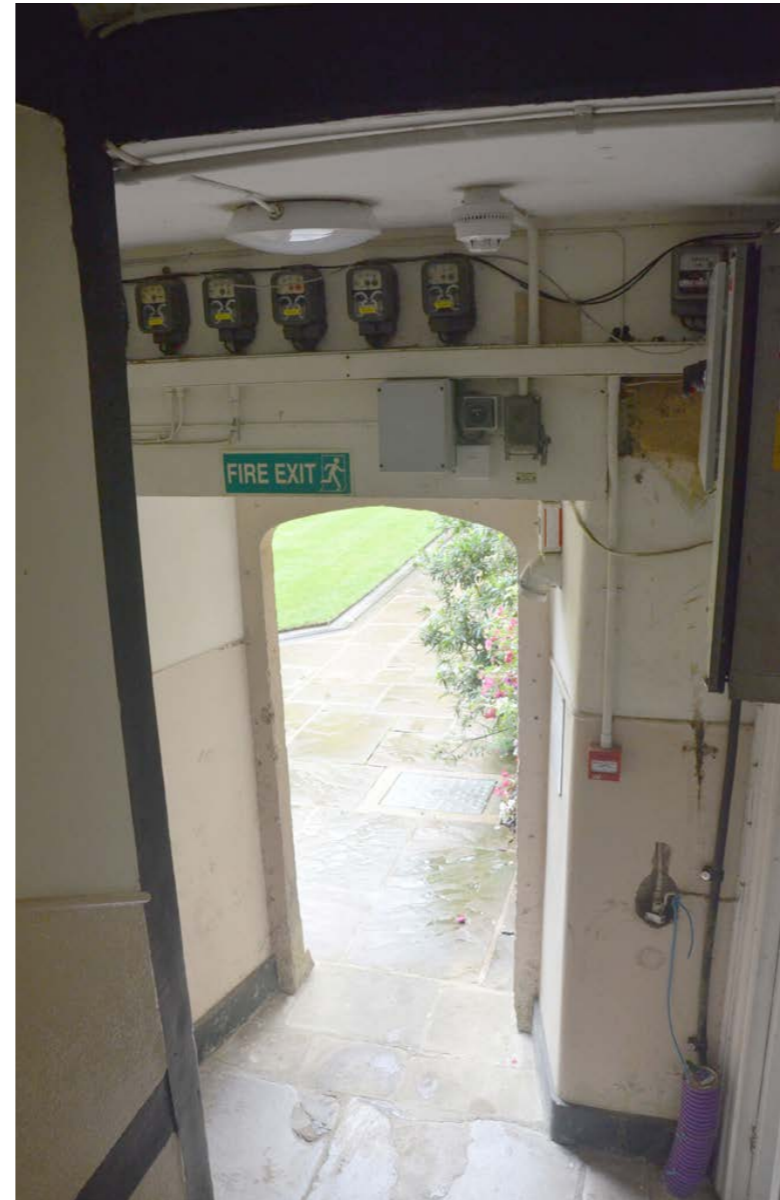
Unsightly electrical installations around Staircase 4 entrance

Exposed services installations above entrance doors will be boxed out within joinery. New room signage is proposed throughout, which will help to introduce consistency between the staircases.

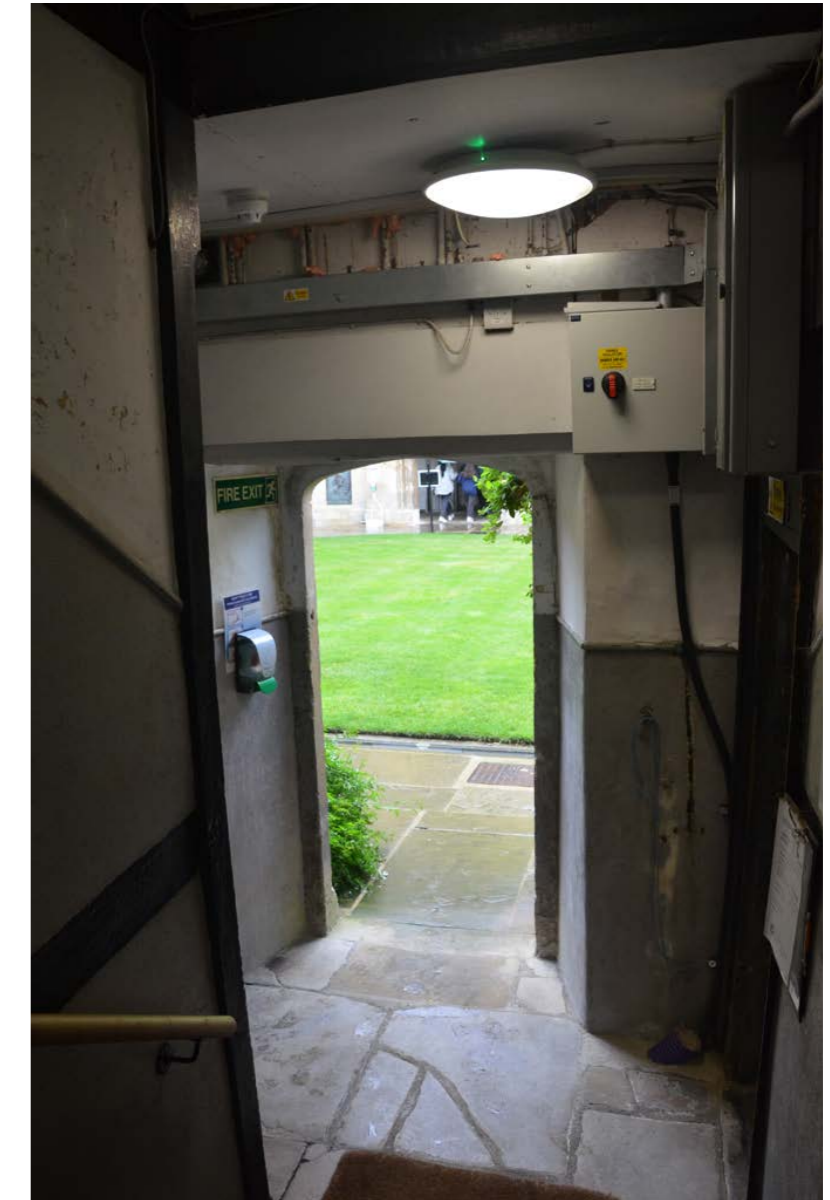
Unsightly electrical installations around Staircase 5 entrance

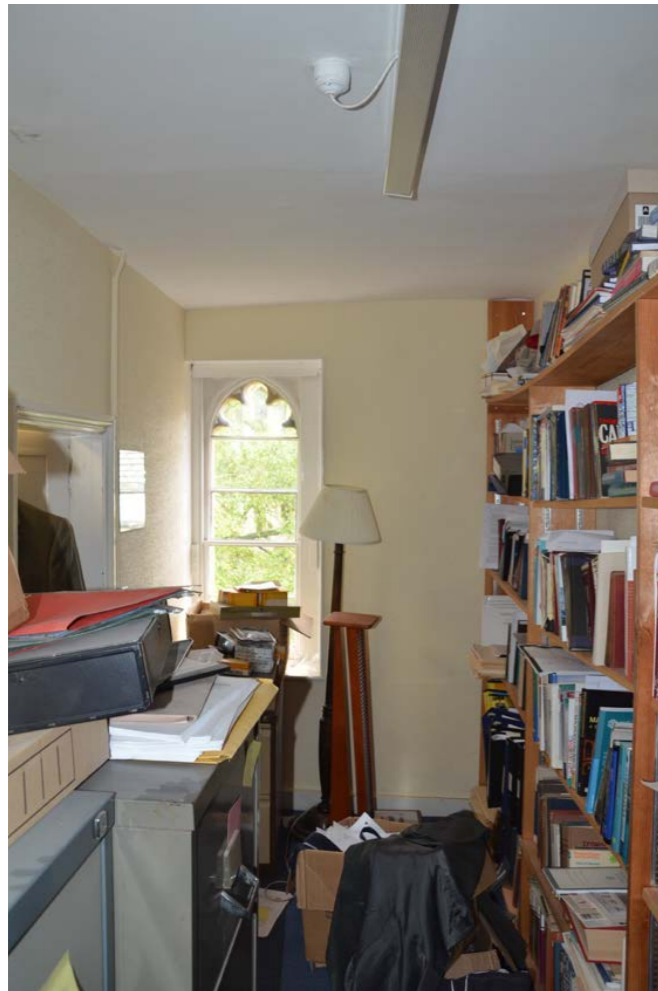
Example of a former bedroom being used for general storage
