**REPLACING END OF LIFE  
COPPER ROOF COVERING**

**EAST RANGE ROOF**

**EAST RANGE, OLD QUAD  
BRASENOSE COLLEGE  
OXFORD  
OX1 4AJ**

**DESIGN AND ACCESS STATEMENT, HERITAGE ASSESSMENT,  
AND NOTES IN SUPPORT OF  
APPLICATIONS FOR PLANNING & LISTED BUILDING CONSENTS**

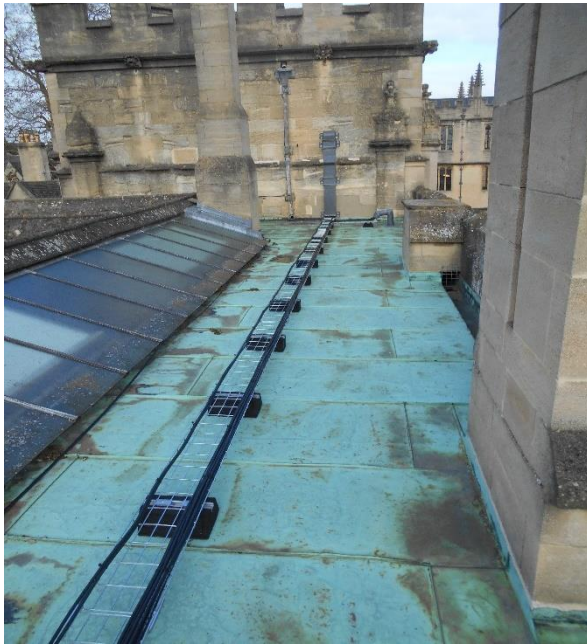
Photograph No 1

General view – towards the Tower of the ‘flat’ roof.

Note: If it is possible, the existing live data cabling trays will be incorporated within the replacement roof construction.

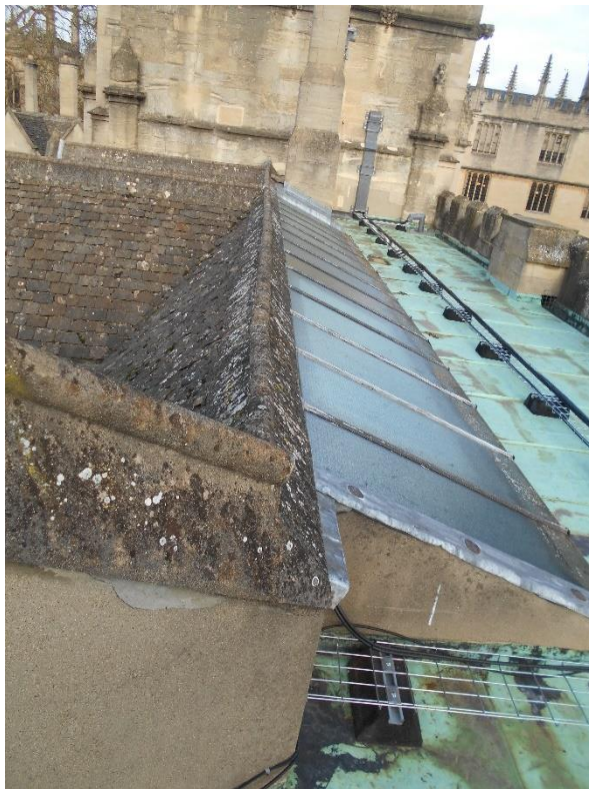
Photograph No 2

General view – mono pitched glazed roof. The second light shaft to the History Library can be identified in this image.

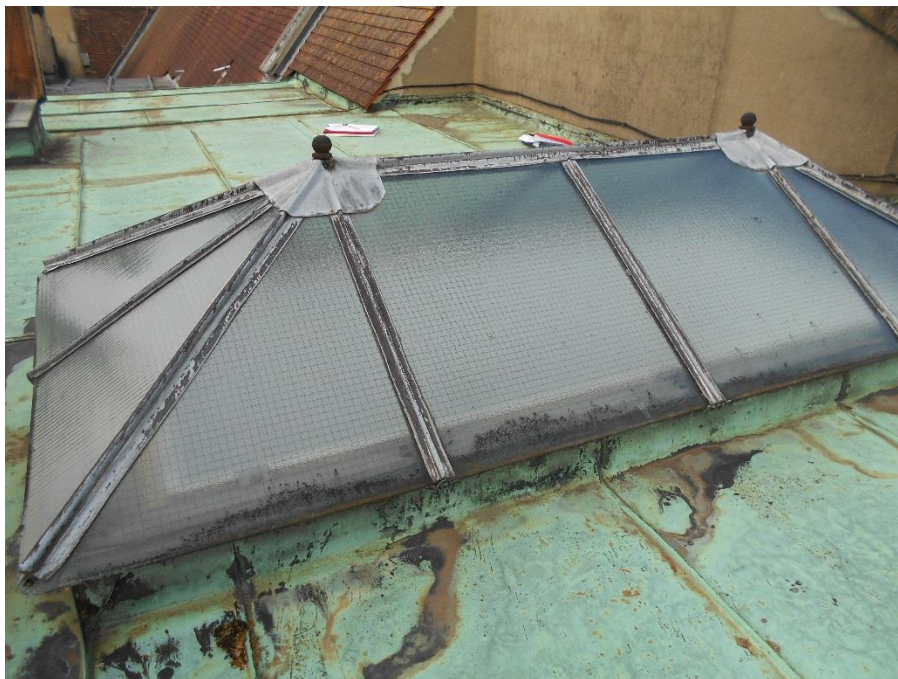
Photograph No 3

- 3.12 The modern metal framing serving both the roof window installation and also the lantern has corroded and the fittings leak.
- 3.13 Roof mounted data cabling and (stainless) steel containment is fixed over the roof covering.

Existing corroded Lantern – Atop the third light shaft into the History Library

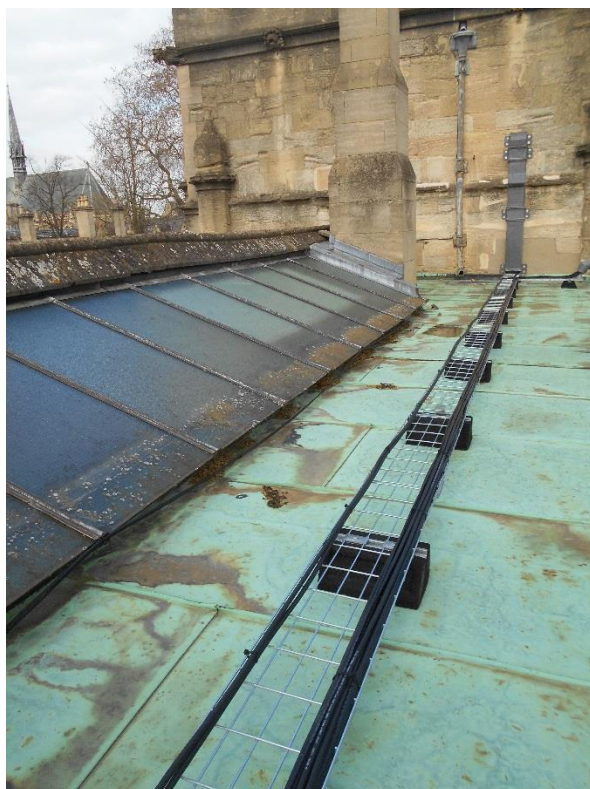
Photograph No 4

Image of the mono pitched corroded roof window which identifies the remaining light shaft into the current History Library below.

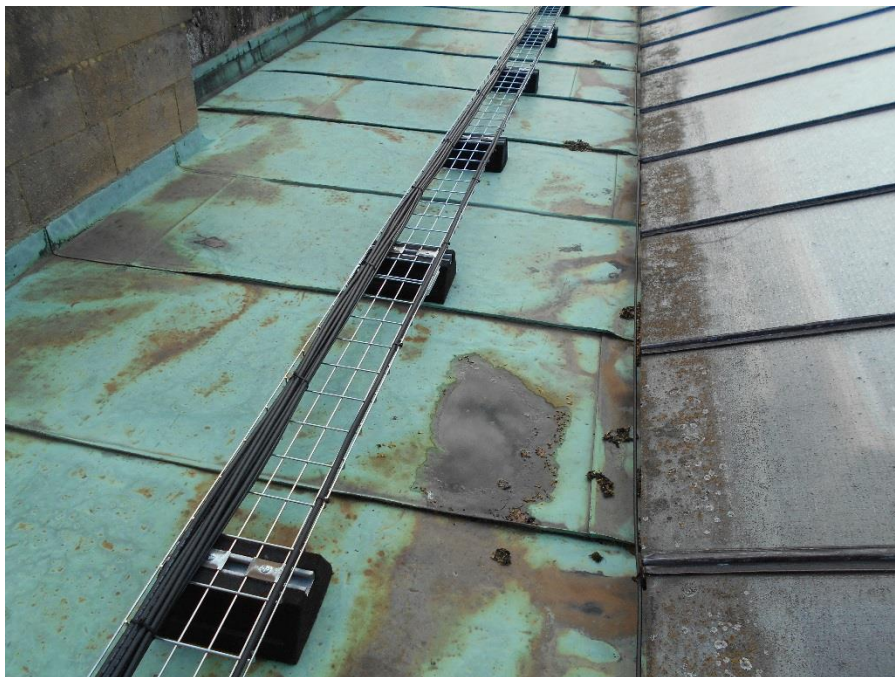
Photograph No 5

- 3.06 Water stands in various locations across the scope of the roof and the copper's patina coating is of different colours. The different coloured areas generally align with the locations where water will stand following rain.

- 3.09 An electronic measured survey of this roof commissioned by the College identified that the fall on the copper roof covering is less than 1 degree. It is in essence flat, pitched significantly lower than the minimum pitch at which this type of metal should be laid.

Water ponding on 'flat' surface and patchy patination.

- 5.01 The proposed works are detailed on the drawings listed in item 1.01 of this document.
- 5.02 The existing roof pitch is too shallow for the covering metal. It has impacted on its reduced life. The proposal is to introduce decking substrate on to the concrete roof slab to facilitate the minimum pitch for an insulated, ventilated copper roof covering to be installed by a specialist copper roofing contractor.
- 5.03 The existing wired glass mono pitched roof window and lantern installations are beyond repair due to corrosion. The proposal is to replace these installations with the clear, insulated safety glazed framed roof window and lantern installations detailed on the drawings.

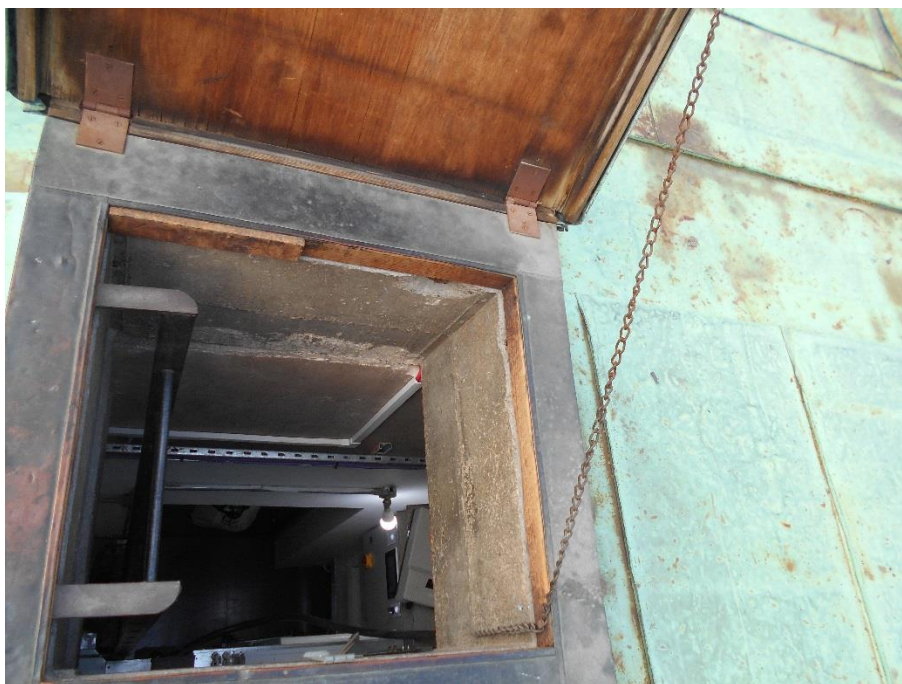
Photograph No 6

The existing roof access hatch.

- 5.05 Accessing the existing roof for maintenance is not straight-forward, and it is not possible to alter the current access arrangement without consequential impact. The maintenance hatch will be raised in line with the new pitch and, to improve safety for those who would be required to gain access to clear gutters in future, the proposed configuration will include a discrete ‘clip-on’ stainless steel wire line fall arrest system.

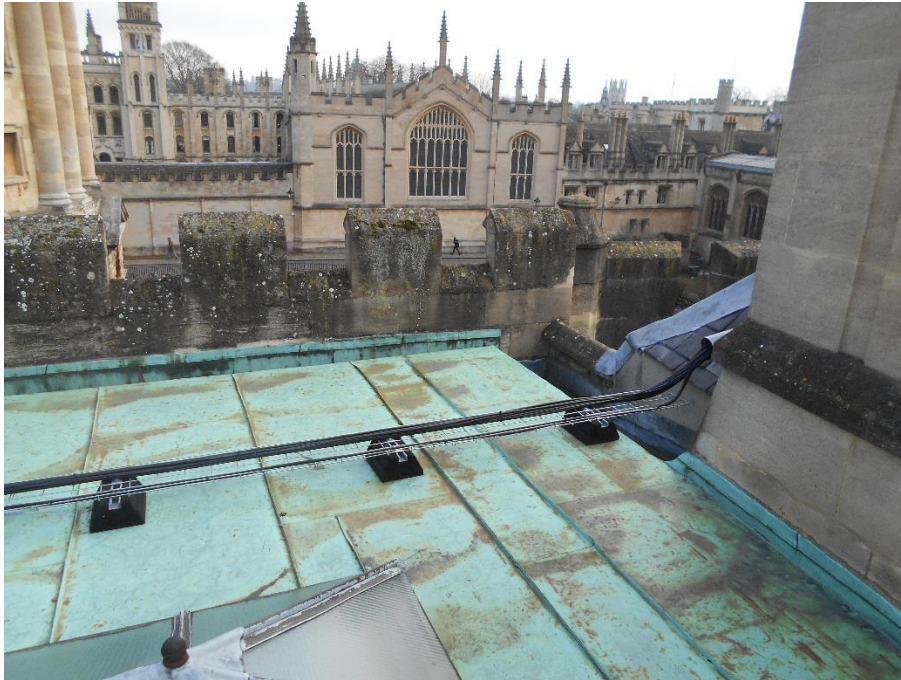
Photograph No 7

- 3.07 There are numerous locations across the roof where the surface of the bay copper is cracked.

Copper – Crazed surface No 1.

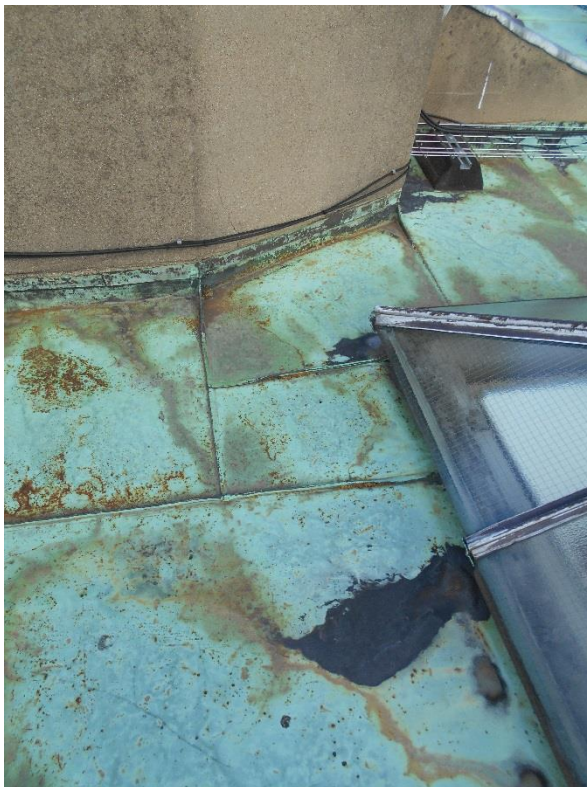
Photograph No 8

Copper – Crazed surface No 2.

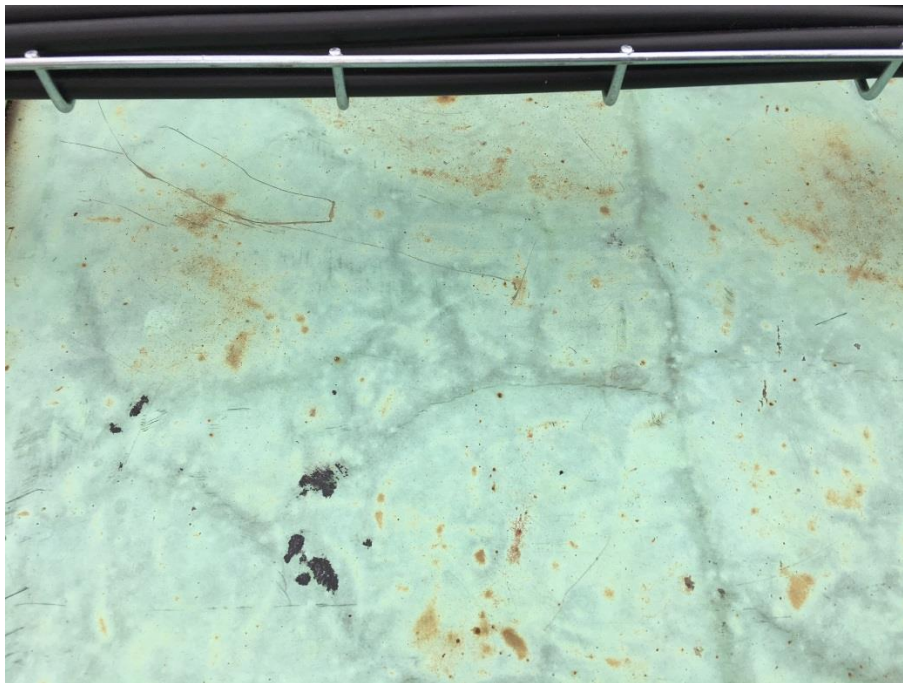
Photograph No 9

Copper – Crazed surface No 3 – Close up highlighting cracks in the surface of one of the copper bays.
