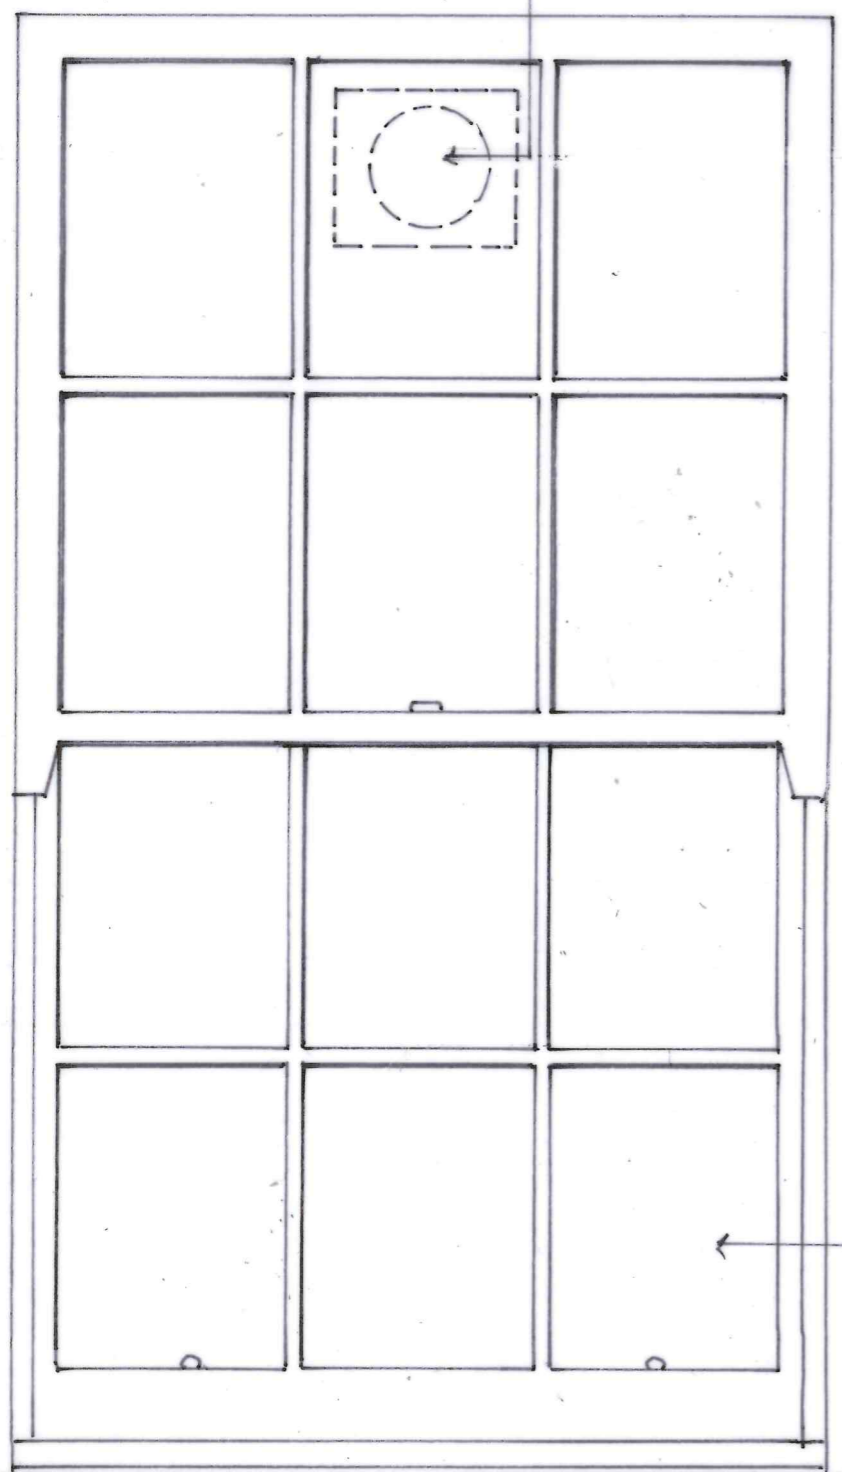
existing
Vent axia removed
