Land at Birchwood, Cadbury Camp Lane, BS20 7SA

Arboricultural Report containing:

On behalf of
Mr Martin Day

Prepared by:
Deb Randall BSc TechArborA
Arboricultural Consultant
April 2024

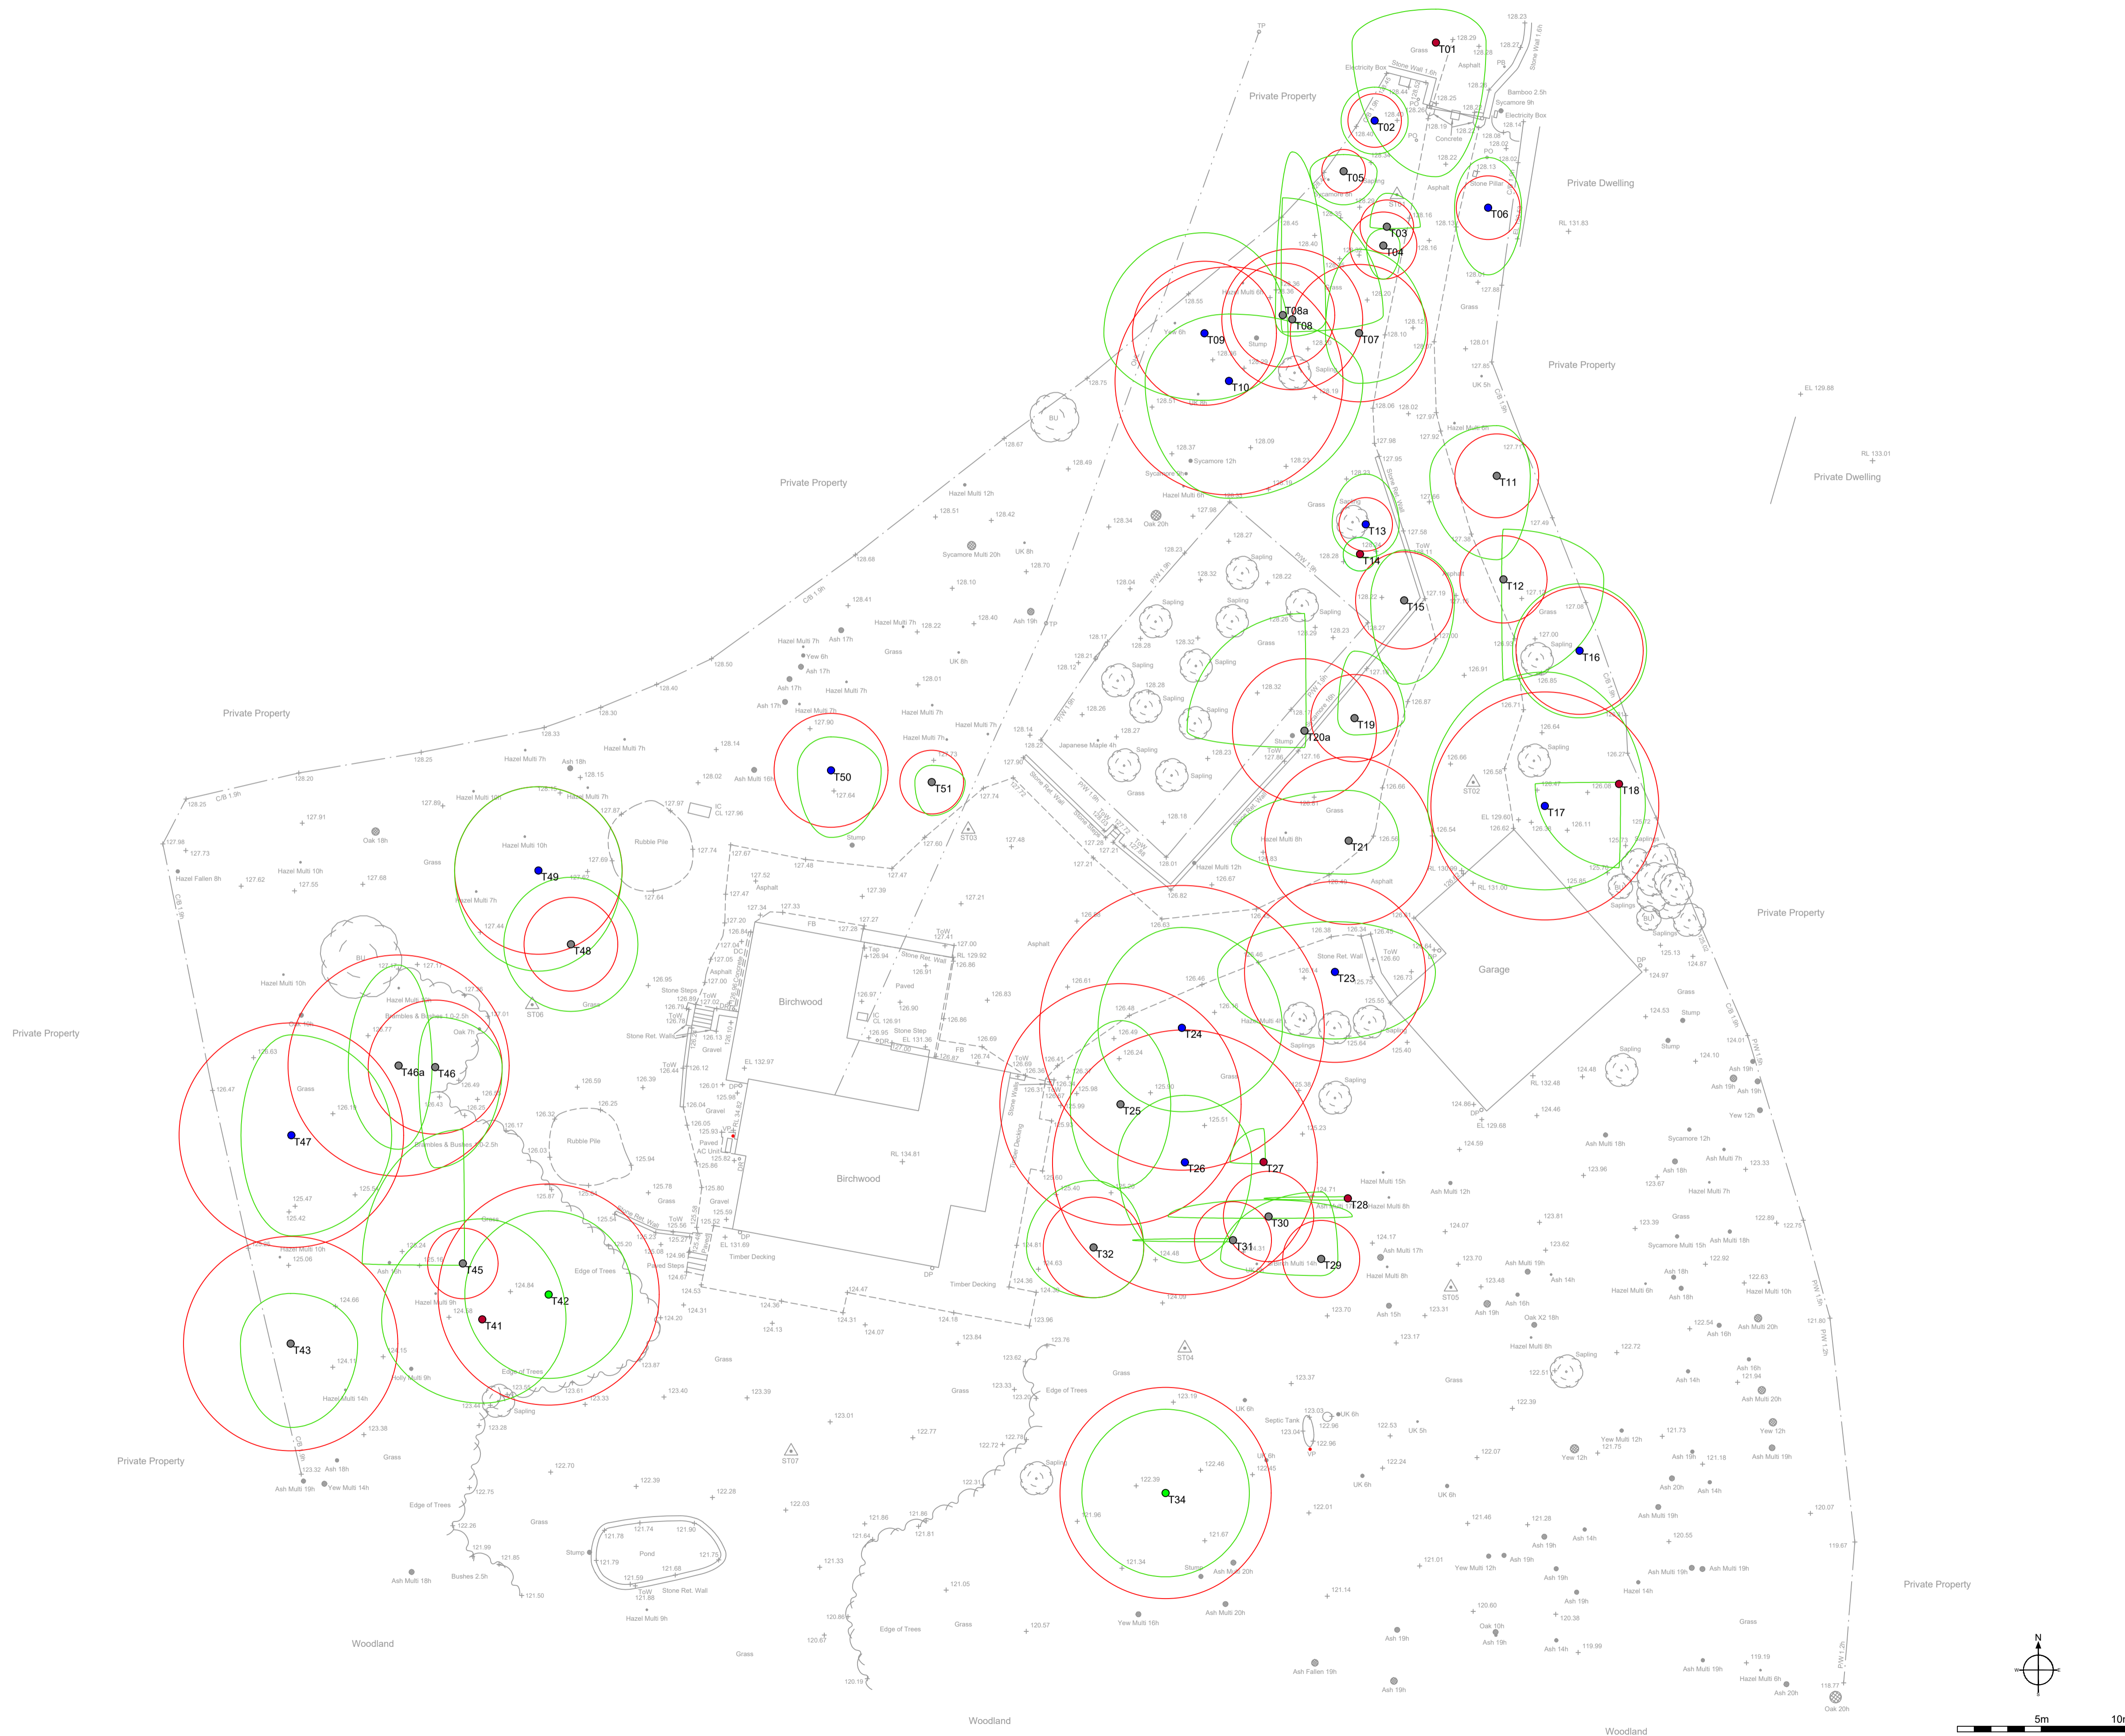
- 6.3 The Tree Constraints Plan (TCP), (appendix 2), shows the Root Protection Areas (RPAs) for the individual trees identified in the tree schedule tables. This represents the minimum area in m² which ideally, should be left undisturbed around each tree were it to be retained. The TCP/ AIA also shows a representation of the crown spread of each tree measured in four cardinal directions. The RPA has been calculated in accordance with Section 4.6 of BS5837:2012 Trees in relation to design, demolition and construction – Recommendations.

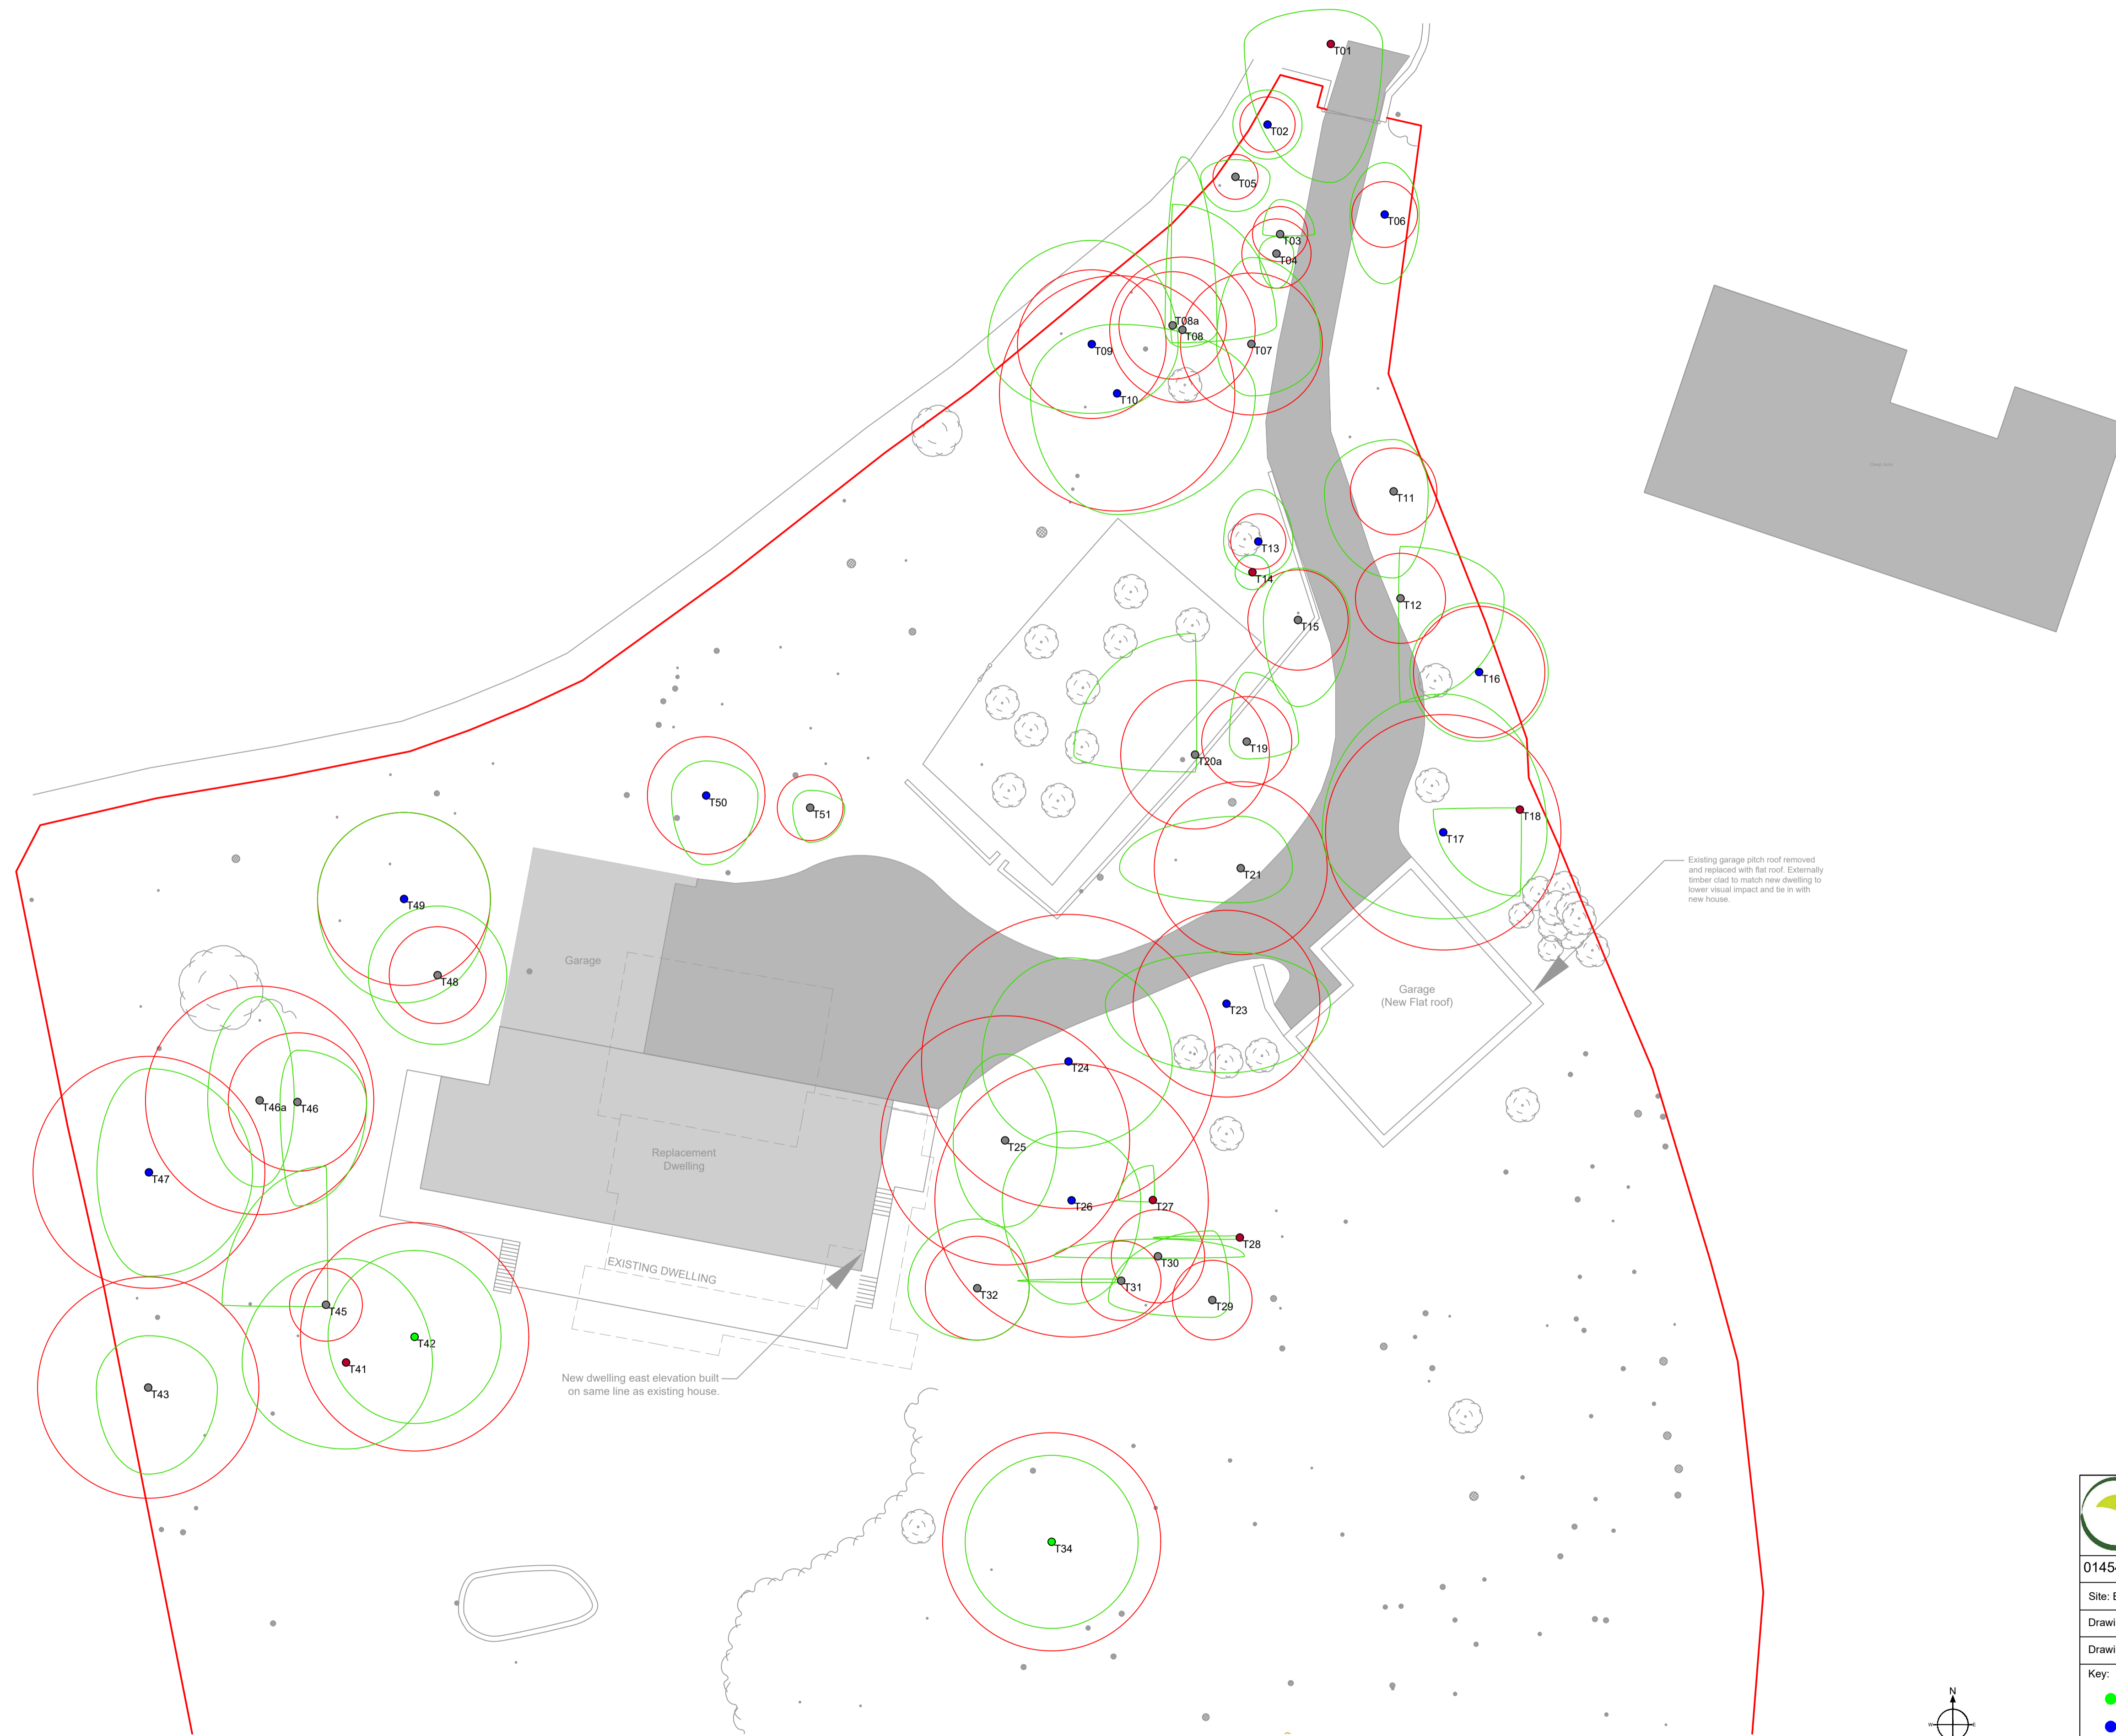
- 7.1 A small section of new hard surfacing is proposed within the calculated Root Protection Area of T25. Any excavation or soil compaction in this area could potentially lead to root severance or damage. This could subsequently lead to a reduction in the trees ability to take up water and nutrients, which may lead to a deterioration in the tree's health.

7.2 Working area will be required within the calculated Root Protection Area of T42 to facilitate the construction of the proposed development. Any soil compaction in this area could potentially lead to root severance or damage.
