An Arboricultural Method Statement at

Abbey Gardens  
Lady Lane  
Swindon  
SN25 2DW

March 2024

Prepared for Mr Peter Mapson

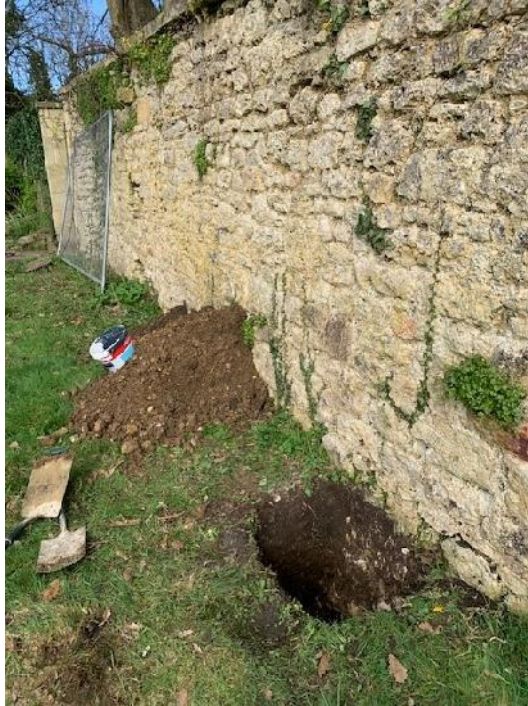
#### **Photograph 1**

### **Trial Pit Hole**

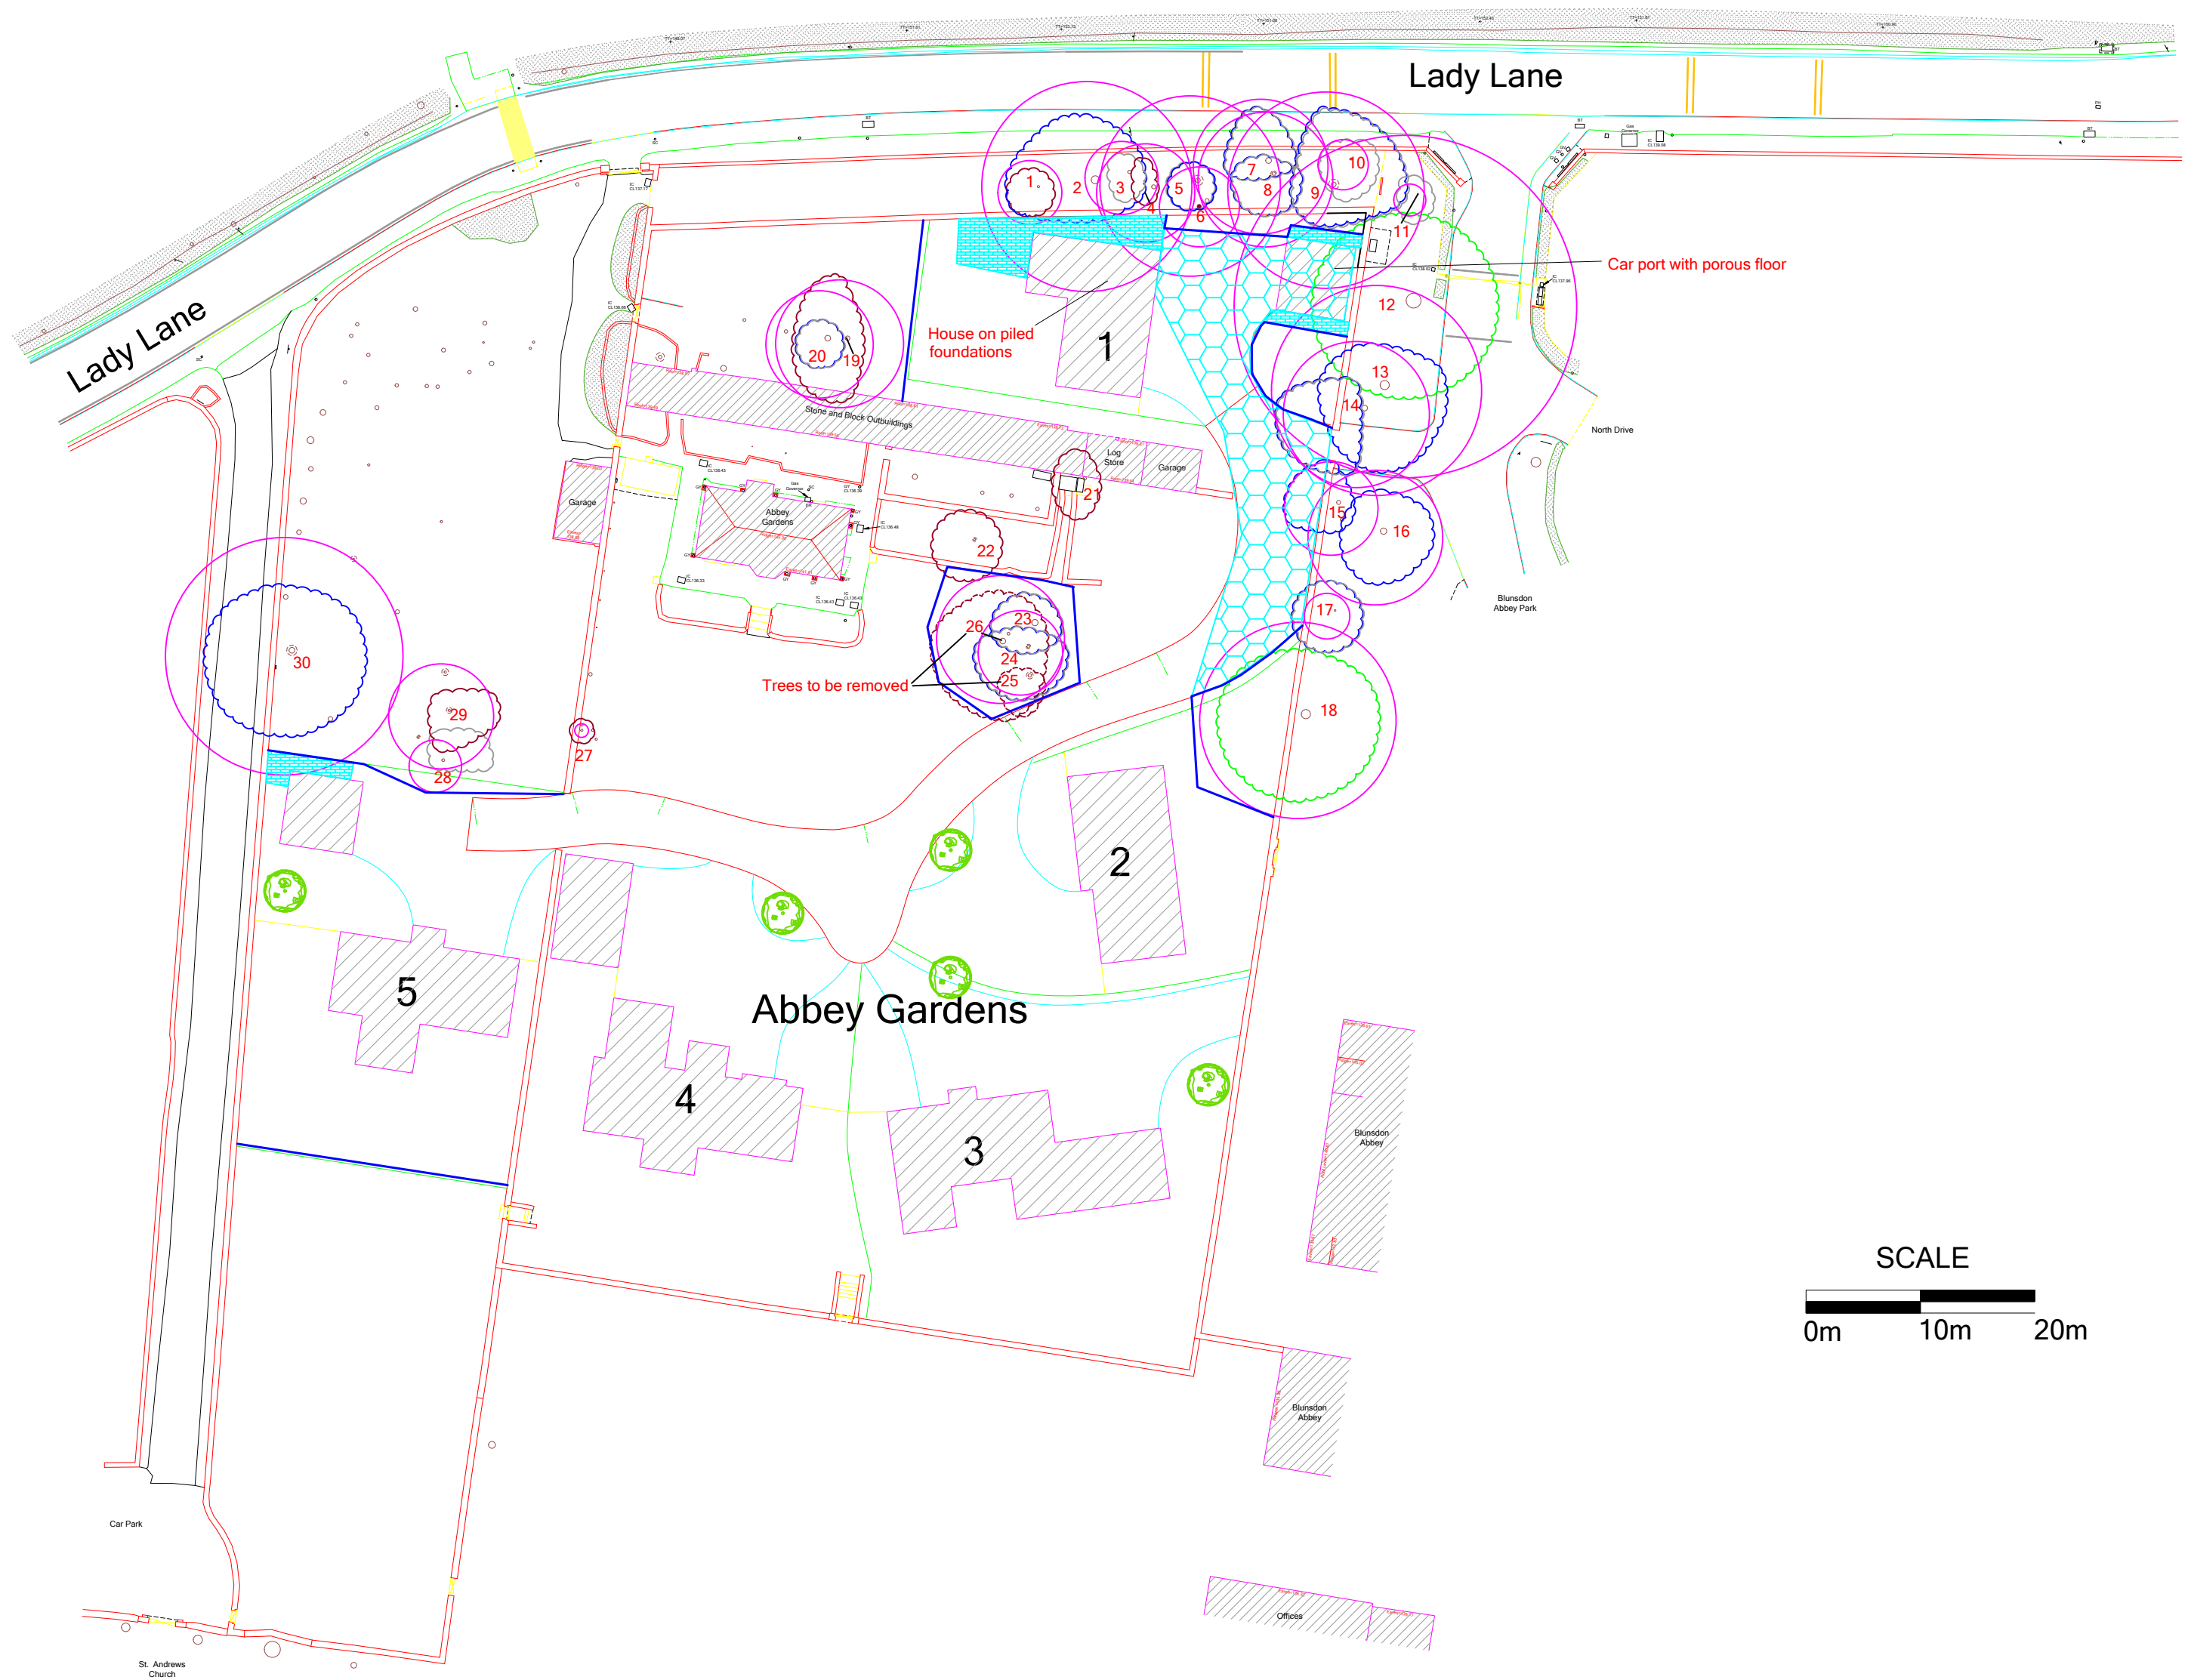
**5.1 Tree Protection Plan:** The included Tree Protection Plan, AG/TPP is designed to minimise the effects of the development and ensure that the trees to be retained will have an adequate volume of soil for future survival and growth. Areas requiring specific protection measures are hatched and labelled on the plan and detailed in **5.2.2** and **5.2.6**.

**5.2.2 Ground Protection:** In order to minimise damage to the roots and soil structure surrounding the neighbouring protected trees and to enable construction, it is proposed to use proprietary ground protection boards laid on a compressible layer such as wood chip. This is intended to be a temporary measure for the duration of construction. There should be no vehicular traffic accessing the site or across the RPA's except on these boards. The protection boards are to remain for the duration of the works. The areas requiring ground protection boards are marked on the Tree Protection Plan, AG/TPP. On completion of all construction work the sections of boarding on the new driveway may be lifted, and the new driveway will be constructed using the no-dig methods, as detailed in **5.2.6**. This is to prevent the construction traffic clogging the pore spaces created in the no-dig drive making it impermeable. The no-dig driveway will only be constructed on completion of construction work.

**5.2.6 No-Dig Driveway:** There is a portion of the RPA of Trees 5, 10, 12 and 15 that will be used as a driveway, parking area and car port, this will be protected by the ground protection boards for the duration of construction. On completion of all construction work the boards may be removed, and the driveway, parking area and car port will be constructed according to the methods detailed in Arboricultural Association Guidance Note 12, included as Appendix 6. Should any roots over 25mm in diameter or occurring in clumps be discovered then consultation with an arboriculturist will be required, as such roots might be essential to the trees health and stability.

- 5.4 Services:** There will be no installation of services either above or below ground in the RPA's.
- 5.5 Mitigation Planting:** It is proposed to plant 5 standard Silver Birch trees, in the locations indicated on the Tree Protection Plan AG/TPP, to mitigate for the loss of the removed trees.
- 5.6 Future Considerations:** The remaining trees should be inspected on a regular basis by a qualified Arboriculturalist.
