Works Specification:

Location Plan: Stokes bay Rd / Anglesey Rd Junction

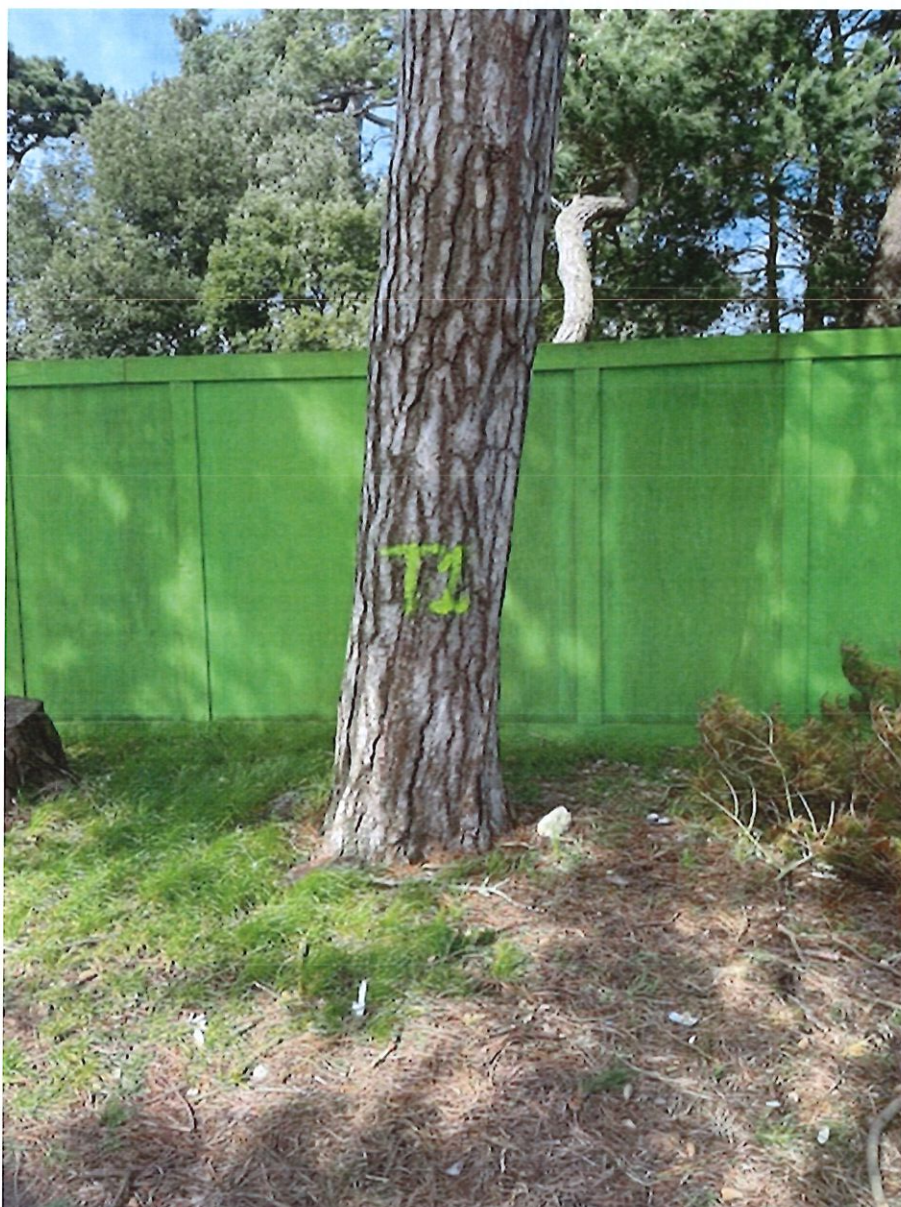
Image 1: T1 Dead Pine trunk / base

Position	Works required
<ul style="list-style-type: none"> • Junction Stokes Bay Road / Anglesey Road • W3W Ref: ///healthier.fund.gift 	<ul style="list-style-type: none"> • T1 Pine: Dead – Remove to ground level • Group 1: Crown lift all trees to min clearance of 3.5m from above ground level, remove all under-storey vegetation to min 1m clearance from footpath edge.

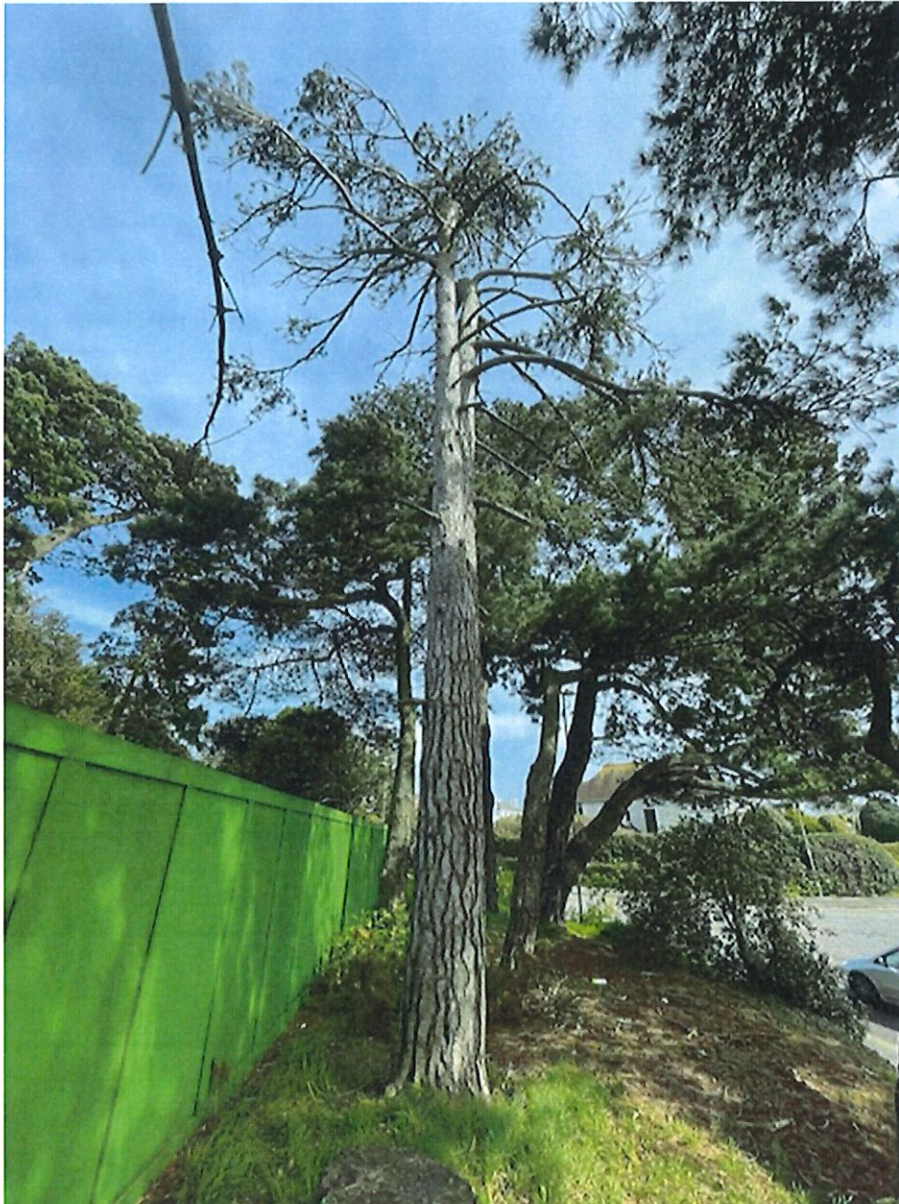
Image 2: T1 Dead pine

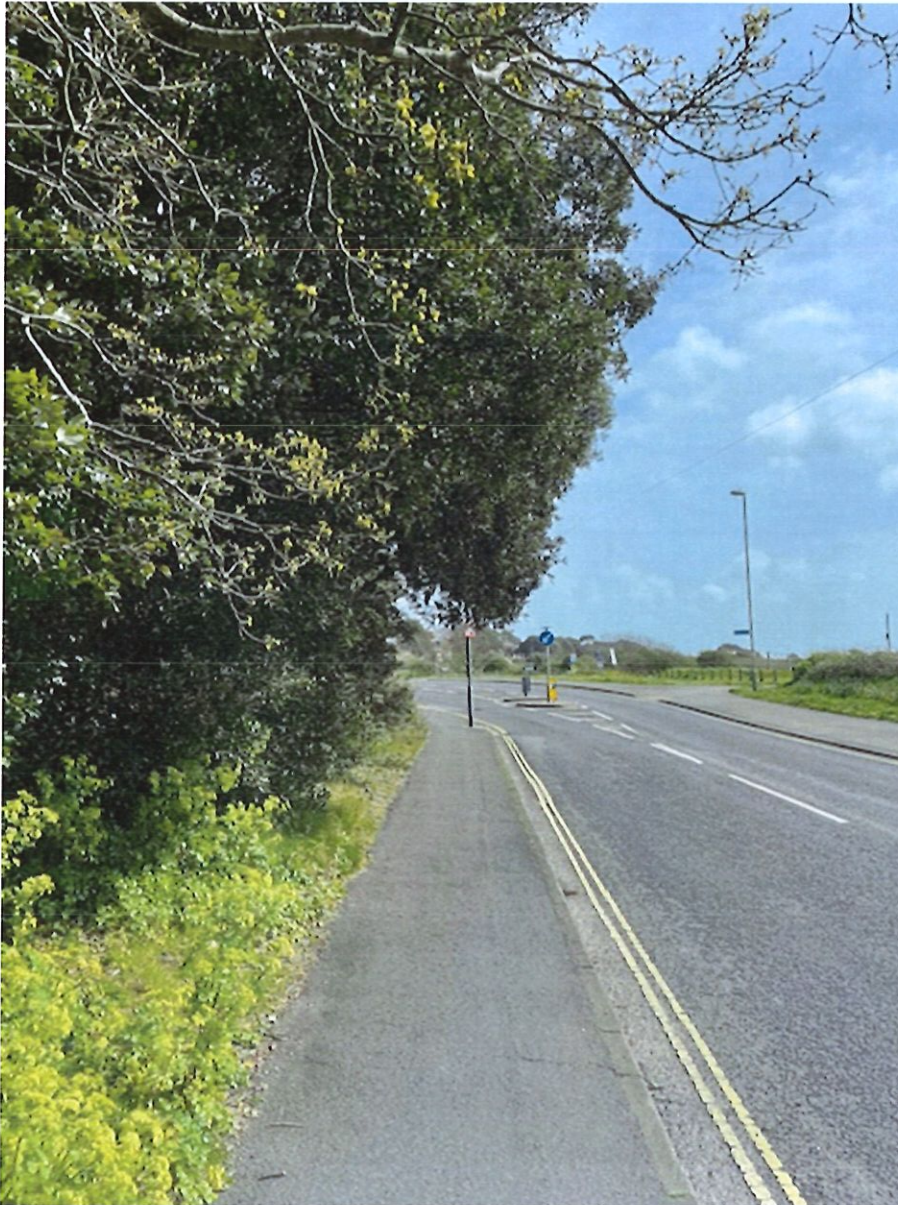
Image 3: Group 1 low trees and under-storey vegetation Stokes Bay Rd leading to roundabout junction with Anglesey Rd

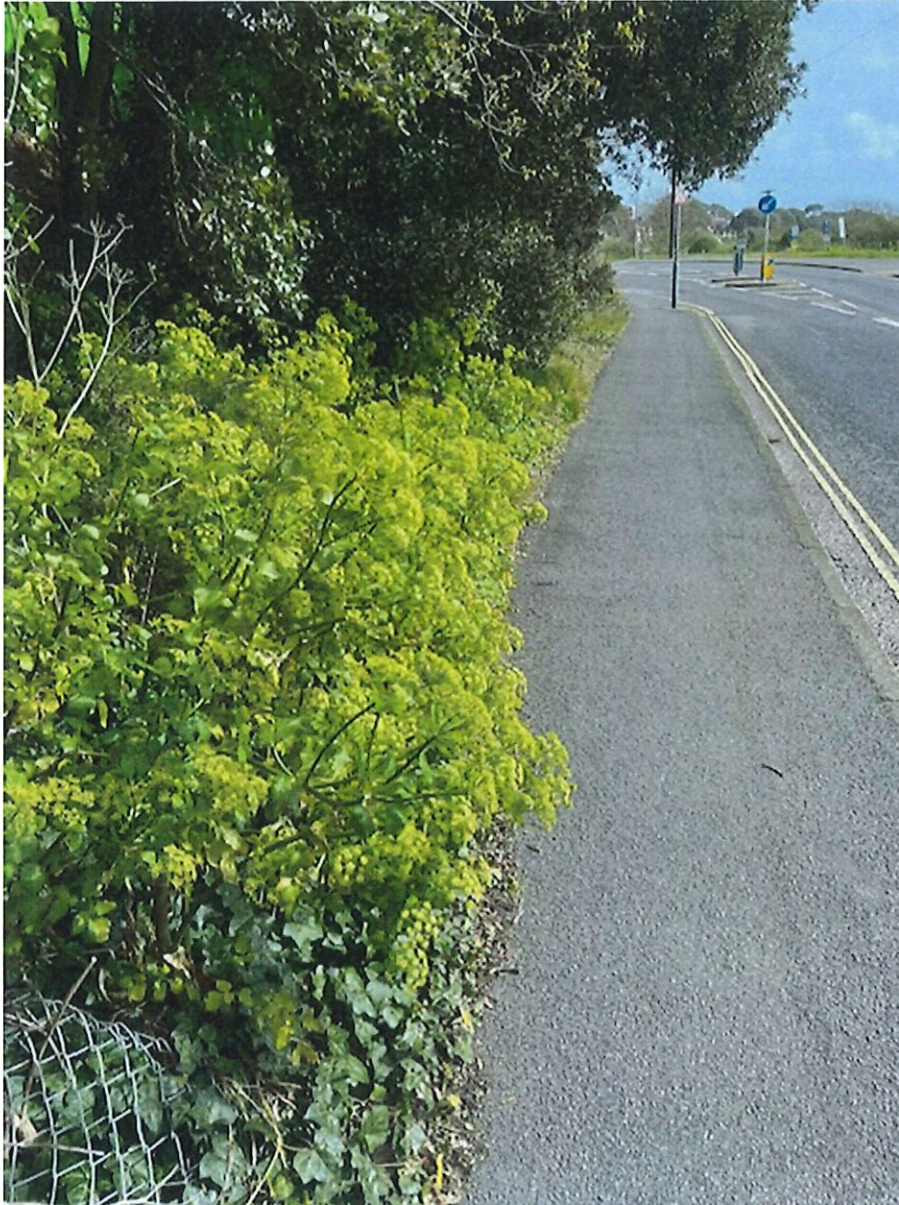
Image 4: Group 1 under-storey vegetation Stokes Bay Rd leading to roundabout junction with Anglesey Rd

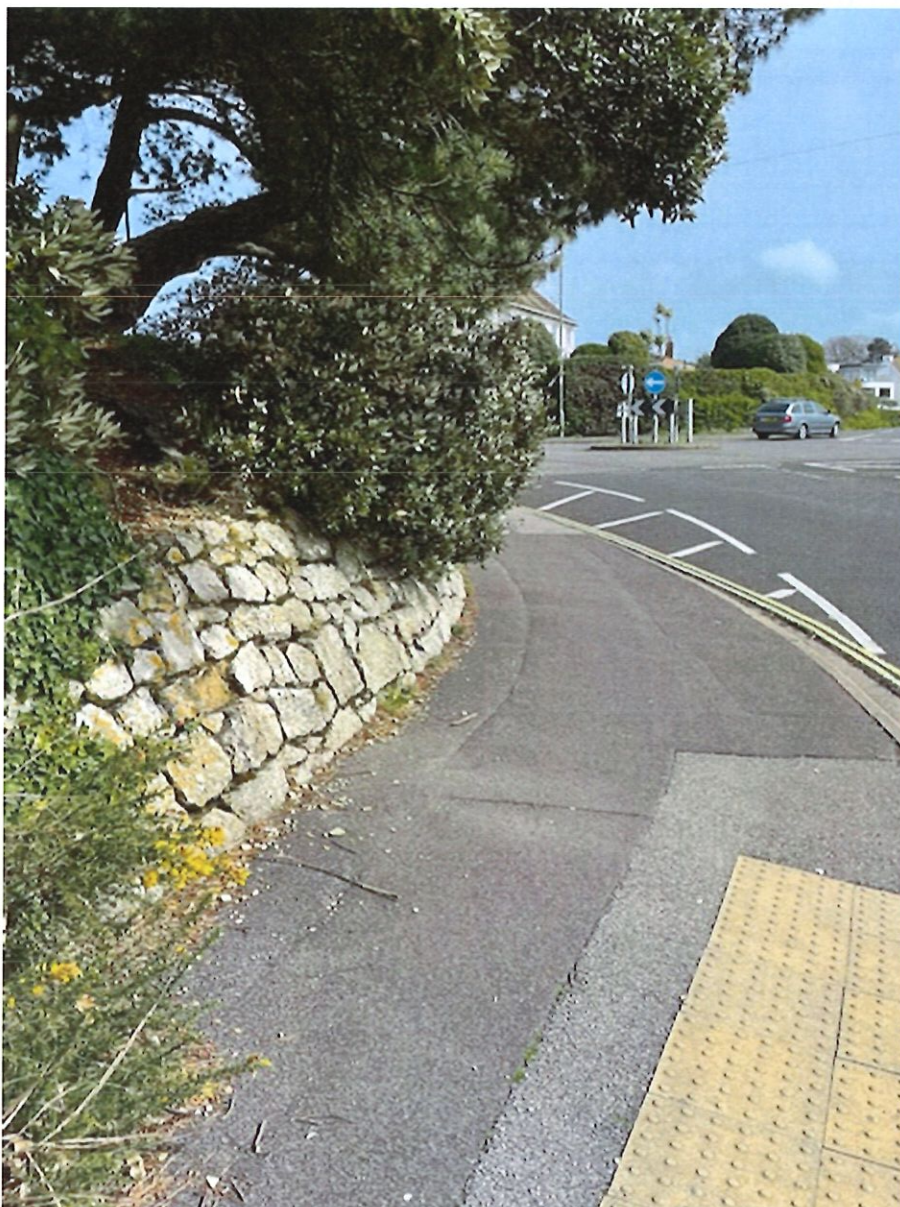
Image 5: Group 1 understorey vegetation on raised bank

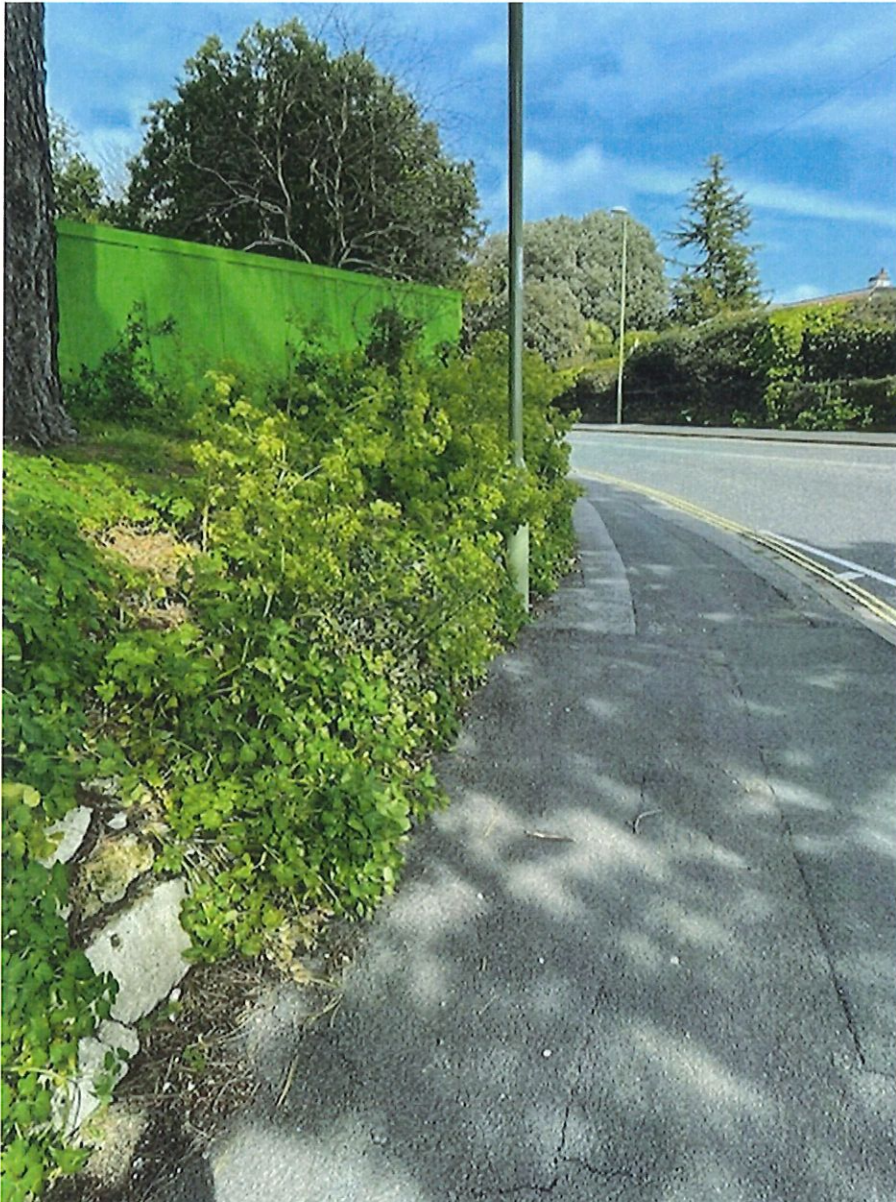
Image 6: Group 1 understorey vegetation on raised bank
