# 23/00798/FUL Land adjacent to 126 Fulford Road

## Condition 12 – Contamination/Remediation Strategy

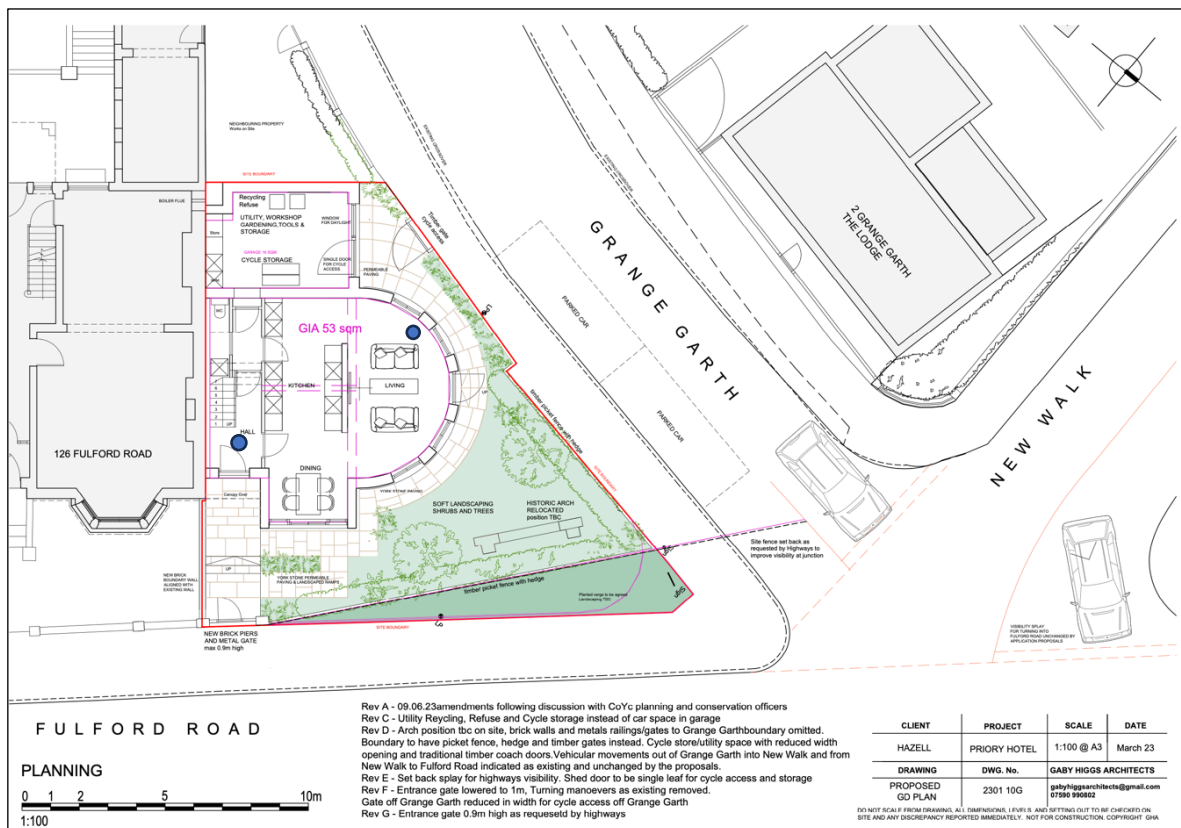
Approved Site Plan – Boreholes locations indicated with blue circles - WS03 and WS04

The report found that in 'Area 2' a thin asphalt surfacing overlying dolomite subbase was recorded below which made ground, comprising soft and firm reworked clays containing some brick, concrete, dolomite and coal fragments, was recorded.

The natural drift deposits comprised firm sandy gravelly clays followed by medium dense SAND. Medium dense silty sand in WS03 was observed.

Samples taken from boreholes for the ground investigation were towards the rear of the site, where buildings and areas of permanent hardstanding are proposed. The source-pathway-receptor pollutant linkage will not exist and any made ground can remain in-situ with no requirement to incorporate clean cover materials.

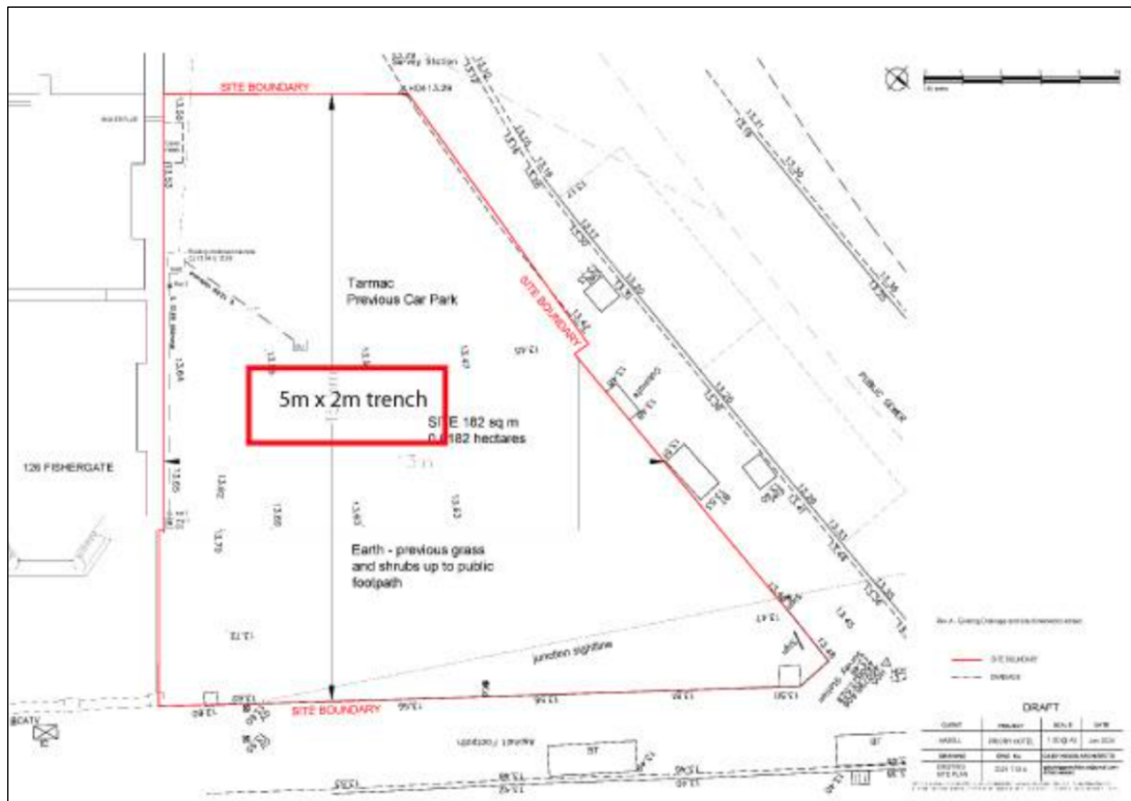
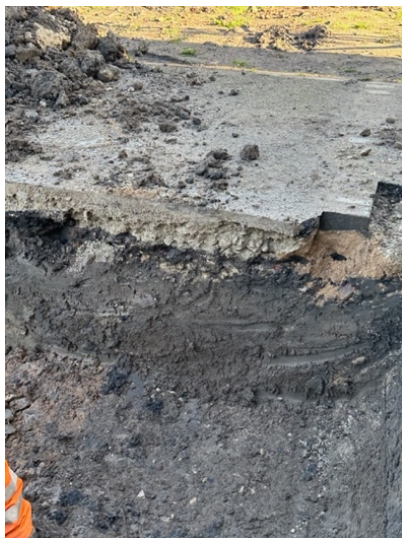
Site Photograph March 2024 – clean horticultural soil

The archaeological report concluded the ground deposits represented medieval to early modern agricultural or horticultural soil. A layer of silt formed a typical garden type soil, probably associated with the 19<sup>th</sup> century Priory Hotel buildings. The ground cover indicates that there has never been any development on the site and clean soil layers were seen below the tarmac within the excavated trench.

Recent investigations have evidenced clean, horticultural soil, with no made ground towards the front of the site, which is where soft landscaping is proposed. Made ground or contamination has not been found and no remediation is required on the site.

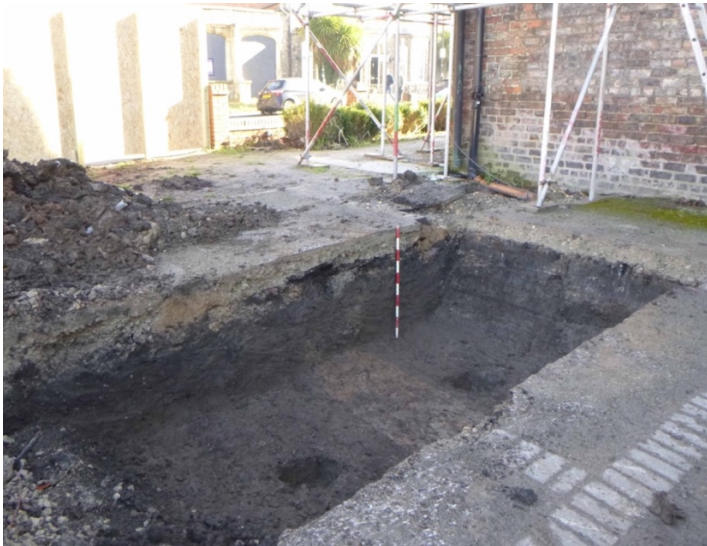
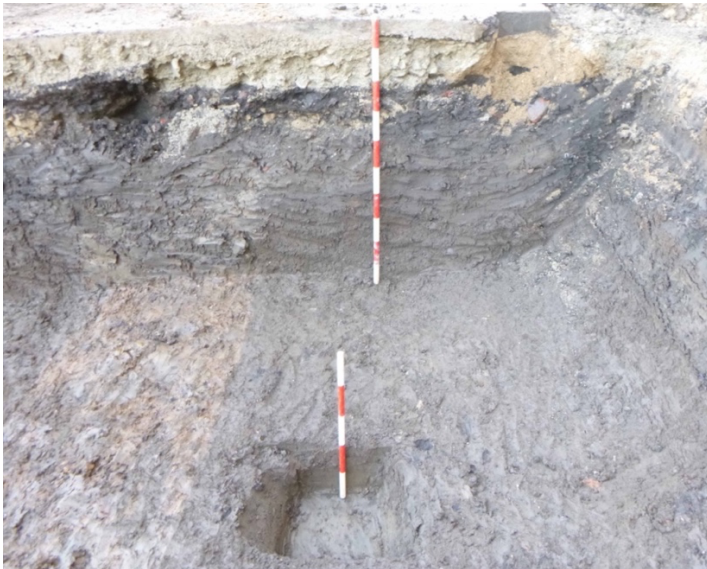
Excavation photographs showing ground layers, courtesy On Site Archaeology
