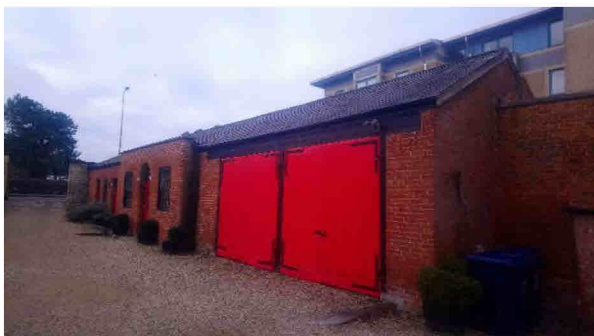
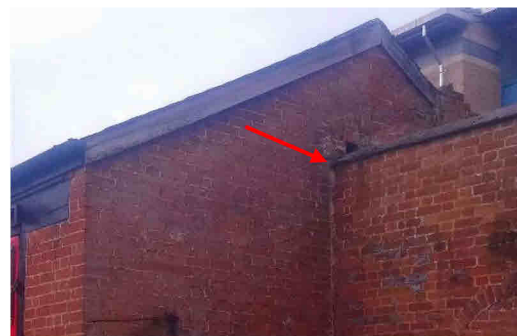
B1, south and east elevations with hole on eastern elevation

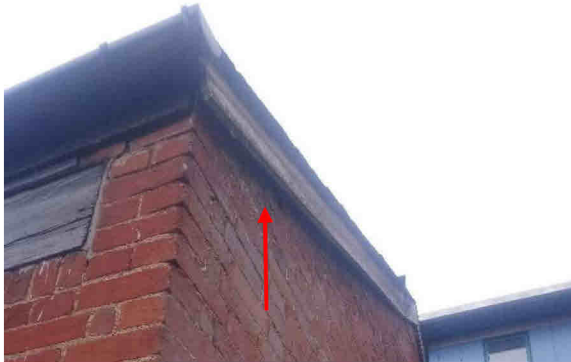
B1 gap under barge board

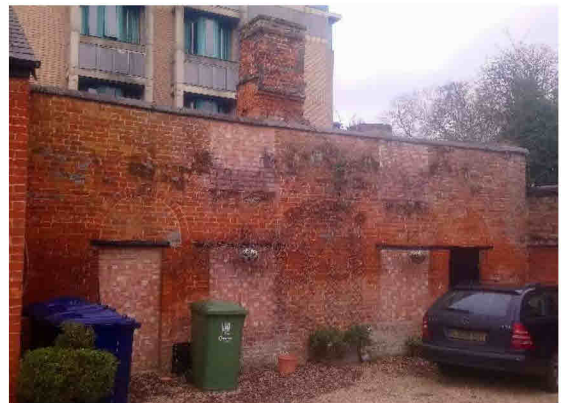
B2 south elevation

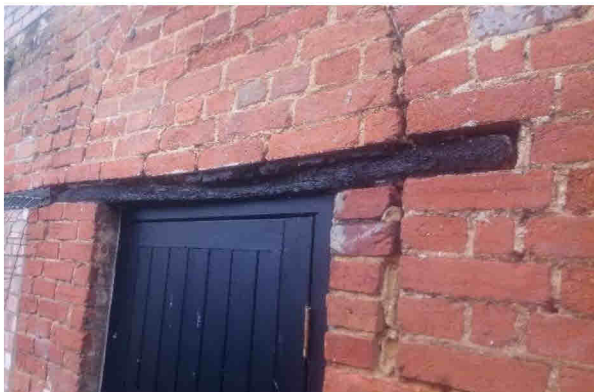
B2, cracks/gaps around lintel

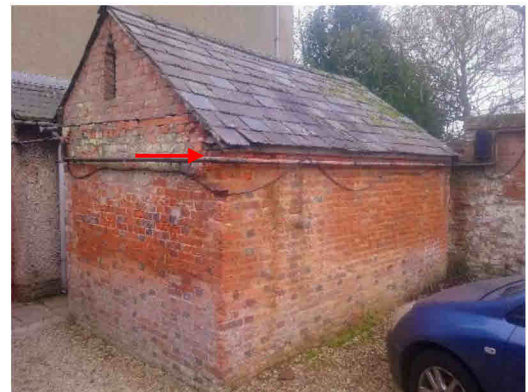
B3, north & west elevations incl gap/hole

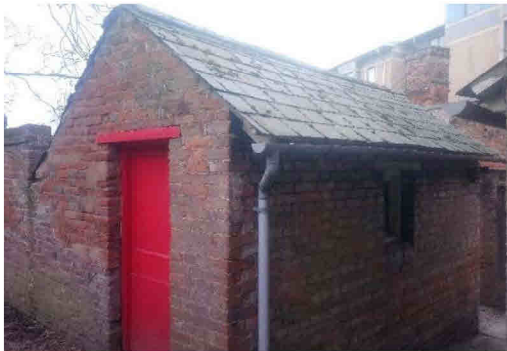
B3, south and east elevations

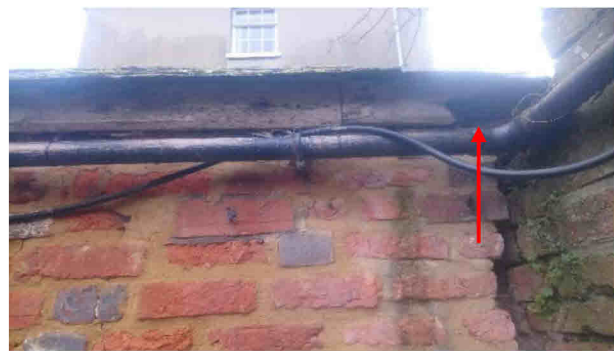
B3, hole in barge point/possible entry point SW cnr

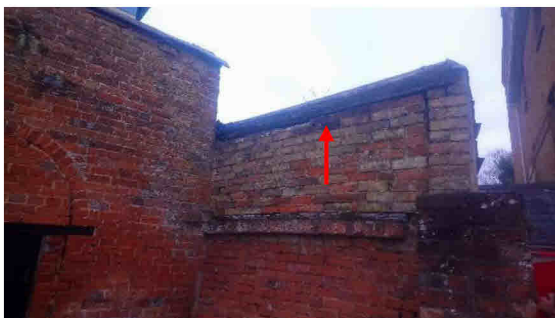
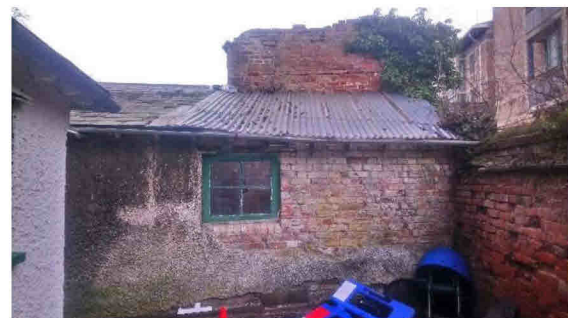
B4, west elevation incl. gap between wall and roof (L) and east elevation (R)

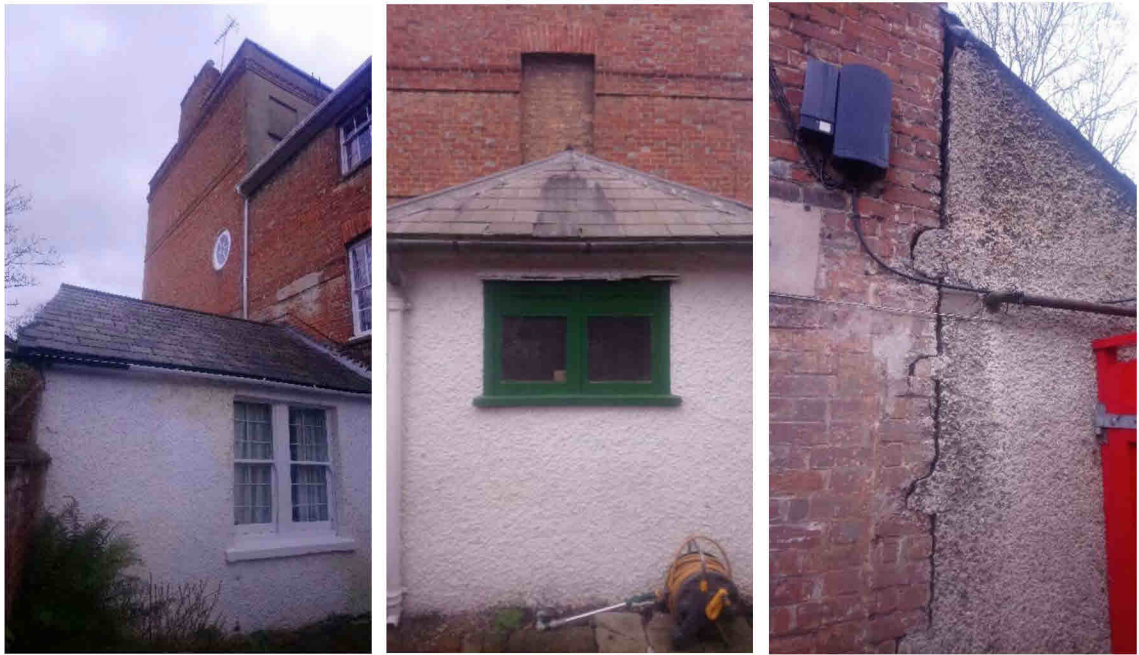
B5, north elevation with single storey 'extensions' (L & C) and crack between main house and extension on western elevation (R)

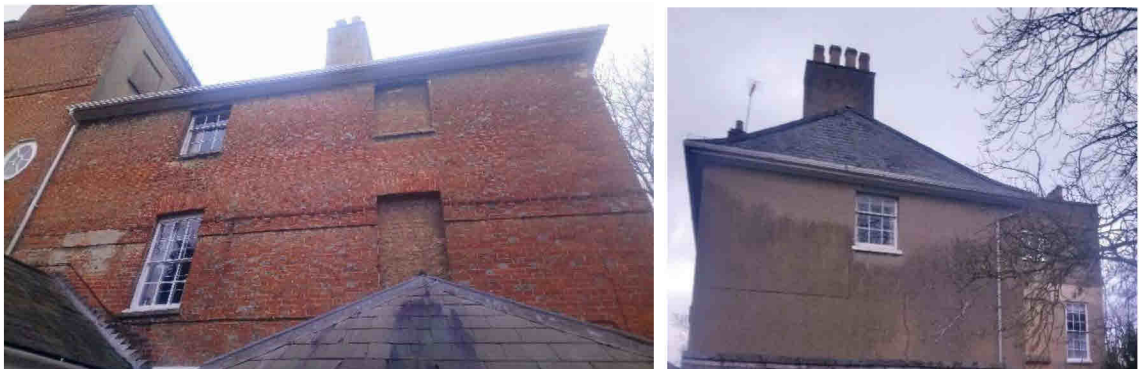
B5, north elevation

B5, west elevation (north)

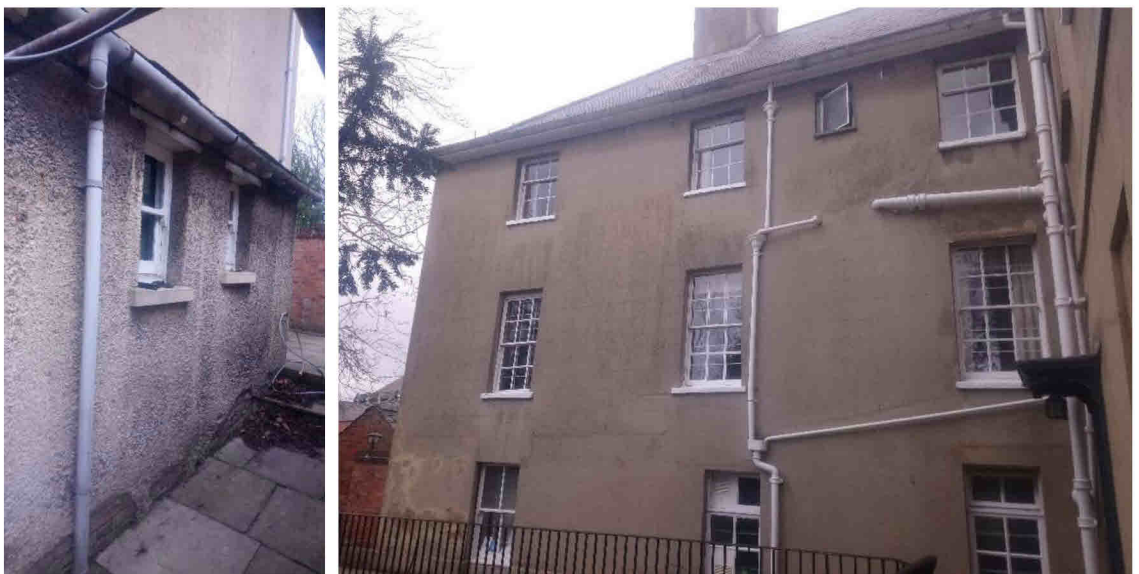
B5, 'extension' west elevation (north, L) and south elevation (west, R)

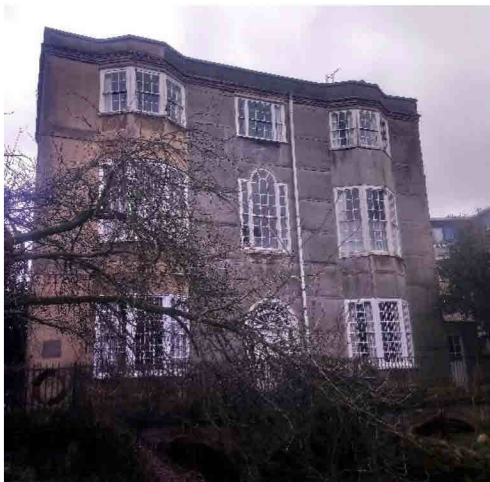
B5, east elevation

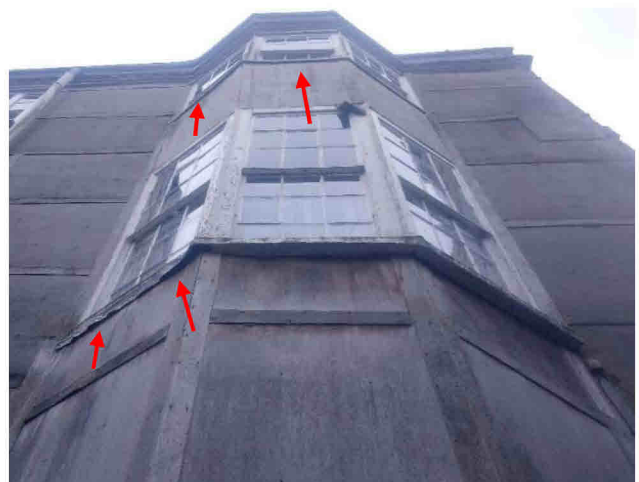
B5, gaps under lead flashing beneath windows

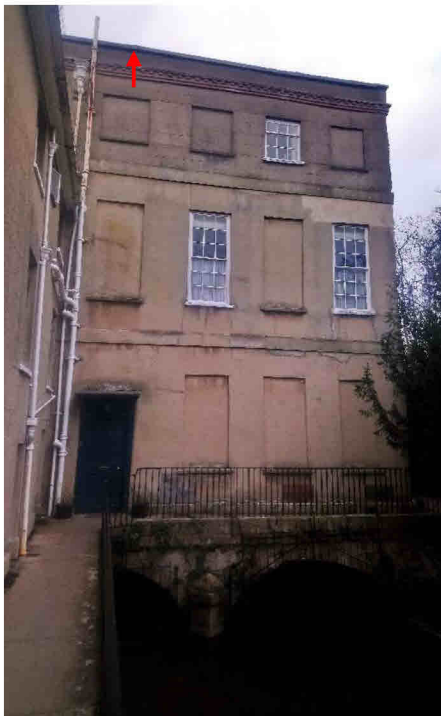
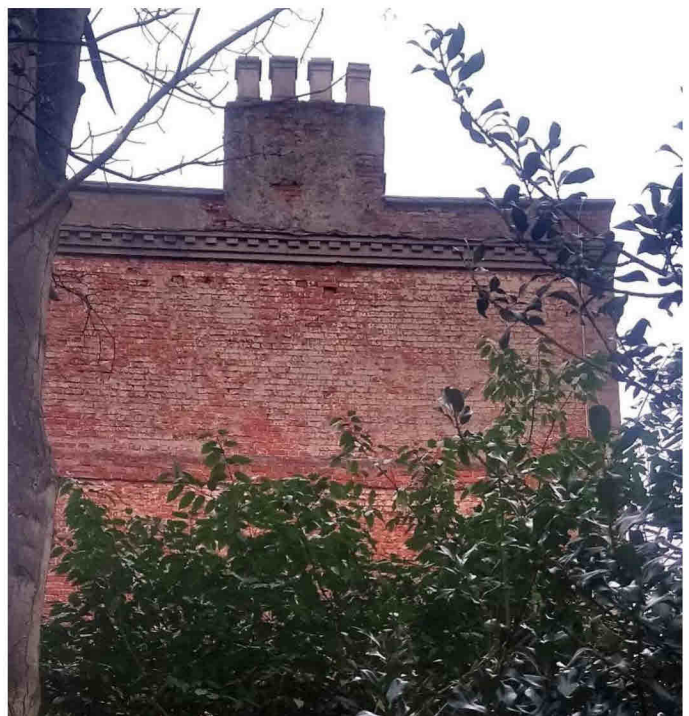
B5, west elevation (south) with gap under lead flashing and upper part of south elevation (east)

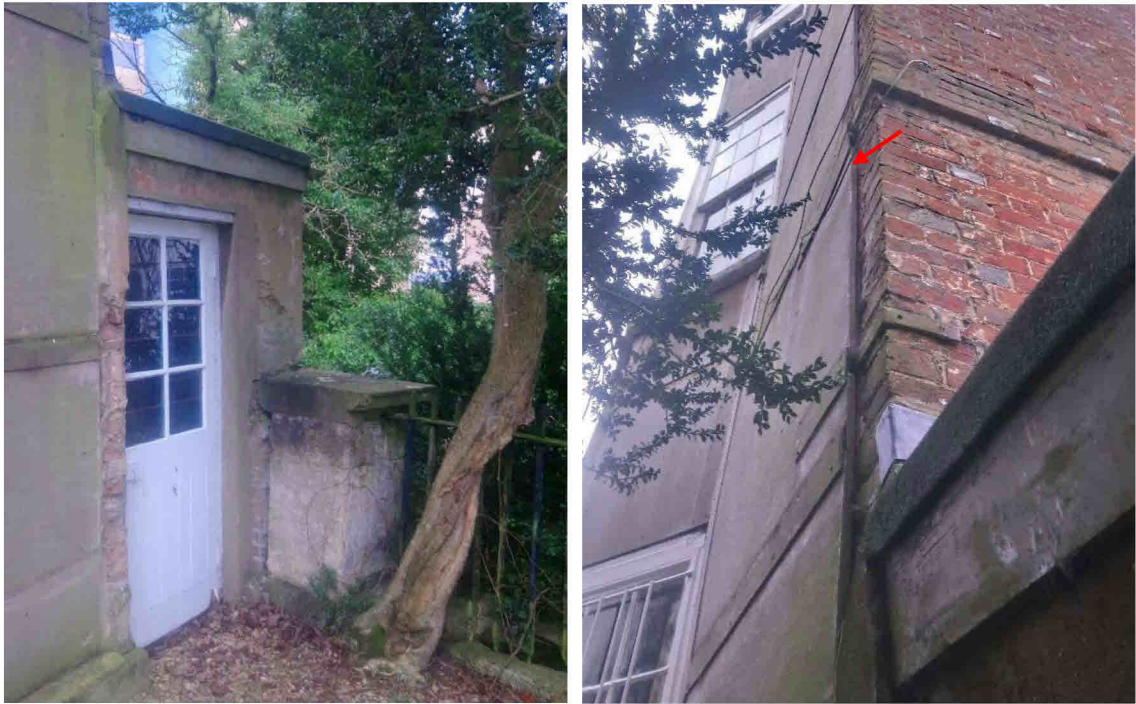
B5, eastern end of single storey extension on north side of building (L) and gaps behind plywood cladding, east elevation (R)

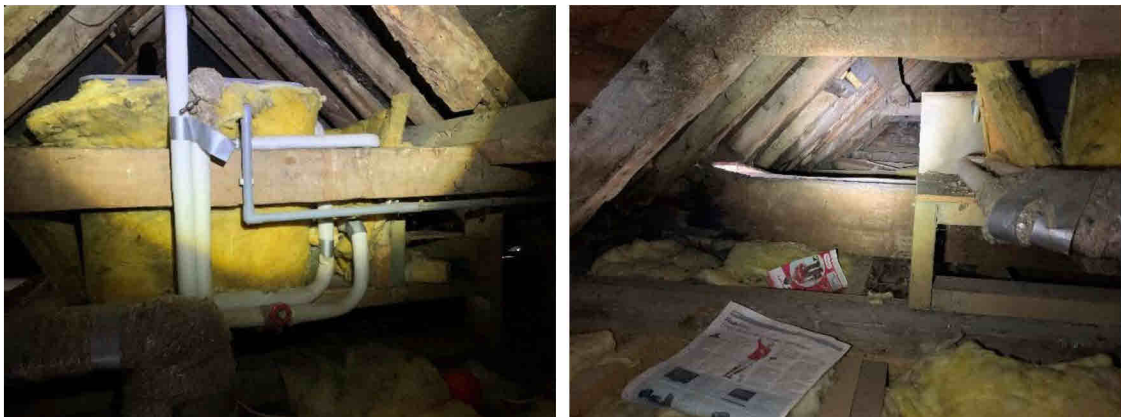
Eastern end of B5's roof void showing large water tank occupying most of the space

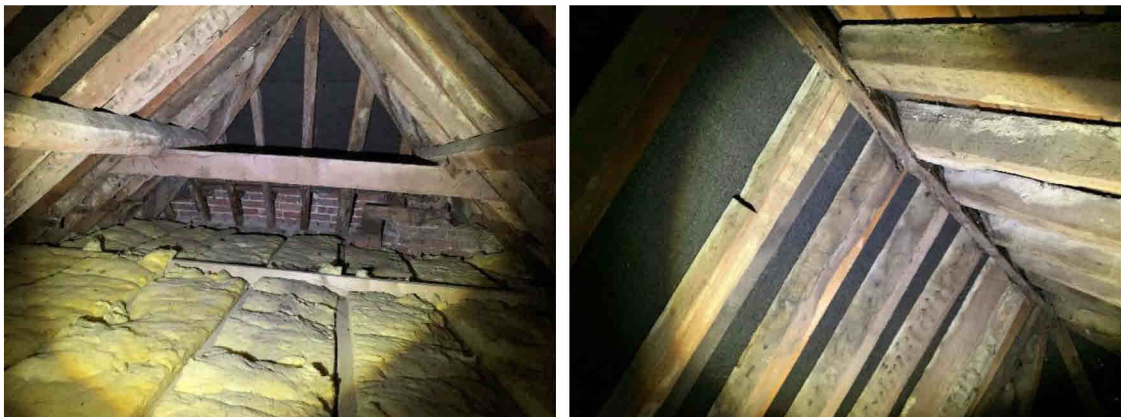
Western end of B5's roof void showing showing exposed timbers and sarking in good condition

- 4.2.3 No bats droppings were found in the B5 roof void so no DNA analysis was undertaken.

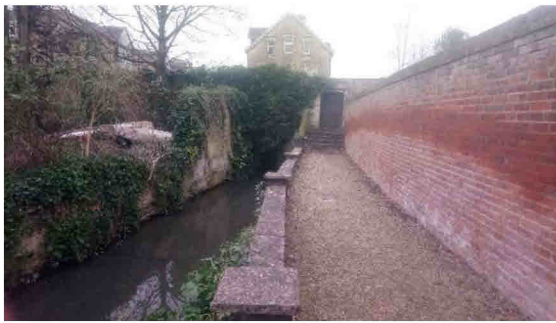
River Thames tributary which enters site via a culvert under the Abingdon Road, traverses then exits via culvert under building B5
