4.2 20TH CENTURY ALTERATIONS

4.3 CONDITION AND NEED OF REPAIR

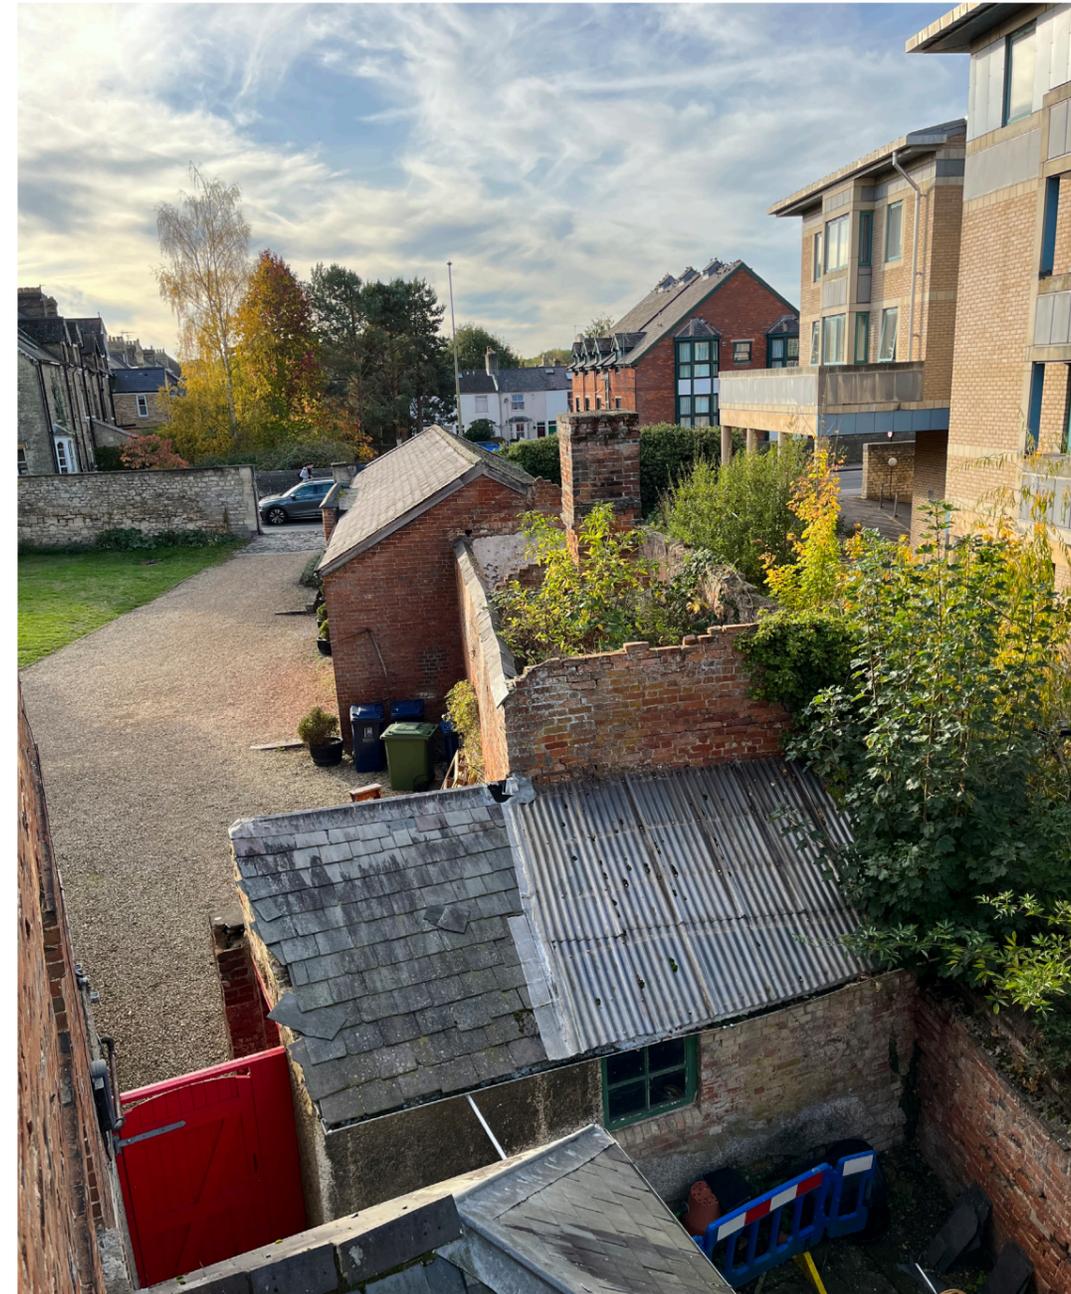
The north boundary river wall enclosing the servant's cottage and the north service yard is partly in a precarious condition and is recommended to be carefully demolished and rebuilt using salvaged brickwork.

Image 21: External view facing west of north service yard, ruined servants cottage, stables block and entrance yard

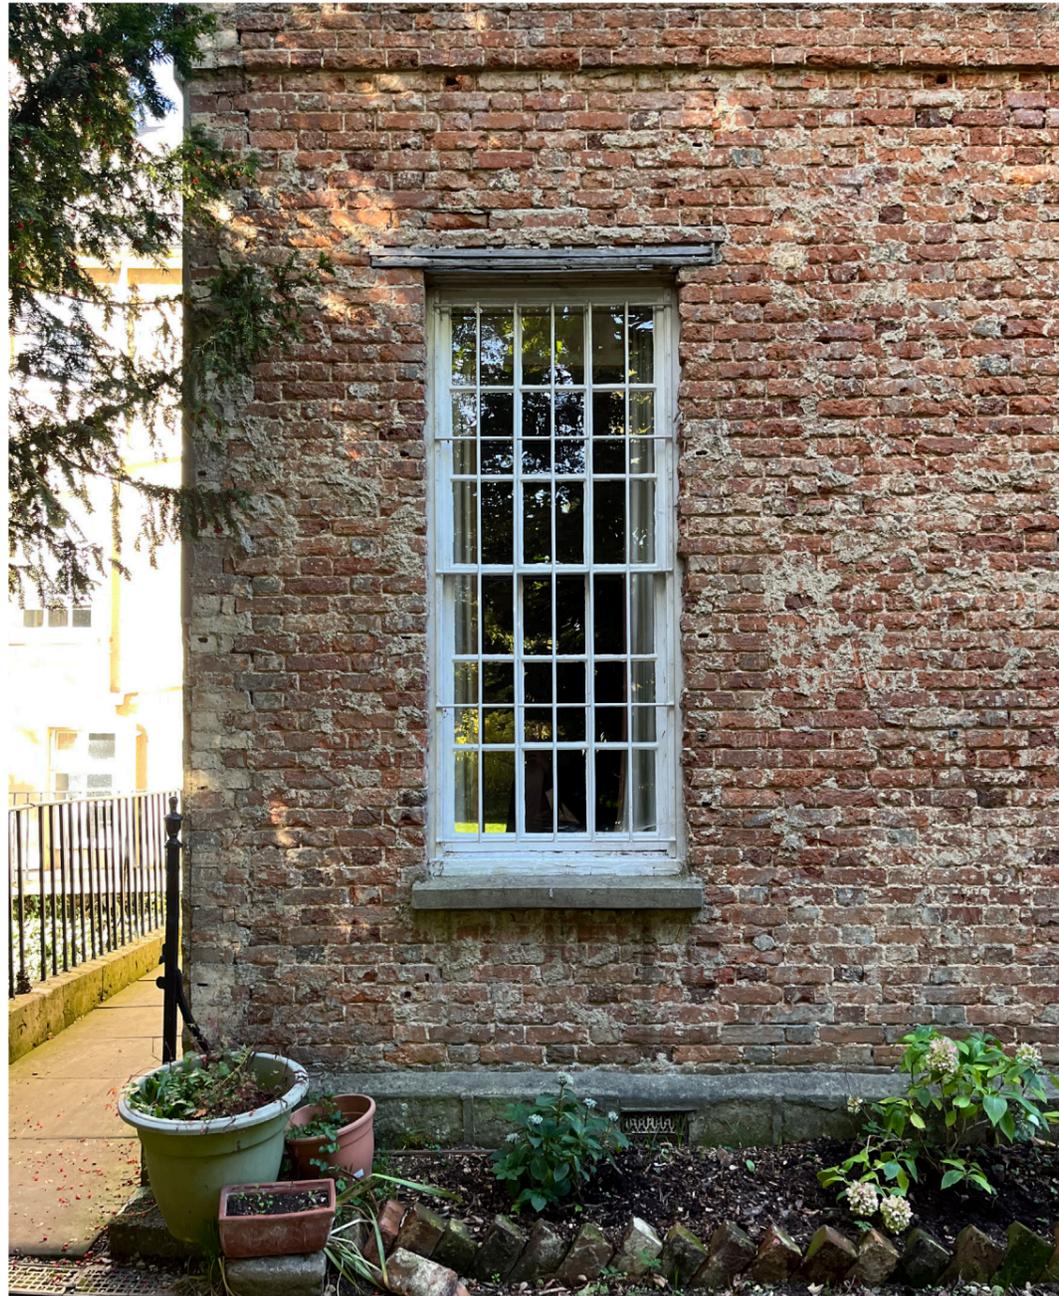
Externally, the property has suffered from a lack of maintenance. The historic fabric is in poor condition and in need of repair. The east wing facades have lost most of their lime render finish, and the exposed brickwork requires repointing.

Image 22: External view of east wing south facade and later addition window

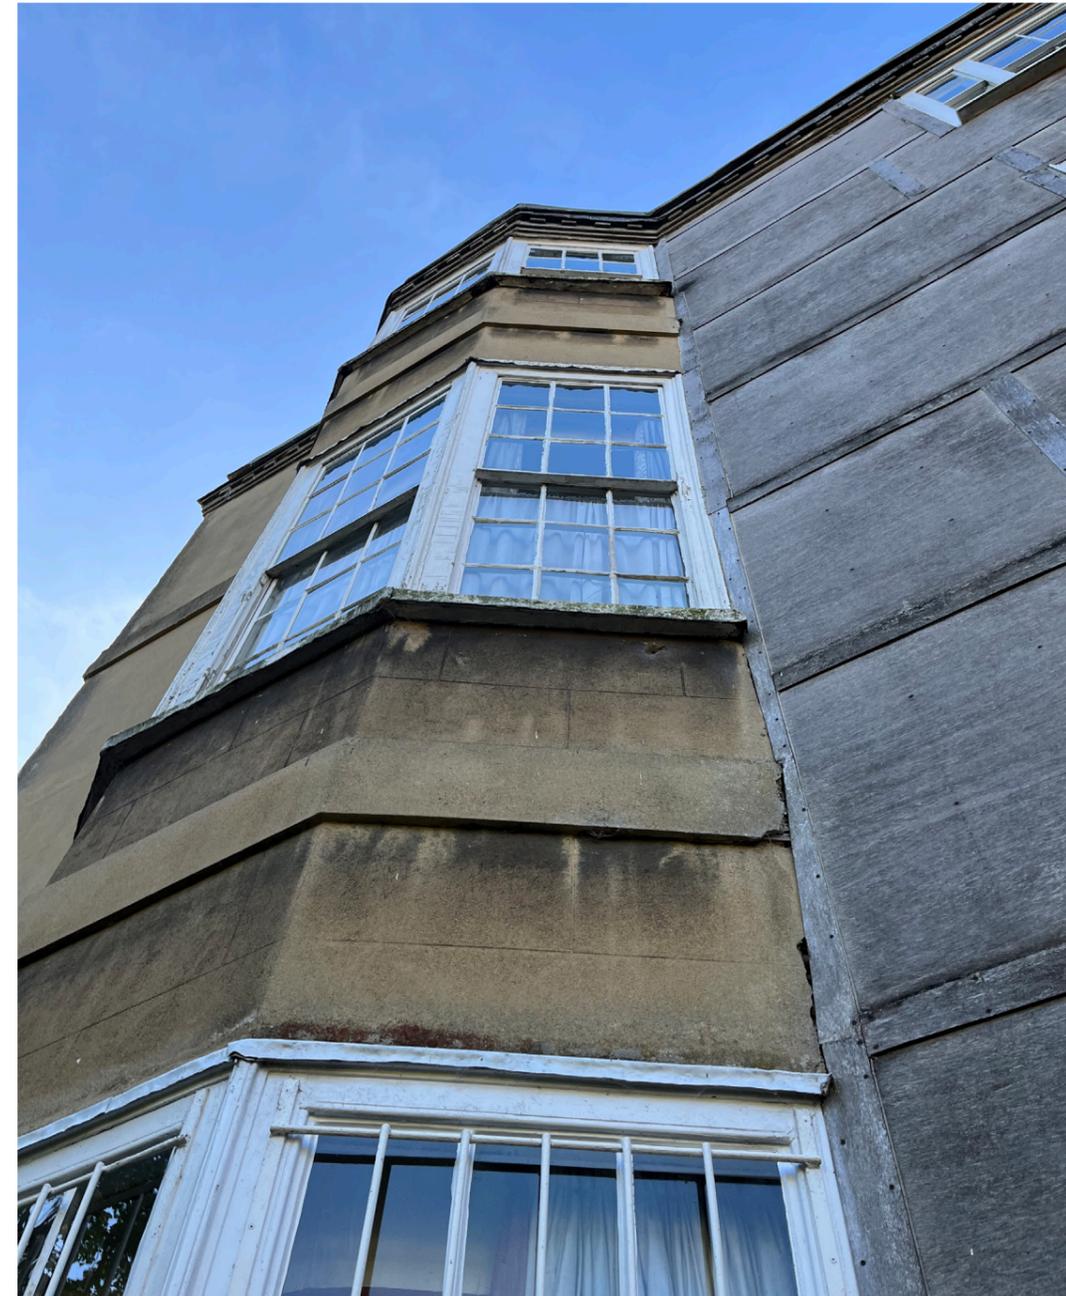
More than half of the front timber stud facade is covered in plywood sheeting as a result. The remaining surviving lime render has been unsympathetically repaired with cement, particularly evident on the second floor of the west facade, along with other patch repairs throughout.

Image 23: External view of east facade canted bay with surviving render and adjacent plywood paneling
