E V Cargo

Quedgeley Depot Unit H Quedgeley Trading Estate Bristol Road Hardwicke Gloucester GL2 4PA

Ref # DGOP240103

Tree Condition and PiCUS Sonic Tomograph Report – Site Address Quedgeley Depot, GL2 4PA – Ref# DGOP240103 – Date of survey 15/0/2024 – Consultant Page **1** of **29**

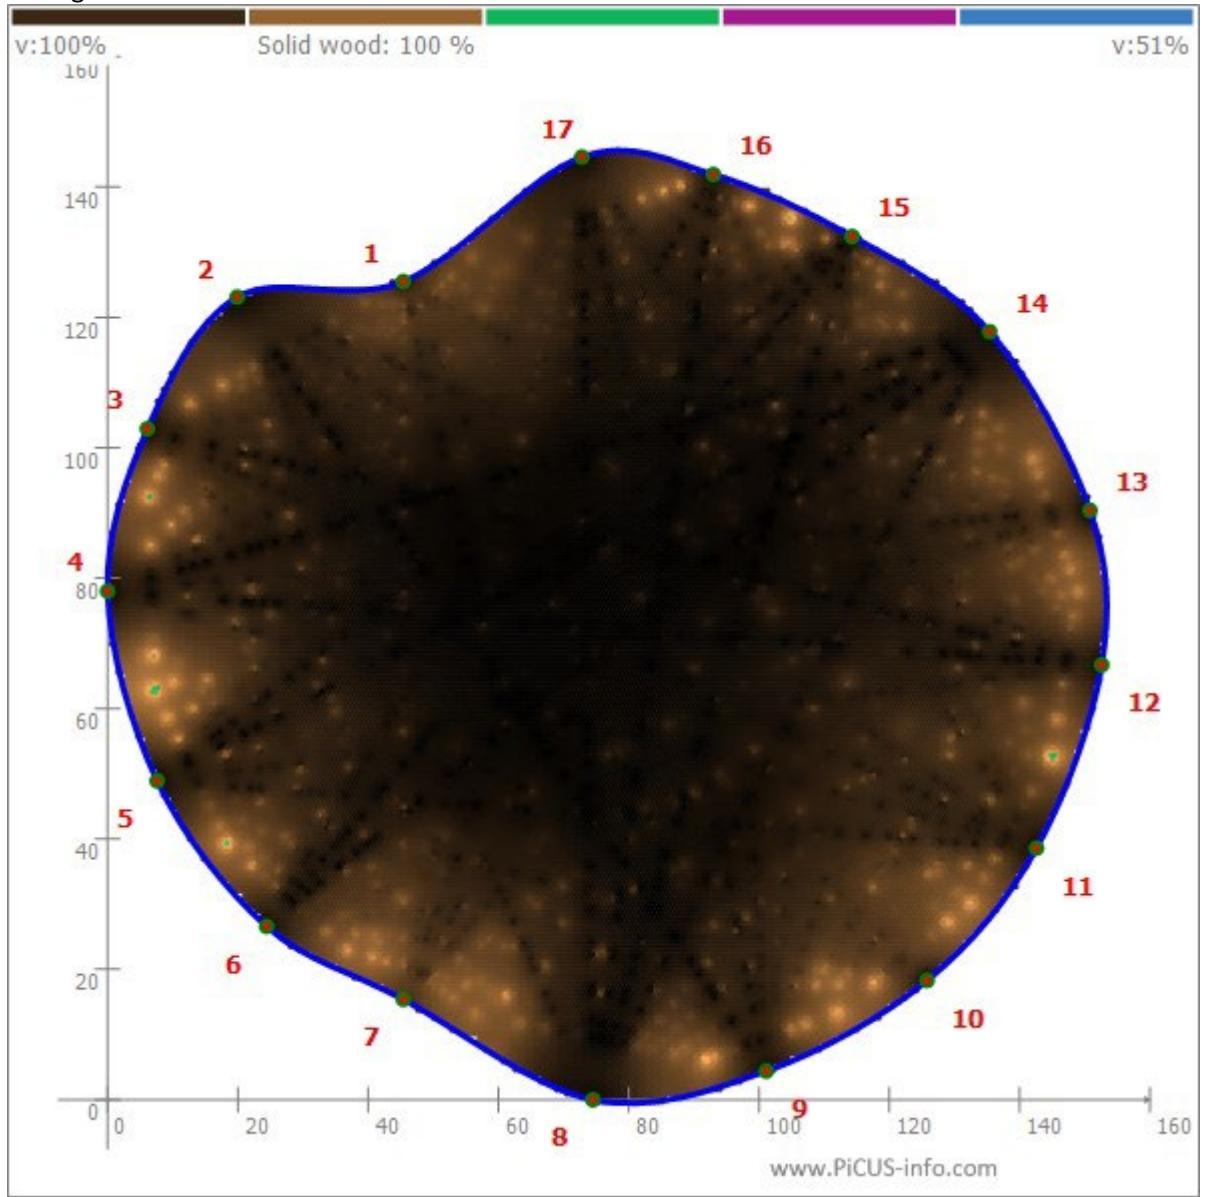
T001 at 0.2m

No indications of potential decay were observed during my visual assessment, no decay detected by tomogram.

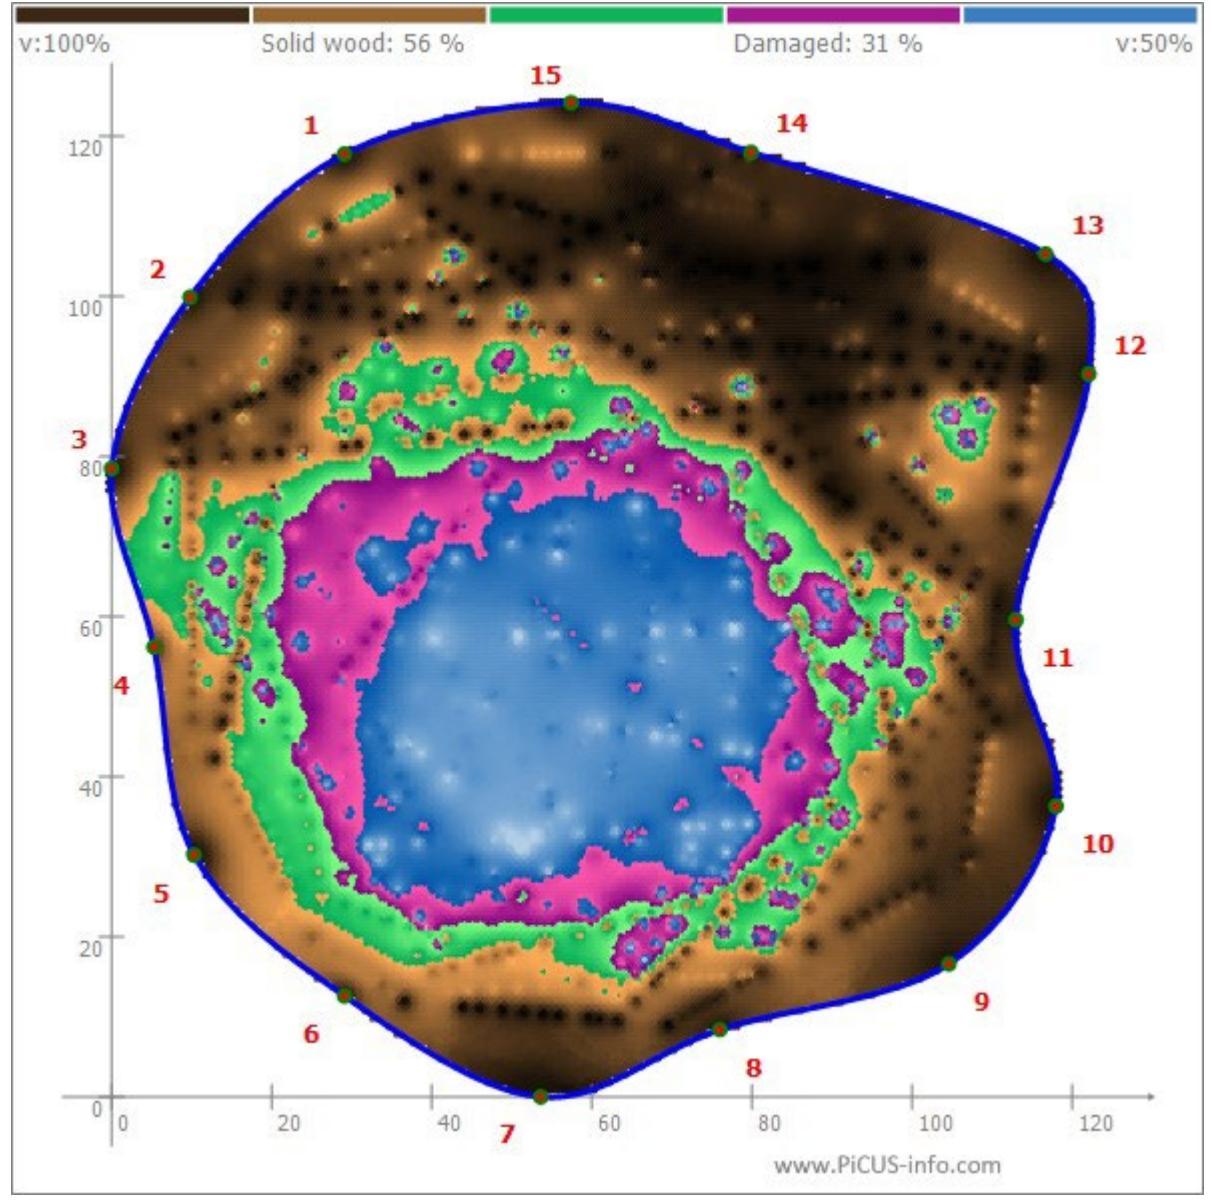
T002 at 0.15m

Ganoderma sp. fungal brackets were observed at measuring points 4, 11 and 14, and between measuring points 8 and 9. All fungal brackets were old and desiccated, as a result I was unable to confirm the species of Ganoderma affecting the tree.

The tomogram clearly shows a significant cavity in the centre of the base, with 31% damaged wood, the cavity is not yet open at any point around the base.

Although the tomogram for tree TOO2 clearly show a significant cavity, I do not believe this to be severe enough to warrant the removal of the tree. Recommendation have been made to reduce the crown to reduce the mechanical loading and windsail area, and for a follow up tomogram to track the progress of decay, in three years.

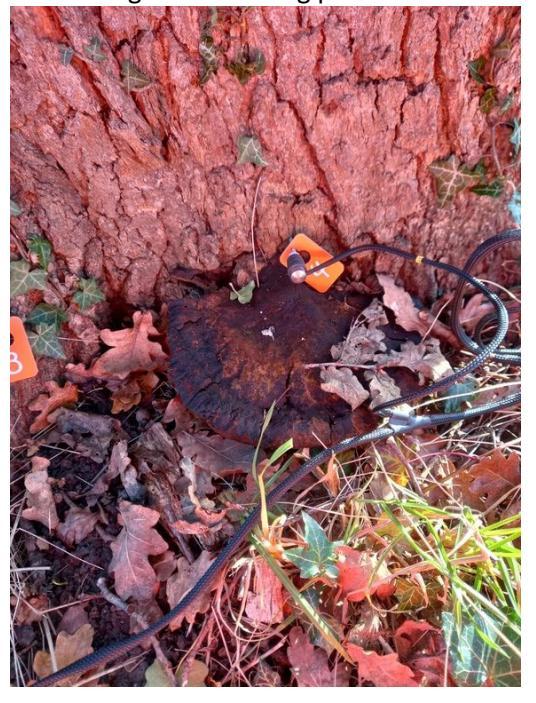
T002. Fungi at measuring point 4

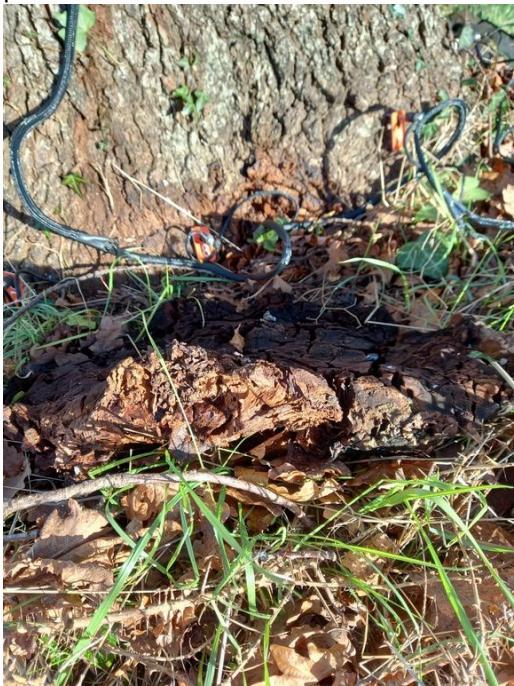
T002. Fungi between measuring points 8 and 9

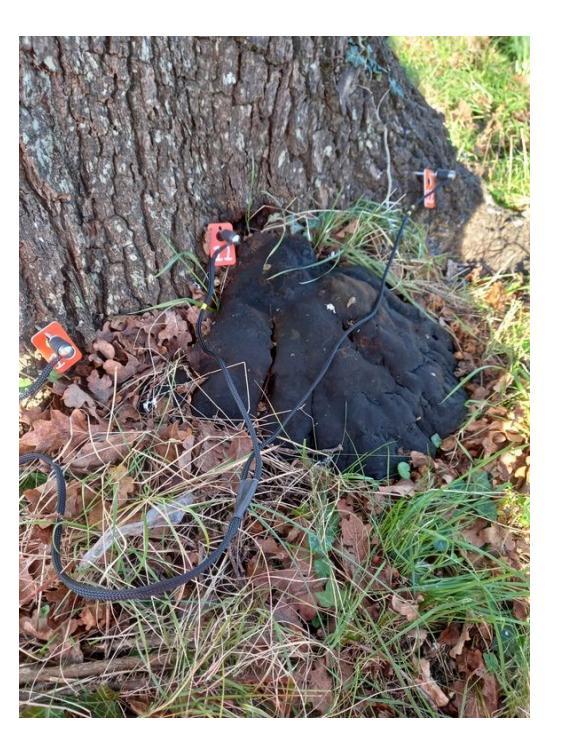
T002. Fungi at measuring point 11

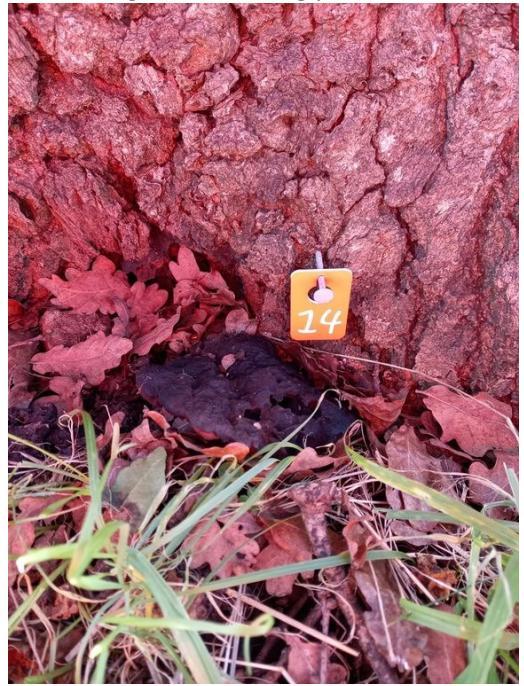
T002. Fungi at measuring point 14
