Holly Farm

Summary

Repair and preservation of associated stone building

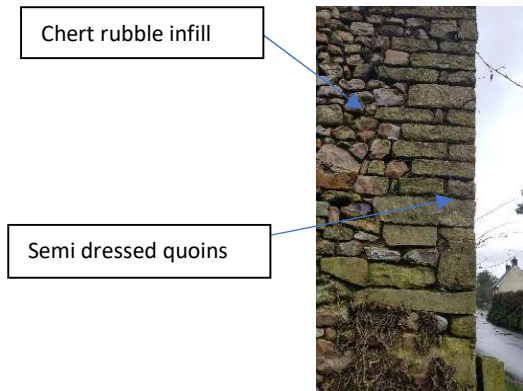
The outbuilding is constructed of mainly chert rubble with limestone quoins to the corners and openings *figs 4 and 5*.

Figure 4. stone building corner.

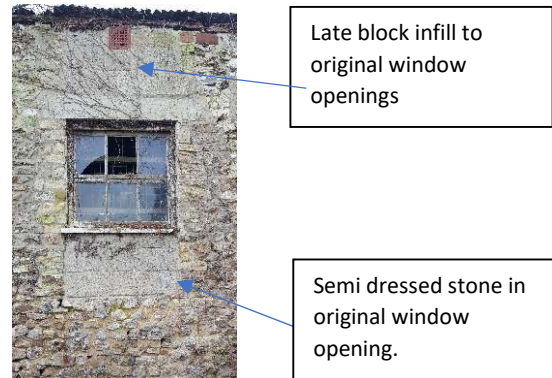
Figure 5. stone building window.

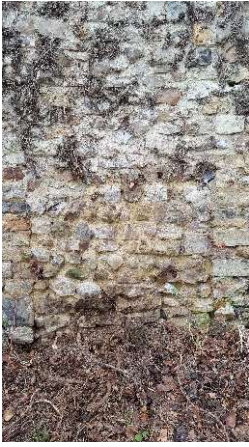
- The walls to the west elevation have been reduced in height to accommodate a mono pitch corrugated tin roof.
- Additional doors created in west elevation. *Fig 9*
- Additional door created in north elevation.
- Original doorway to east elevation infilled. *Fig 6*
- Window openings in east elevation partially infilled. *Figs 7 & 8*
- Concrete floor added.
- Blockwork stone building and timber store added. *Fig 10*
- Concrete apron laid.
- Internal blockwork stalls created.

Figure 6. infilled doorway.

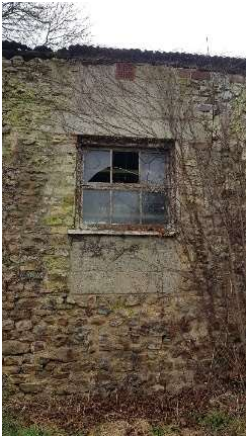
There are currently two windows, one to each side of the former central door. This arrangement is the same architectural style as the farmhouse. The cement blocks above and below these windows would indicate that these windows have been replaced and significantly changed in position *fig 7*. The style of these windows would suggest they were fitted post 1940's. The windows have been raised up from the level of the ground floor windows possibly to protect them from damage from animals and to simplify the alteration.

Figure 7. left hand window.

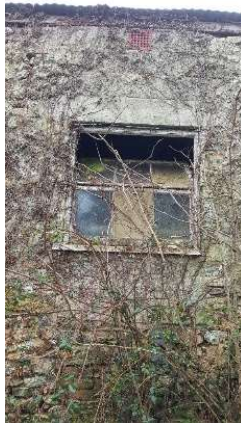
Figure 8. right hand window.

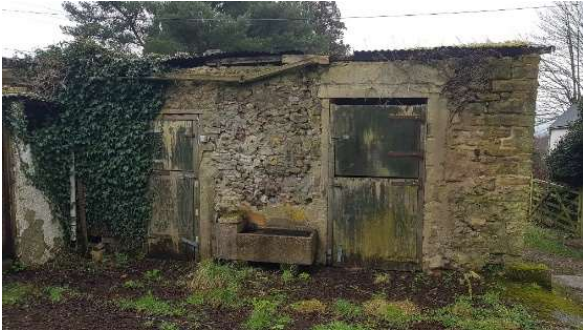
Three doorways were created in the west face of the stone building *fig 9*, possibly utilising two previous window openings and an original doorway. One of these doorways has subsequently been infilled with concrete block. These alterations, along with water ingress from the failing roof and rainwater goods, have caused some structural instability on this wall.

Figure 9. west elevation

- The walls of the stone building will be renovated with traditional materials. The west wall will be partially dismantled and rebuilt using existing materials.
- The wall to the west elevation will be rebuilt to the same height as the east and a metal clad hipped roof added.
- The concrete extension will be renovated, with a new corrugated steel gabled roof and stable doors.
- Create a continuous roof over the concrete extension and timber log store.

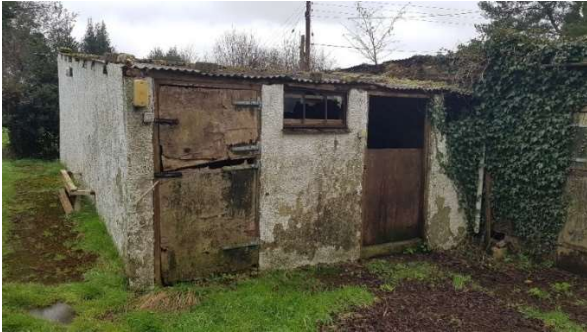
At some point a concrete block extension *fig 10* and an attached timber framed log store have been added around the northwest corner of the stone building. These are also in need of repair.

Figure 10. concrete block extension.
