Holly Farm

Alston

Summary

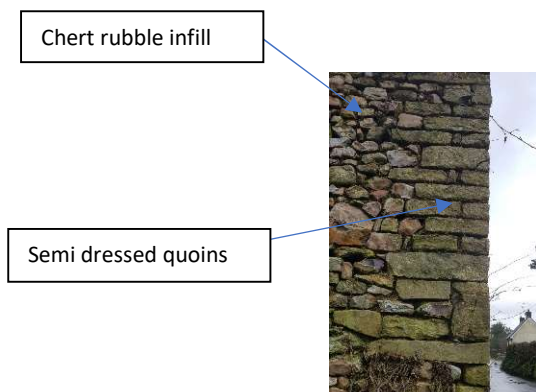
The outbuilding is constructed of mainly chert rubble with limestone quoins to the corners and openings *figs 4 and 5*.

Figure 4. stone building corner.

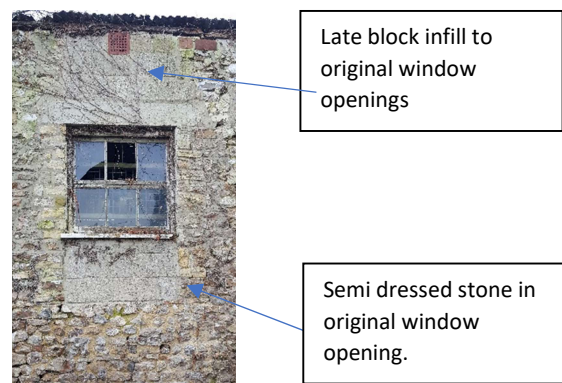
Figure 5. stone building window.

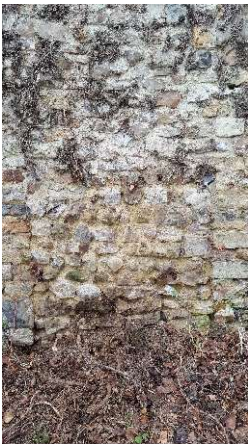
- The walls to the west elevation have been reduced in height to accommodate a mono pitch corrugated tin roof.
- Additional doors created in west elevation. *Fig 9*
- Additional door created in north elevation.
- Original doorway to east elevation infilled. *Fig 6*
- Window openings in east elevation partially infilled. *Figs 7 & 8*
- Concrete floor added.
- Blockwork stone building and timber store added. *Fig 10*
- Concrete apron laid.
- Internal blockwork stalls created.

Figure 6. infilled doorway.

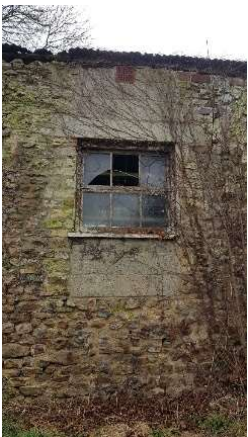
There are currently two windows, one to each side of the former central door. This arrangement is the same architectural style as the farmhouse. The cement blocks above and below these windows would indicate that these windows have been replaced and significantly changed in position *fig 7*. The style of these windows would suggest they were fitted post 1940's. The windows have been raised up from the level of the ground floor windows possibly to protect them from damage from animals and to simplify the alteration.

Figure 7. left hand window.

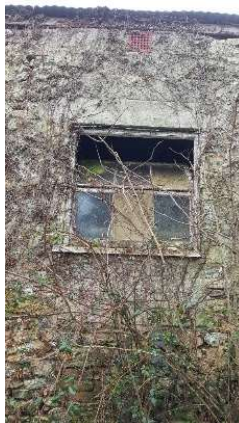
Figure 8. right hand window.

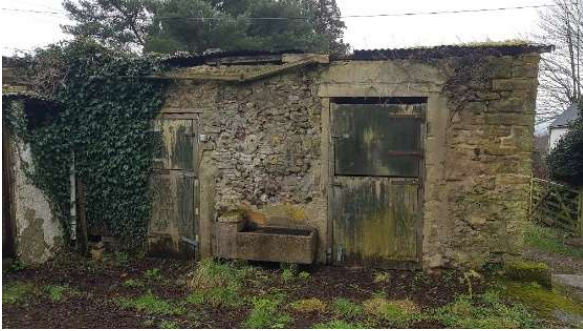
Figure 9. west elevation

Three doorways were created in the west face of the stone building *fig 9*, possibly utilising two previous window openings and an original doorway. One of these doorways has subsequently been infilled with concrete block. These alterations, along with water ingress from the failing roof and rainwater goods, have caused some structural instability on this wall.

- The walls of the stone building will be renovated with traditional materials. The west wall will be partially dismantled and rebuilt using existing materials.
- The wall to the west elevation will be rebuilt to the same height as the east and a metal clad hipped roof added.
- The concrete extension will be renovated, with a new corrugated steel gabled roof and stable doors.
- Create a continuous roof over the concrete extension and timber log store.

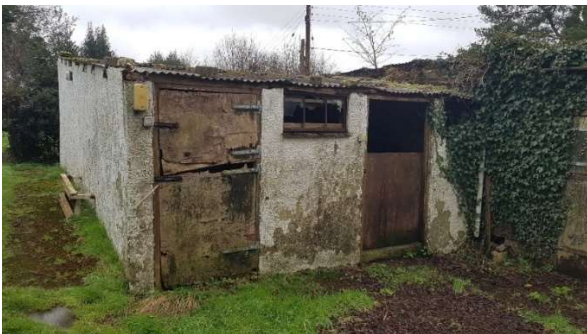
At some point a concrete block extension *fig 10* and an attached timber framed log store have been added around the northwest corner of the stone building. These are also in need of repair.

Figure 10. concrete block extension.
