## **Preliminary Roost Assessment**

**The Garage to the rear of The Bell,  
The Bury, Odiham**

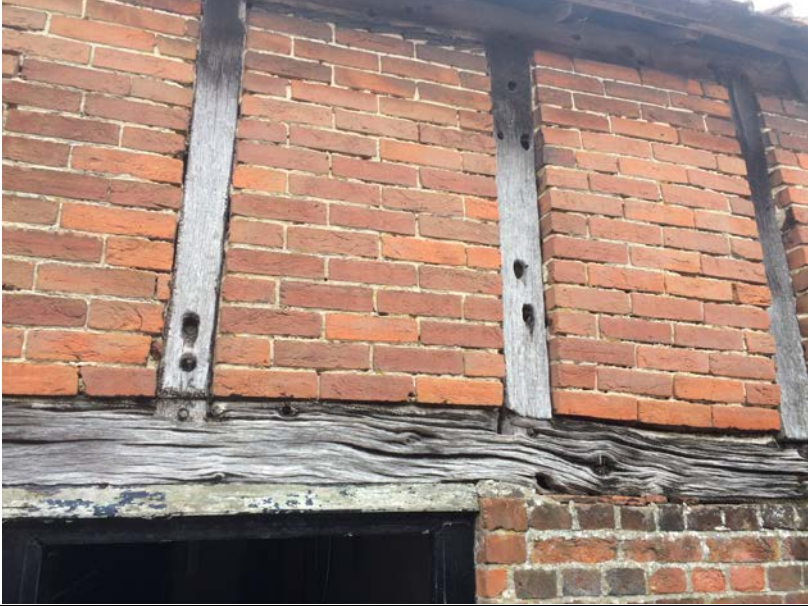
- 3.2 The two storey garage building on site supports external features with potential suitability for crevice dwelling bat species such as slipped, missing or curved clay tiles. Crevices were also recorded within the exposed wooden beams on the eastern elevation of the building and small gaps between the wooden beams and brickwork. Underneath the eaves, large gaps were recorded allowing access to a variety of bat species into the loft space.
- 3.3 Internally, the upper floor was divided into two sections; the eastern part contained two rooms with plasterboard type ceiling tiles creating a loft void above, with the western side open storage space with no loft void. In the eastern part, the loft void measured

<p><b>Photo 1:</b> Crevices present within the wooden beams on the eastern elevation of the two storey garage building</p>

- 4.5 it is recommended that two dusk emergence or dawn re-entry surveys are undertaken. Further surveys may be subsequently recommended dependent on the level of bat activity on site. The aim of this survey is to determine if bats are present within this building in addition to the type and number of bats present. The results of these surveys will inform an application for a Natural England licence to legalise the loss / disturbance to bat roosts should they be present on site and appropriate mitigation.

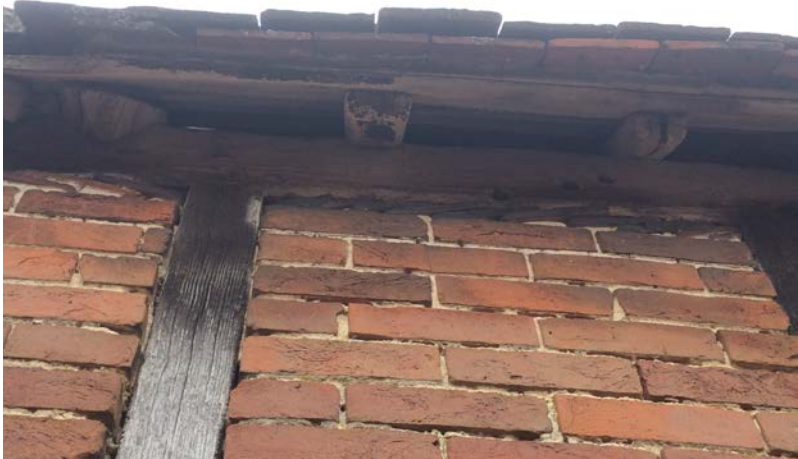
A close-up photograph of a brick wall. Three vertical wooden beams are attached to the wall. There are visible gaps and crevices between the beams and the bricks, particularly near the top. The bricks are reddish-brown and laid in a standard pattern. The wooden beams are weathered and greyish.
<p><b>Photo 2:</b> Showing large open gaps underneath the eaves of the two storey garage building.</p>

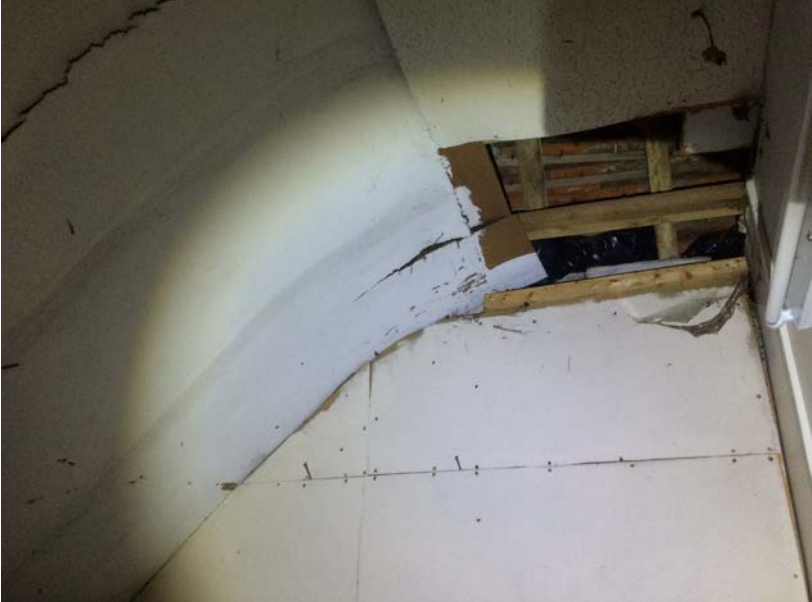
approximately 5m long by 2m wide and 1m high, and some of the ceiling boards had fallen or had holes in places.

<p><b>Photo 3:</b> Showing the plaster board inside the eastern half of the two storey garage building.</p>

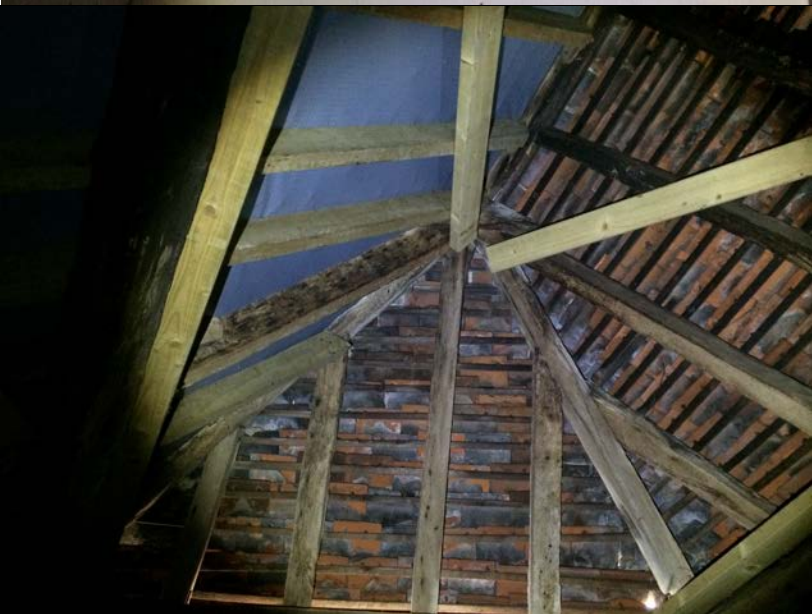
3.4 The western half, measuring approximately 3m long, 2m wide and 3m high, had an exposed roof structure and showed the southern half was lined with plastic sheeting whilst the northern elevation was unlined. While no obvious roost features were recorded, there was potential for roosting bats between the ridge and rafter wooden beams, particularly the ridge within the western half and above plaster boards in the eastern half. Evidence of bat use, consisting of five bat droppings were recorded in the southwestern corner of the building, although these were considered to be old droppings due to the amount of dust on them. Feeding remains were also recorded within a meter of the bat droppings, underneath the ridge. The droppings were collected and sent off for DNA analysis.

3.5 The DNA analysis could not identify bat DNA as it appears to have been contaminated with starling droppings, indeed evidence of birds within the roof was noted. As such, it is considered that the droppings identified are not conclusive of bat.

A photograph showing the interior of a garage. The ceiling is made of white plasterboard, which is severely damaged and peeling away from the wooden joists above. The damage is most prominent in the upper right quadrant, where the plaster has crumbled, revealing the underlying wooden structure. The lighting is somewhat dim, with a bright spot on the left side of the ceiling.
<p><b>Photo 4:</b> Western roof space of the two storey garage building. Five bat droppings were found underneath this roof space.</p>

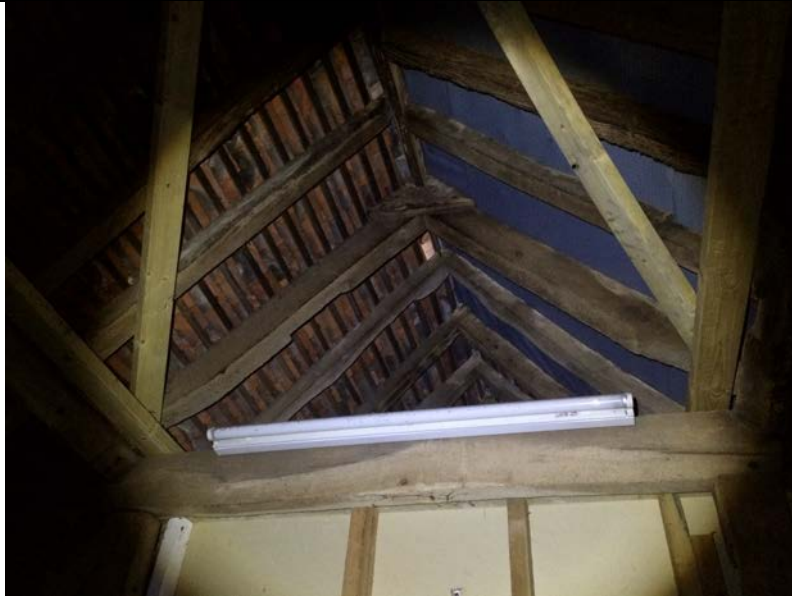
**Photo 5:**  
Internal roof  
space  
towards the  
eastern end  
of the two  
storey  
garage  
building.

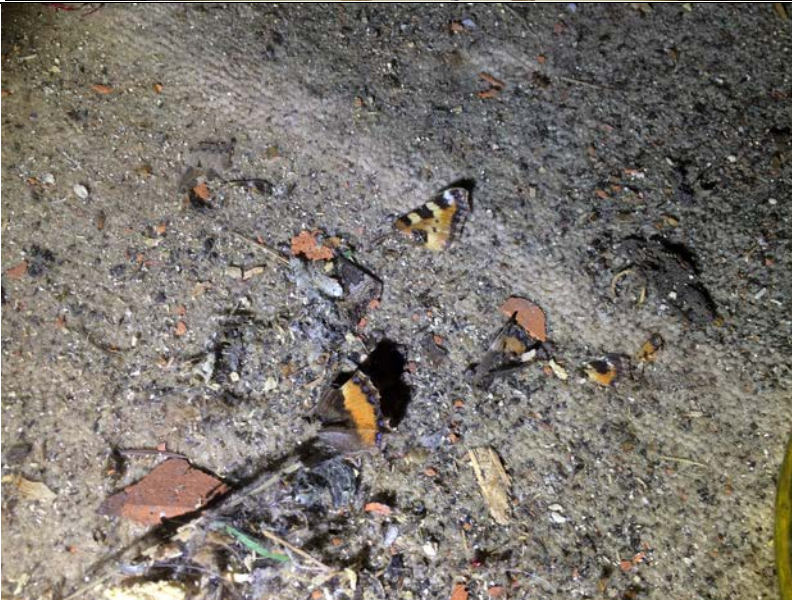
**Photo 6:**  
Butterfly  
feeding  
remains  
recorded  
with the  
western half  
of the two  
storey  
garage  
building.
