## **HERITAGE STATEMENT**

**THE ANNEX, CHURCH ST, ODIHAM,  
HAMPSHIRE, RG29 1LY**

ODIHAM BELL LTD  
MARCH 2024

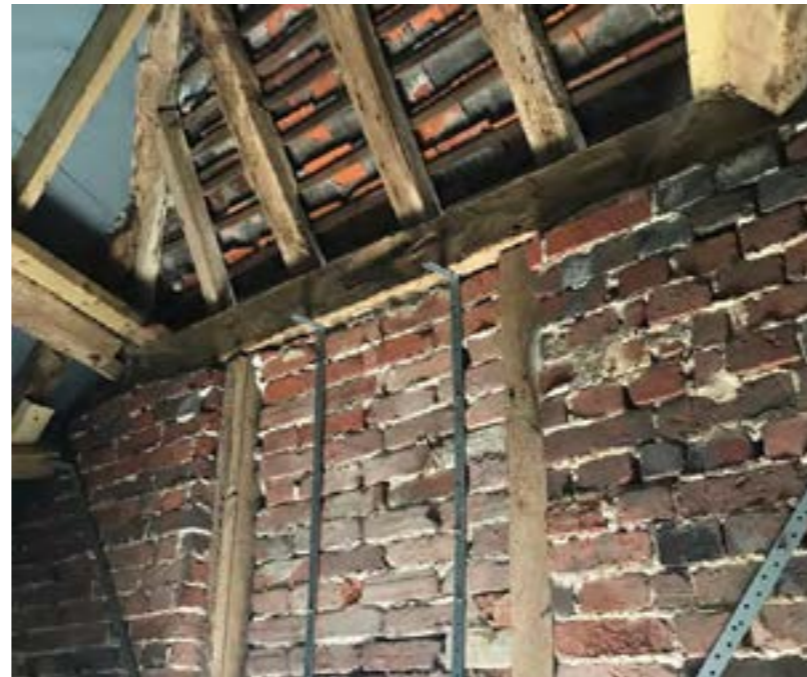
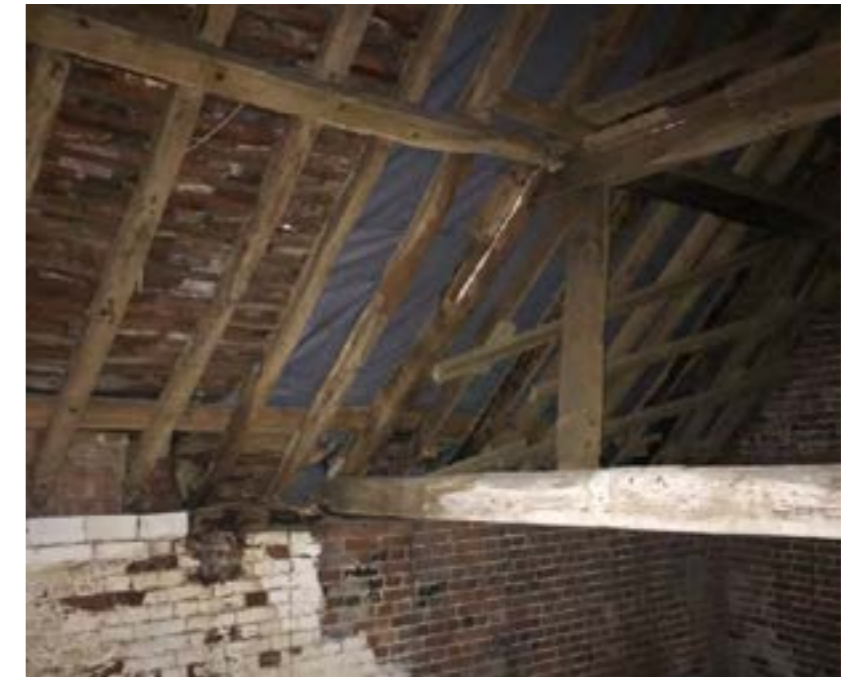
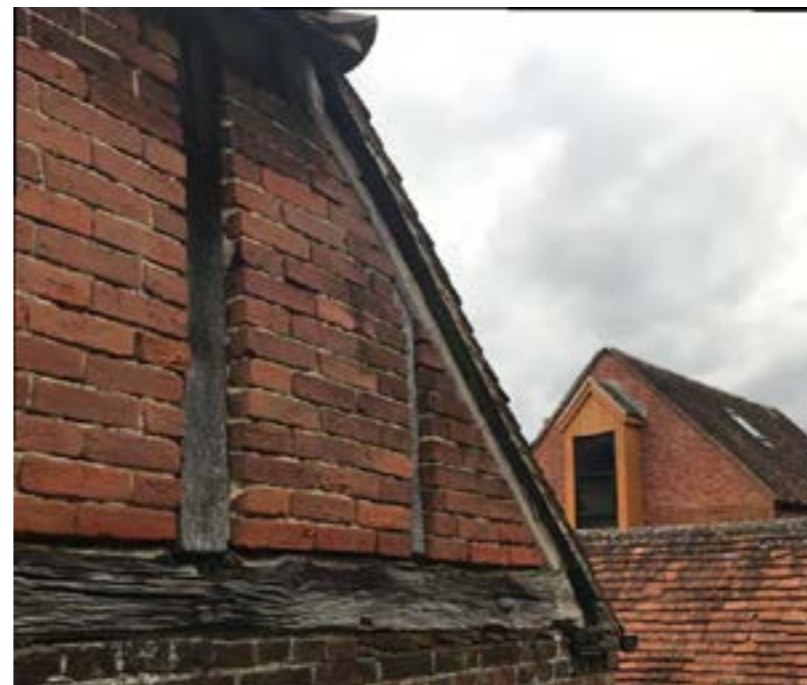
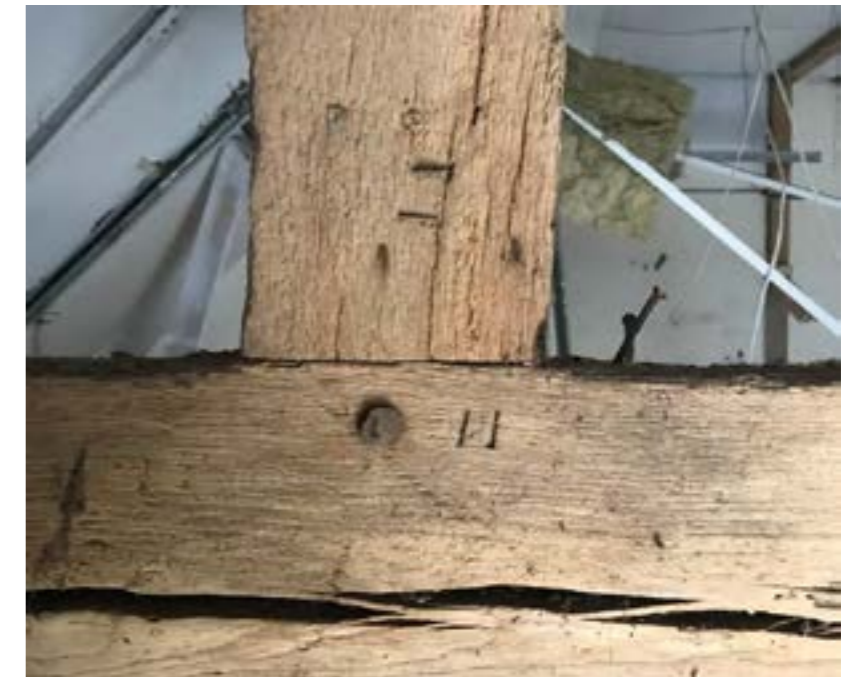
The condition of the building is poor; repairs and works to allow a new use for the building and bring it in line with contemporary standards will be substantial and costly. The annexe is very damp; the urgent priority is to dry it out, which can be achieved by ventilation and removing all cement-based components.

The lower structural walls that support the roof have been extensively repaired in the past, with evidence of stitching in the upper north-west corner of the building. Whilst these thicker walls currently appear to be sound, the narrower gable walls and infill panels that form part of the roof enclosure are falling away from the building at both ends. Crude attempts to brace the rafters so as to limit structural racking have been made at the west end of the roof.

The tie beam at the west gable is built into the wall with minimum cover to the outside face of the wall, which leaves it vulnerable to decay. This situation is a design defect that demonstrates the inconsistencies in combining the different construction traditions used for the walls and the roof. The only lasting solution is to either remove the truss and rebuild the gable in load-bearing brickwork or duplicate the exposed truss arrangement used for the opposite gable wall.

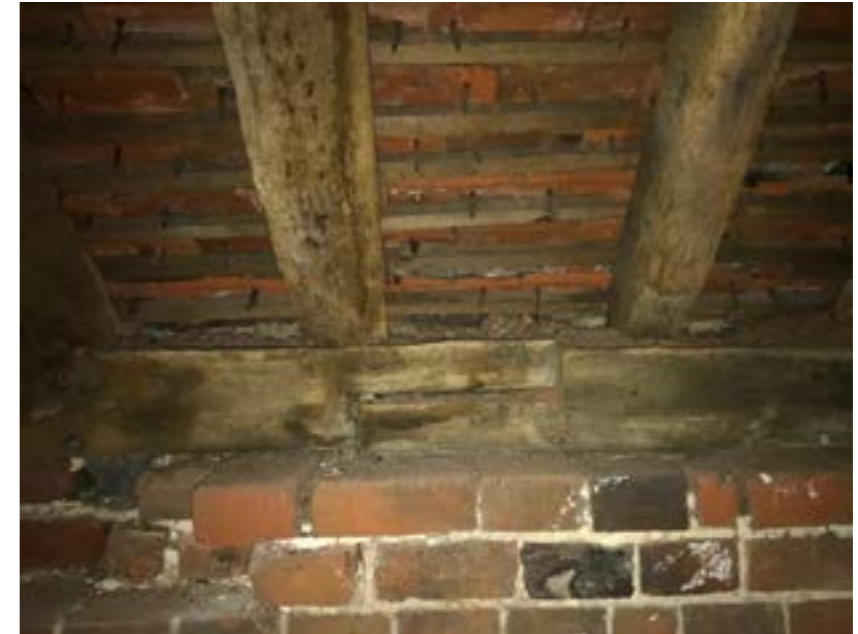
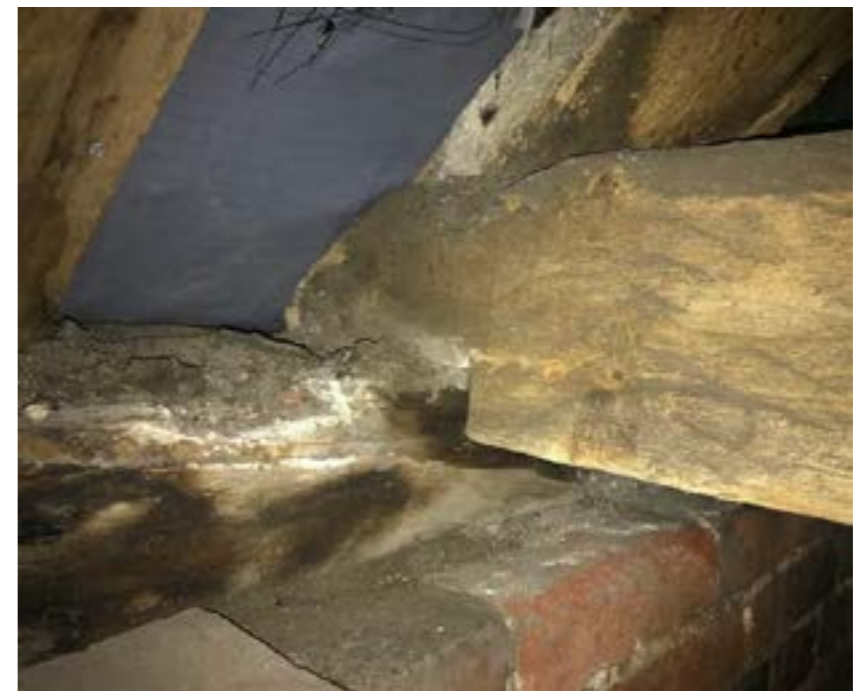
Handmade clay peg tiles are fixed to battens with ferrous roofing nails that have rusted and need replacing. There is no sarking felt or roof insulation. Plastic rainwater goods have reached the end of their life and will be replaced. The box valley gutter shared with 4 Webb House is poorly designed and leaks. It should be rebuilt with an adequate up-stand to eliminate water ingress.

Above: Handmade clay peg tiles are hung using ferrous roofing nails which have corroded  
Note size of wall plate and pegged half-lap scarf joint supported on solid brick wall  
Below: Decay to joint between tie beam and wall plate. Dovetail missing from wall plate.
