Thompson
CONSULTANCY

Arboricultural Report: Tree Condition

Client: Whitehurst, Rebecca
Site: 23 Spring Hill Terrace
Leeds
Postcode: LS6 4EY
Date: October 2023
Prepared by: Mike Kiss BSc (Hons), Dip Arb L6 (ABC), Tech Cert (ArborA), MArborA
Checked by: David Robinson FdSc (Arb), Tech Cert (ArborA), MArborA

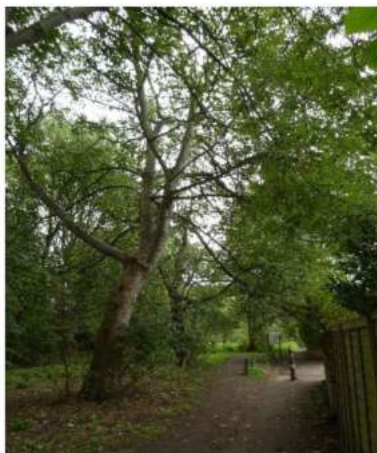
T1 Sycamore

3.4 T1 - Sycamore (*Acer platanoides*)

T1 is a mature sycamore located within the treed strip of land between Springhill Terrace and Meanwood Beck and appears to be within the curtilage of 25 Springhill Terrace. Inspection of this tree is outside the scope of this report, and it is included only for the purposes of retaining consistency between the tree numbers used in this report and those cited on the Tree Preservation Order.

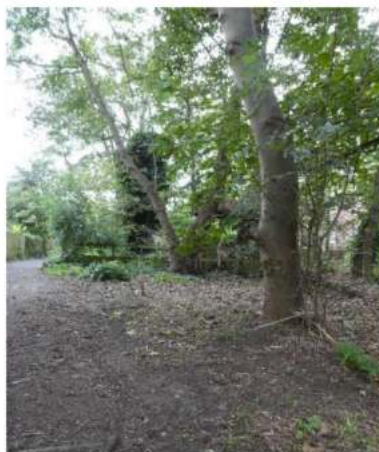
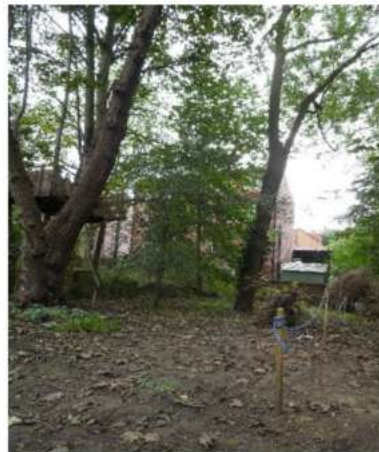
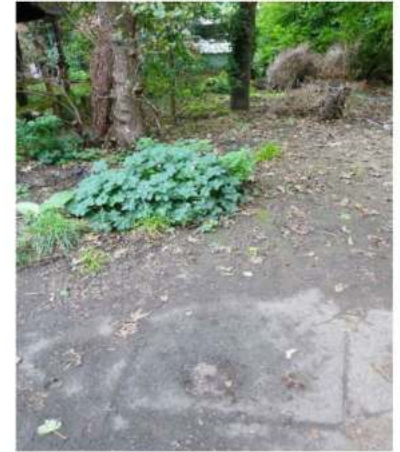
The public footpath to the west of the tree is within 3m of the base of the main stem and is hard surfaced. There is a gas service hatch within the pavement, indicative of the presence of underground services.

An area of ground approximately 2m to the south of the tree is visibly discoloured (approximately 3m x 3m). I understand that this area used for the temporary storage of spoil excavated from the formal rear garden of 23 Springhill Terrace. I understand that the spoil was removed by hand and taken to a skip located on Brookfield Road. The resulting levels appear broadly similar to those of adjacent gardens and surrounding ground. The lighter colouration of this area appears to be due to visible clays and the absence of surface organic matter (leaves, deadwood, humus).

Alder T2 has a visible taper to the base of the main stem and the buttresses are visible.

It may be beneficial to seek to improve conditions within the rooting area of the trees. This should involve removal of the small amount of residual clay spoil and application of woodchip mulch over the rooting area. This would help produce favourable conditions within the rooting zone through increasing soil moisture, increasing earthworm activity, increasing aeration, increasing soil organisms, and increasing recycling of material.

- Removal of the small amount of residual clay spoil
- Application of woodchip mulch over the rooting area of alder (T2) & ash (T3) ¹
- Regular formal inspection & informal checks for change in condition ²

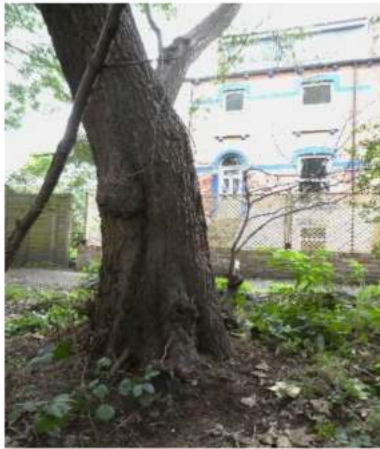
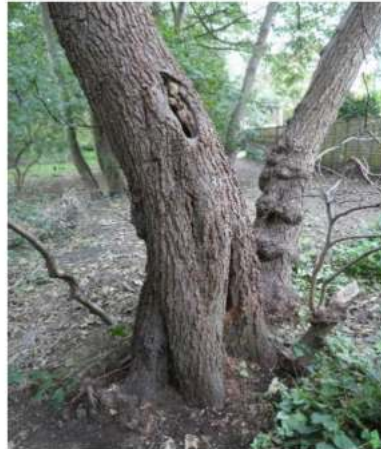
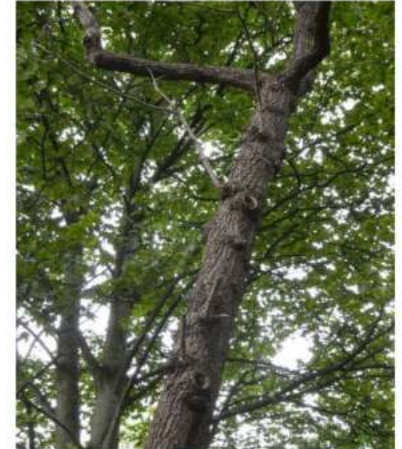
Twin stemmed tree with tight fork between stems.

The eastern stem has an open cavity from ground level to approximately 1.5m, with visible hollowing to a depth of approximately 300mm. An adventitious root is present at the base of this stem, immediately below a slightly sunken strip between the buttresses. Probing into the ground at this location was met with little resistance, indicative of decay of roots on this side.

Sounding with a nylon mallet indicates extensive decay of the buttress to the north, the sunken strip to the east and of the eastern stem to a height of at least 2m.

The eastern stem has a moderate lean to the southeast, with a small, high crown, and is partially suppressed by the adjacent sycamore and ash. The first branch is at approximately 9m. Wounds below this are indicative of historic branch failure or pruning and are partially occluded with some visible decay. An opening at 5m to the north-northeast has smoothed edges and may be used by birds or mammals.

The western stem is subdominant and has a moderate lean to the west. Sounding of the western stem doesn't indicate audible decay, and the branch architecture of this stem suggests a younger life stage.

In my assessment, alder (T2) is currently in fair physiological condition and fair to poor structural condition.

There is extensive decay of the lower part of the dominant eastern stem and northern buttress. However, the crown of this stem is small relative to the stem diameter, and well sheltered. There appears to be low to negligible target values (occupation) within the area likely impacted in the event of failure. Although the pest damage to the foliage detracts a little from the aesthetics of the tree, it is unlikely to greatly stress the tree at current levels. However, repeated attack and loss of photosynthetic area may contribute to the future decline of the tree.

In my opinion, no tree work is currently required. The crown architecture of alder (T1) is not conducive to pruning to reduce the sail area, and any removal of leaf bearing material would likely be detrimental to its longevity. It is possible that if the eastern stem were to fail, it would produce regrowth from the point of failure and the tree would live on, initially supported by the western stem.

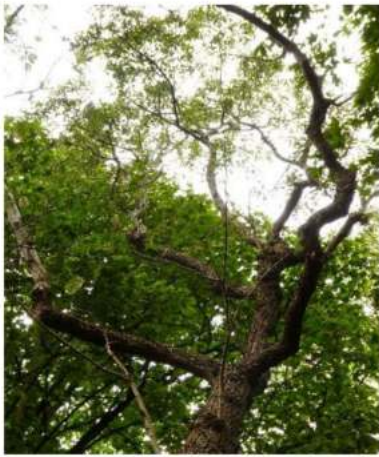
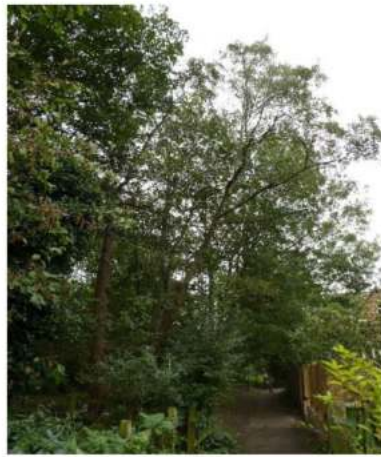
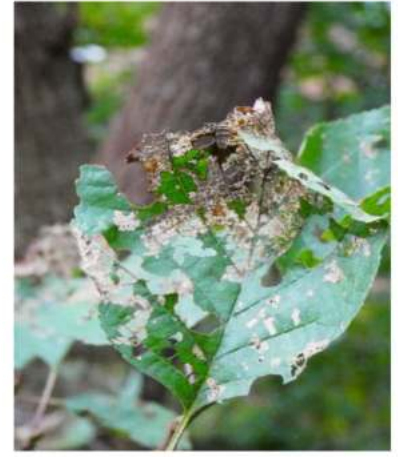
The dominant, eastern stem holds the majority of its leaf bearing twiggy growth high up at the distal ends of its branches, forming a small and high crown.

Throughout the crown, the foliage is moderately affected by pest damage. Some of the leaves show skeletal remains symptomatic of alder leaf beetle (*Agelastica alni*), and larger areas of damage symptomatic of alder sawfly (*Eriocampa ovata*). This pattern of damage is also present on other alder trees in the vicinity.

There is minor deadwood throughout the crown.

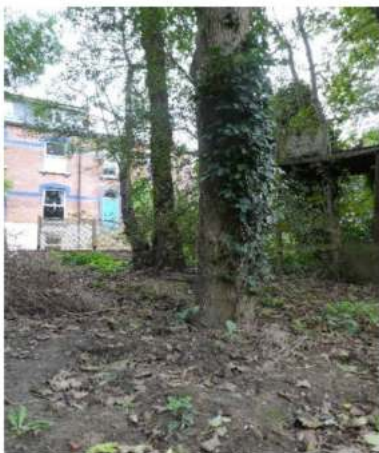
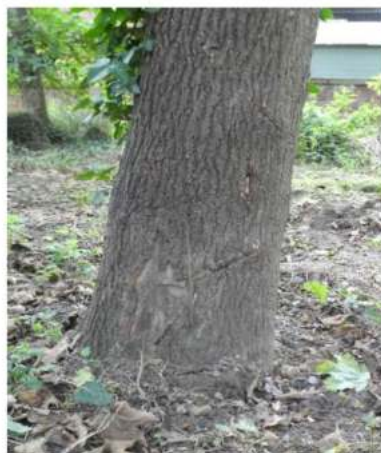
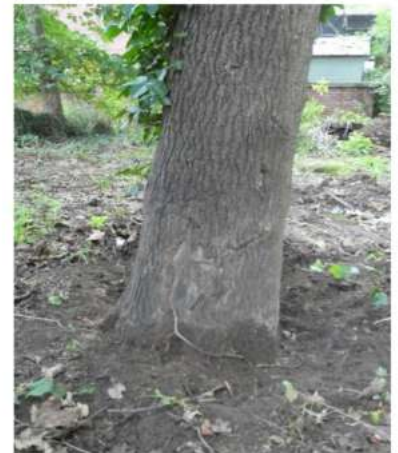
Several small areas of shallow excavations were present at the time of inspection. I understand these were related to recent metal detecting activities and undertaken with care by hand tools.

On initial inspection, the taper at the base of the main stem was barely visible above the current ground level. However, careful removal of a small amount of soil revealed a taper just below the current level.

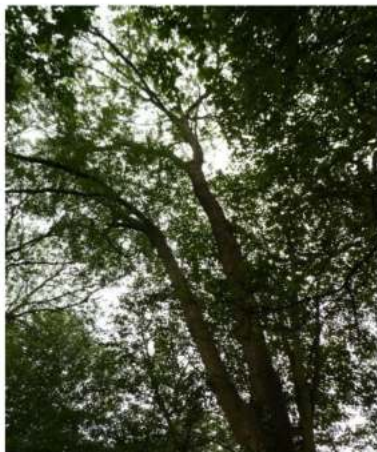
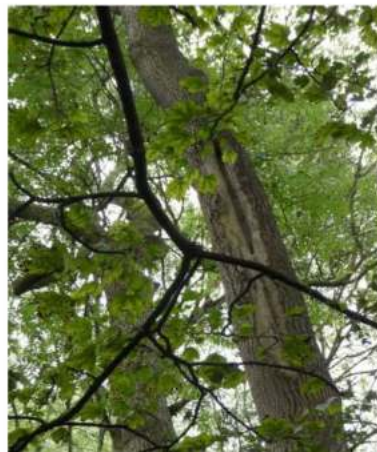
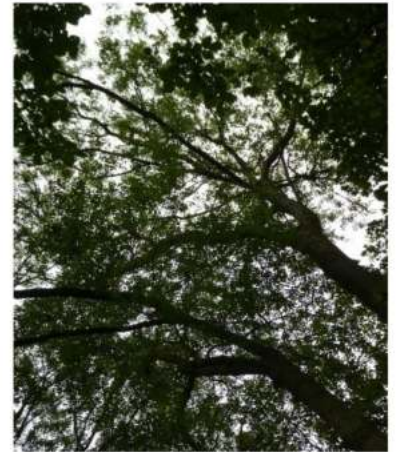
There is minor historic damage to west of main stem at ground level to a height of approximately 250mm. This appears to be superficial and is occluding well. Sounding with a nylon mallet doesn't indicate any audible decay of the lower main stem.

The main stem bifurcates at 3.5m. There is a historic wound on the western stem at approximately 5m to 7m. The lower 600mm of this wound is nearly fully occluded.

Both stems have a slight lean, and asymmetric crown biased to the southeast.

The tree is currently exhibiting symptoms consistent with very minor ash dieback: occasional undersized leaves and dieback of individual branches. Note that full assessment of ash dieback is somewhat compromised due to the height of the crown and the onset of autumn.

There is minor and major deadwood throughout the crown.

In my assessment, ash (T3) is currently in fair physiological condition and fair structural condition.

Any infection by ash dieback currently appears to be very minor and / or the tree is tolerant of the disease. However, I recommend that regular informal checks are made due to the potential for rapid decline in condition. Symptoms of ash dieback include leaf wilt, leaf loss, crown dieback and bark lesions. Epicormic shoots are often formed as a stress response on affected trees and result in a bushy appearance in the crown. Of key importance regarding structural tree condition is the associated embrittlement of the wood, potential for multiple entry points and the reduction in tree vitality which promotes conditions for secondary infection by pathogens such as honey fungus (*Armillaria mellea*) and wood decay fungi such as giant ash bracket (*Perenniporia fraxinea*) or shaggy bracket (*Inonotus hispidus*).

² I recommend that all trees are formally reinspected within three years of the date of this report. In addition, I recommend that regular informal checks are made for obvious changes in condition or presence of annual fungal fruiting bodies. Checks should also be carried out after high wind events. If any defects are noted or there is a significant change in condition from the benchmark set out in this report, then a suitably qualified arboriculturist should be consulted.
