HERITAGE STATEMENT

WEST PIER,
SCARBOROUGH

JULY 2023

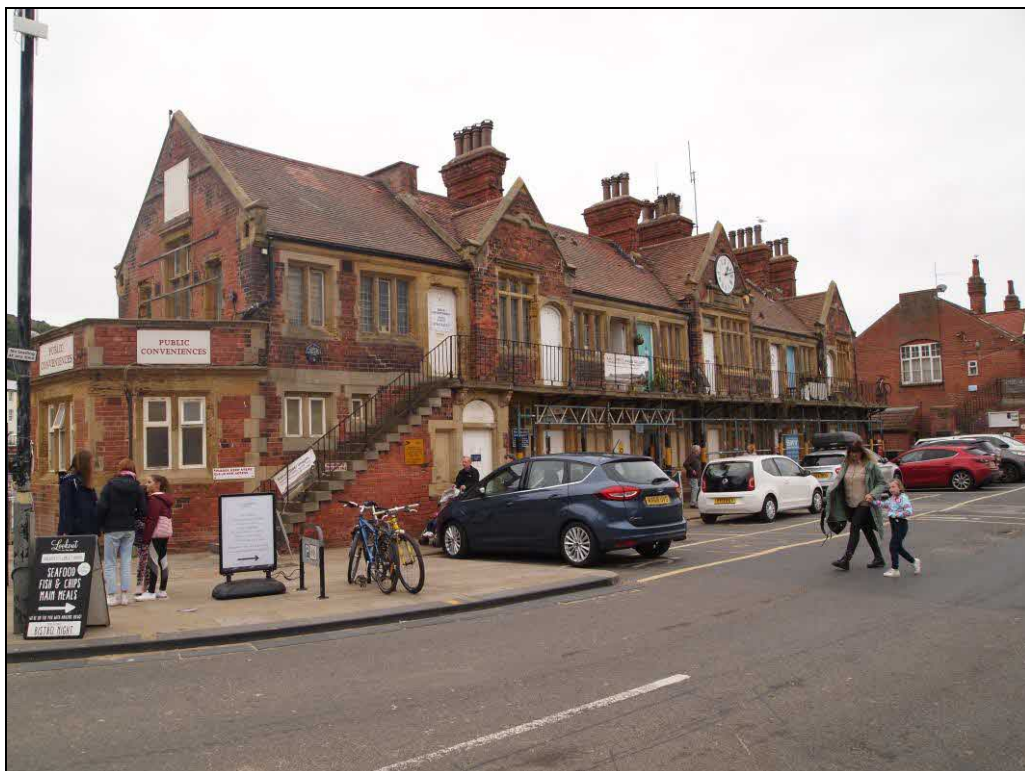
Figure 5: Building 1 front elevation.

- d There is a cantilevered stone balcony across the front elevation with metal railings. The balcony is currently supported on "Acrow" props and scaffolding.
- e The original structure has 3 No. pedimented gables finished with a sandstone capping with kneelers. There is a clock to the central gable.
- f Doors are timber batten set into stone reveals and heads, some with curved heads. The windows comprise lead came glazing set into metal casements.

- a Building 1 is currently in a poor state of repair with deterioration of both the internal and external fabric which will require attending to as part of any development works.

- b Externally the stone dressings forming the door and window openings and to the pedimented gables are in poor condition with severe erosion caused by wind scour of the bed faced stone. The decayed/eroded sections of stone will need to be removed and replaced with new sandstone selected to match the existing for colour and texture.

- c The elevations are formed with a soft brick which has been repointed previously with a cement gauged mortar. The mortar is causing the accelerated erosion of the brickwork to parts of the front elevation and the pointing will be raked out and replaced with a traditional lime mortar where needed to prevent further erosion. Previous repairs have been made using a modern brick. Badly eroded bricks will be replaced with a handmade red clay brick to match.

- e The balcony and stairs are formed in stone with modern concrete elements where previous repairs/alterations have been made. The balcony is in an unsafe condition and is propped temporarily with a structural scaffold.

- f The steps on both sides of the balcony have been refurbished in the past and are formed with a modern clay brick walling, with the stone treads set into concrete steps. The metal railings fixed to the balcony and steps are deteriorating through corrosion.

- k The balcony and railings are in poor condition and shall be removed along with the steps to the north end and the steps and brick structures to the south end. A glass structure is proposed to the west (front) elevation across the elevation at ground floor level. The roof of this structure will form a new balcony/terrace which will step out sufficiently to allow for additional covers externally.

- m The current condition of the steps, balcony and railings necessitates their repair/replacement. The new steps and railings match the existing features in material and scale but the opportunity has been taken to increase the useable floor space by extending the balcony over the new glass structure on the ground floor creating a terrace.

Proposed Works	Impact on Significance	Mitigation to reduce harm on setting
Building 1			
6.1.1	Replacement of decayed/eroded stone dressings to door and window openings.	Positive – The eroded sections of stone impact on the visual appearance of the building and its structural integrity. Consolidation of the historic fabric will help maintain the building for the future.	Cut out the eroded sections of stone dressing and replace in sandstone to match existing, bedded in a traditional lime mortar.

6.1.2	Replacement of decayed/eroded stone dressings to the pedimented gables.	Positive – The eroded sections of stone affect the visual appearance of the building and its structural integrity.	Carefully remove by hand the eroded sections of stone and replace in sandstone to match existing bedded on a traditional lime mortar. Consider inserting lead dressings to improve permeation of rainwater into the fabric.

6.1.3	The elevations are pointed in a cement gauged mortar which is causing accelerated erosion of the brickwork. Rake out and repoint brickwork.	Positive – The cement mortar is causing deterioration of the soft brickwork. Repointing will arrest any further deterioration.	Carefully rake out cement gauged pointing and repoint with a traditional lime mortar. Any raking out to be carried out by hand to prevent damage to the brick edges. No mechanical tools will be allowed.

6.1.4	Replacement of badly eroded brick.	Positive – The eroded bricks affect the visual appearance of the building and will lead to further deterioration.	Carefully cut out by hand eroded brickwork and replace with new handmade clay bricks to match in size, colour and texture, bedded in a lime mortar.

6.1.6	Remove the existing balcony.	Negative – Loss of historic fabric. The balcony is part of the original design providing access to the upper rooms. The existing fabric is in a badly deteriorated condition and is supported by a temporary structural scaffold.	Take down and remove the defective and dangerous balcony structure. A new balcony structure shall be provided.

6.1.9	Remove the metal railings to the balcony and stairs.	Negative – Loss of historic fabric. The metal railings are part of the balcony. The metal railings are corroded and are in poor condition.	Remove the defective metal railings. New railings shall be incorporated in the new proposals.
