HERITAGE STATEMENT

WEST PIER,
SCARBOROUGH

JULY 2023

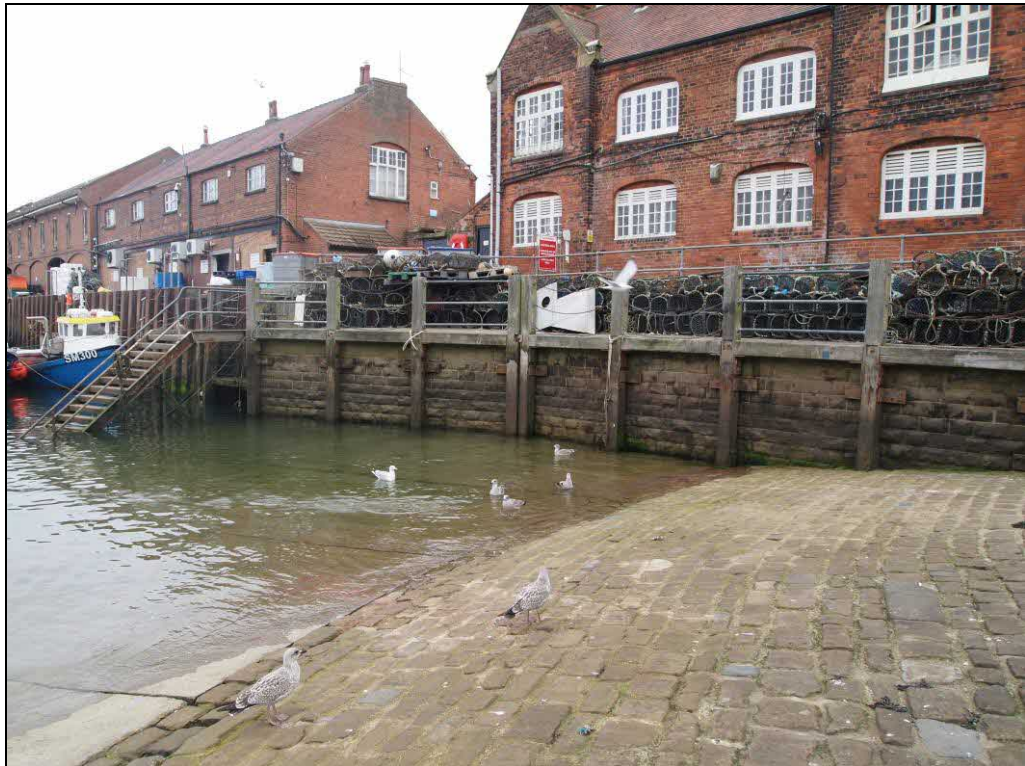
Figure 3: Sandstone wall possibly from original pier structure built in 1817.

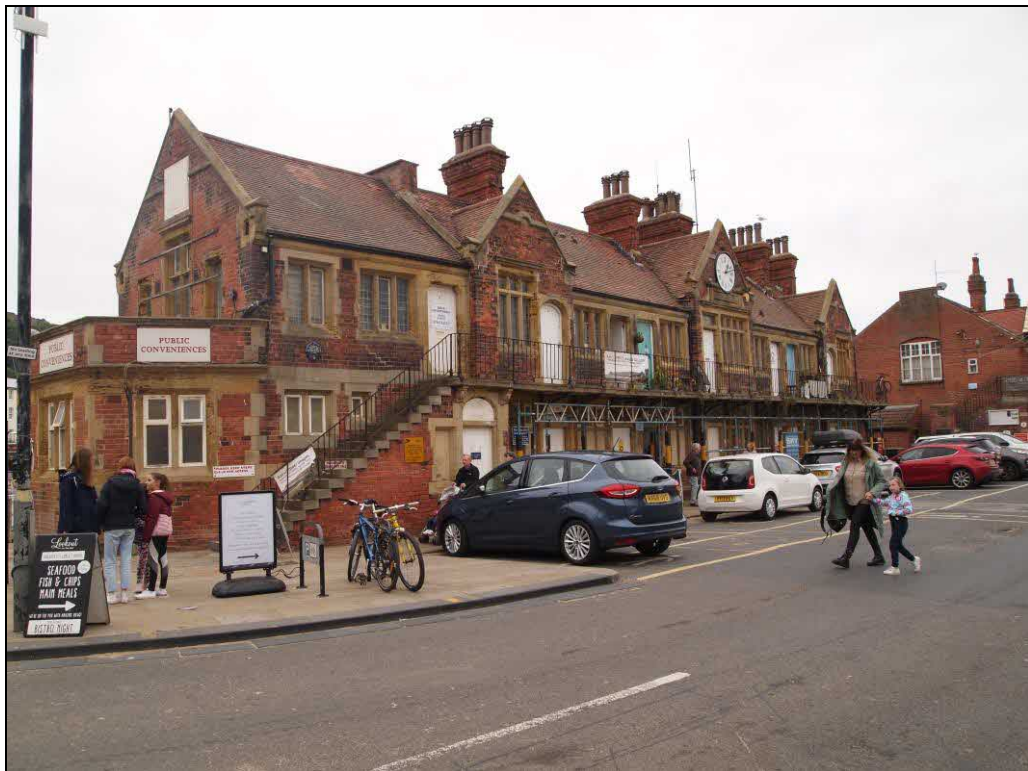
Figure 5: Building 1 front elevation.

- d There is a cantilevered stone balcony across the front elevation with metal railings. The balcony is currently supported on "Acrow" props and scaffolding.
- e The original structure has 3 No. pedimented gables finished with a sandstone capping with kneelers. There is a clock to the central gable.
- f Doors are timber batten set into stone reveals and heads, some with curved heads. The windows comprise lead came glazing set into metal casements.

- a Building 1 is currently in a poor state of repair with deterioration of both the internal and external fabric which will require attending to as part of any development works.

- b Externally the stone dressings forming the door and window openings and to the pedimented gables are in poor condition with severe erosion caused by wind scour of the bed faced stone. The decayed/eroded sections of stone will need to be removed and replaced with new sandstone selected to match the existing for colour and texture.

- c The elevations are formed with a soft brick which has been repointed previously with a cement gauged mortar. The mortar is causing the accelerated erosion of the brickwork to parts of the front elevation and the pointing will be raked out and replaced with a traditional lime mortar where needed to prevent further erosion. Previous repairs have been made using a modern brick. Badly eroded bricks will be replaced with a handmade red clay brick to match.

- e The balcony and stairs are formed in stone with modern concrete elements where previous repairs/alterations have been made. The balcony is in an unsafe condition and is propped temporarily with a structural scaffold.

- k The balcony and railings are in poor condition and shall be removed along with the steps to the north end and the steps and brick structures to the south end. A glass structure is proposed to the west (front) elevation across the elevation at ground floor level. The roof of this structure will form a new balcony/terrace which will step out sufficiently to allow for additional covers externally.

- m The current condition of the steps, balcony and railings necessitates their repair/replacement. The new steps and railings match the existing features in material and scale but the opportunity has been taken to increase the useable floor space by extending the balcony over the new glass structure on the ground floor creating a terrace.

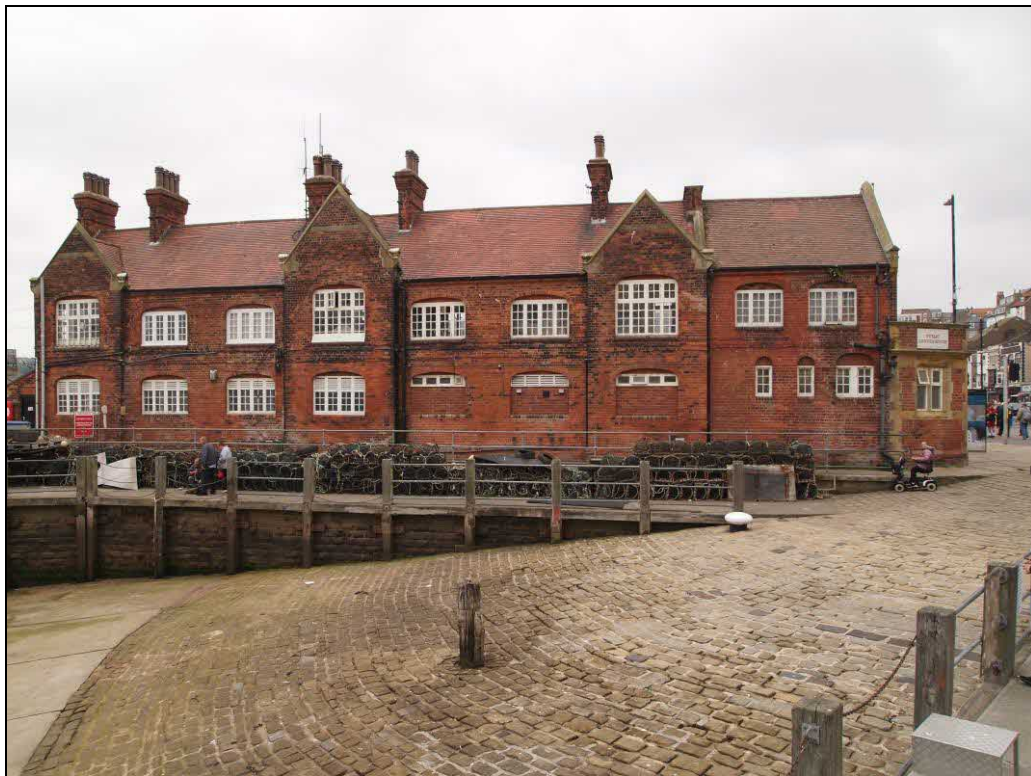
Figure 6: Building 1 rear elevation.

- i The south gable is plain with stone capping to the head of the gable and chimney stack at the ridge. There is a single timber casement window to the right side of the elevation. The opening has been altered but the brick arch detail remains to the head.
- j Stone steps to the left side access the balcony. There is an attached single storey brick built store to the right side with pantile covered mono pitched roof. There is a further small brick building adjacent with flat roof. These are later additions.

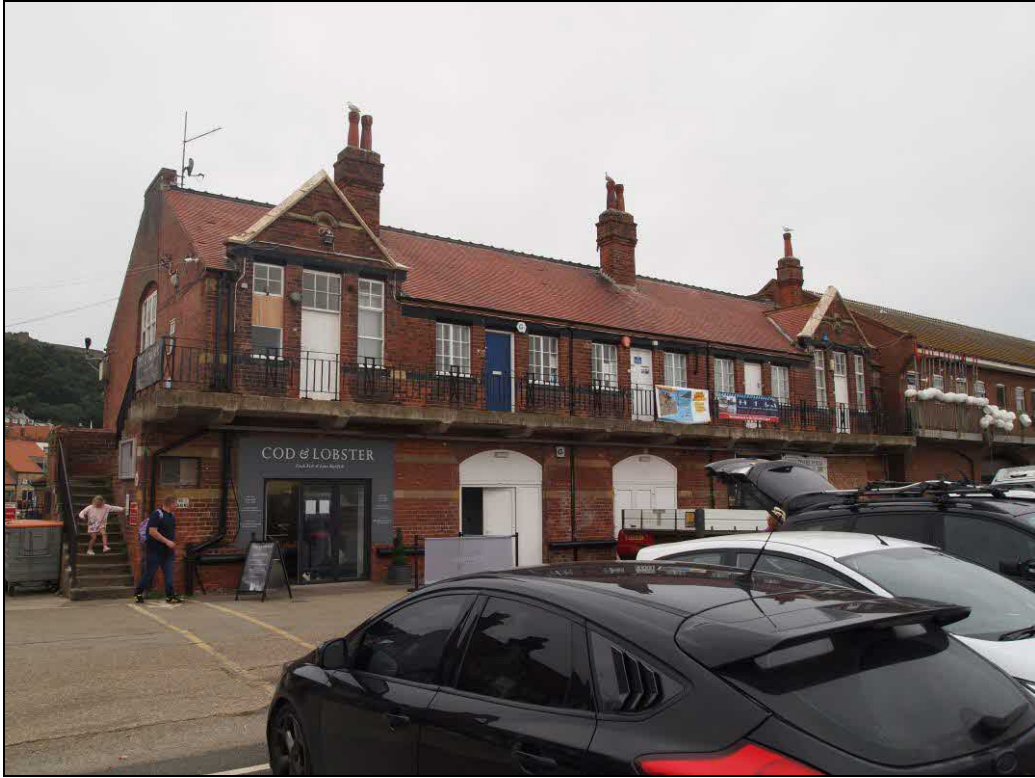
Figure 9: Building 2 front elevation.

- h The rear (east) elevation is a plain brick façade. The first floor brick panel is supported on supported on a full length steel beam. There are timber casement windows set in brick reveals with brick arched head and stone cills.
- i The ground floor openings have been infilled with brick panels. Modern openings have been inserted to the right side of the elevation with concrete lintels over.
- j The south gable is a plain brick façade sited close to the north gable of Building 3. The space is infilled with modern metal steps and walkway serving both of these buildings.

- a Building 2 is currently in a reasonable state of repair but some deterioration is occurring to both the internal and external fabric. This will require attending to as part of any development works.

- b The stone dressings to the door and window openings and also to the gable features are beginning to erode and the worst affected sections shall be cut out and replaced in new sandstone to match.

- c The brickwork is generally in sound condition but there are a small number of areas where the brickwork is eroded and failing. The badly eroded bricks shall be carefully removed and replaced with a new clay red multi to match.

- h The cast iron rainwater goods are in poor condition and sections are missing. The gutters and downpipes will be taken down and replaced in

- i The timber windows are deteriorating through wet rot rendering the windows beyond economic repair. The worst affected windows will be removed and replaced with new to match.
