Arboricultural Report

Arboricultural Impact Assessment A9 Braco Services, Balhaldie

Date: October 2023

ADAS Ref: 1052216

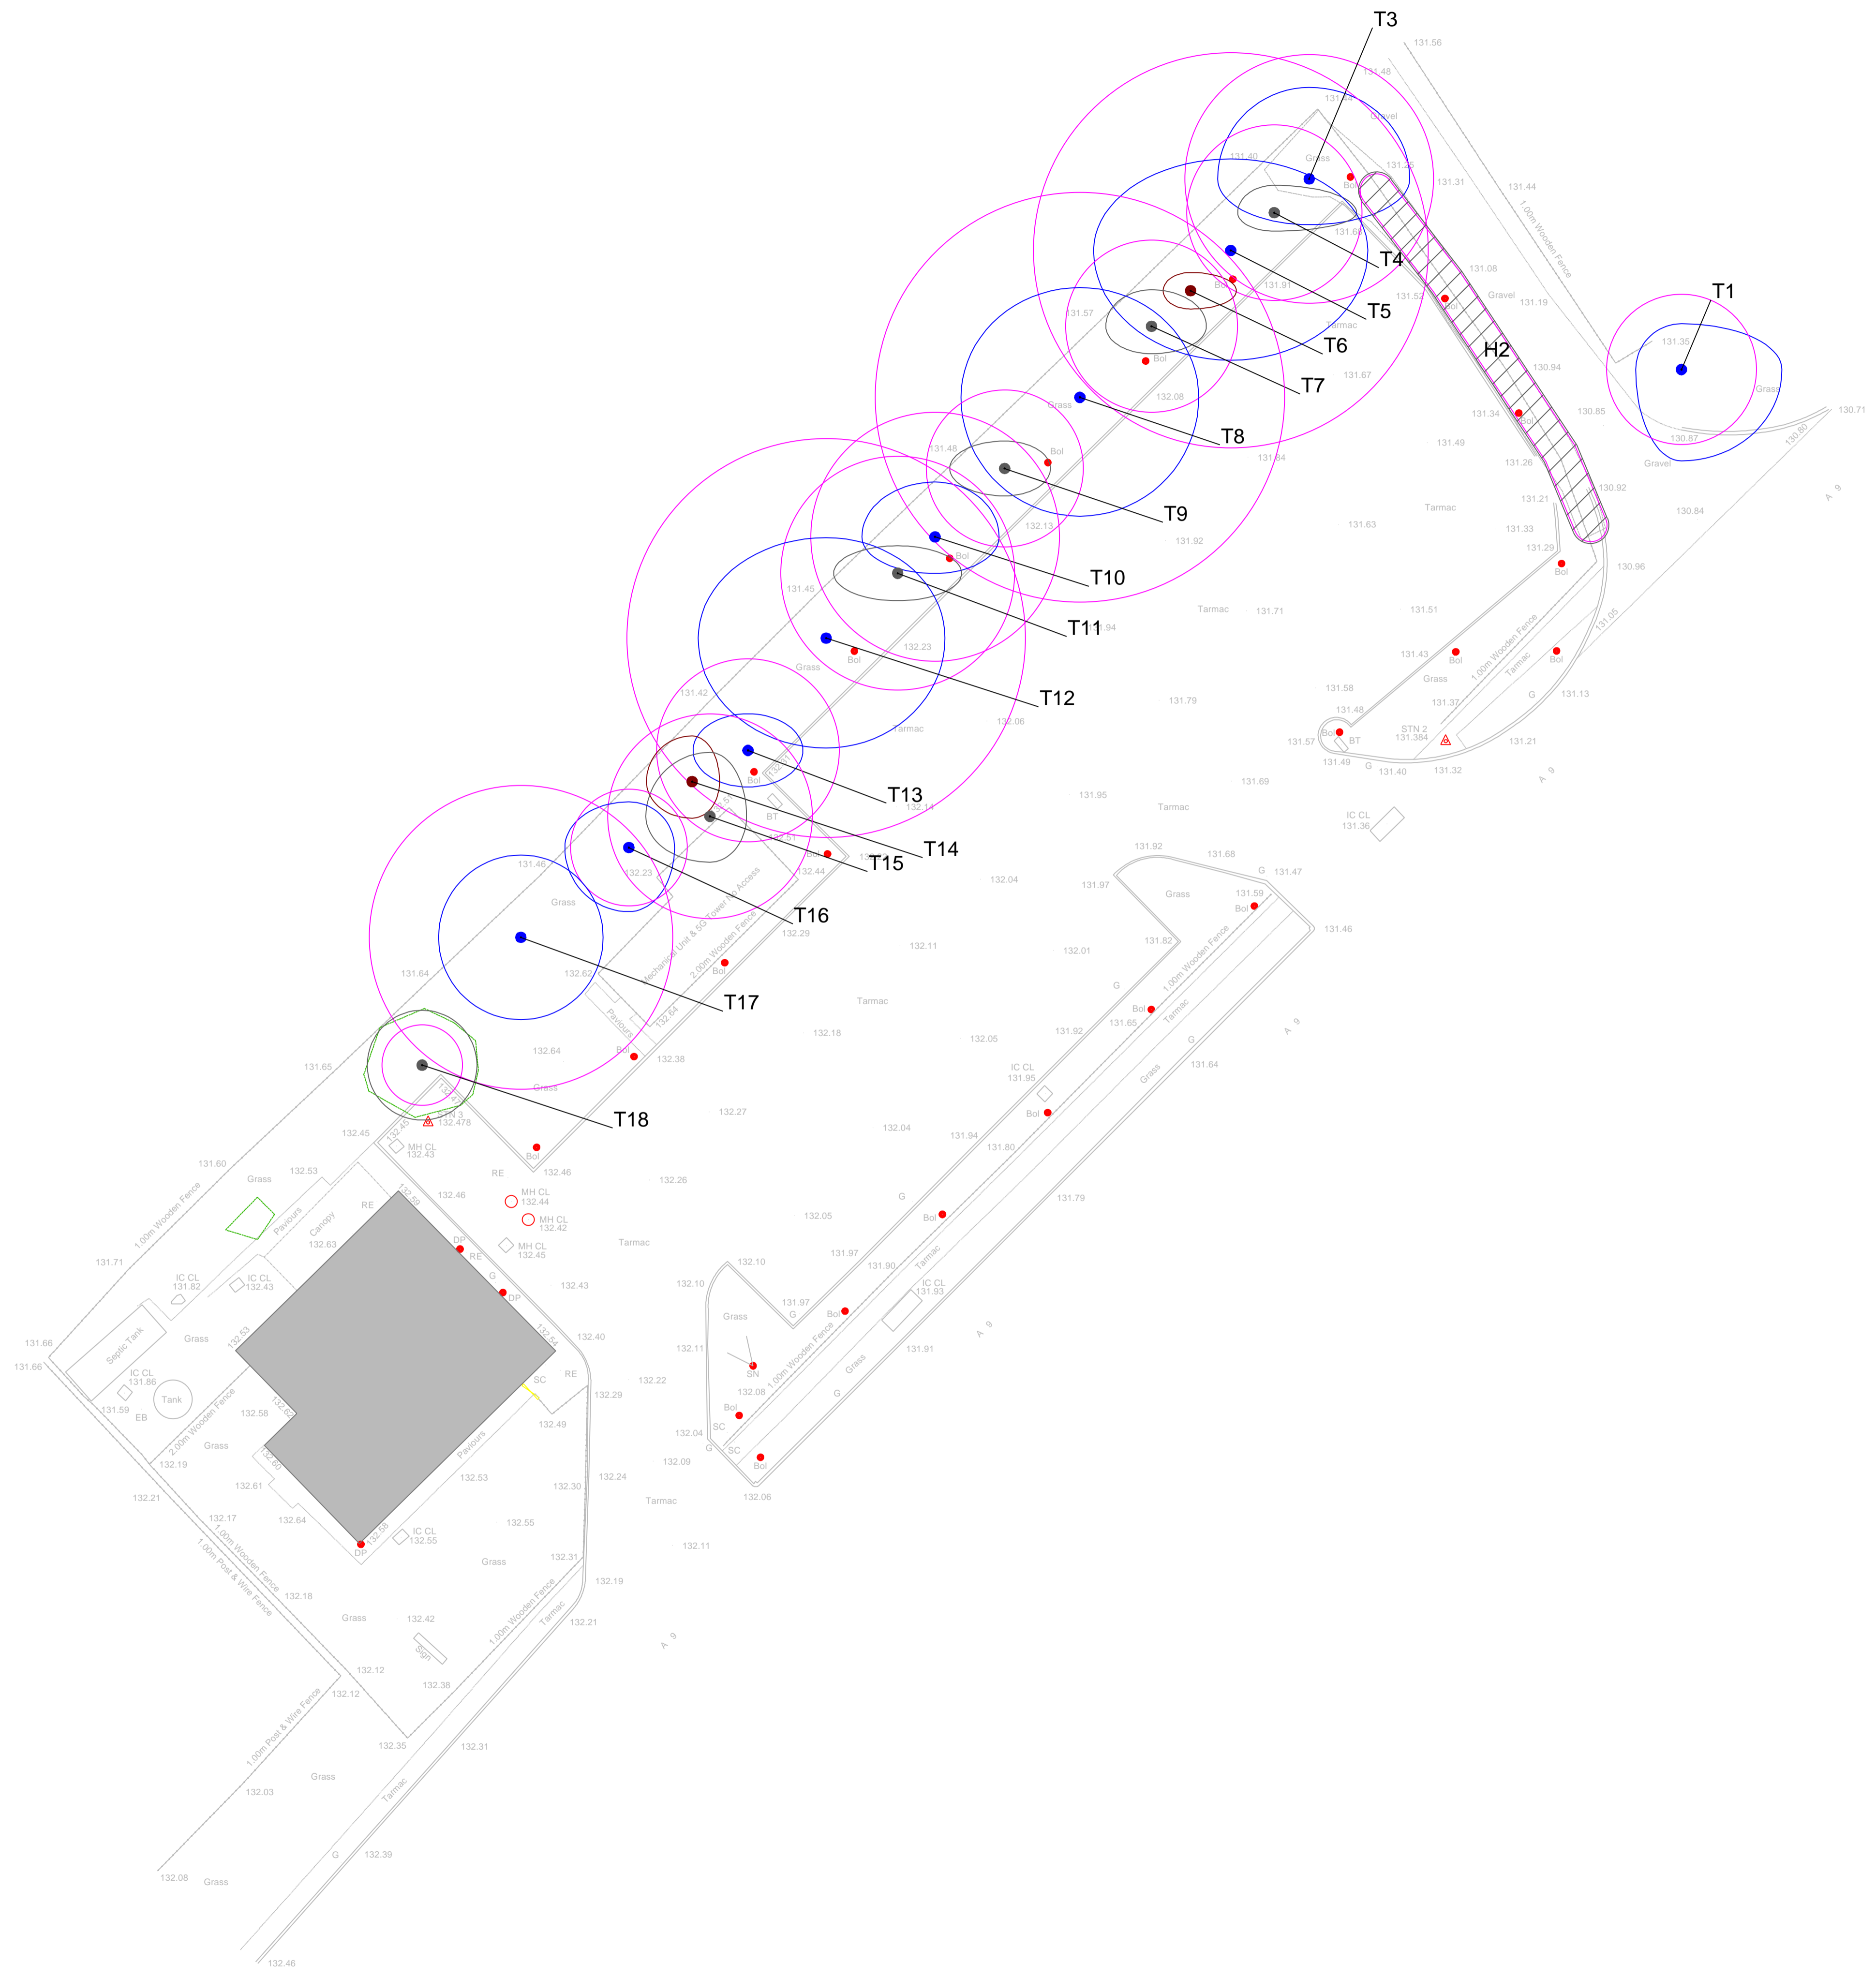
Appendix 3: Tree Constraints Plan

Of the 18 features surveyed, none were of a high quality (category A), nine were of a moderate quality (category B) and seven were of a low quality (category C). Two trees were assessed as being unsuitable for retention (category U).

The proposed development will not require the removal of any of the surveyed trees to facilitate its implementation. However, the removal of the two category U trees (T6 and T14) is recommended for reasons of sound arboricultural management.

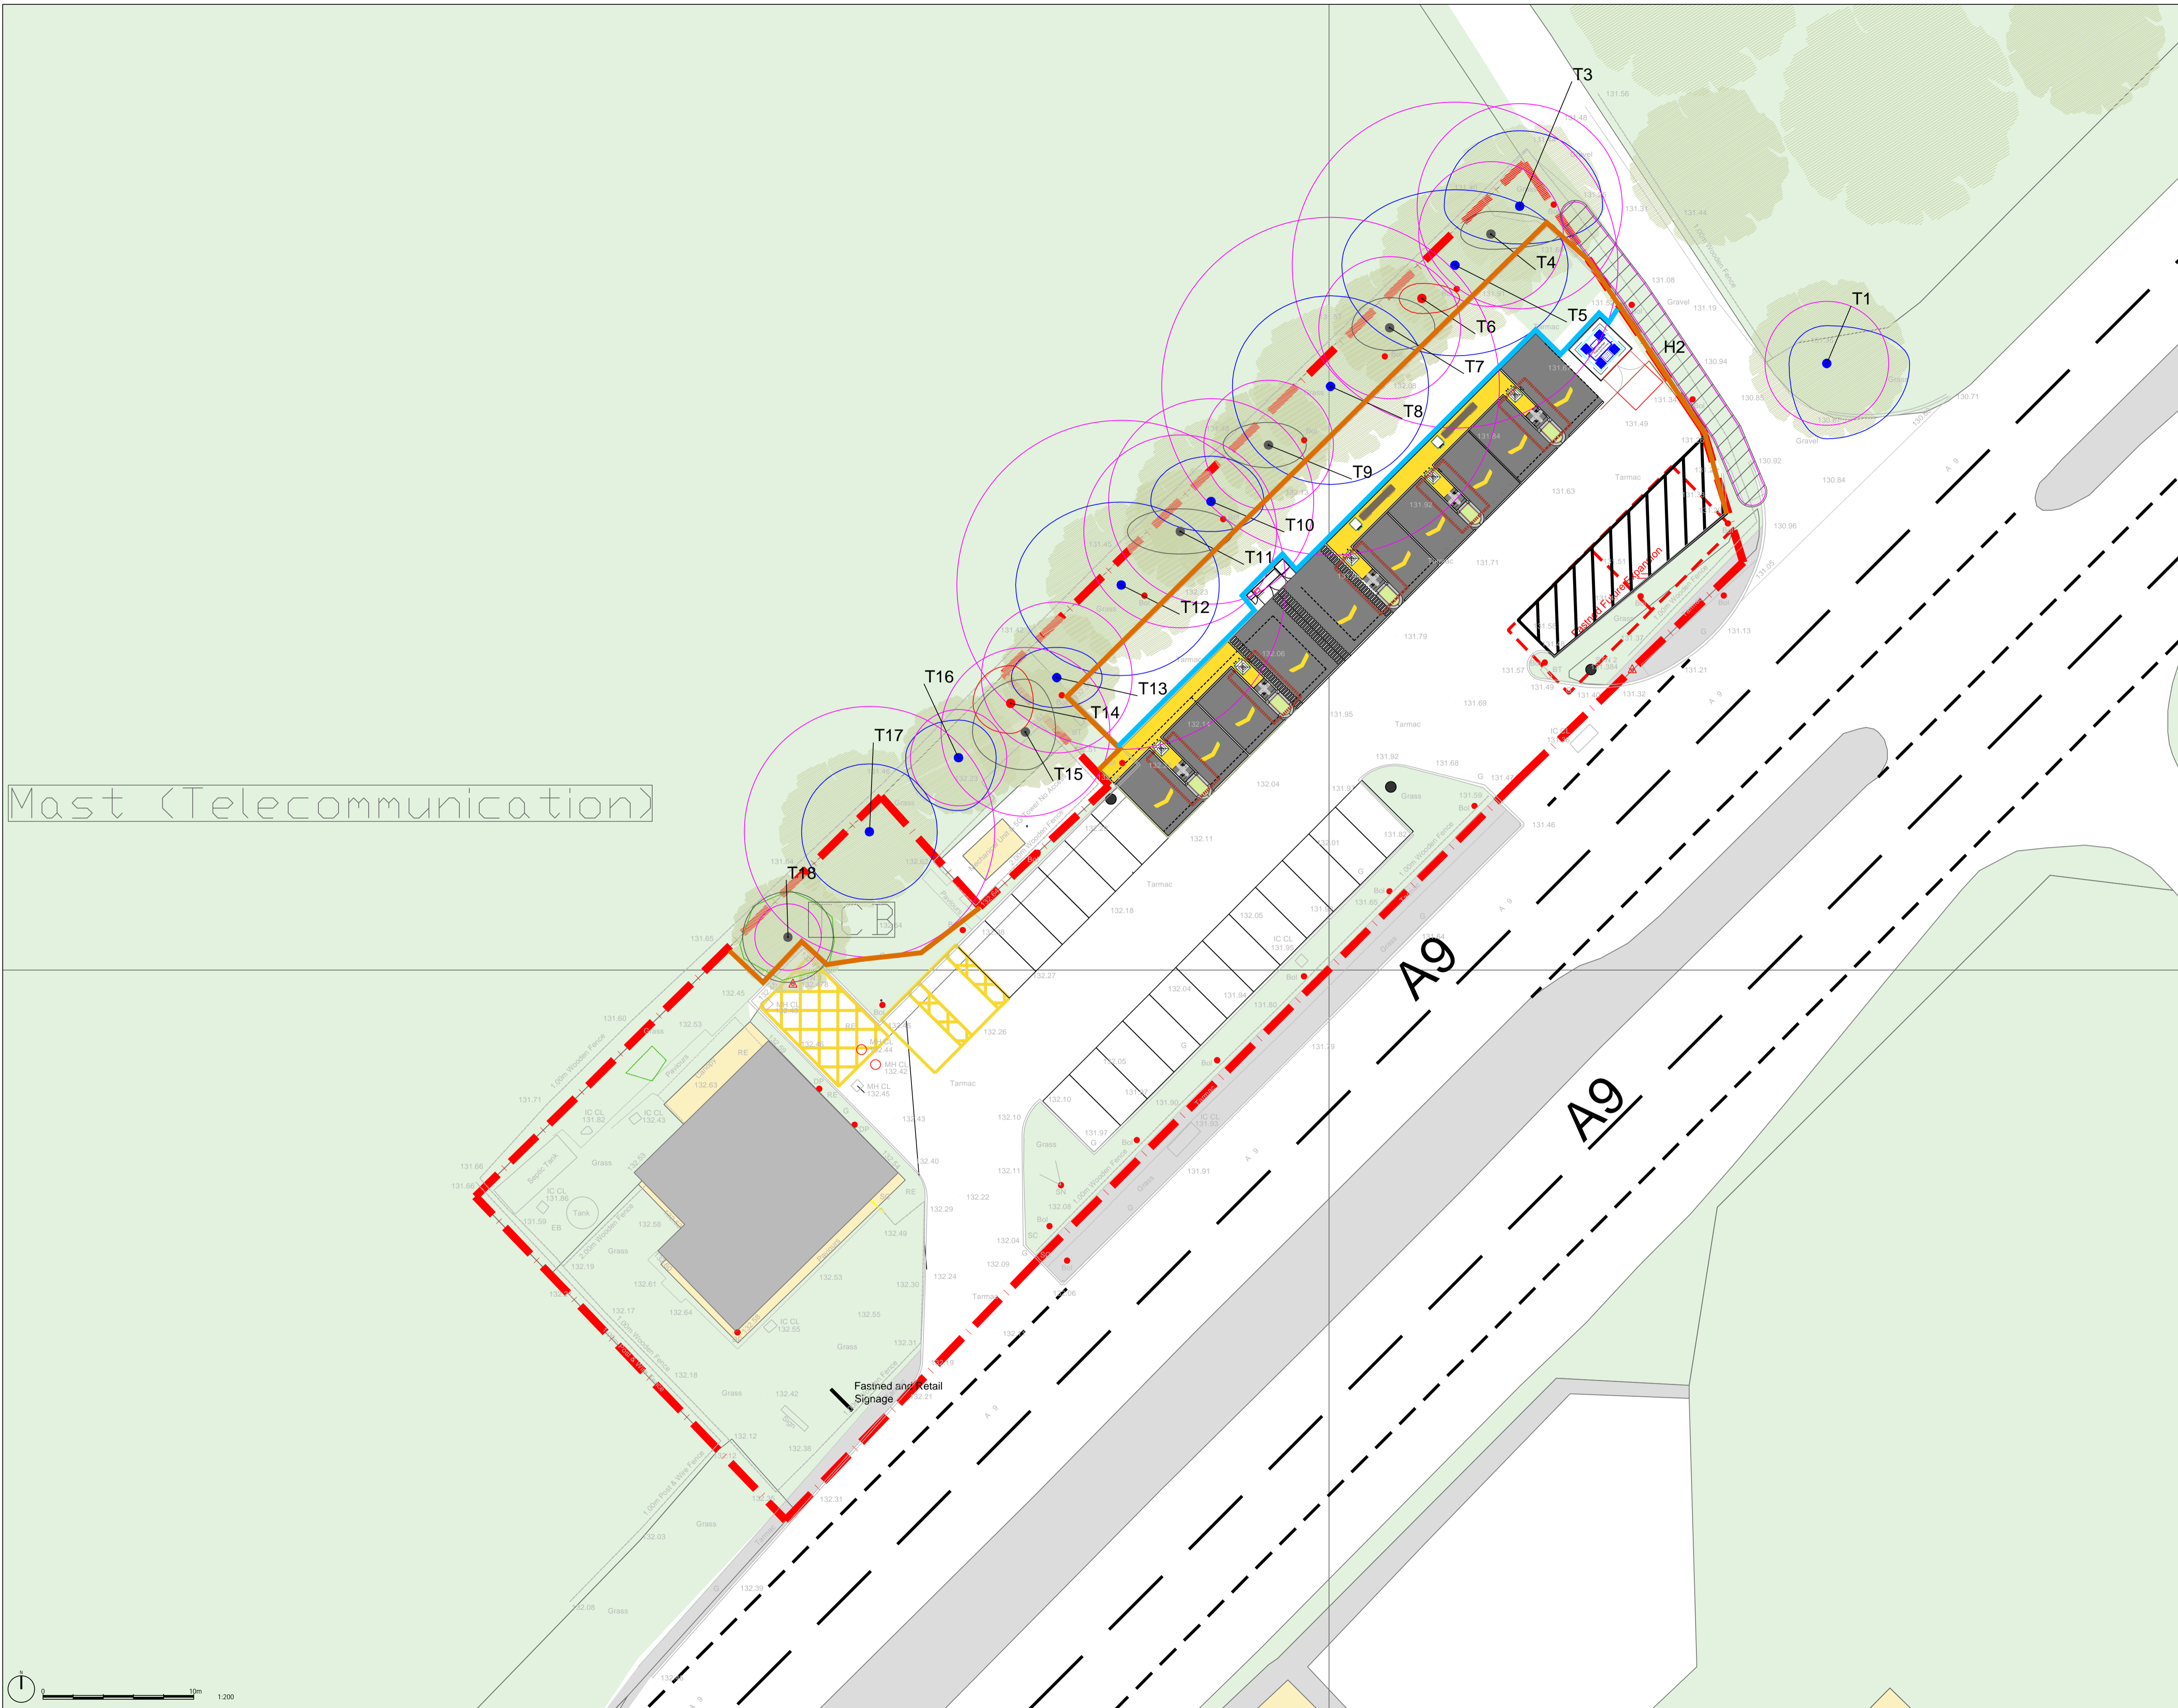
Appendix 4: Arboricultural Impact Assessment Plan

Overall, it is considered that subject to precautions in detailed design, the proposed development will have minimal potential to cause significant harm to the root systems of retained trees.

The proposed development will require localised excavations within the RPAs of five retained trees (T5, T8, T10, T11 and T12) to facilitate construction of the new canopies, transformer station, feeder pillars and associated cable runs. These works all occur within sections of the RPAs that are currently hard surfaced in areas where root development is likely to have been impaired by suboptimal growing conditions. It is considered that the potential for significant harm to occur to the retained trees from these operations is likely to be within tolerable limits subject to the adoption of some precautions in detailed design and adherence to appropriate working methodologies, under arboricultural supervision, at construction stage.

The proposed development will not require the removal of any trees within the site to facilitate its implementation, however it is recommended that the two dead category U trees (T6 & T14) are removed for safety reasons as they are within falling distance of the proposed development.
