TREE SURVEY TUDOR COTTAGE WEDMANS LANE ROTHERWICK HAMPSHIRE RG27 9BN

TREE SURVEY

TS22-1

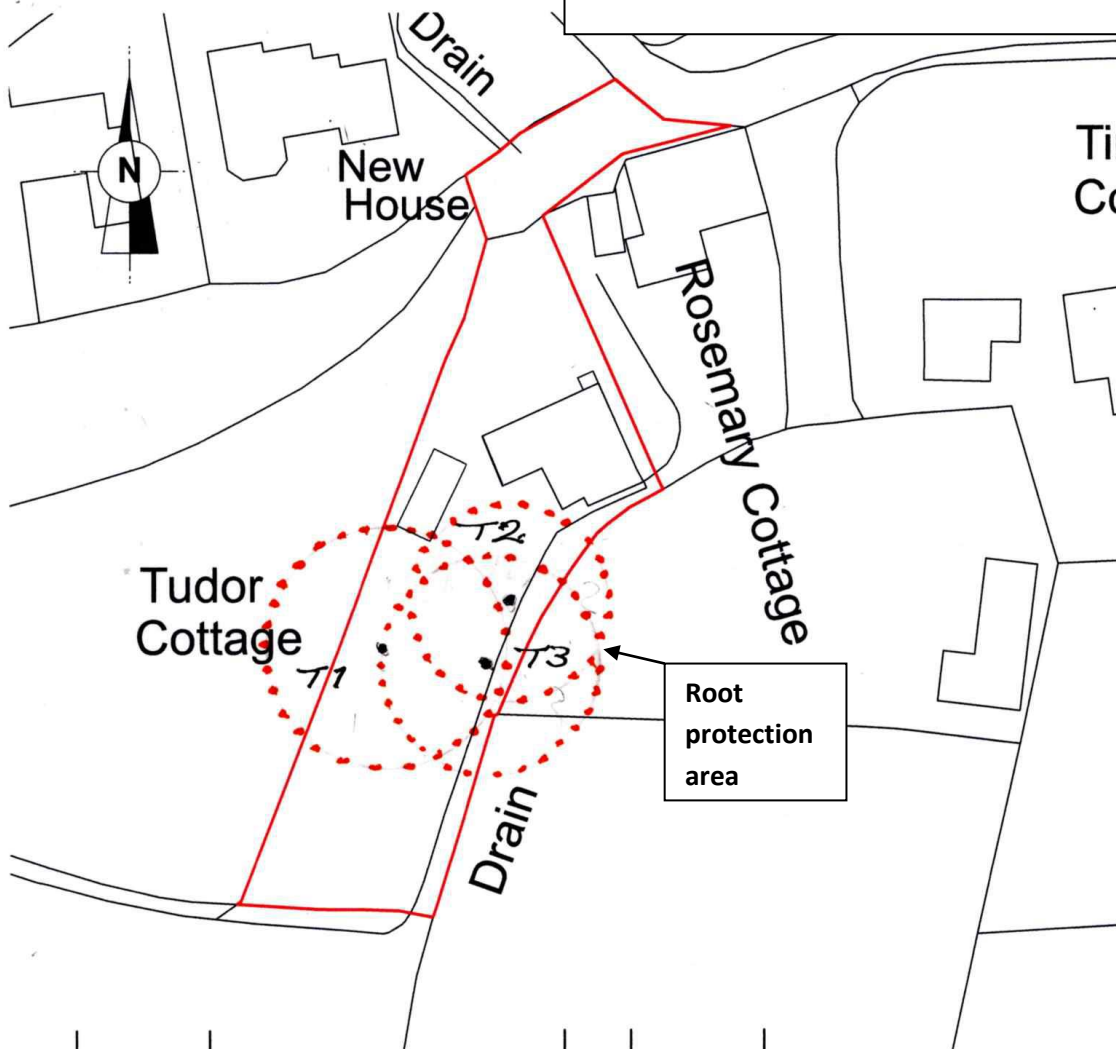
The RPA would require a circle around the tree with a radius of 12 times the diameter of the tree left undisturbed to protect roots. This would need to be considered for any development proposal to ensure trees are given maximum protection. The RPA of the trees are plotted on the plan, TS22-1, on page 4.

The British Standard recommends a fence on the RPA line should be erected to protect any tree to be retained with the construction details of this fence following the recommendations of the BS 5837, i.e. a strong scaffolding framework with either plywood boarding or a strong mesh attached firmly to the fence. It will not be possible to erect such a protective fence as the RPAs of any of the three Lawsons as they are already close to the existing garage which is to be replaced with a larger structure.

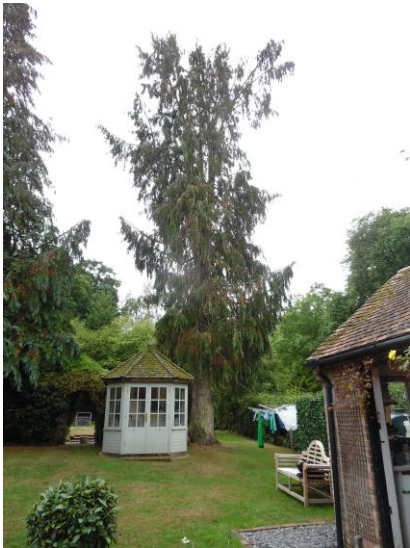
This is a mature tree growing near the centre of the garden immediately behind a small summer house. It is a prominent feature but the canopy does appear to be rather thin and showing signs of dieback. There is a cavity on the south west side of the trunk and a probe penetrated 200mm. This cavity has not decayed sufficiently to weaken the structure of the tree. The tree will need to be monitored as it may continue to decline over the next few years health.

T1, looking south.

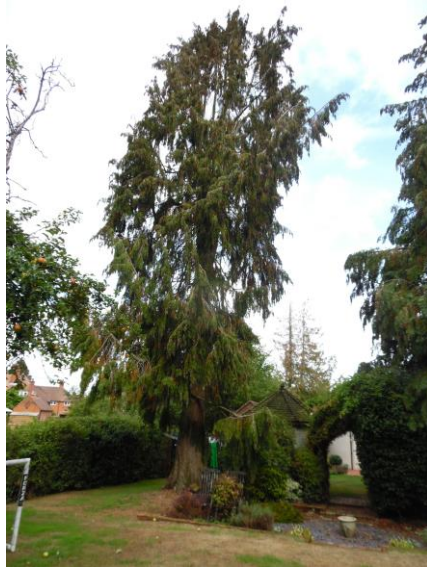
T1 from the north.

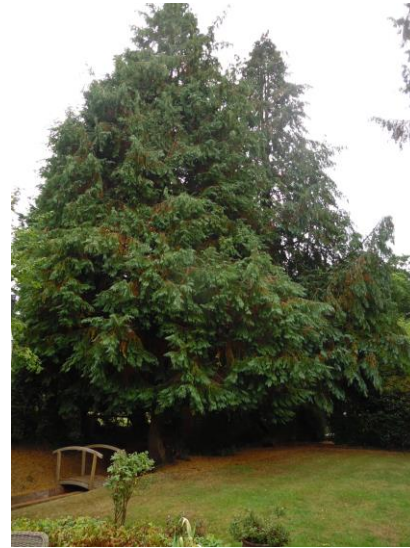
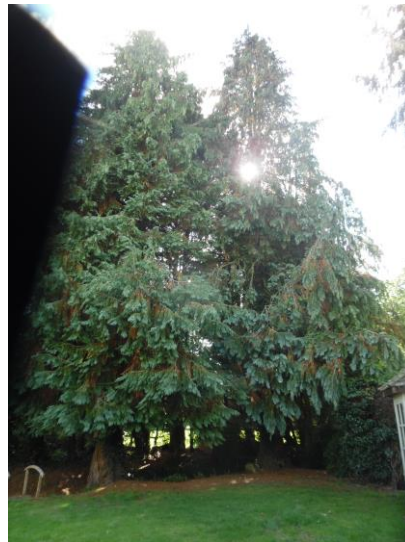
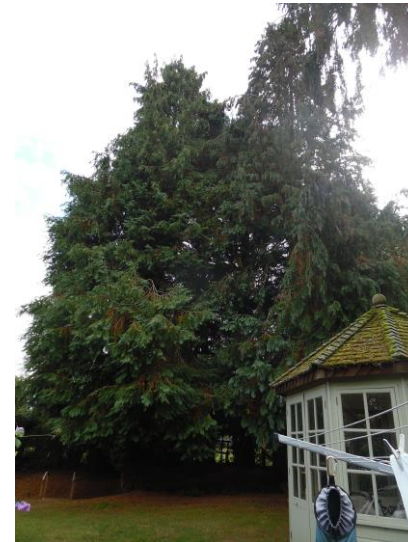
This is a mature tree growing near the east boundary. It is on the western edge of a drainage ditch which is approximately 1 metre deep. It appeared to be in good condition and is a prominent feature.

T2 & T3.

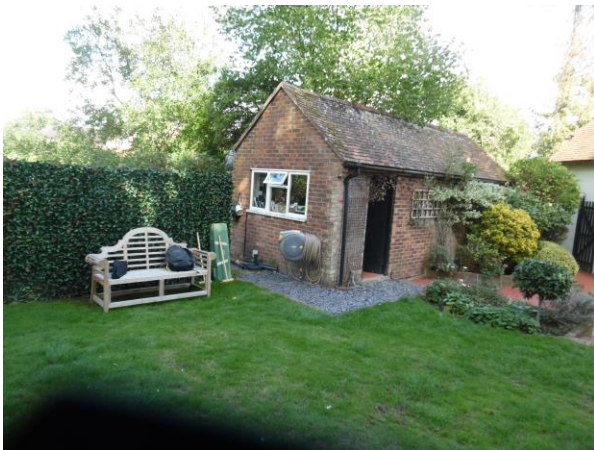
The existing structure.

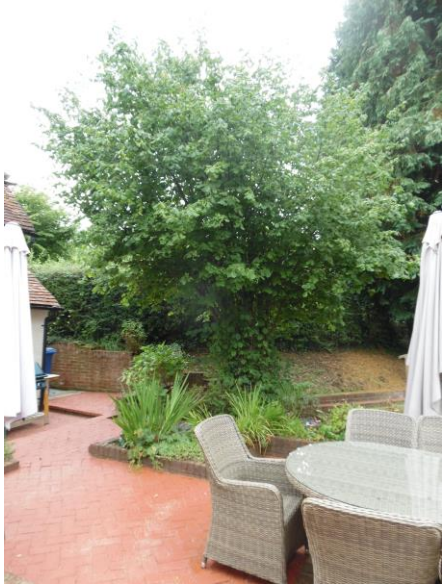
There are two large Hazel coppice stools in the garden, one to the immediate west of the garage and one to the east, close to the drainage ditch and the patio, south of the house. These are of limited value and really only of value for the residents of Tudor Cottage. They could both be coppiced to encourage bushy growth and contain the plants.

Hazel near the house.

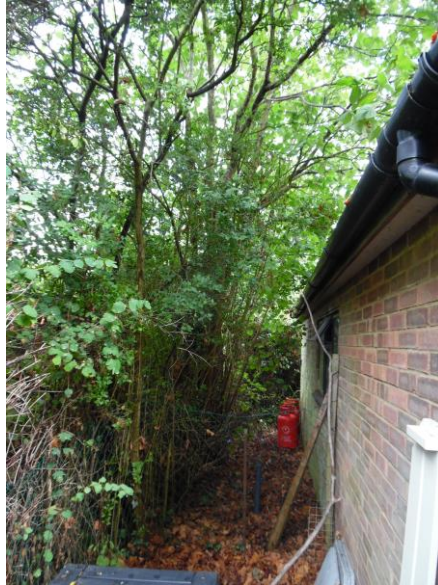
Hazel west of garage.
