# Design, Access and Heritage Statement

2. The building to which this application refers is Mulberry Cottage, Walden Road, Littlebury, Saffron Walden, CB11 4TA.
3. The property lies within the Littlebury Conservation Area.

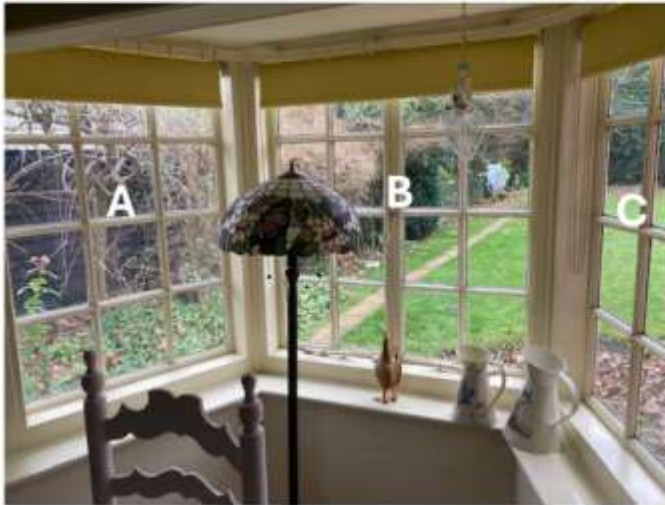
### Block Plan Reference – G1 & G2

Softwood, very poor condition, subject to numerous renovation attempts.

Minimal effective security

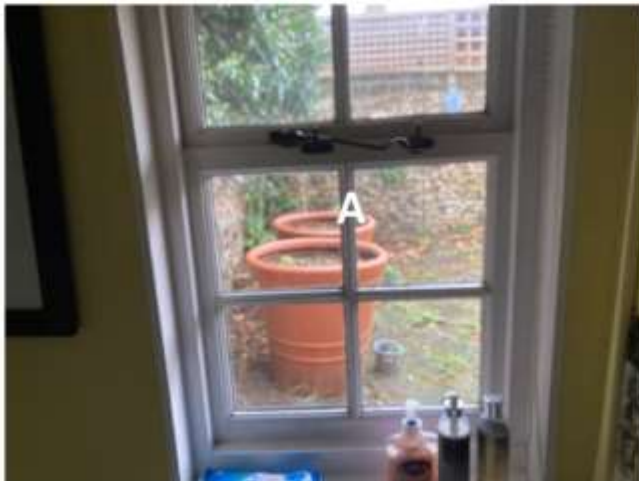
### Block Plan Reference – G3 & G4

Softwood, poor condition, subject to numerous renovation attempts.

Minimal effective security

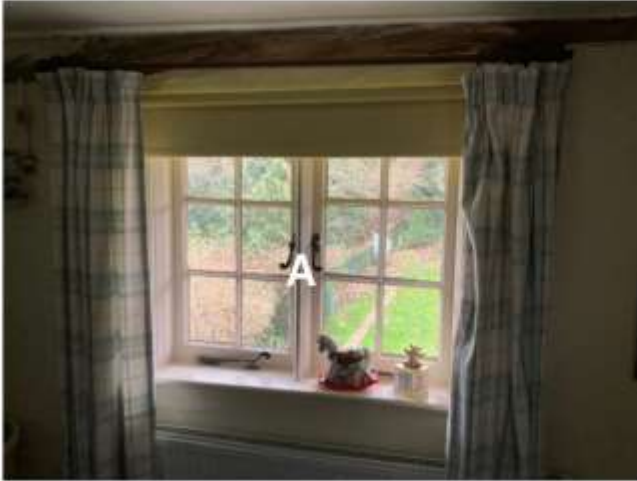
**Block Plan Reference – F1 & F2**

Fixed mullion

Softwood, poor condition, subject to numerous renovation attempts.

Minimal effective security

7. The affected windows currently have single glazing.
8. Windows reference F1 & F2 will have fixed mullions replaced with flying mullions to comply with prevailing legislation regards egress from a bedroom.

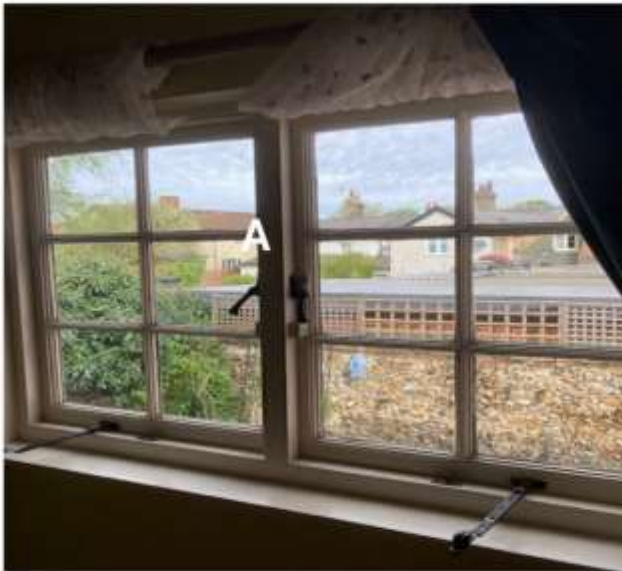
**Block Plan Reference – F3**

Fixed mullion

Softwood, poor condition, subject to numerous renovation attempts.

Minimal effective security

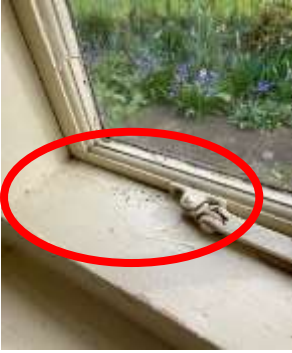
Gapping, water ingress

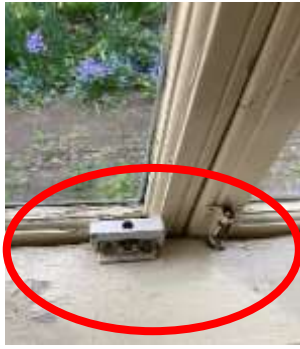
Excessive gapping when closed

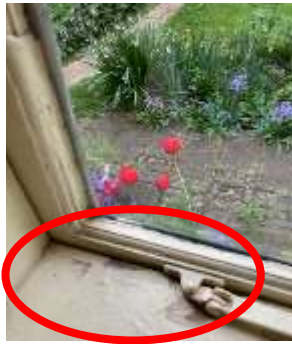
Gapping, frame deterioration

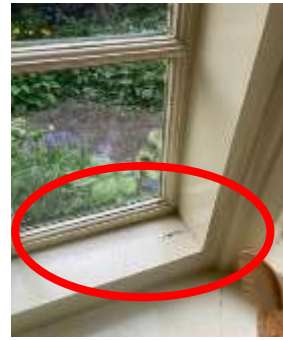
Frame deterioration

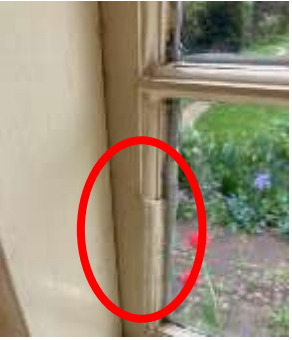
Multiple poorly spliced repairs

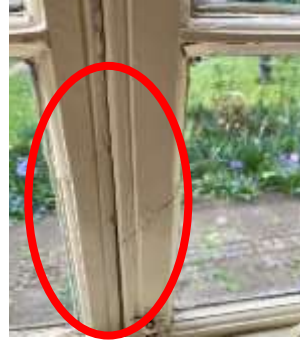
Multiple poorly spliced repairs

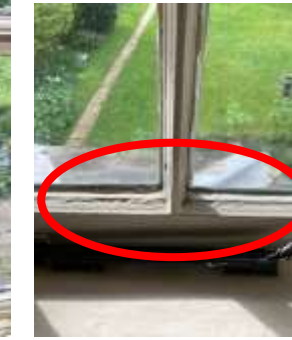
Interior Deterioration

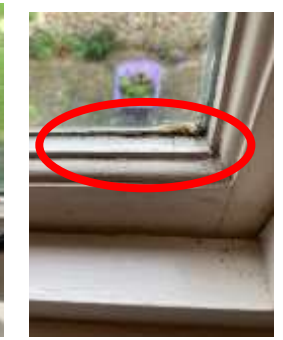
Interior Deterioration

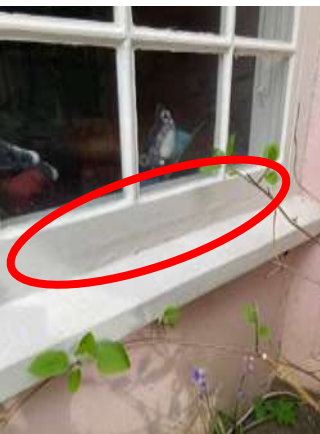
Repeatedly filled external frame & sill

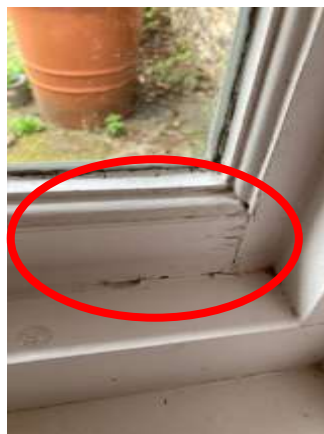
Frame Deterioration & Rot
