Design & Heritage Statement (incl. Statement of Significance)

Replacement Windows,
Replacement Mechanical Extract Ventilation (toilets and kitchen),
and Proposed Through Wall Vents to Below Floor Void.

Sidmouth YMCA, Mill Street, Sidmouth, EX10 8DF

Revised 22 April 2024

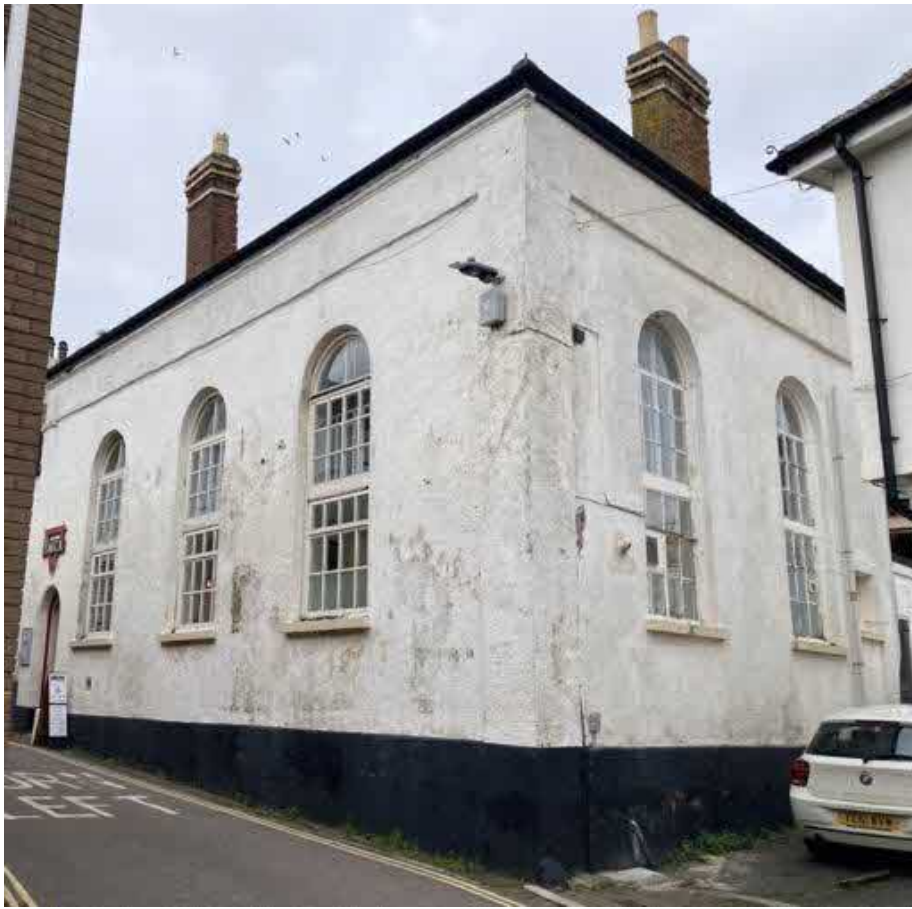
Fig 1 - Two Main External Elevations.

- 2.1.4 Refer to drawings 1271/24/05 to /11 inclusive which shows existing window elevations at 1:10 scale, and existing window sections at 1:2 scale.
- 2.1.5 Refer to fig 1 at Appendix B which shows the two main external elevations, containing all windows to which this application refers.

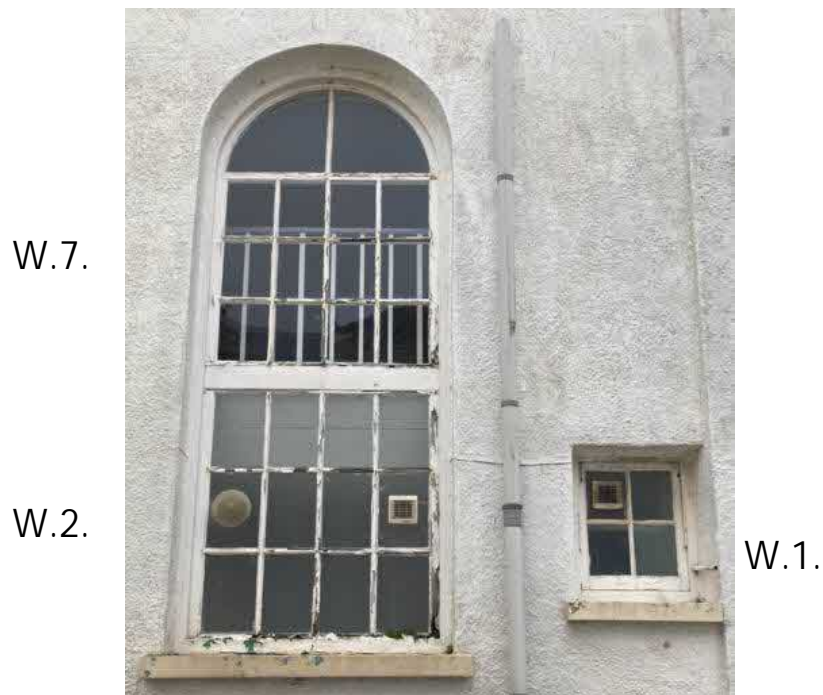
Fig 2 - Windows W.1, W.2 and W.7 (East Elevation).

2.3.2 There is a small window to the gents toilet, which looks like an afterthought, not aligning with anything else. This window no longer opens but was designed with pivot hinges (secured half way up sides), to open inwards and with a button latch to the top of the window (refer to figs 2 and 3). The window moulding internally is late C19 Ovolo.

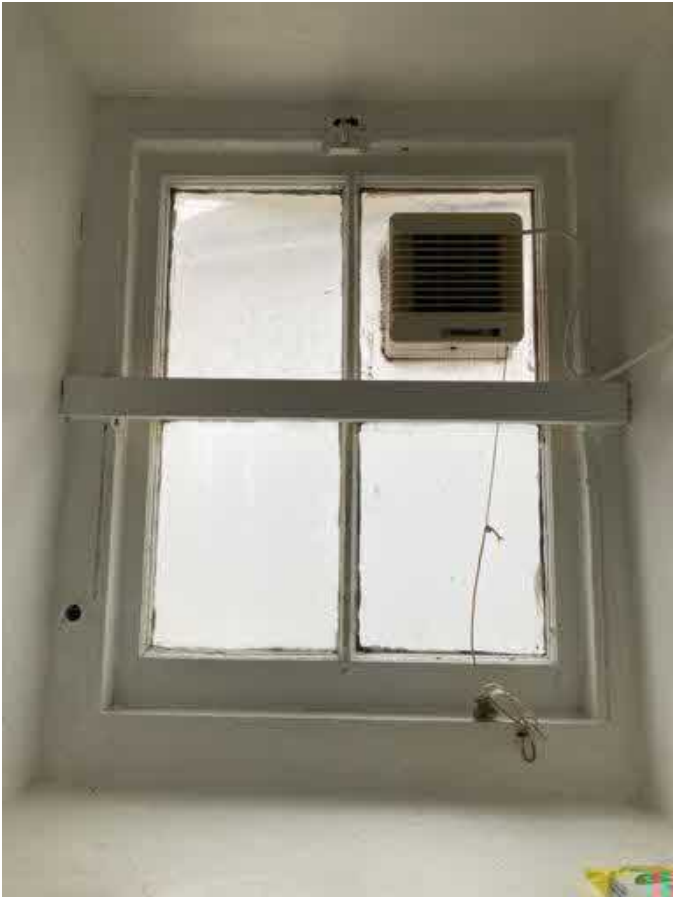
Fig 3 - Window W.1 - Inside View.

5.2.0 Window W.1. is most likely an original window from when this window opening was formed, thought to have been added in the late C19. Now in a poor state of repair. The moulding detail to the inside of the window consists a simple ogee mould as shown on drawing 1271-24-05 (Existing sections at 1:2 scale). In line with section 5.1 of 'HETW' the proposed replacement is a copy of the form and detailing of the original window, refer to drawing 1271-24-14 Rev A. For practical and security reasons the window is not required to open, and is therefore shown to be fixed shut. Alternative ventilation (mechanical) is proposed. This window is located in a non significant location, on a side elevation, not directly facing the street, in fact the window is thought to have been a later addition, an afterthought, for the practical purpose of light and ventilation to a toilet. Section 6.1 and point 3 of 'HETW' suggests '*Where historic windows or replacement windows of historic pattern survive without historic glass it may be possible to introduce slim-profile double glazing without harming the significance of the listed building*'. We do not consider the existing glass has any historic value / importance. Paragraph 5 at section 6.1 also refers to '*broken reflections by individually glazing each pane*', which is what we have proposed.

4.1.1 It is proposed to replace the existing window with new bespoke joinery as shown by drawing 1271/24/14, with internal mouldings to match existing. Window to be fixed shut.

4.1.2 Proposed glazing to be conservation double glazing, approx. overall thickness 12mm.

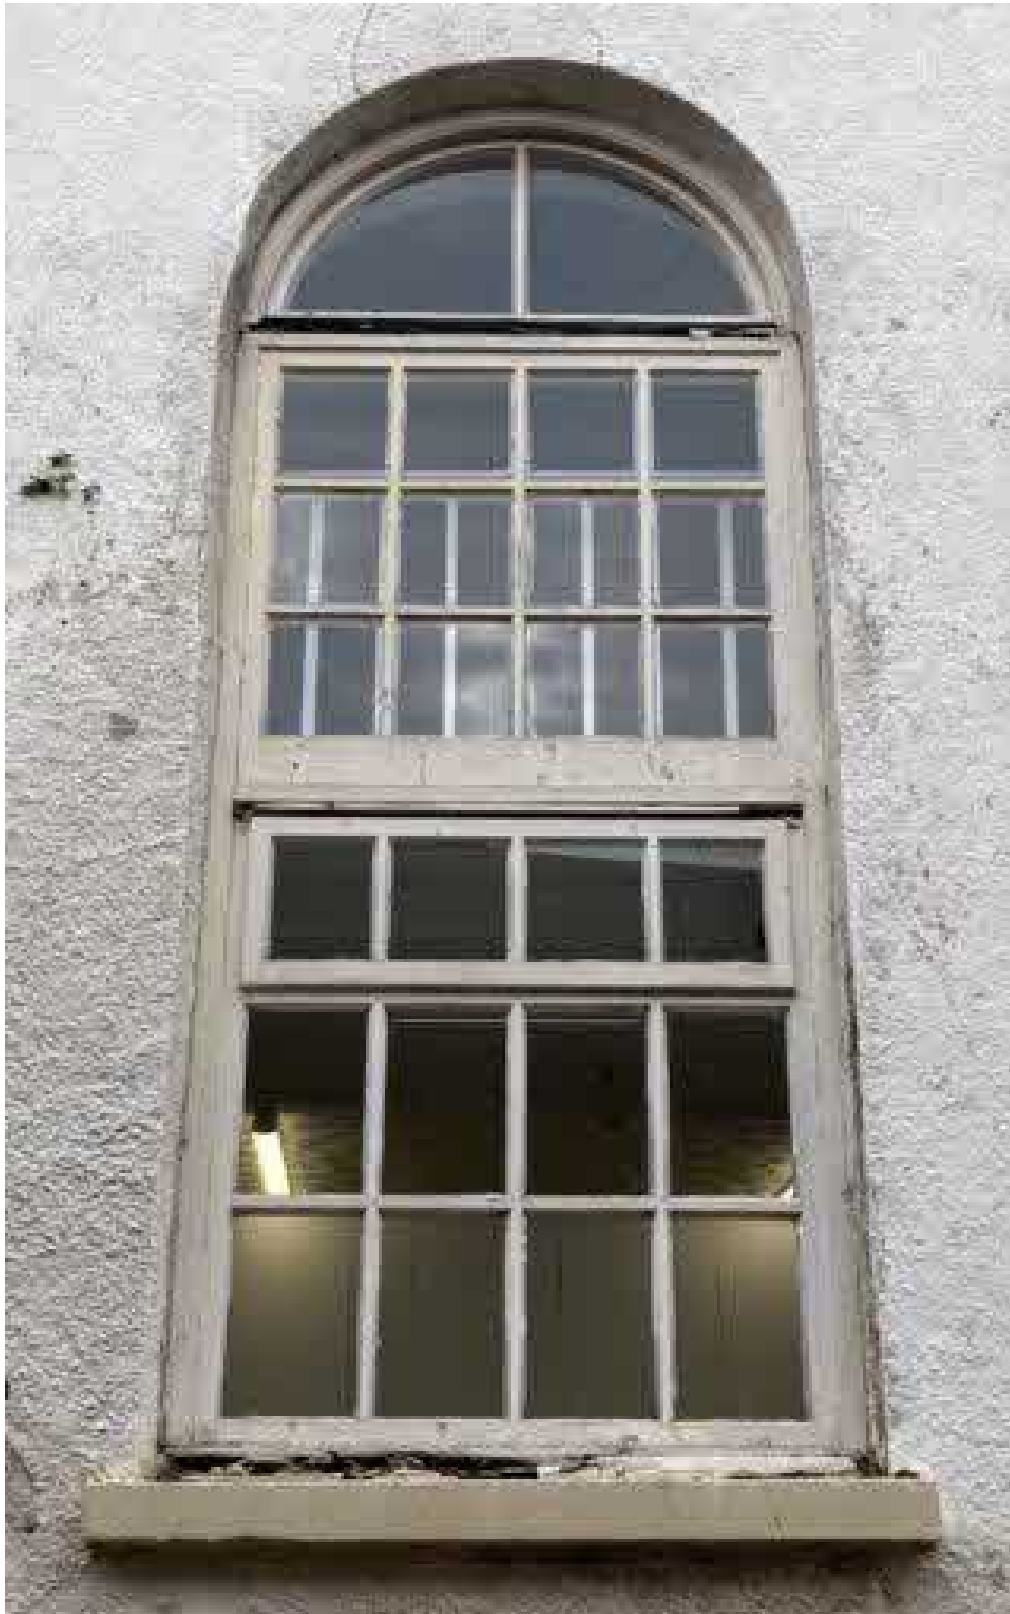
Fig 7 - Windows W.4. and W.9. (South Elevation).
Windows W.5. / W.10. and W.6. / W.11. are the same.

- 5.4.0 Windows W.4. / W.9., W.5. / W.10 and W.6. / W.11 are modern replacements, with storm proof top hung fanlights, now significantly decayed in places, and letting water in. Section 6.1 of 'HETW' point 1 states '*Where historic windows, whether original or later insertions, make a positive contribution to the significance of a listed building they should be retained and repaired where possible. If beyond repair they should be replaced with accurate copies*'. These windows are not historic and do not make a positive contribution. We consider these window to be inappropriate in their design and form and are detrimental to the heritage asset. Point 3 at 6.1 of 'HETW' states '*Where historic windows or replacement windows of historic pattern survive without historic glass it may be possible to introduce slim-profile double glazing without harming the significance of the listed building*'. We consider the replacement windows with individual small panes and slim-profile double glazing would not harm the significance of this building, providing the joinery is constructed in line with the section drawings provided. As discussed above at 5.3.0 the proposed replacement windows would follow the pattern of the windows shown at fig 17 (see also 5.5.0 below), with central mullion and two panes either side and four panes high for W.4, W.5 and W.6.

4.3.1 It is proposed to replace the existing windows with new bespoke joinery as shown on drawing 1271/24/15 and /16.

4.3.2 Proposed glazing to be conservation double glazing, approx. overall thickness 12mm.

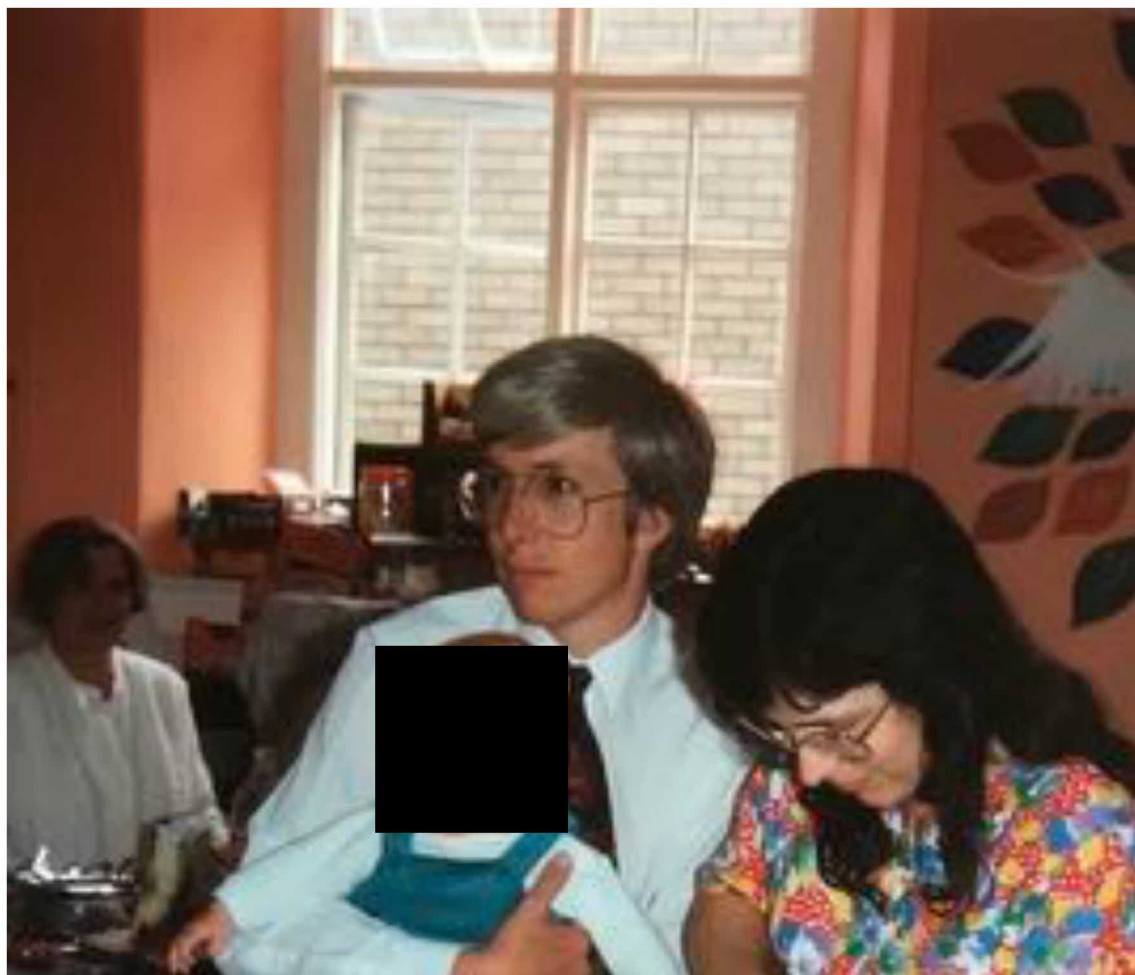
Fig 17 - Photograph taken in 1993, showing Internal View of Window W.5.
Prior to Replacement with Current Windows.

- 5.5.0 Refer to fig 17 which shows an internal view of window W.5. prior to replacement with the current window. The photograph is not particularly clear, however what can be made out is side hung casements with central mullion and top hung fan lights. The image is not clear enough to make out moulding detail and we don't know whether this window was an original from 1837, however this is unlikely. What we can make out from this image is wide cover boards (vertical) either side of the window, which doesn't tie up with what we see for window W.2. which appears to have remains of an early frame with simple bead detail, refer to fig 6, there is no wide vertical cover boards?

- 5.6.0 All existing windows at the lower level (W.2, W.3, W.4, W.5 and W.6) currently consist of four panes wide and three panes high. Fig 17 shows window W.5. to be four panes wide and four pane high?

- 5.7.0 Deciding on the design for replacement windows is not straightforward, because there is insufficient information to know exactly what the windows should be like. However fig 17 with central mullion and four panes high appears to be something to work with, this feels more authentic than the current window design / configuration. We have therefore shown a central mullion at both ground floor and first floor, with flush casements, fixed shut generally apart from the fanlights (outward opening) at the top of the ground floor windows and the inward opening half round fanlights at first floor.
