**BARN AT "THE OLD BAKERY", MAIN STREET, FLINTHAM, NOTTINGHAMSHIRE NG23 5LA**

**Heritage Statement to accompany proposed conversion as a residential annexe.**

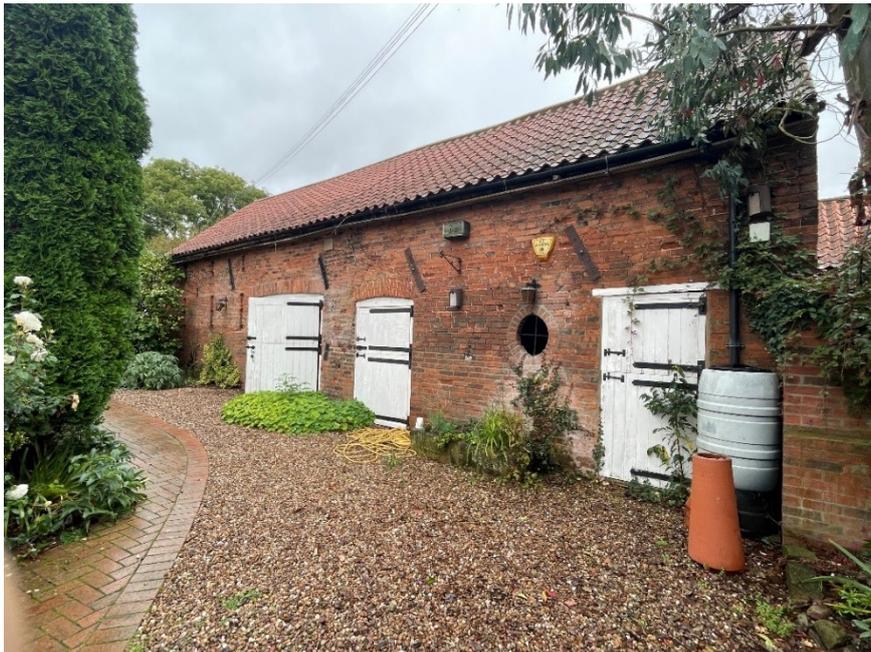
1. General view of front (west) elevation. Only the central of the three doorways is original. The jambs of the double doors to the left have clearly been cut through pre-existing brickwork, and a triangular spandrel of brickwork above these doors has been rebuilt. The right hand door, with timber lintel, is also cut through pre-existing brickwork. The breather vents and oval opening are original. Note also the four pattress bars; the further one cranks up internally and is fixed to the tiebeam of the kingpost truss; the next one connects across the width of the building in the normal way; the two others are fixed to beam ends in the first floor over the stable, and are repeated at the other ends of those beams.

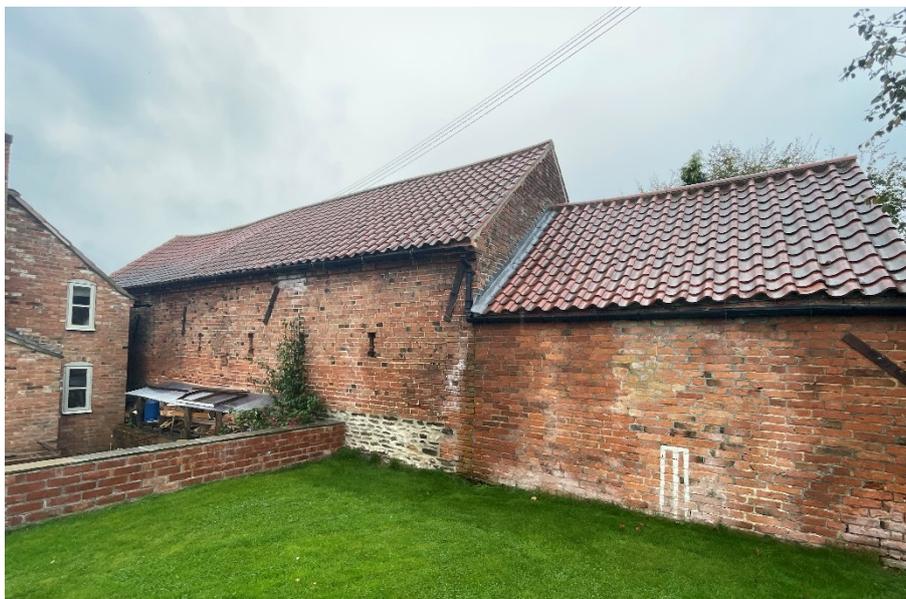
11. The building was built against the east boundary of the plot, such that its rear wall (**Photo 2**) is also the boundary wall with the adjoining property. The rear wall has a rubblestone plinth, which may be older than the brick building now built on top of it, given that it is the only part of the building to have such a plinth. The lower part of the internal cross wall also contains rubble stonework about 14” thick, which again may be “inherited” from a previous building. The first floor structure over the stable at the south end of the building contains joists which are re-used, possibly from a previous building on the site.

by the introduction of two steel purlins and additional timberwork, to arrest a pronounced sag. The original roof over the stable part comprised pairs of rafters jointed and pegged where they met at the apex, with no purlins or ridgeboard / ridgebeam (**Photo 9**). The rafters were “triangulated” to some extent by collars halved into each pair, but the lower ends of the rafters below the collar line were still able to bend and sag under the weight, and eventually this led to distress, failure and replacement of the collars and rafters in the central part of the loft, where the outward stress was greatest.

14. I assume that the roof of the entire building was formerly of the rafter-and-collar construction just described, but over the barn part it has been replaced with a conventional roof comprising a bolted softwood kingpost truss, purlins, rafters and ridgeboard. The severe outward bulging of the walls in the building, very evident today, is likely to have been caused principally by the original, inadequate roof, whose lack of lateral restraint would have pushed the walls out, causing a tendency to “self-destruction”.

2. Rear (east) elevation of the building, taken by kind permission of the neighbouring owner. Note the sag over the south (left-hand) end of the roof, caused by spread and failure of the original 18<sup>th</sup> century roof construction, which partly remains "in situ" there and is restrained by modern steelwork.

19. The building is under-used, and too large just for domestic storage. While its essential maintenance has clearly been attended to, it requires significant investment if its future is to be safeguarded. The brickwork requires repair and there is evidence of structural movement that appears to be ongoing, e.g. at the north-west corner. The rear wall in particular is significantly out of plumb and requires the opinion of an experienced structural engineer to determine whether it can be restrained in its existing position, or will require rebuilding.

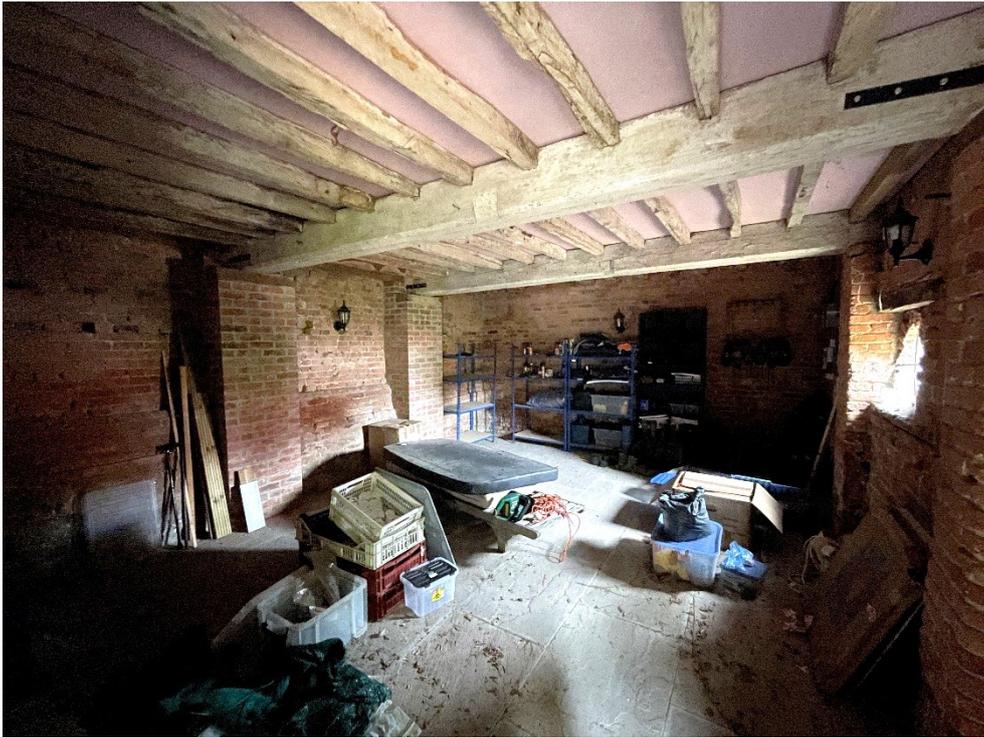
3. Interior of stable, looking south-east. Notches in the two main beams are likely to indicate where the original stall dividers were fixed to them. Some of the joists are re-used, and now support a modern boarded floor in the loft above. The joists above the former mangers on the back wall are modern, and may indicate the former presence of a slot in the floor there, for pitching fodder into the racks from the loft above.

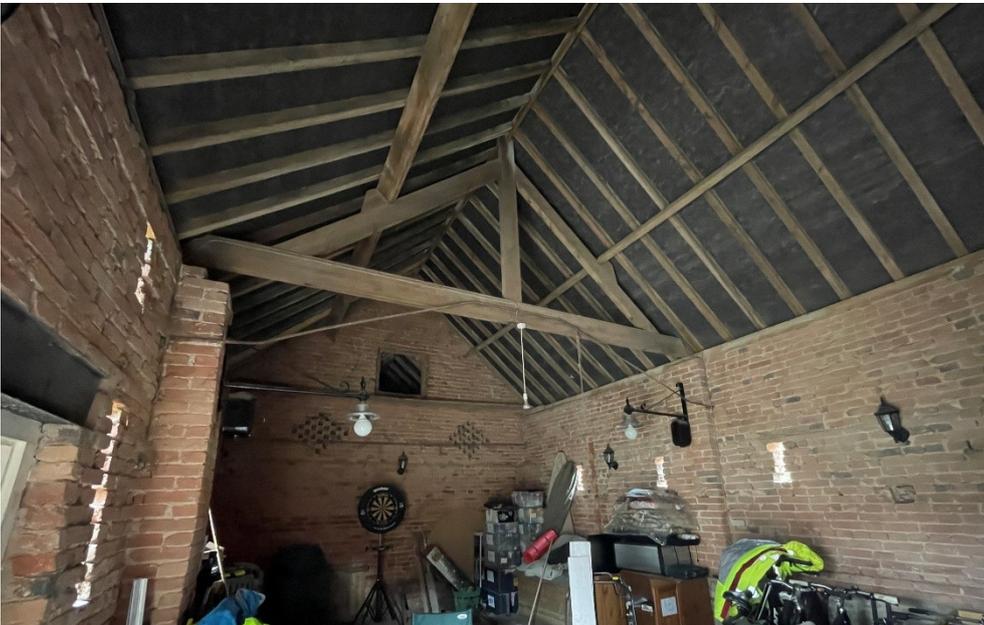
16. The other, larger, part of the building to the north has breather vents like a threshing barn (**Photos 4 and 8**), and is open full-height like a threshing barn, but had no door in the east wall to create the required through-draught for flail threshing. The large doorway in the front is itself not the original one, as can be seen by examination of its jambs and the rebuilding of a triangular panel above its arch. Presumably there was a smaller doorway here before.

4. Interior of barn looking north, showing ?early 20<sup>th</sup> century roof carpentry, and underfelt from a more recent re-tiling. The projecting pilasters may suggest an earlier roof truss in the position of the present one, perhaps consisting only of two rafters of more generous section than the others, with a collar and a tie beam. Note the tie rod, which cranks upwards to meet the tie beam.

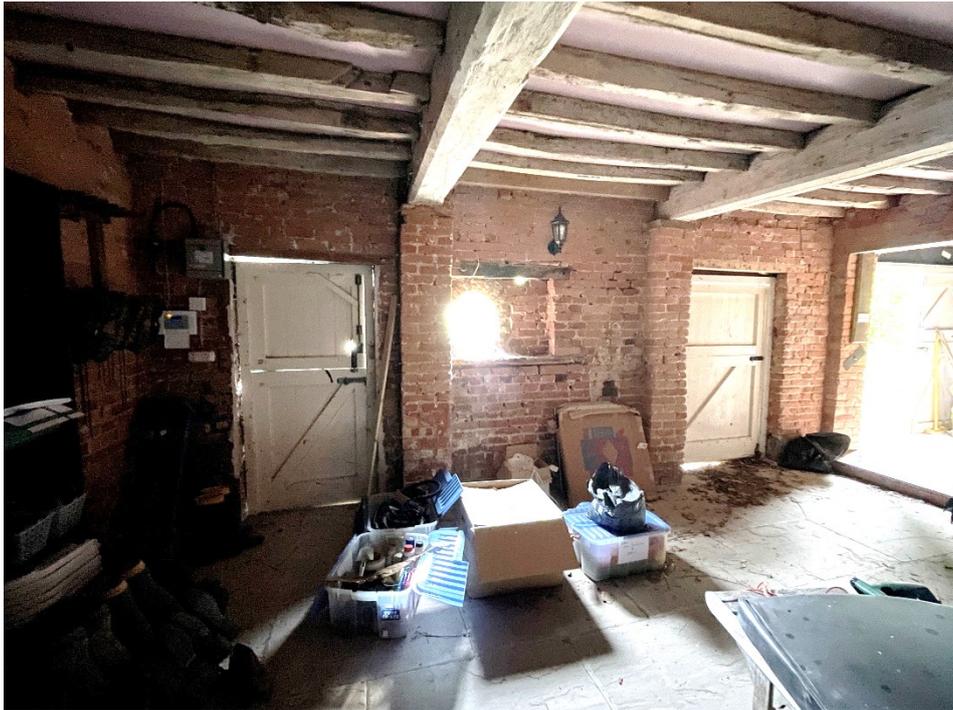
15. The stable part has been stripped of its fittings (**Photo 6**), but there appear to have been three stalls in it, with racks and mangers on the rear (east) wall. Replacement rafters in the first floor structure suggest that there were originally gaps down the east side for pitching hay down from the loft into the racks, in the usual manner. There is an original door in the front wall, and an oval opening which appears to have been designed to have an internal shutter to slide across it (**Photo 5**).

5. Front (west) wall of stable, showing recess by oval window which presumably once housed a sliding shutter.

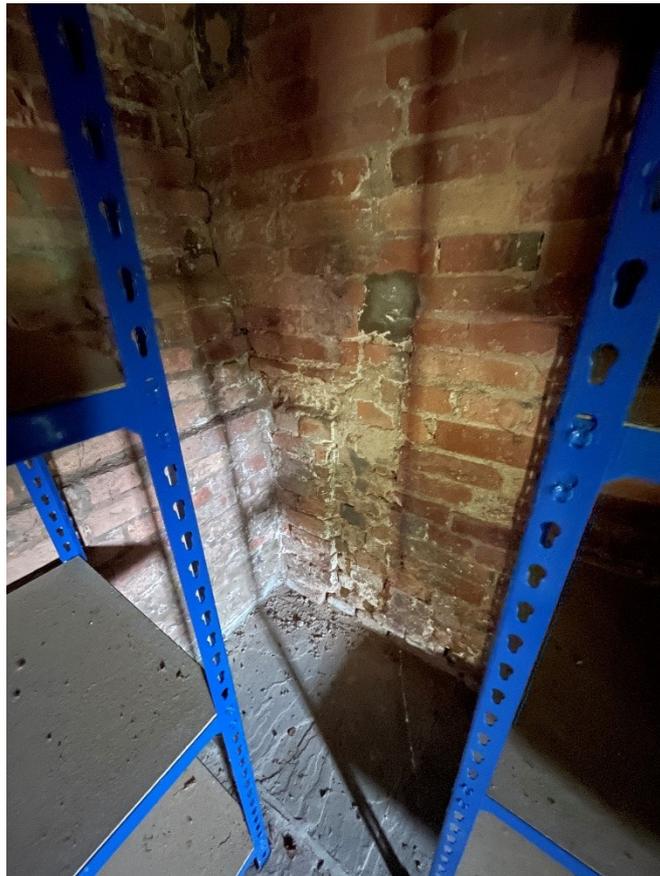
6. "Ghostings" or scars in the south-east corner of the stable hint that former brick-built mangers have been rebuilt.

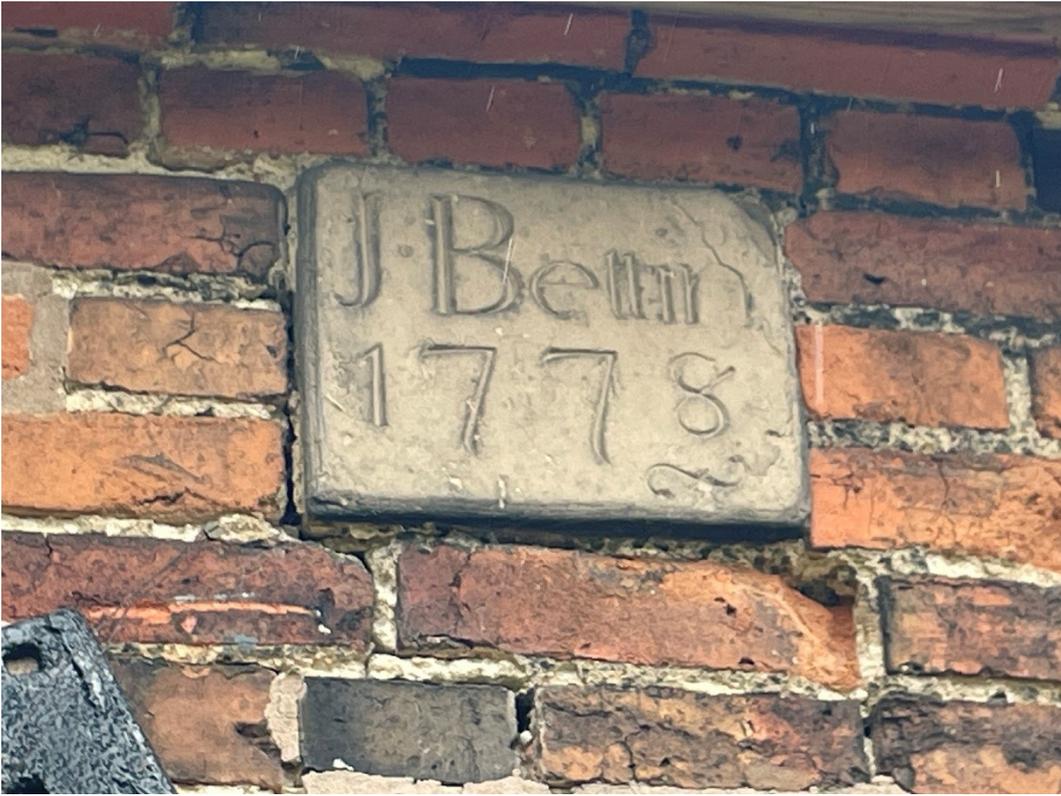
12. The building has a helpful datestone on the front, reading “J. Bettinson 1778” (**Photo 7**), and there is no reason to doubt this as the date of the present building, whose details appear generally consistent with such a date. In the main, it is built of 9” brickwork in a variant of English Bond, with a course of headers following every three courses of stretchers. The bond is interrupted in the upper part of the front wall at the stable (south) end, and the south gable end may be of a later period entirely; it may be that the 1778 building was built against an earlier one at the south end, and that the south gable had to be rebuilt when that building was removed.

7. Name and date stone on front of building reading "J. Bettinson 1778". The letters "son" are awkwardly squeezed into the top right-hand corner.

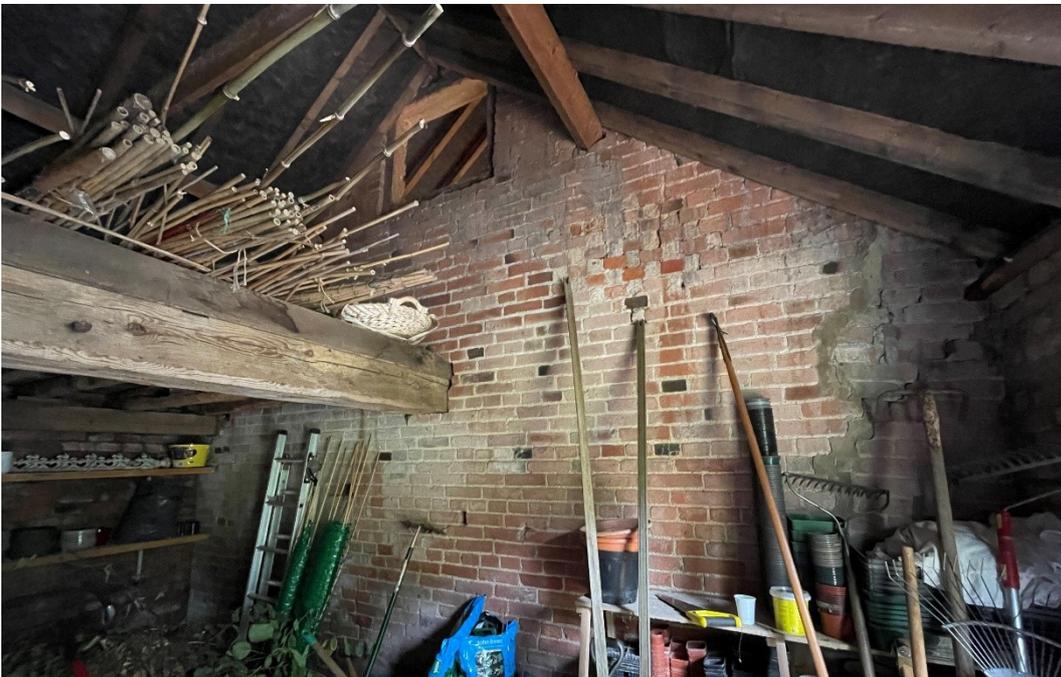
8. North gable end of original building, taken from the interior of the north addition, looking south. Note the pitching door high in the gable, and one of the diamond breather patterns below it and to the right, bricked up.

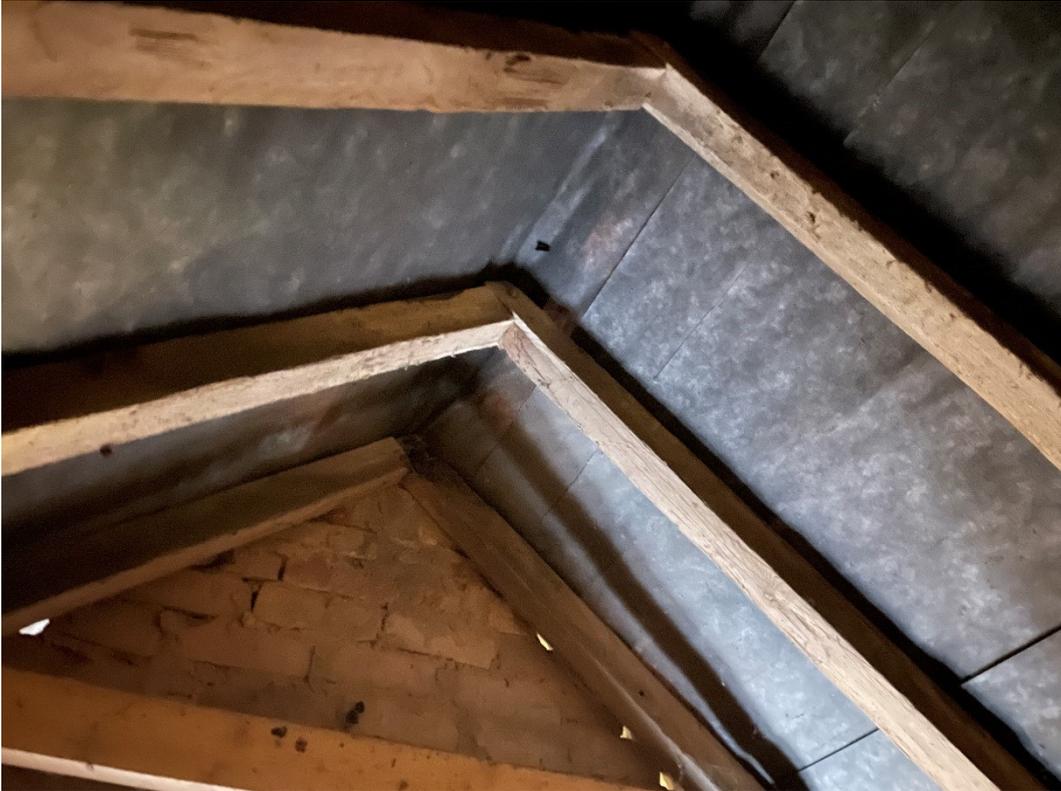
9. Ten pairs of the original coupled rafters remain in situ in the roof over the stable, pegged together at the apex without ridgeboard or ridgebeam, in line with common 18<sup>th</sup> century practice. They were “triangulated” by horizontal collars halved into them part way down.

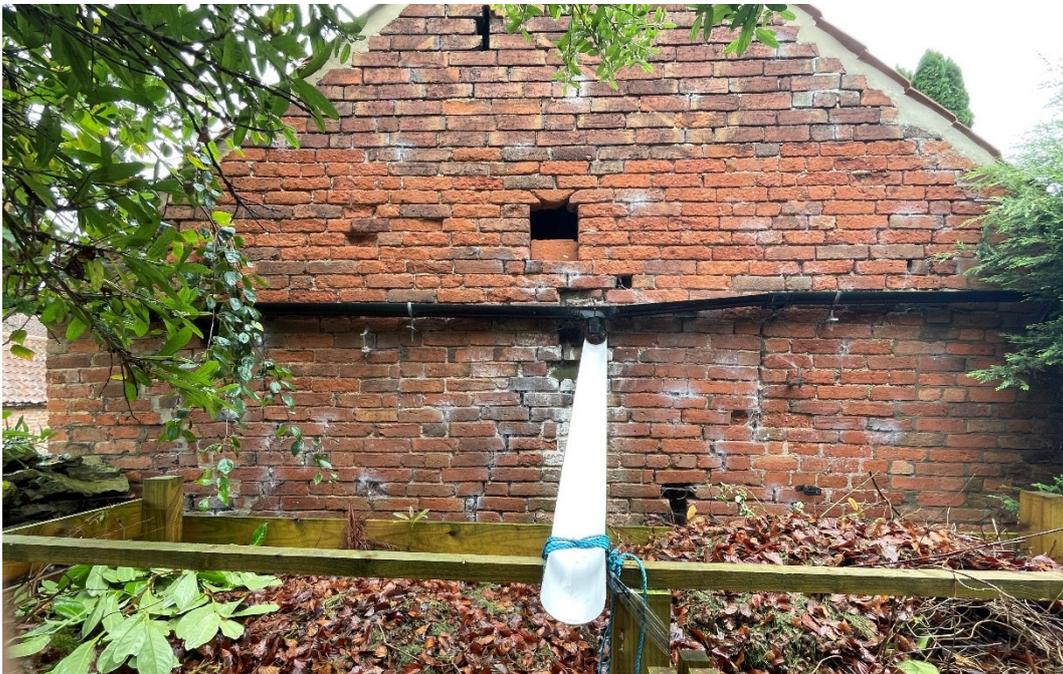
10. North gable end of north addition. There are two square-ish blocked openings, symmetrically placed, below the line of the present gutter. Not also the small opening above the gutter, perhaps intended to allow access by hens to a loft.
