Arboricultural Impact Assessment and Tree Protection Plan

West Bradley House

5th March 2024

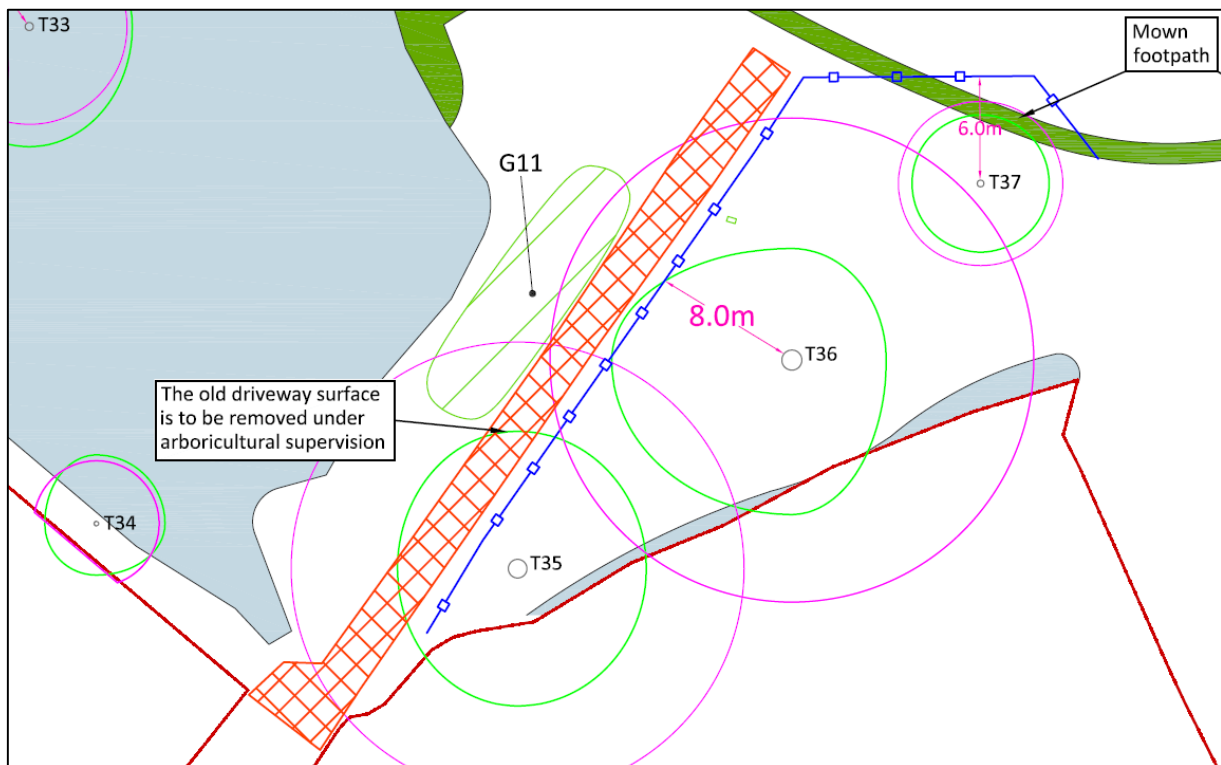
3.6.1 The old tarmac driveway surface is to be removed and reverted to soft-landscaping. It is likely that roots from trees T35 and T36 will be situated beneath this surface. These are important landscape trees and there is the potential that their roots could be damaged by the removal of the old tarmac. Therefore, it is proposed that the removal of this old drive is carried out under arboricultural supervision.

Figure 1: The area where special care will be required when removing the old tarmac driveway is identified with orange hatching.

3.6.2 The area where special care will be required is identified by orange hatching on the Tree Protection Plan. A record of this supervision will be produced by the project arboriculturist and this will be supplied to the Somerset Council tree officer.
